Preliminary Environmental Site Investigation
Naval Point Recreational Reserve
54 and 56 Godley Quay
Lyttelton

Submitted to:
Christchurch City Council
OP – Assets and Networks Unit
PO Box 73011
Christchurch 8154

26.01.2015
11539.000.001

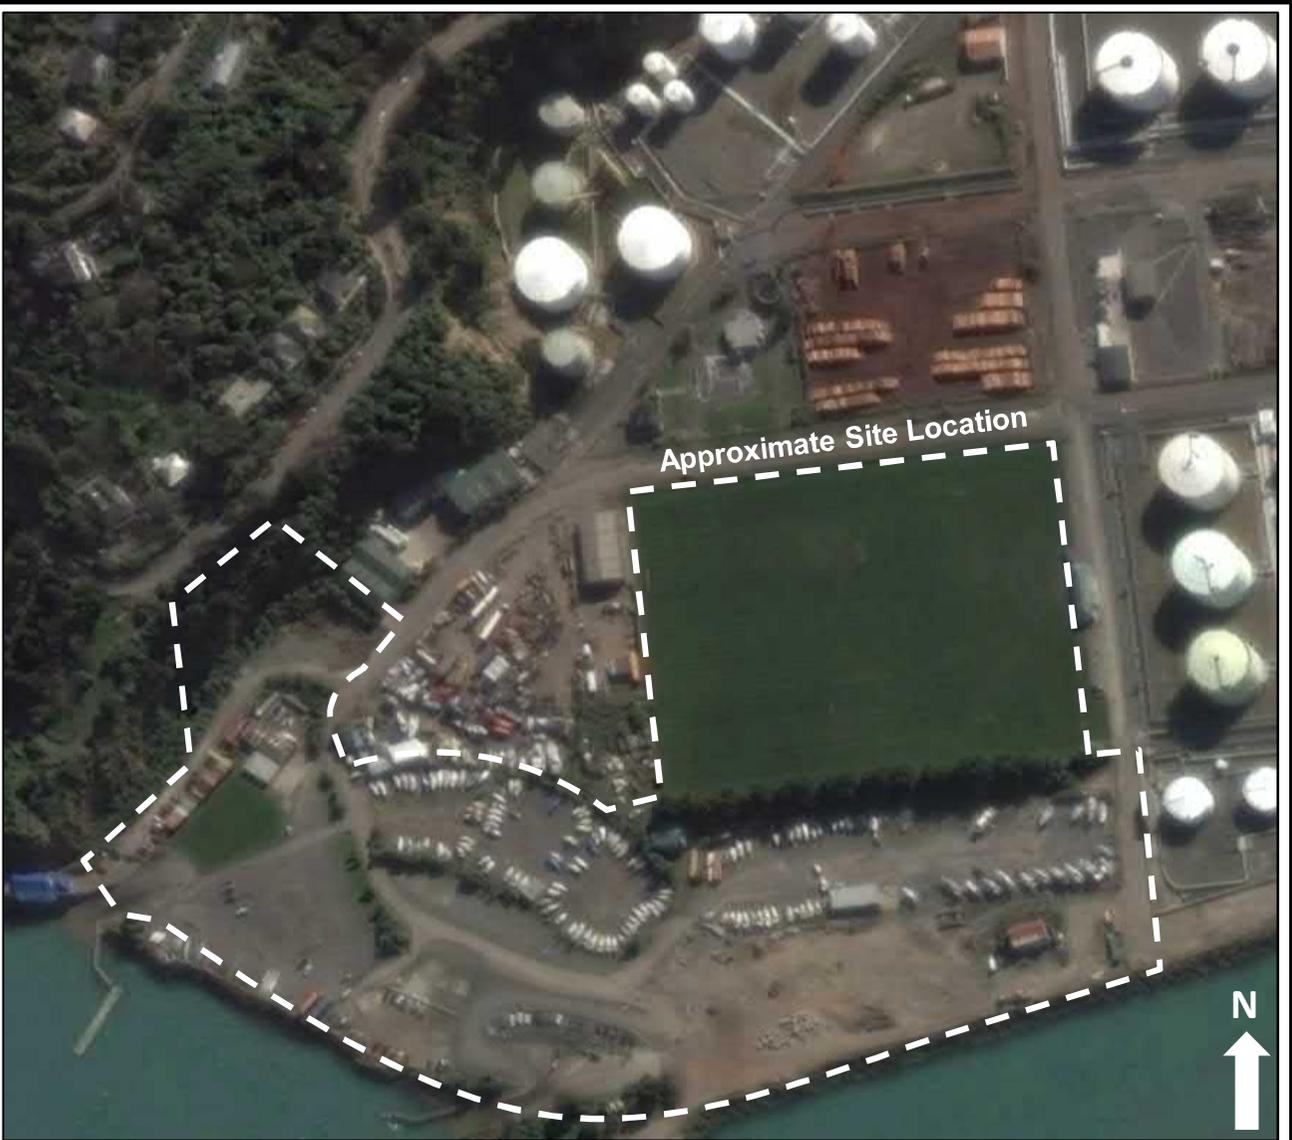
Date	Jan-15	Client	Christchurch City Council		
Drawn by	CM	Project	Naval Point Recreational Reserve		
Approved by	DR	Description	Site Location Plan and 2011 Aerial Photograph		
Scale	NTS	Figure Number	1	Project Number	11539.000.001_1

Existing Groundwater Monitoring Well

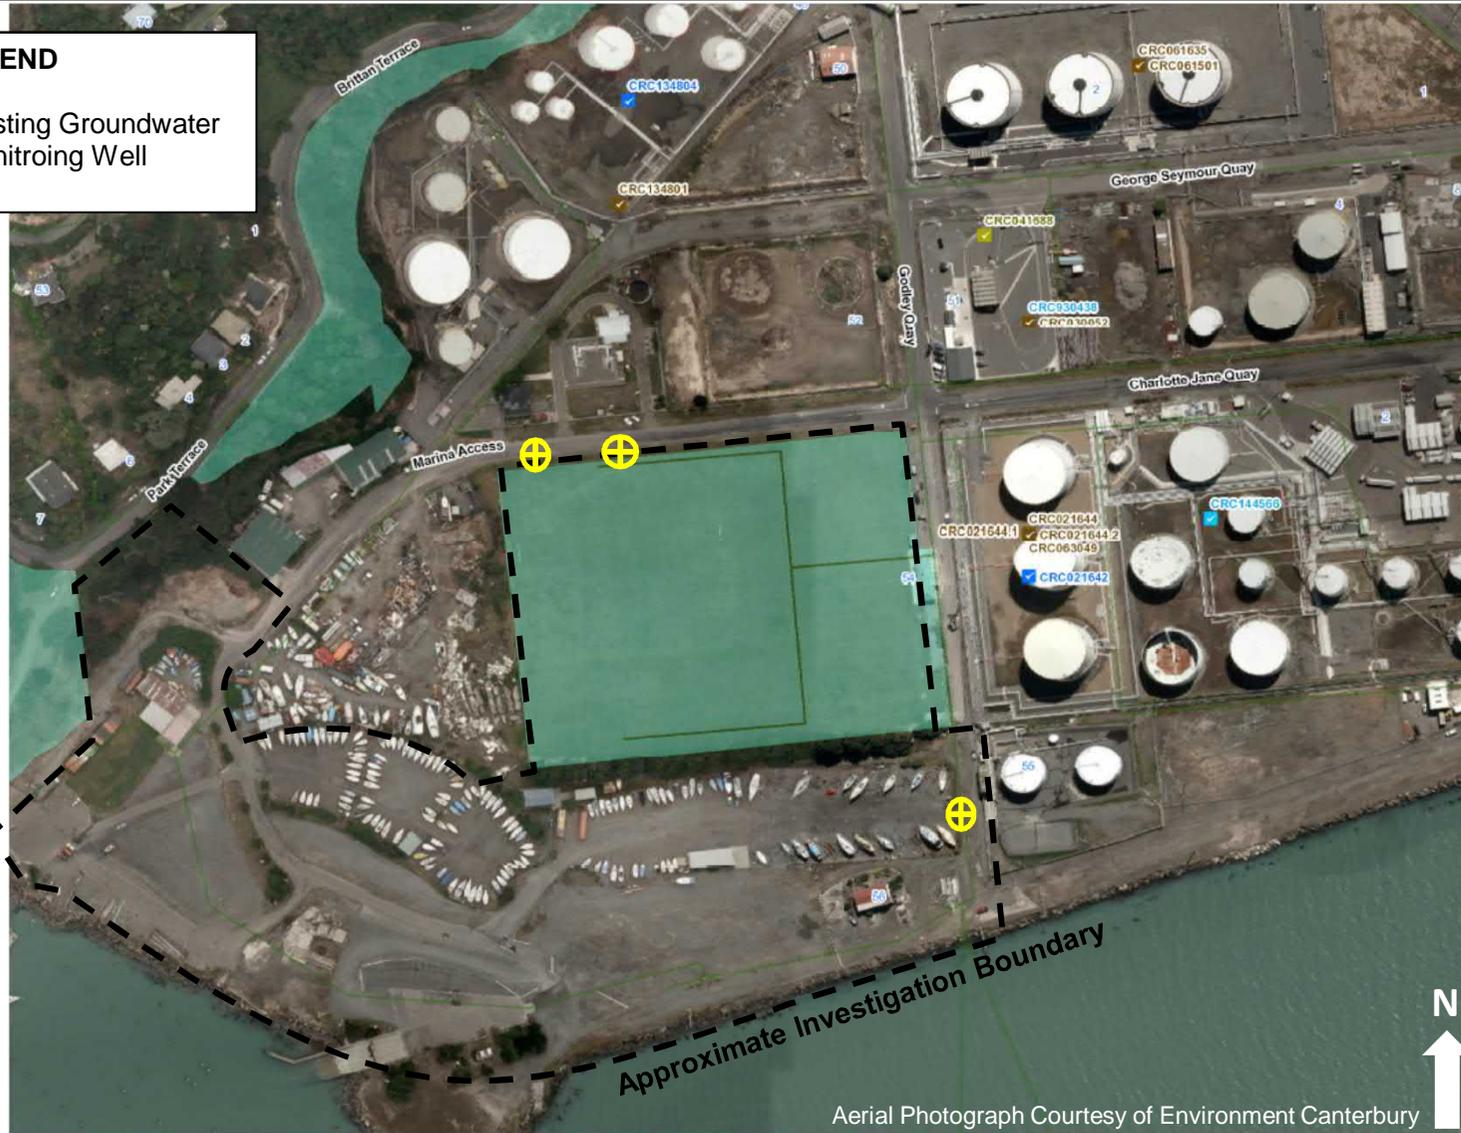
Date	Jan-15	Client	Christchurch City Council		
Drawn by	CM	Project	Naval Point Recreational Reserve		
Approved by	DR	Description	Discharge Consents		
Scale	NTS	Figure Number	2	Project Number	11539.000.001_1

Item	Description
	groundwater flow direction was reported as southerly (Refer to Appendix 2). The shallow non-artesian aquifer does not meet the criteria to be classed as sensitive according to the MfE ⁷ (Refer to Appendix 2).
Groundwater Abstractions⁵	A record of a consent to abstract groundwater was found within 100 m of the site, however the permit was terminated in 2007.
Discharge Consents⁵	Four consents to discharge contaminants were found within 100 m of the site (Refer to Figure 2), however only one remains active as the rest have expired or have been terminated: CRC021644.2 is held by BP Oil New Zealand Limited to allow the discharge of a contaminant (stormwater) onto or into land in circumstances which may result in that contaminant entering water. The conditions of the consent limit the discharge to tank condensation water and stormwater from the bunded areas “to the Banks Peninsula District Council Godley Quay stormwater main via an API separator”.

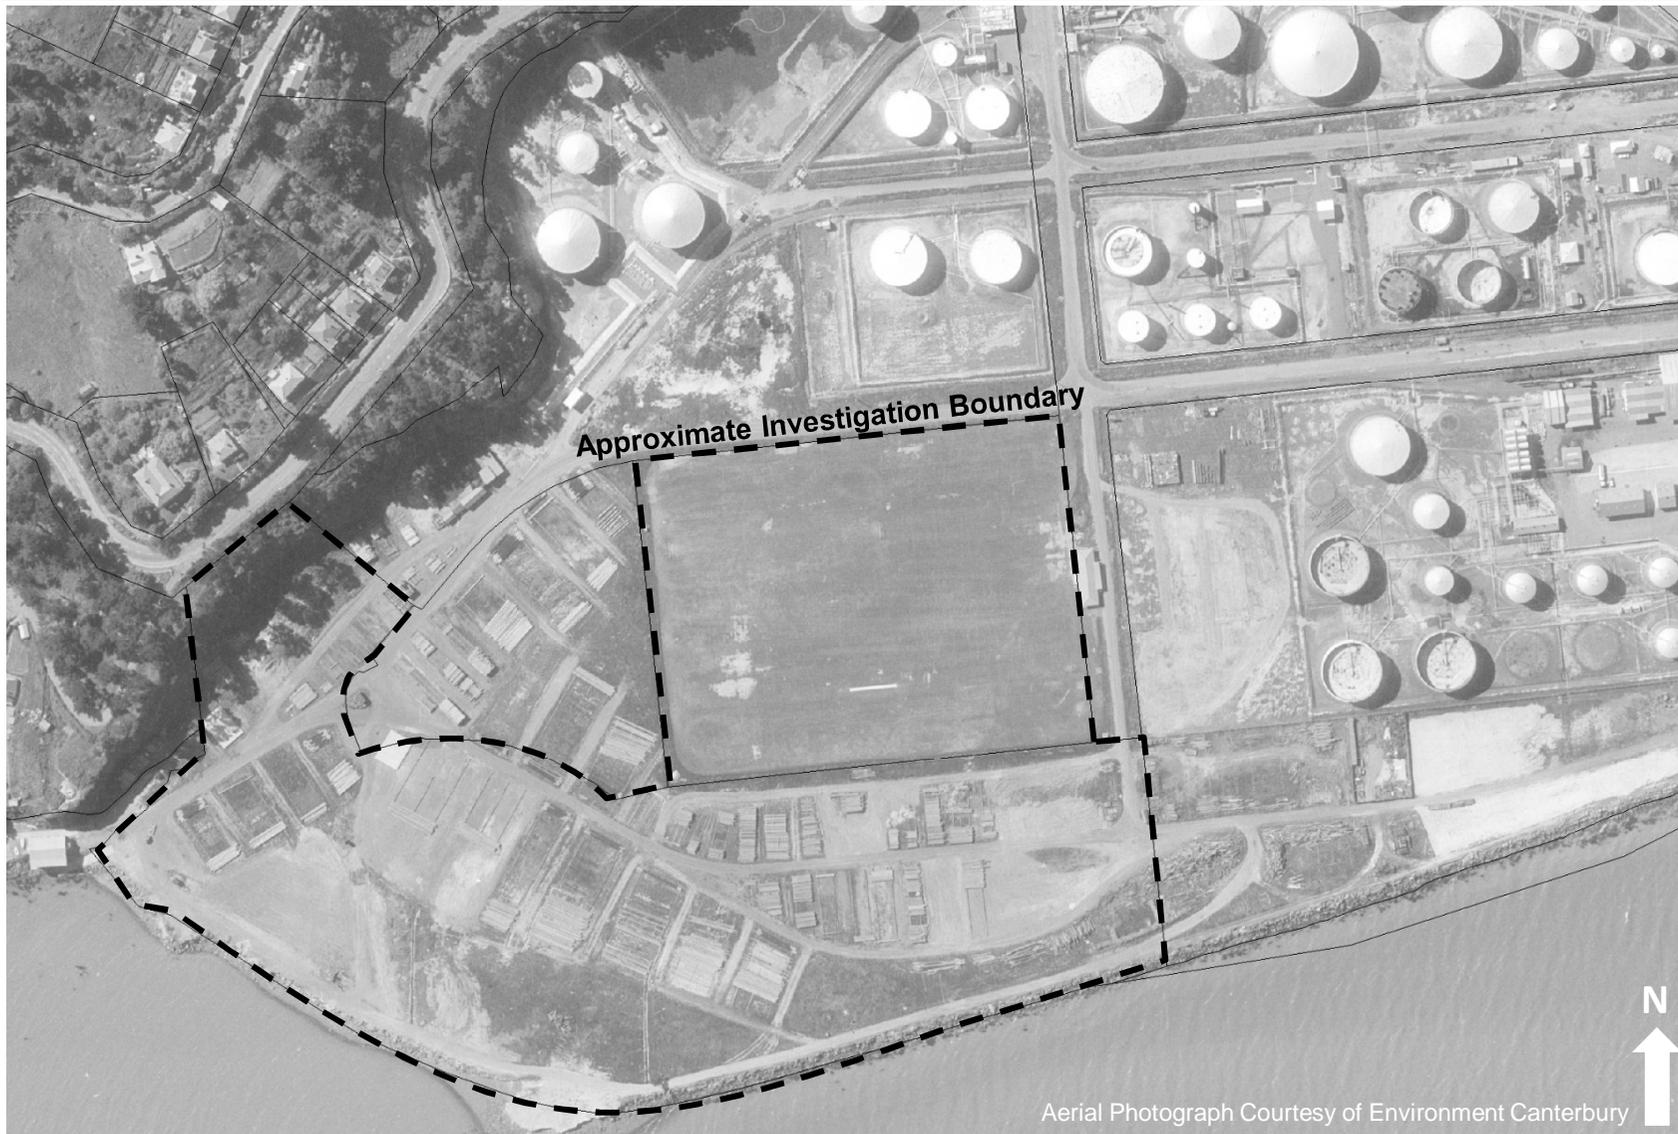
Date	Jan-15	Client	Christchurch City Council		
Drawn by	CM	Project	Naval Point Recreational Reserve		
Approved by	DR	Description	1965 Aerial Photograph		
Scale	NTS	Figure Number	3	Project Number	11539.000.001_1

Aerial photographs dating from 1937 to 2014 have been reviewed (refer to Figures 3, 4 and 5). The relevant visible features are summarised in Table 5.

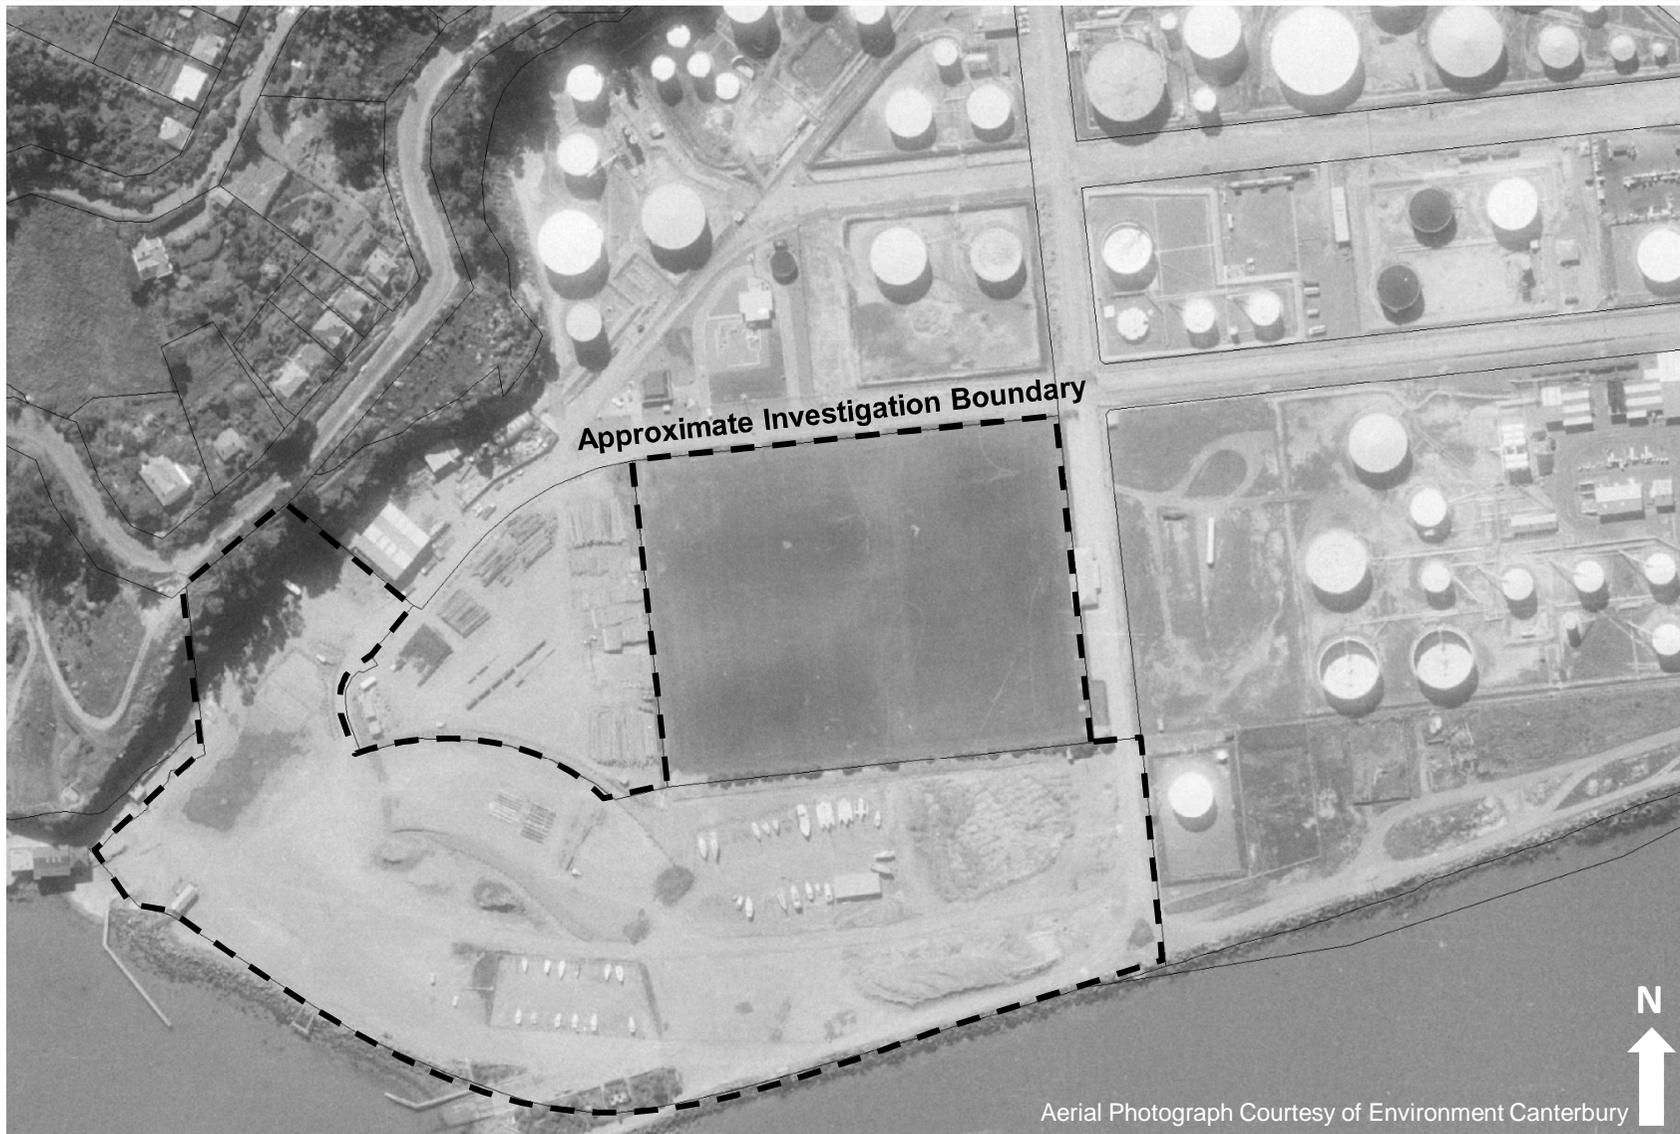
Date	Jan-15	Client	Christchurch City Council		
Drawn by	CM	Project	Naval Point Recreational Reserve		
Approved by	DR	Description	1984 Aerial Photograph		
Scale	NTS	Figure Number	4	Project Number	11539.000.001_1

Site Condition	Comments
	Scouts building.
Surface water appearance	No surface water was observed. No evidence of contamination was observed in adjacent harbour water.
Current surrounding land use	Industrial, recreational and residential
Local sensitive environments	The Lyttelton Harbour is located along the southern boundary of the site.
Visible signs of plant stress	None observed
Potential for on or off site migration of contaminants	The potential exists for migration of contamination to the site in groundwater from surrounding sites towards the north.
Additional Observations (if any)	Tarpaulin covered stockpiles were observed in a fenced yard in the north west corner of the site. An underground fuel storage tank filling point was located adjacent to the Coast Guard building in the south east of the site. Three groundwater monitoring wells were observed around the site. Their locations are indicated on Figure 4.

If off-site disposal of material excavated from zones highlighted in Figure 4 is required during future redevelopment works, it is recommended that the material be characterised to determine the suitability of the intended disposal facility / receptor site.

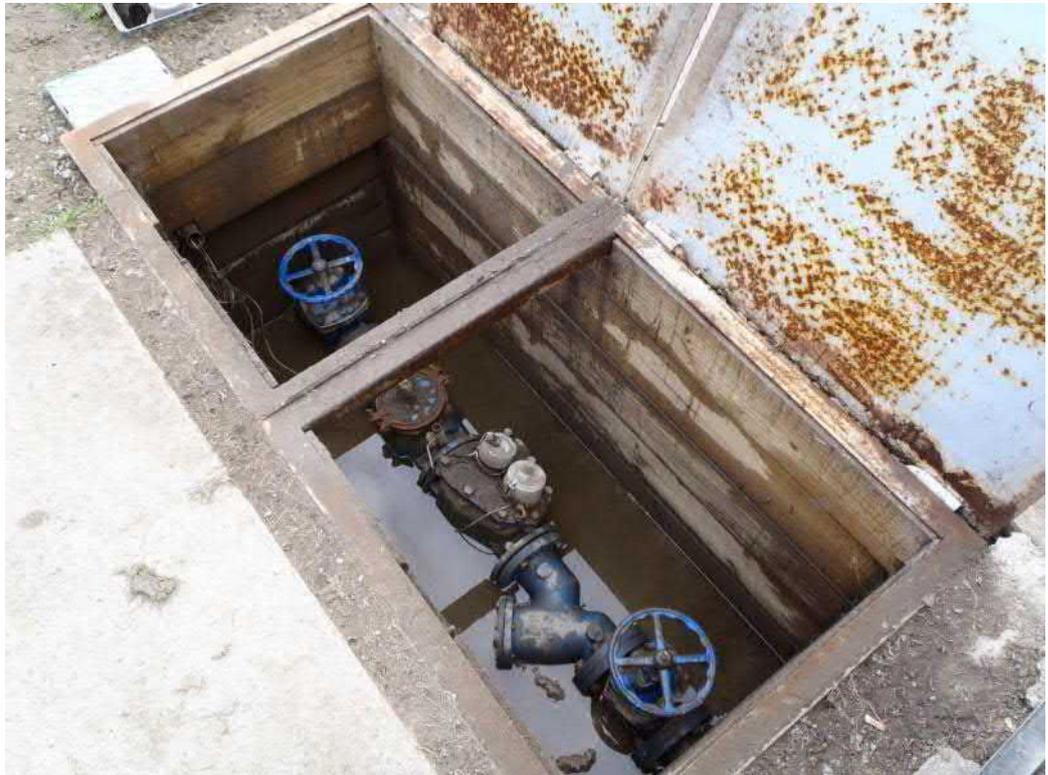
Photo No. 10	Date: 10/09/13
-------------------------------	--------------------------

Description:
Man hole near north western corner of building

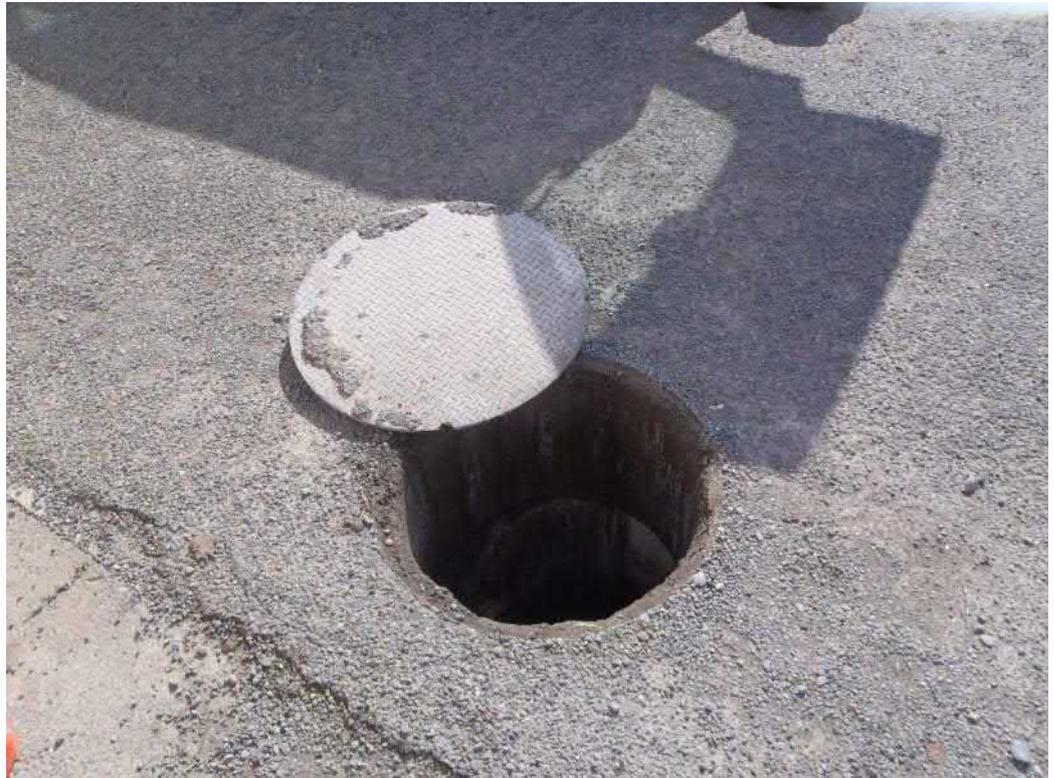
Description:
Manhole near northeast corner of building

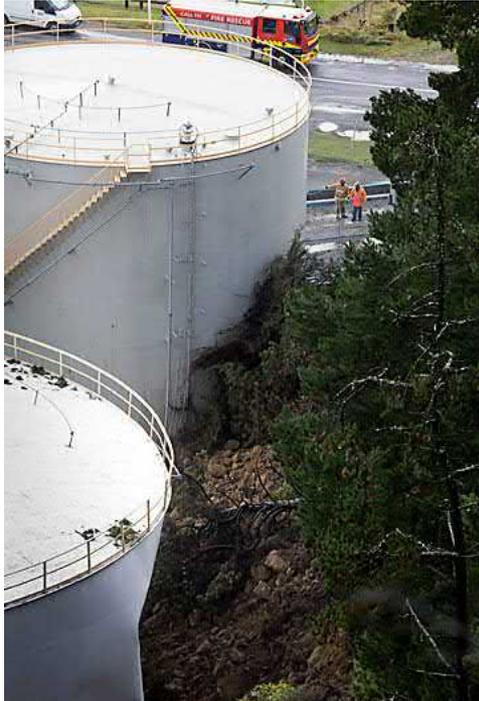
DAMAGED: A slip has damaged a fuel tank at Lyttelton.

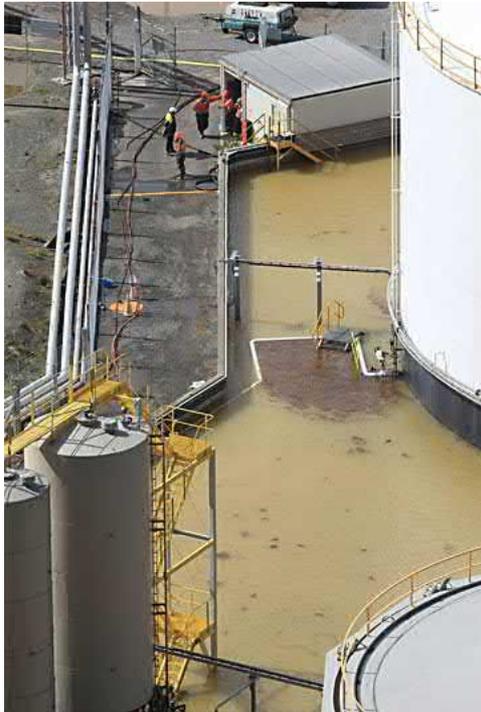
JET FUEL: Most of the aviation fuel that leaked from a punctured tank at Lyttelton Port, has been contained, but 1500 litres has flowed into the harbour.

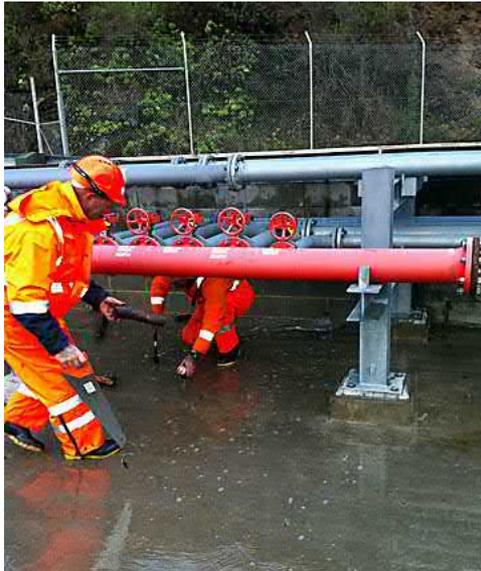
QUICK FIX: Lyttelton tank farm workers cut make-shift bungs from branches to shove into holes in Mobil secondary containment wall, or bund, to stop the flow of jet fuel to the harbour. One of the five holes can be seen in the background under the pipes.

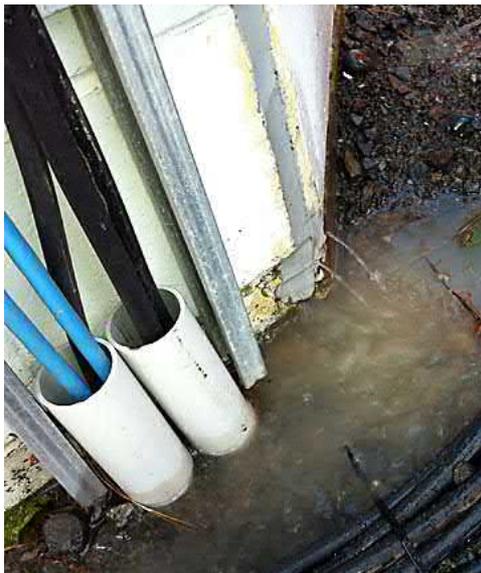
LEAKING: Steadily flowing leaks from repairs in Mobil's secondary containment wall, or bund, pool on the ground. A Mobil worker told the ECan harbour master they were earthquake repair patches.

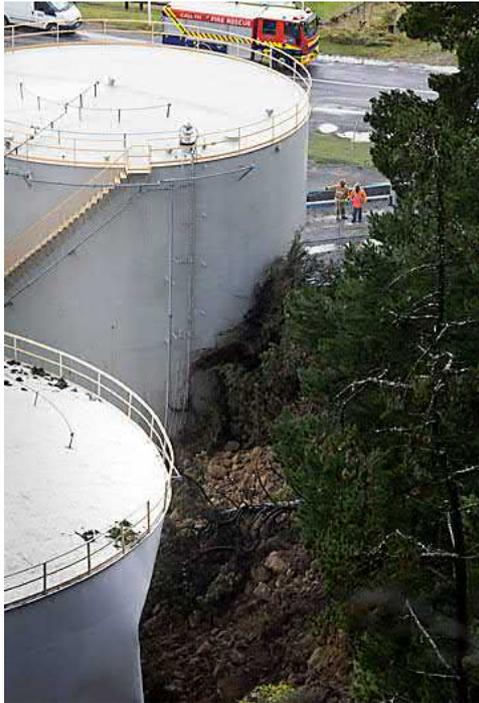
Online news articles published by 'The Press' indicate that 1.2 million litres of jet fuel leaked from a bulk liquid fuel storage tank when a cliff collapsed and punctured the tank on the 5th of March 2014. The majority of the fuel was contained within a bunded holding area around the tank, but approximately 40,000 litres was able to discharge from the site into the public stormwater system. Reportedly, 1,500 litres of fuel eventually discharged to the Lyttelton Harbour through the stormwater system, while the remainder of the fuel in the system was removed from the stormwater lines.

DAMAGED: A slip has damaged a fuel tank at Lyttelton.

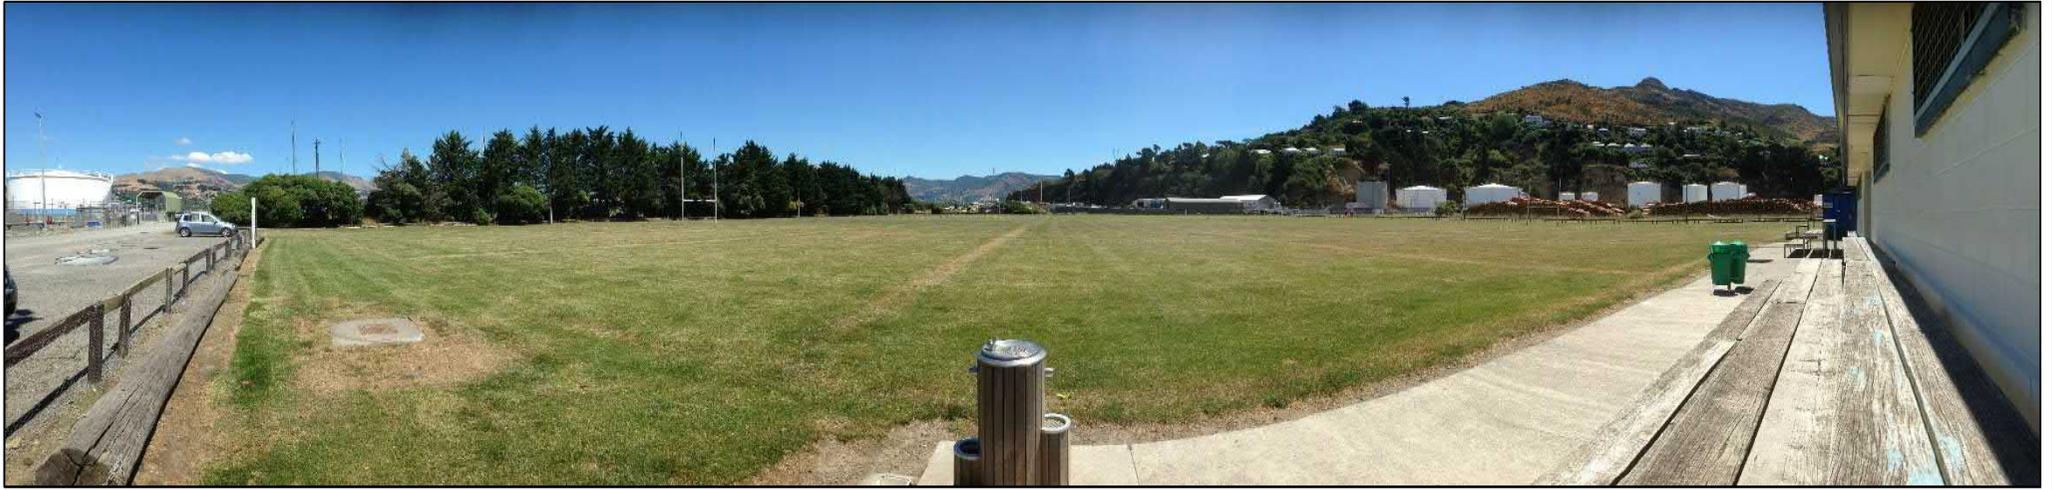
Investigations:

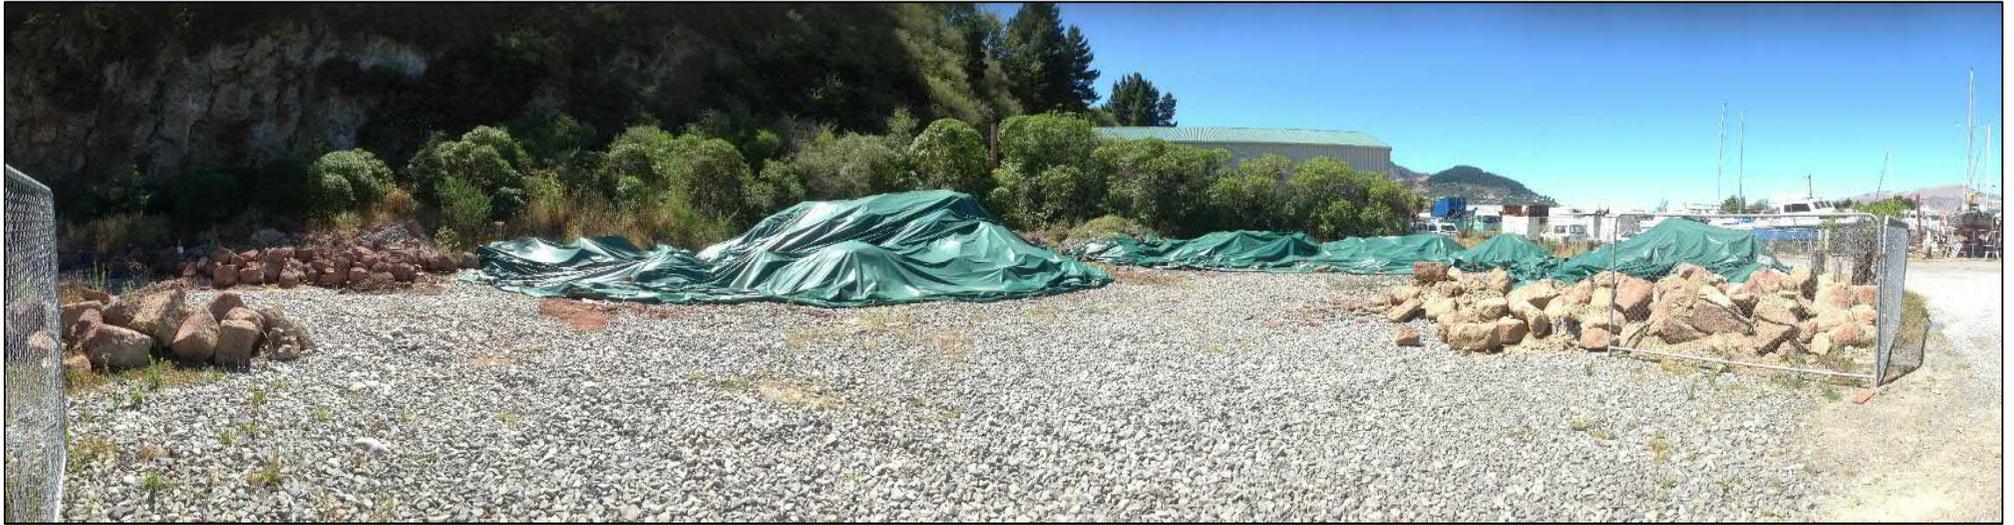
Several sources of contamination were observed during the site walkover including a single underground fuel storage tank, surface oil stains, a small campfire area, old and new treated timber poles, covered stockpiles of unknown material and possible asbestos-containing materials. The majority of these are considered unlikely to represent a risk to human health in their current positions. However, earthworks associated with possible future redevelopment of the site can create conditions where exposure to the contaminants and / or discharge to the surrounding environment is more likely. Demolition of buildings and / or off-site disposal of material from some parts of the site, if required, may also result in conditions of increased risk of exposure to contaminants or increased risk of discharge to the surrounding environment.

Photo 2: Tarp covered stockpiles

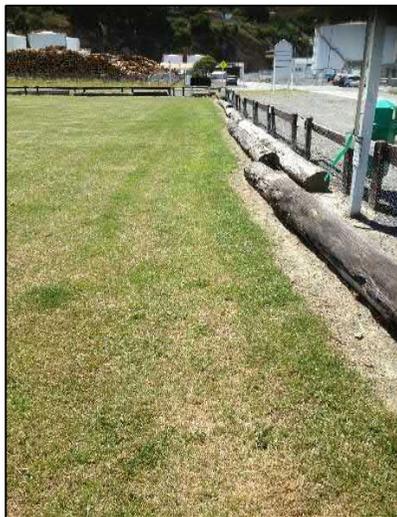
Site Condition	Comments
Visible signs of contamination	No significant signs of contamination were observed. Minor oil stains were present in the boat refurbishment area. Old tar covered poles were placed in certain areas of the site (very little tar remains). A small campfire area was located near to the Sea

Photo 4: Old treated timber poles at the sports field

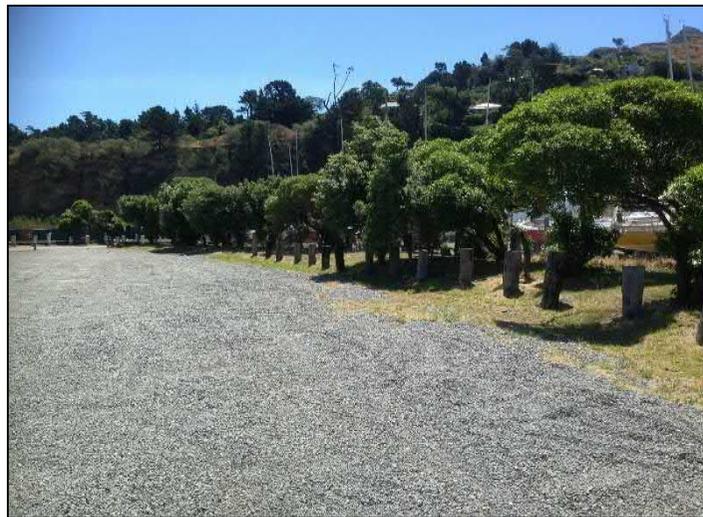
Photo 5: Old treated timber poles at the boat storage area

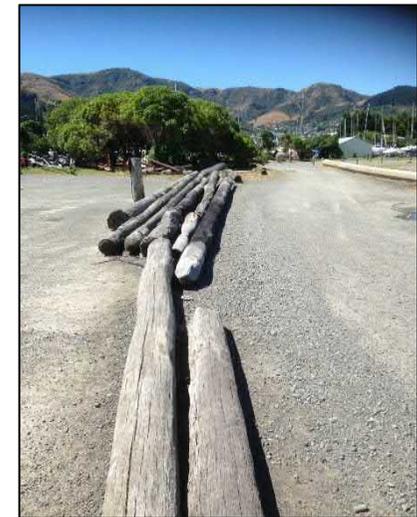
Photo 6: Old treated timber poles near to the marina

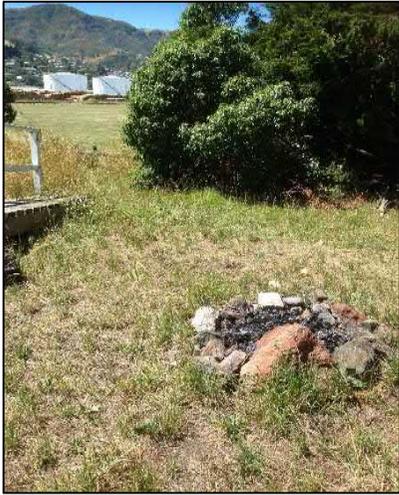
Photo 7: Campfire at the Sea Scouts

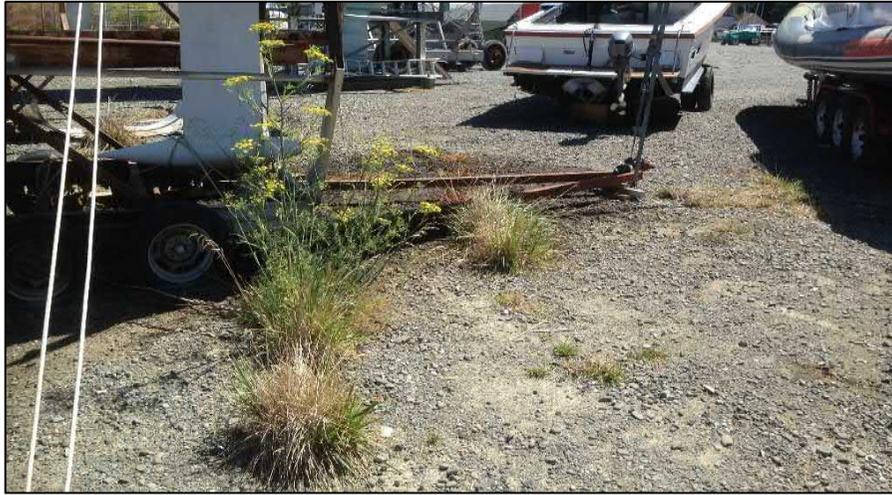
Photo 8: Oil staining in boat maintenance area

It is recommended that limited soil sampling be undertaken at the boat maintenance area and the sports fields to assess the risks to human health from those parts of the site in their current states.

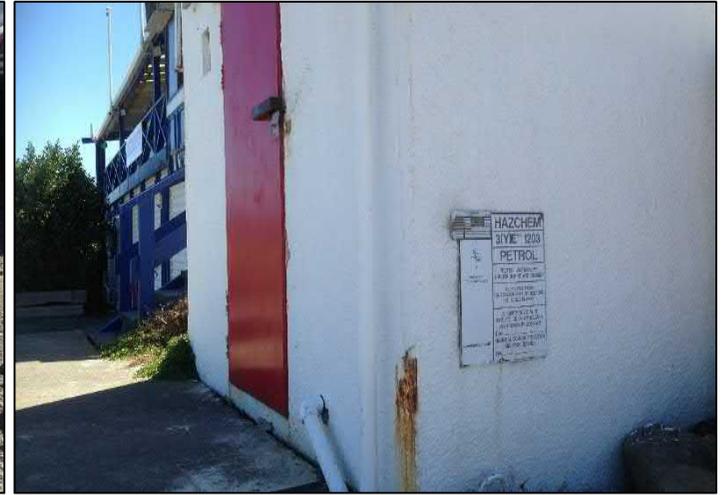
Photo 9: Underground fuel tank at the Coast Guard building

If the underground fuel storage tank is ever removed from its location adjacent to the Coast Guard building, it is recommended that the works be undertaken according to the MfE guidance on the removal of petroleum underground storage tanks².

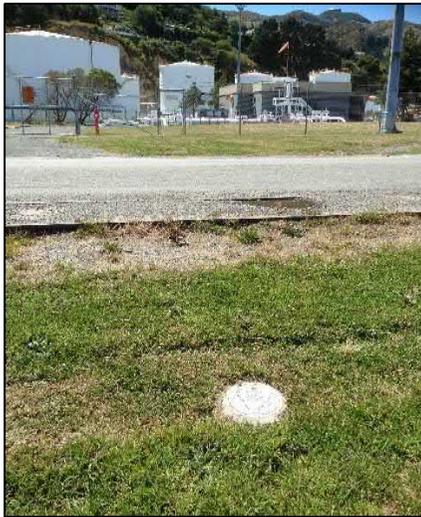
Photo 10: Groundwater monitoring well

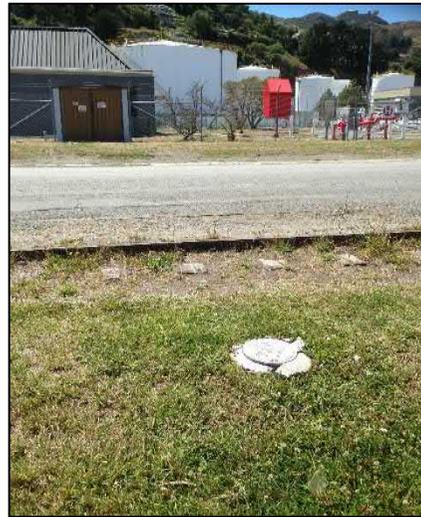
Photo 11: Groundwater monitoring well

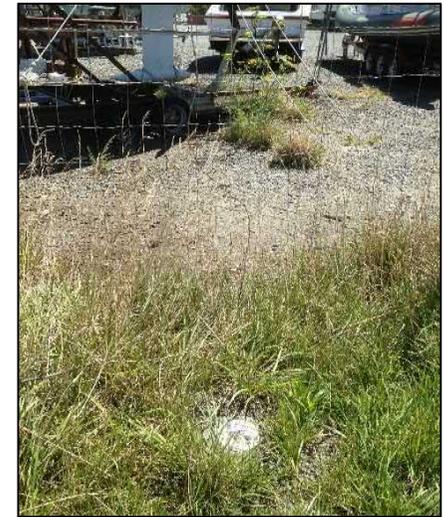
Photo 12: Groundwater monitoring well
