Parklands Library – Detailed Engineering Evaluation BU 2334-001 EQ2 Qualitative Report

Prepared for Christchurch City Council (Client)

By Beca Carter Hollings & Ferner Ltd (Beca)

14 June 2012

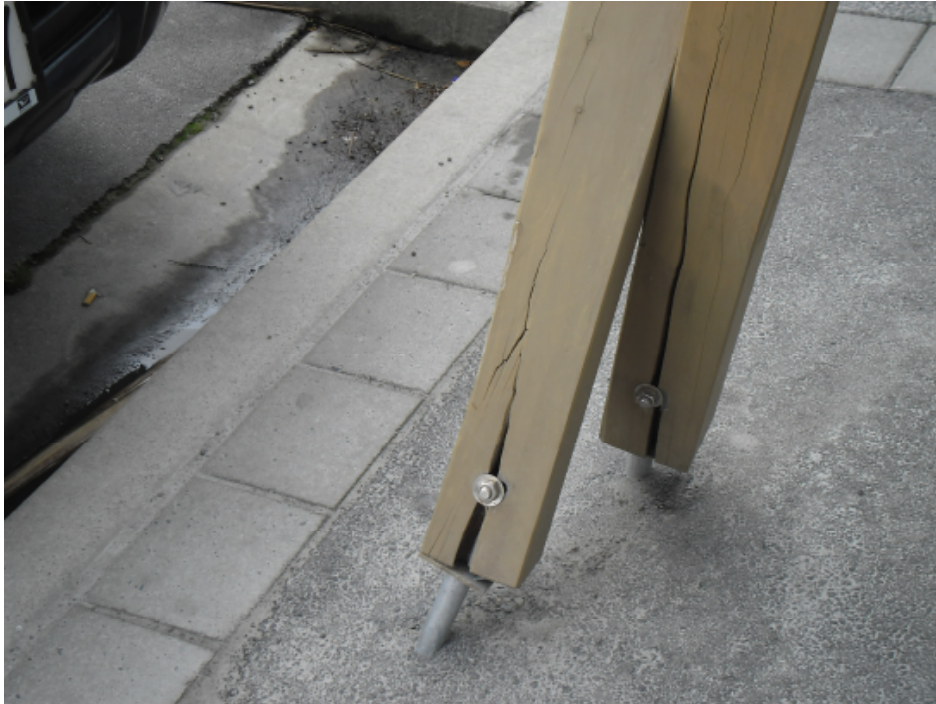
Photo 1

Observed Damage: Splitting at base of inclined timber columns

Recommended Repair: Remove and reinstate damaged member (typical)

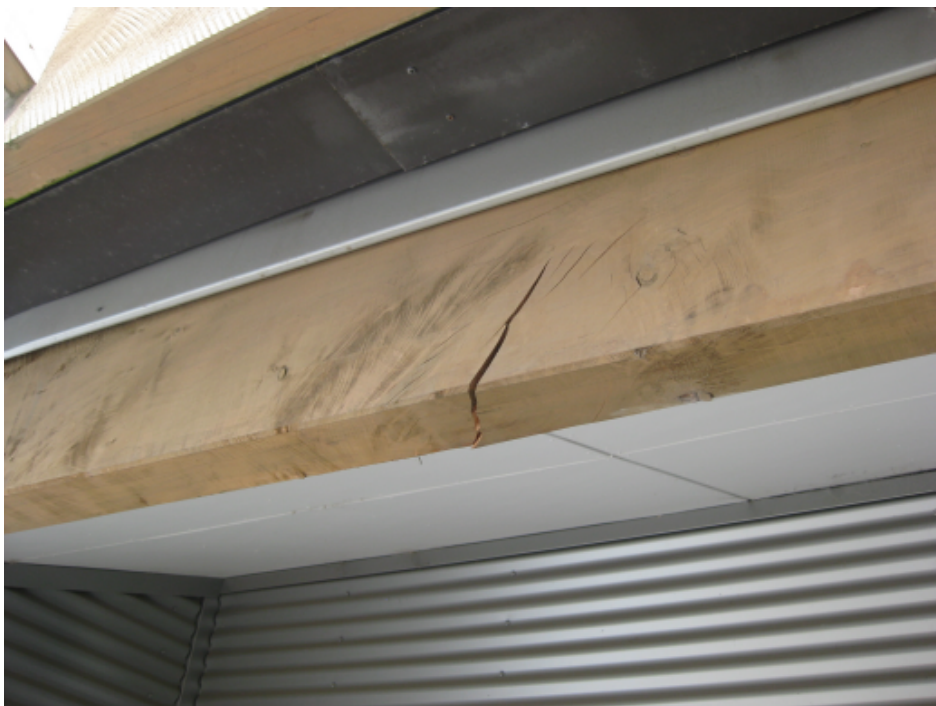
Photo 2

Observed Damage: flexural crack in timber beam

Recommended Repair: remove and reinstate damaged member

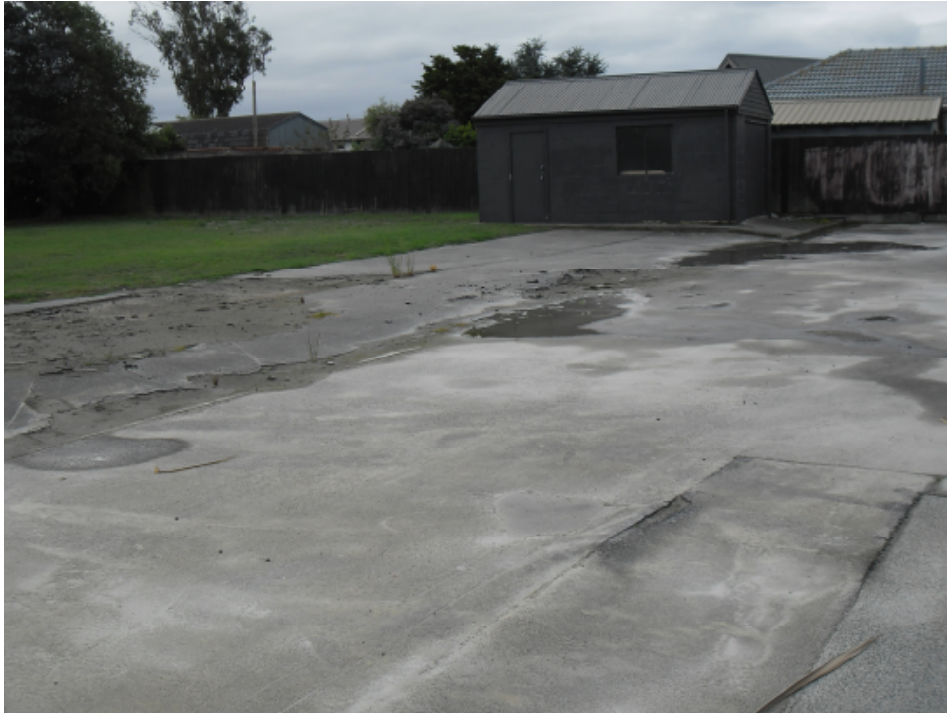
Photo 3

Observed Damage: Liquefaction in adjacent parking area

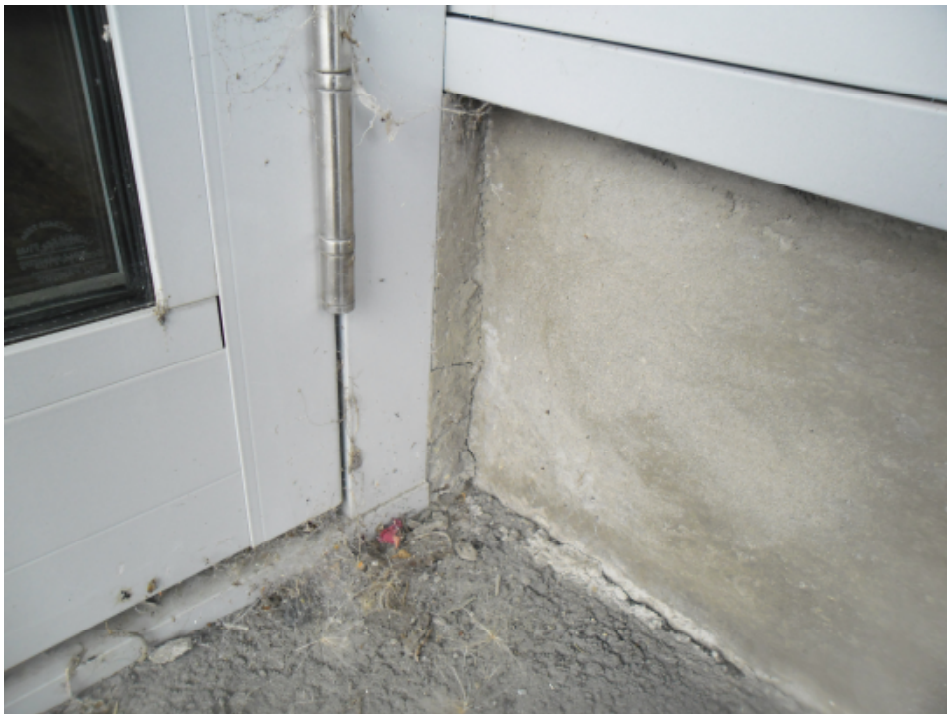
Photo 4

Observed Damage: Minor cracking to base of foundation slab potentially due to lateral spread or other ground movement such as liquefaction

Recommended Repair: Grout injection concrete cracks on site.

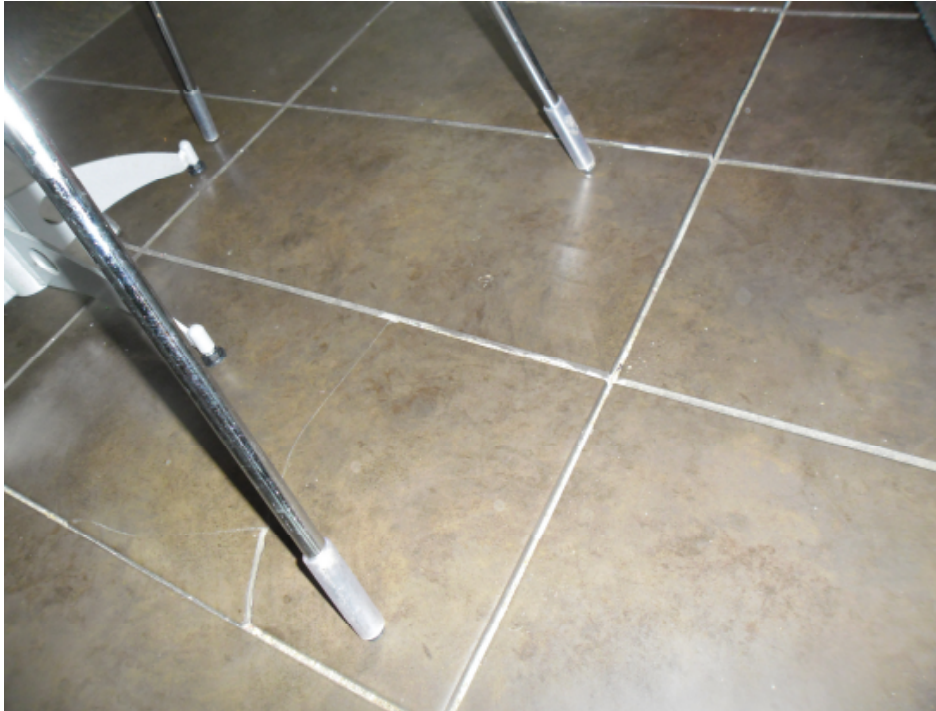
Photo 5

Observed Damage: Cracked floor tiles in places, potentially due to differential settlement along slab construction joint due to earthquake events causing liquefaction.

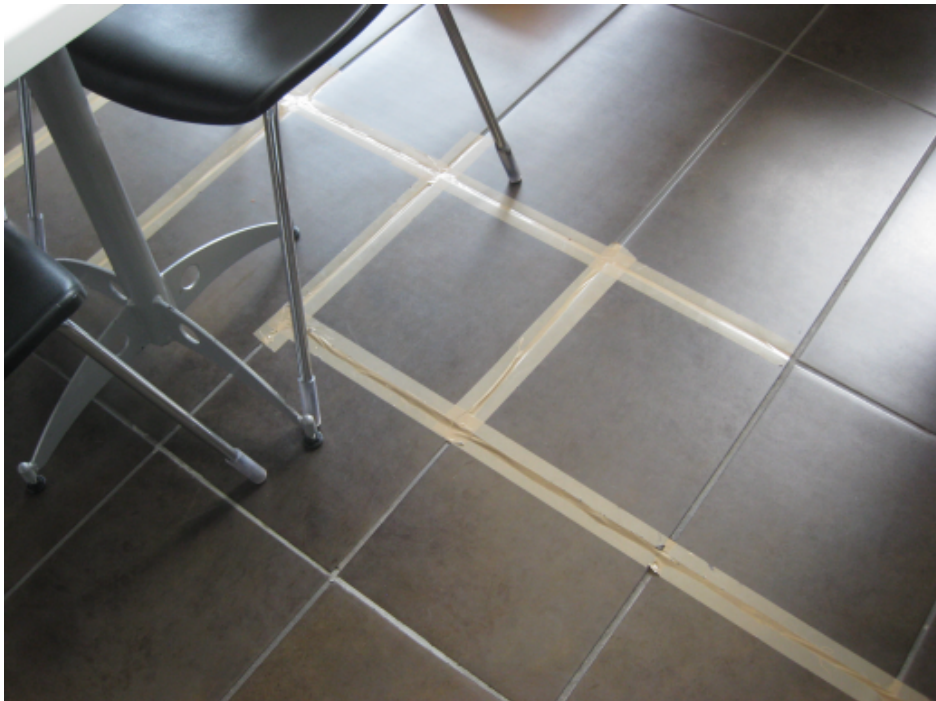
Photo 6

Observed Damage: Cracked floor tiles in places, potentially due to differential settlement along slab construction joint due to earthquake events causing liquefaction.

Recommended Repair: Replace all cracked floor tiles.

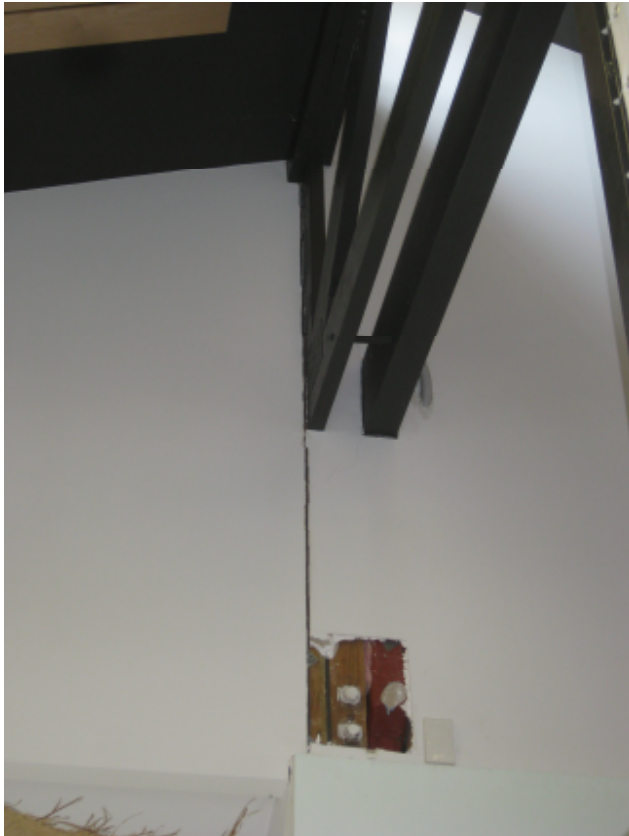
Photo 7

Observed Damage: Crack in Gib brace line near original church timber portal connection with wall.

Recommended Repair: Remove and reinstate lining or plaster over cracks using approved Gib brace line repair plaster.

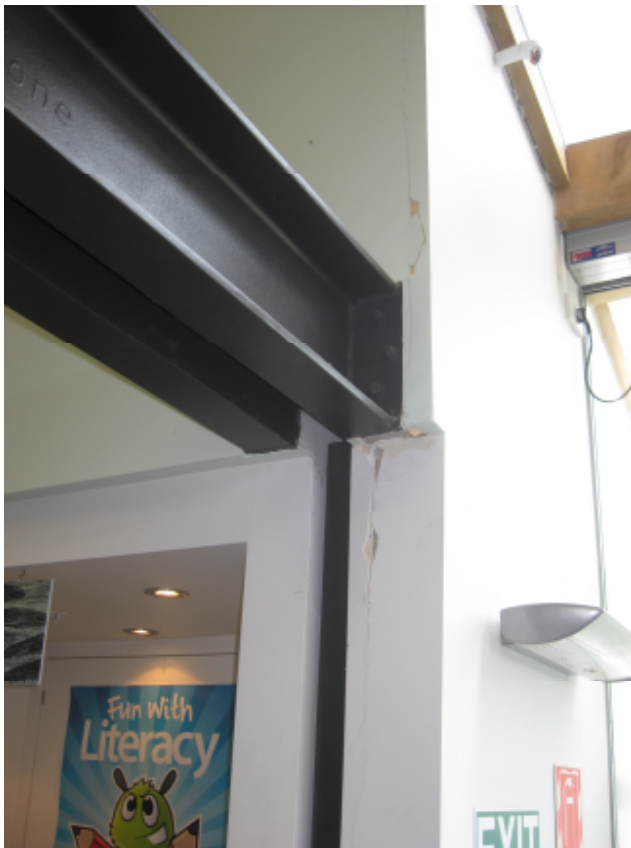
Photo 8

Observed Damage: Cosmetic cracking around steel beam supports

Recommended Repair: Remove and reinstate lining or plaster over cracks using approved Gib brace line repair plaster.

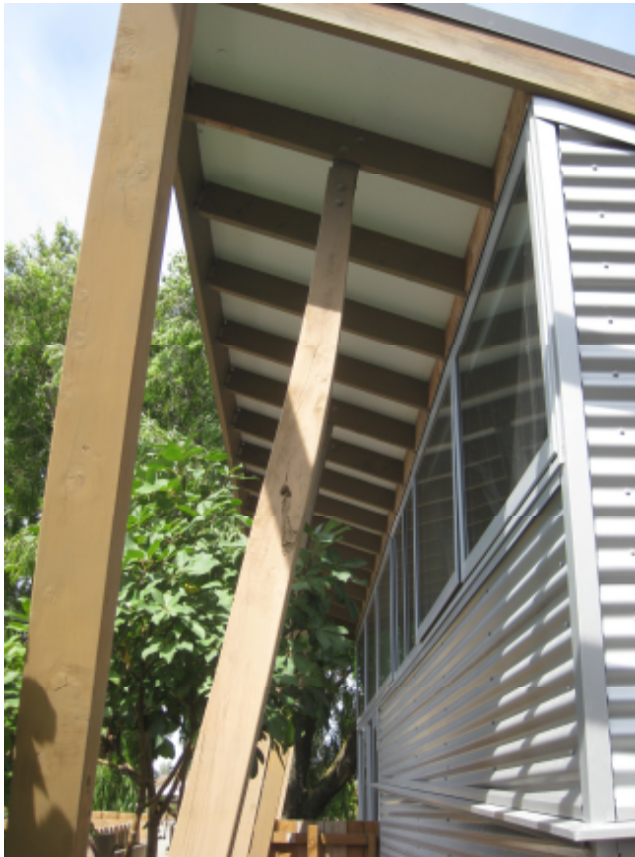
Photo 9

Observed Damage: Buckling of slanted columns

Recommended Repair: Remove and reinstate, typical or temporarily prop until at least a quantitative assessment has been carried

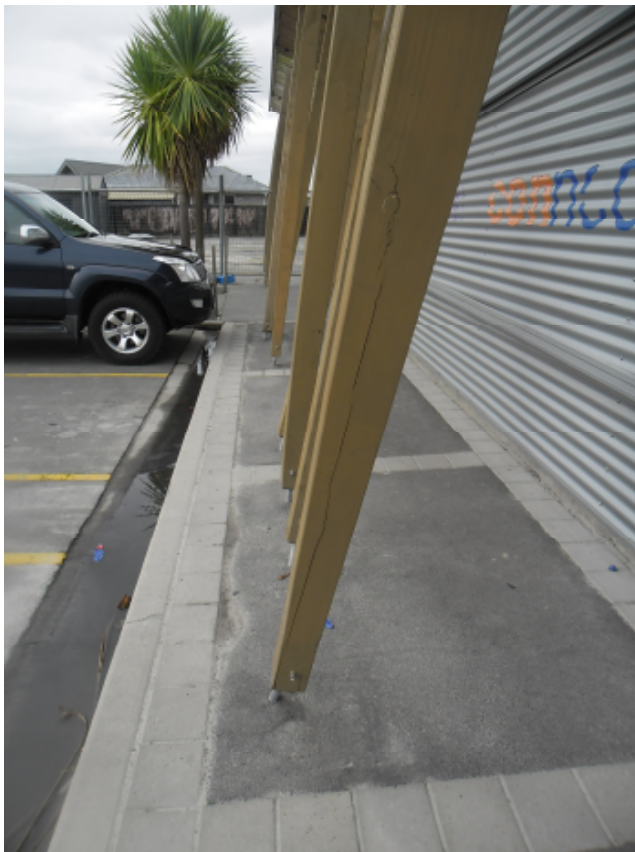
Photo 10

Observed Damage: Cracking of slanted timber columns

Recommended Repair: Remove and reinstate, typical or temporarily prop until at least a quantitative assessment has been carried out

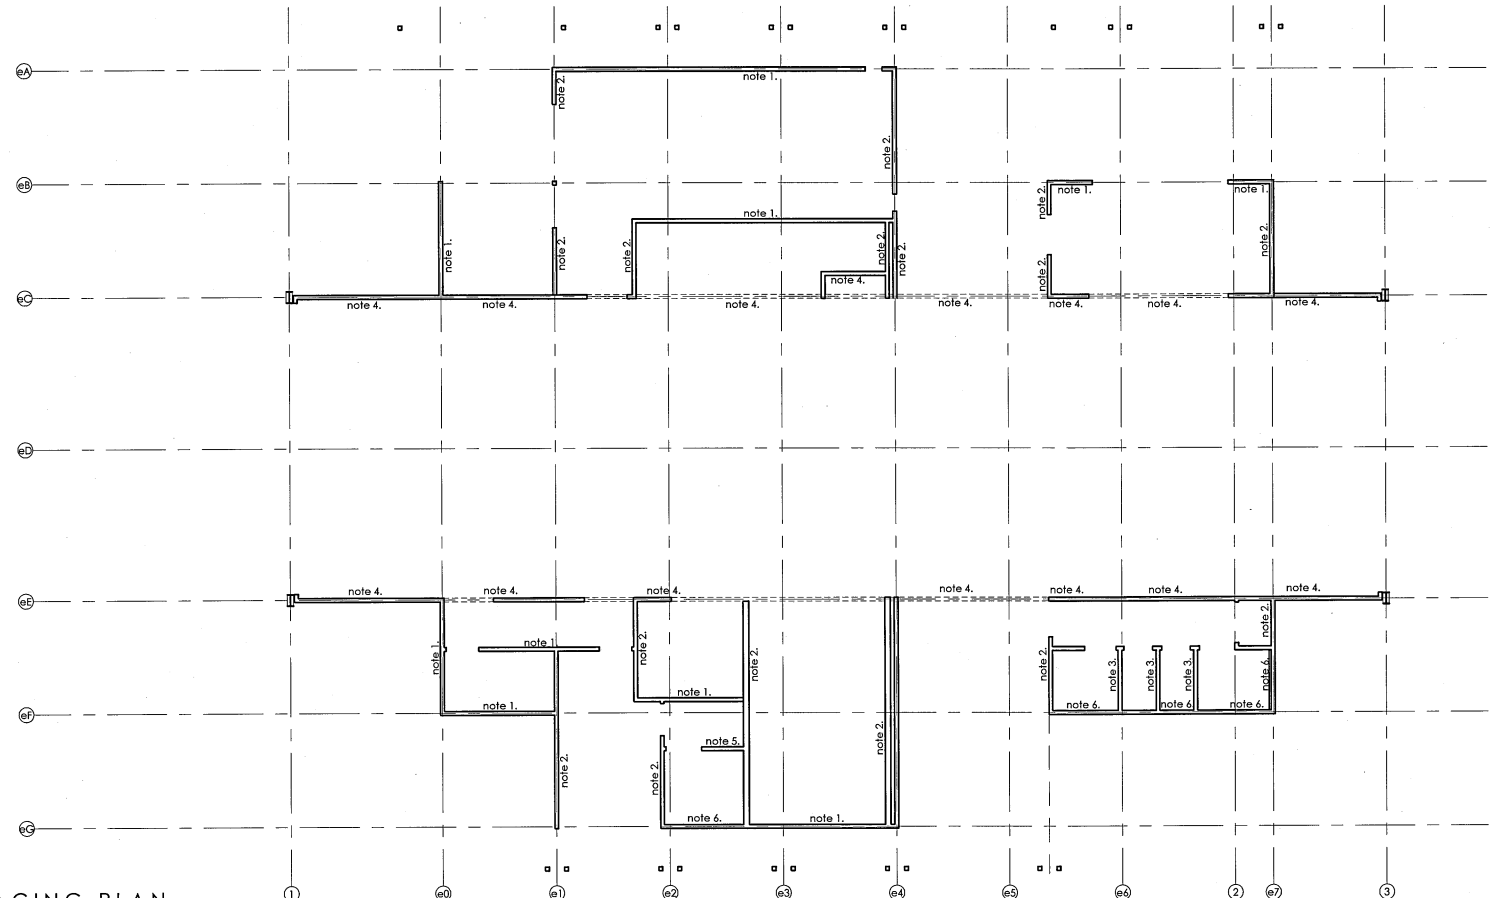
WALL BRACING PLAN
1:100

- note 1. Standard 13 mm Gib plasterboard to one side (internal).
- note 2. 10mm Gib Braceline with 6KN floor plate connections to one side only (internal).
- note 3. Standard 10mm Villaboard both faces.
- note 4. 10mm Gib Braceline with 6 KN floor plate connection one side (internal) / 9mm plywood to the other (external).
- note 5. Standard 10mm Gib Aqualine to one side with diagonal brace (internal).
- note 6. Standard 9mm Villaboard to one side with diagonal brace (internal).

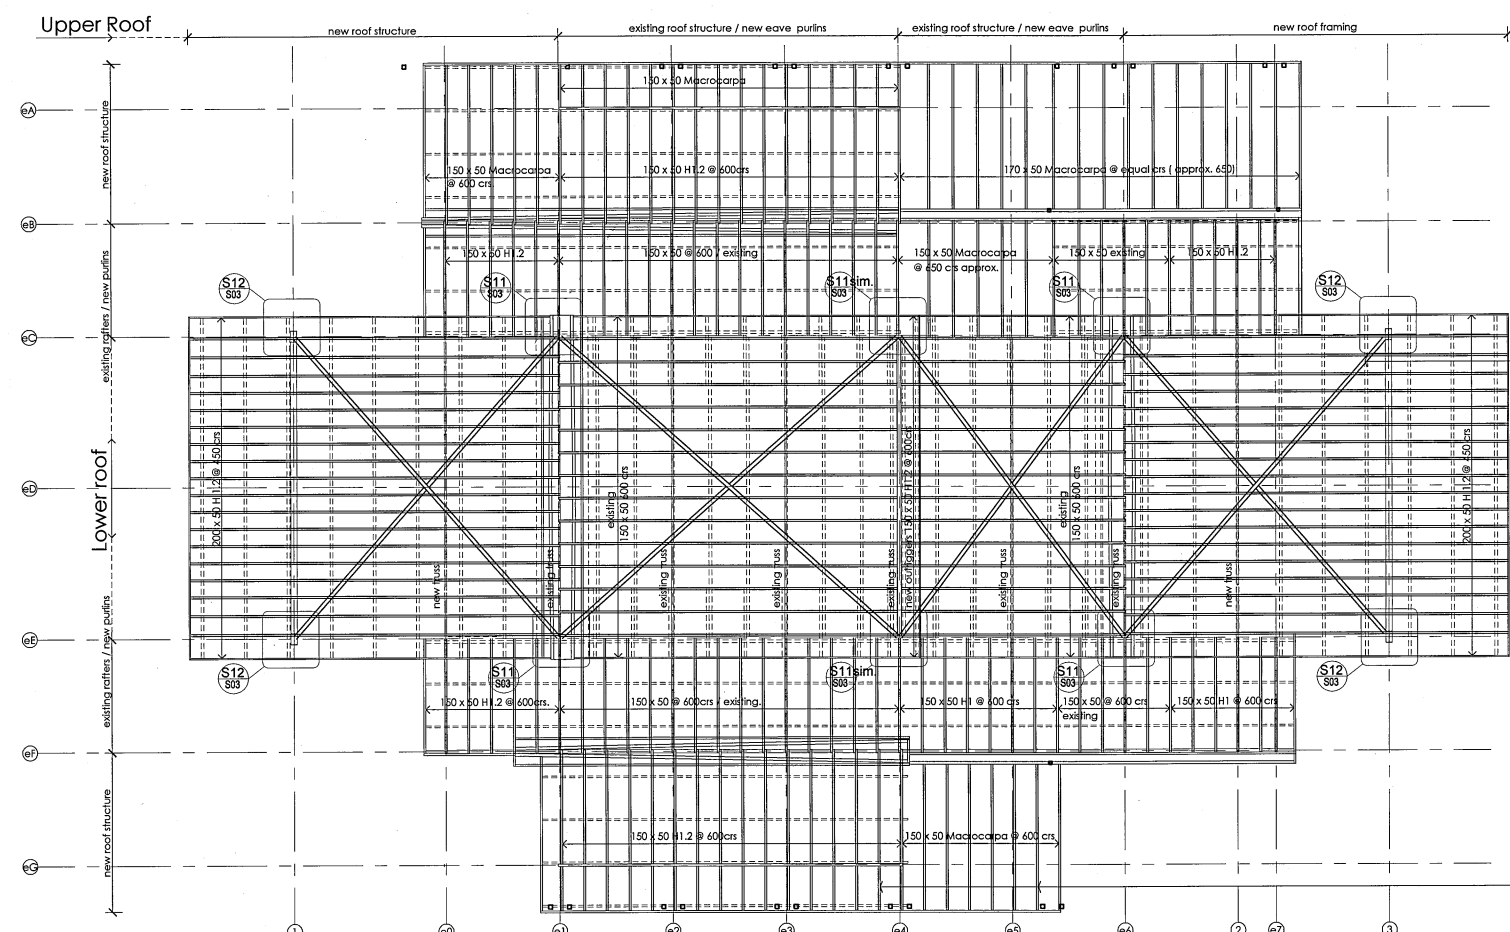
ROOF FRAMING PLAN
1:100
Rafters annotated.

100 x 3 mm galv MS flat cross braces
notched flush into purlins and nailed to
detail.

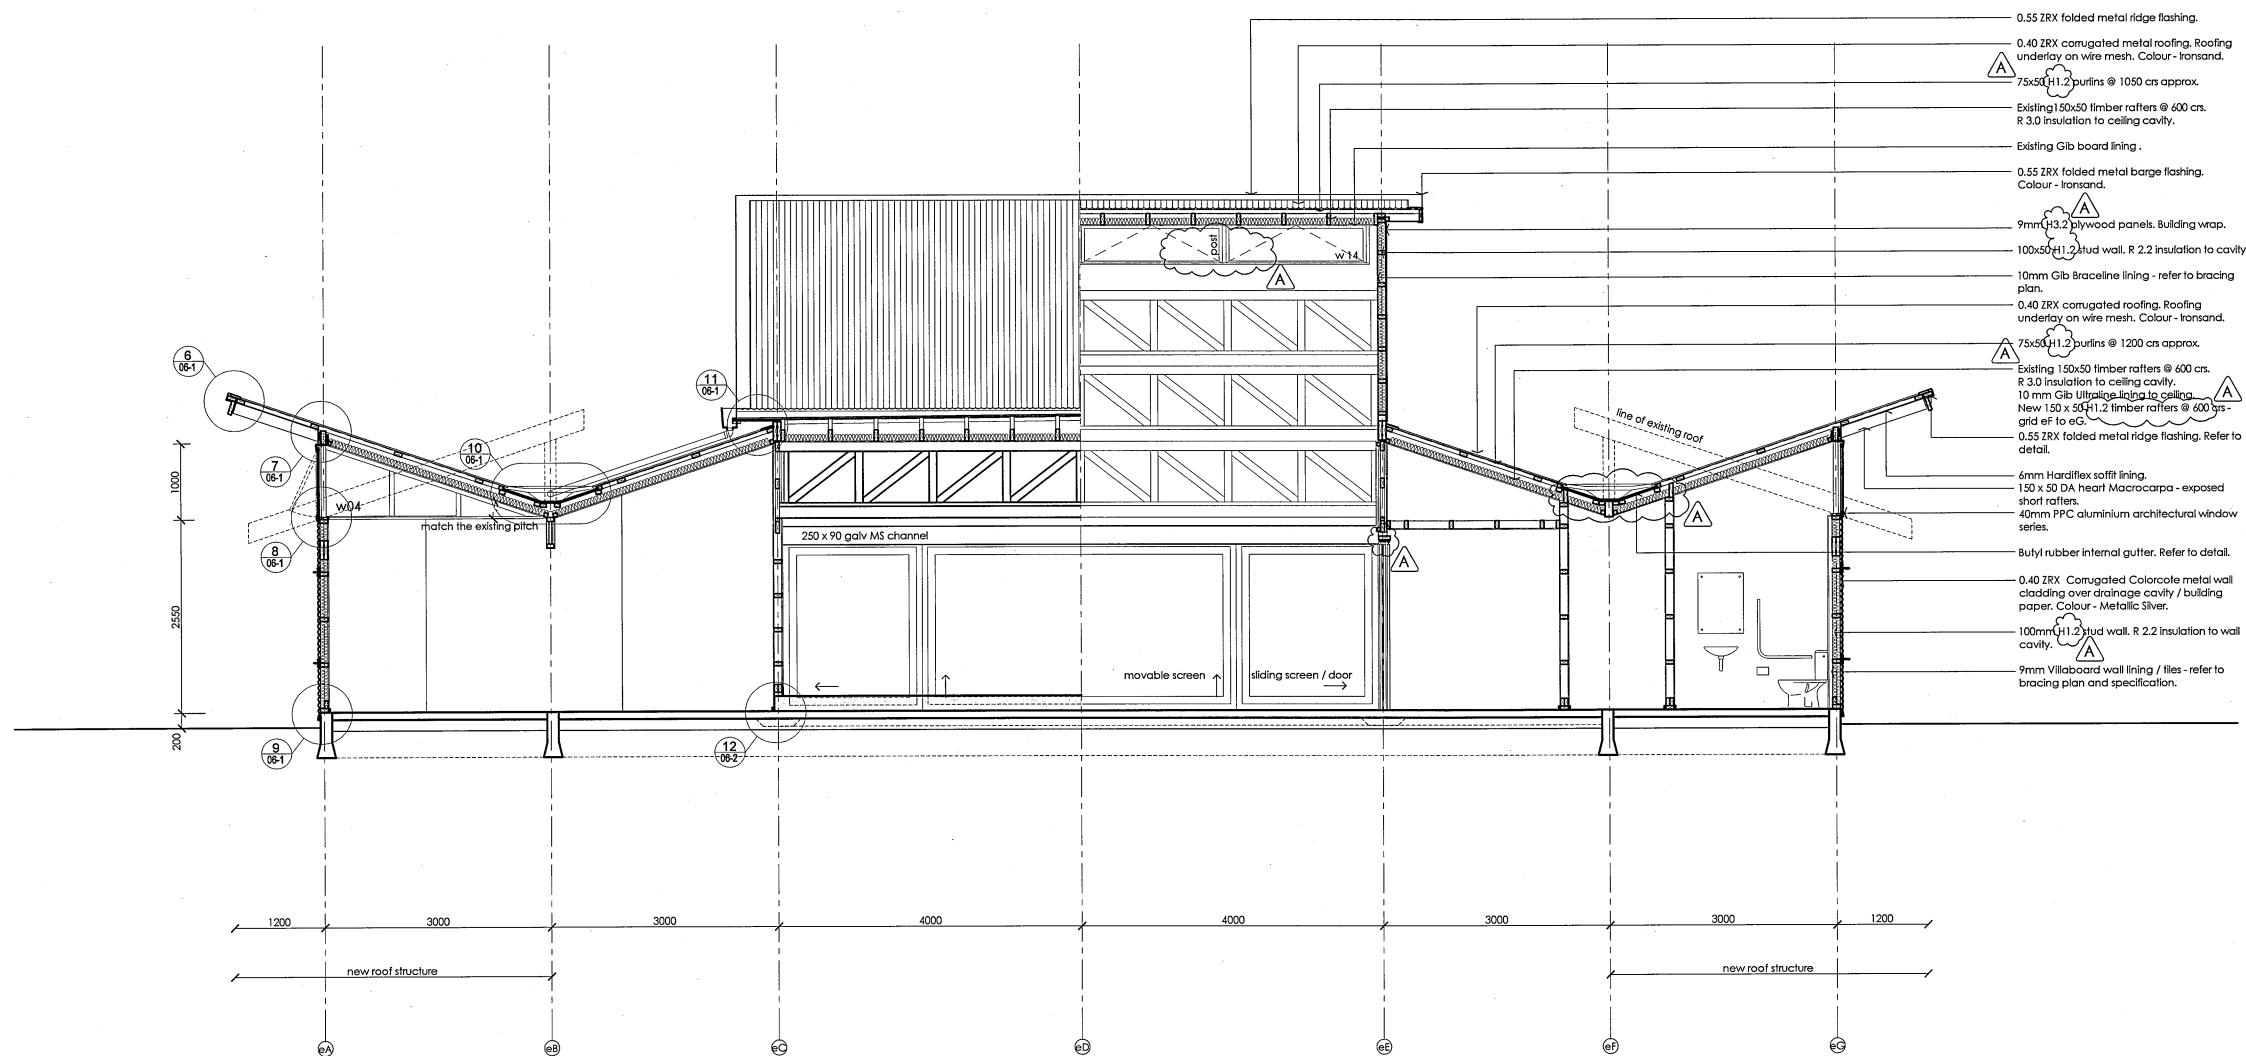
SECTION A 1:50
Note: section line staggered.

- 0.55 ZRX folded metal ridge flashing.
- 0.40 ZRX corrugated metal roofing. Roofing underlay on wire mesh. Colour - tansand.
- 75x50 H1.2 purlins @ 1050 cns approx.

- Existing 150x50 timber rafters @ 600 cns.
- Existing 3.0 insulation to ceiling cavity.
- Existing Gib board lining.
- 0.55 ZRX folded metal barge flashing. Colour - tansand.

- 100mm H1.2 stud wall. R 2.2 insulation to wall cavity.
- 9mm Villaboard wall lining / tiles - refer to bracing plan and specification.

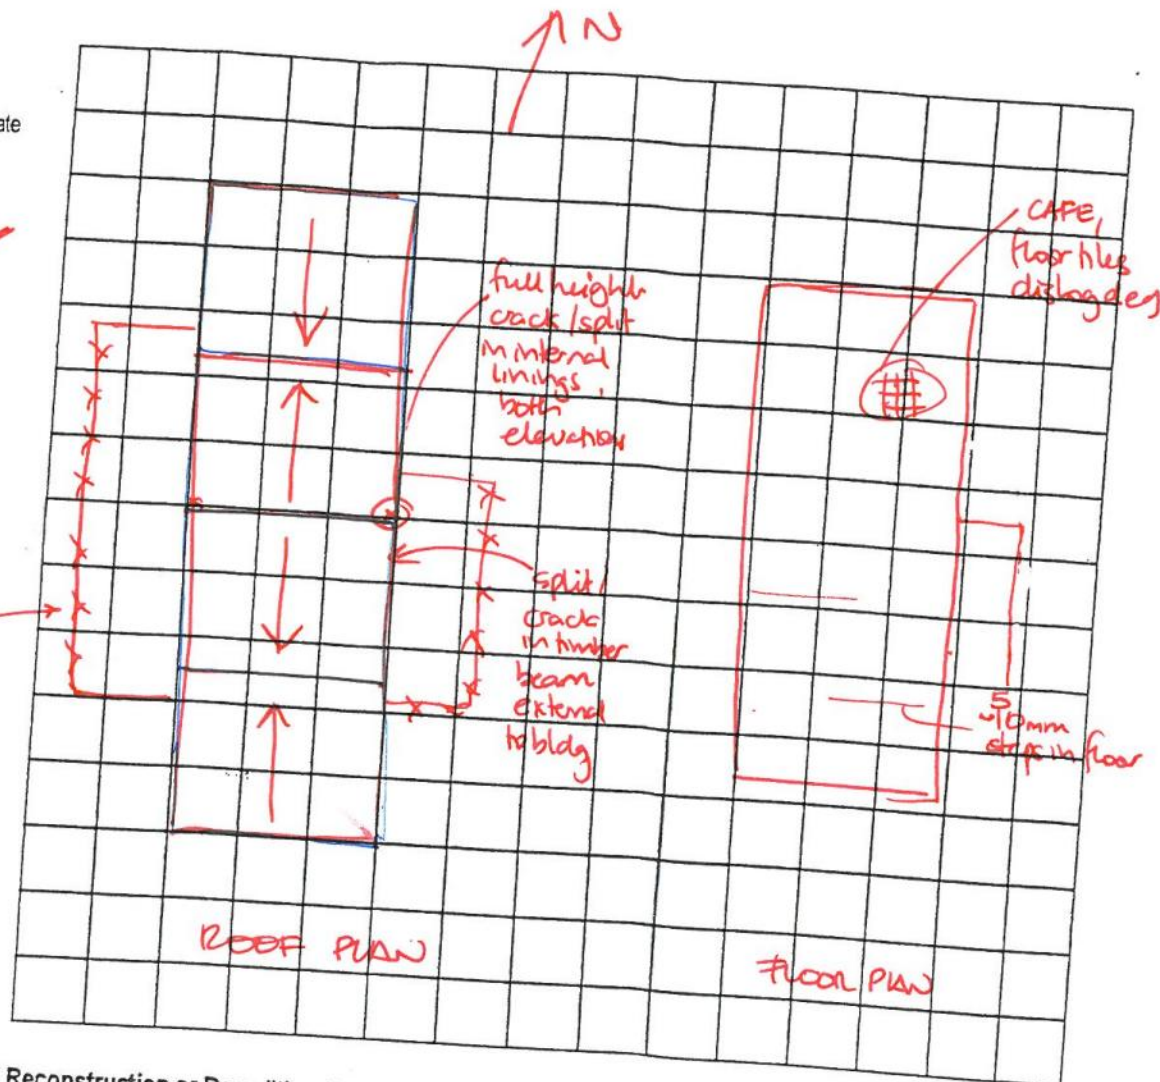
Sketch (optional)

Provide a sketch of the entire building or damage points. Indicate damage points.

- x undertake detailed engineering evaluation
- x assess reliance of roof on timber braces to provide support → confirm if non-structural
