## FLOODING IN THE HEATHCOTE RIVER VOLUME 1 - A HISTORY AND DATABASE

PREPARED BY  
ANDREW P NICHOLS -  
DRAINAGE AND WASTE MANAGEMENT UNIT  
JULY 1992

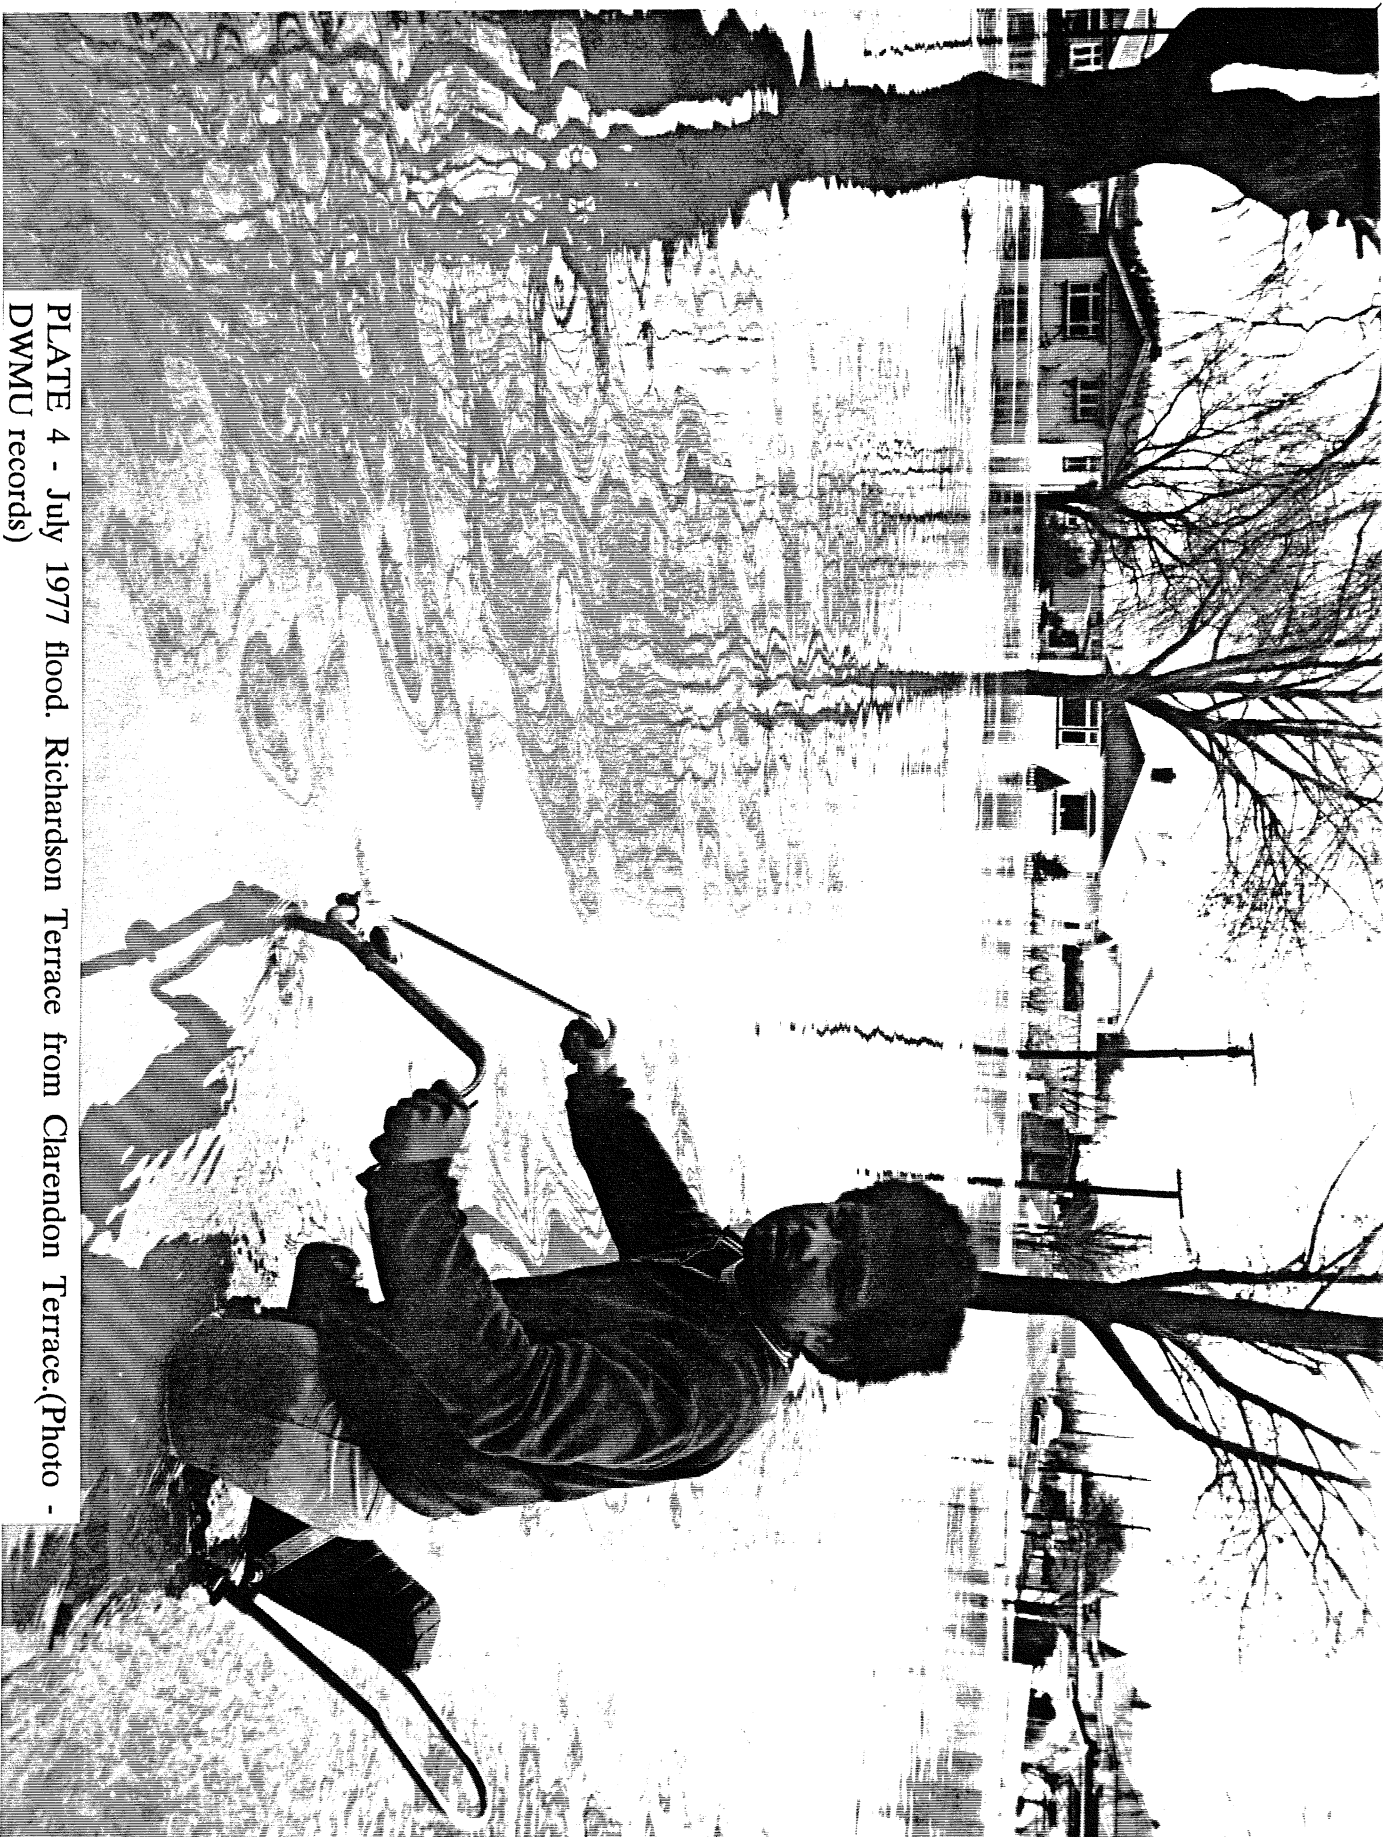
PLATE 4 - July 1977 flood. Richardson Terrace from Clarendon Terrace.(Photo - DWMU records)

Houses were evacuated in Barrington Street, Fairview Street, Waimea Terrace, Eastern Terrace, Opawa Road, Ford Road, Aynsley Terrace, Clarendon Terrace, Richardson Terrace and Mackenzie Avenue. Plate 4 shows the severity of this event in the Clarendon/Richardson Terrace reach.

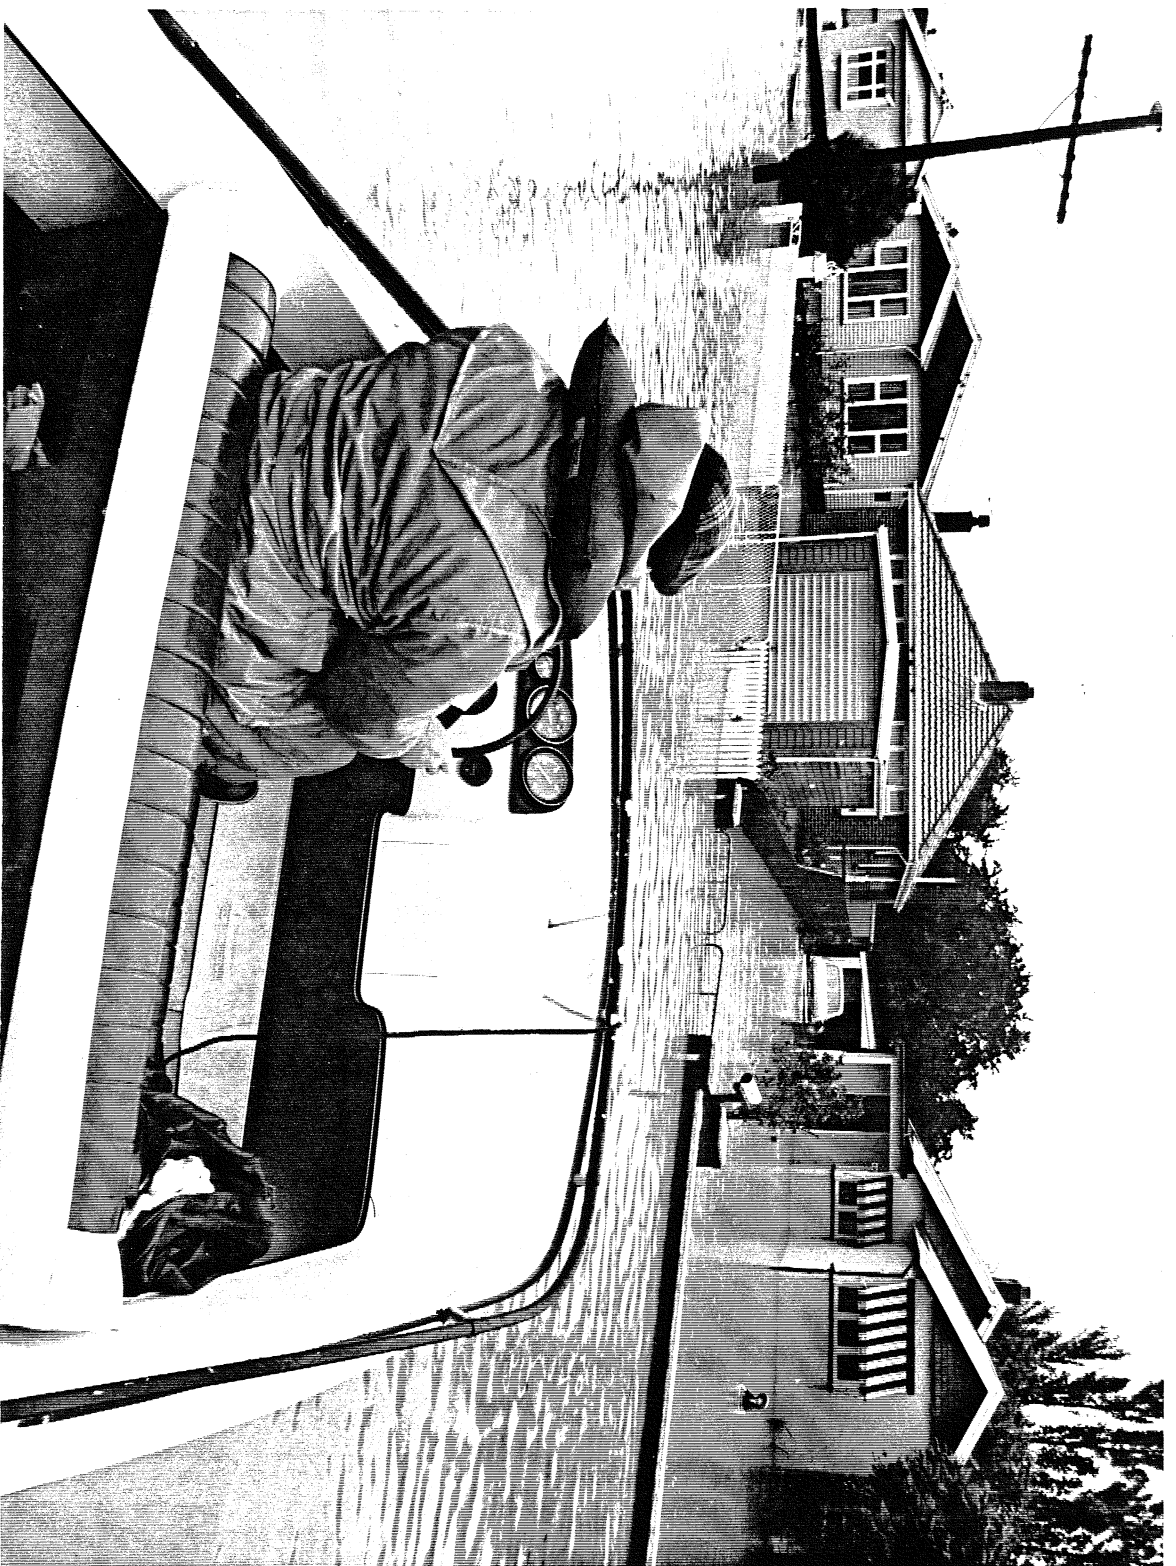
PLATE 5 - January 1980 flood. Jetboat rescue for Clarendon Terrace.(Photo - DWMU records)

The worst flooding occurred in and adjacent to the river with water entering three houses in Waimea Terrace, one in Palatine Terrace and eight in the Clarendon (Plate 5), Richardson and Aynsley Terrace areas. Overall flood levels in the lower reaches of the river were comparable to those of the Wahine Storm. In addition, riverside properties in the Upper Heathcote nearly as far as Lincoln Road were seriously flooded for the first time, although water did not enter houses. The rating curve derived peak flow figures for Smarts Bridge and Buxton Terrace of 15.5 cumec and 31.8 cumec respectively, correspond to a return period of approximately 12 years for the event.
