Appendix 3 - Ecological and Parks Assessment

Chris McClure – Lizard assessment

Andrew Crossland – Bird Ecology (Summarised)

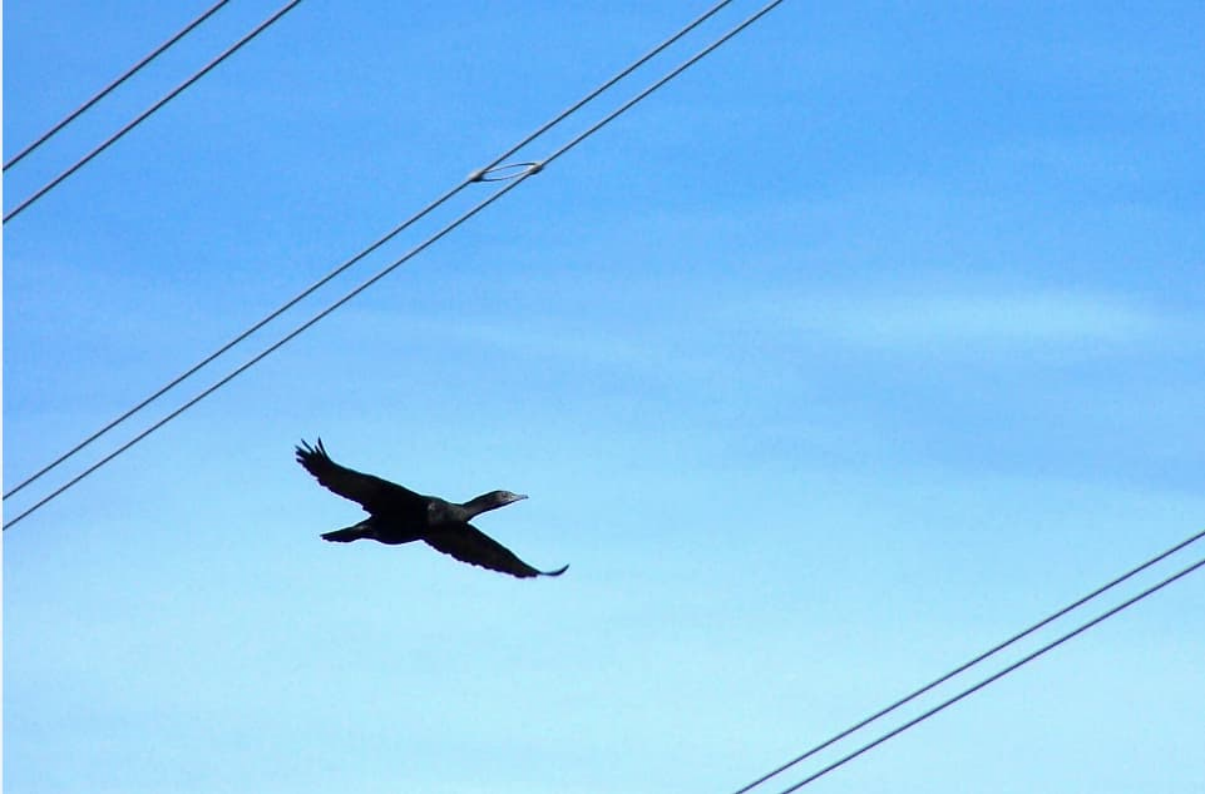
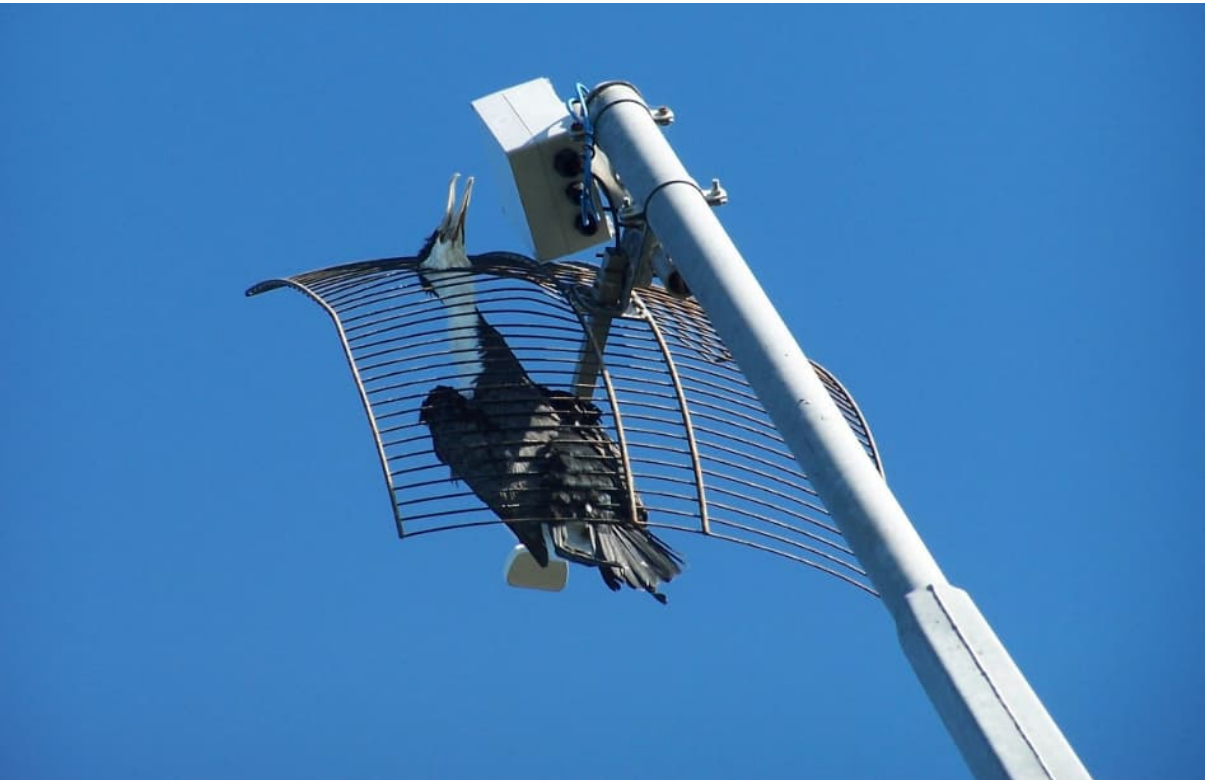
- The stacked storage of containers *en masse* have created both a physical obstacle to cormorants and other birds moving between the roosting trees and the estuary, and have eliminated clear sight lines to the roosts. Bird approach routes have now changed. The containers, fences and other infrastructure have added to the potential collision hazards for incoming birds, which had previously mainly comprised high tension power lines and tower structures further east and north in the wider area. The photos below are local examples – Left: a Little Black Cormorant negotiating high tension power lines over Charlesworth Wetland on its way to roost, and right: a dead Pied Cormorant caught in a tower at Bromley Oxidation Ponds.
