Report

Contamination Assessment - Cranford Basin

Prepared for Christchurch City Council

Prepared by Beca Ltd (Beca)

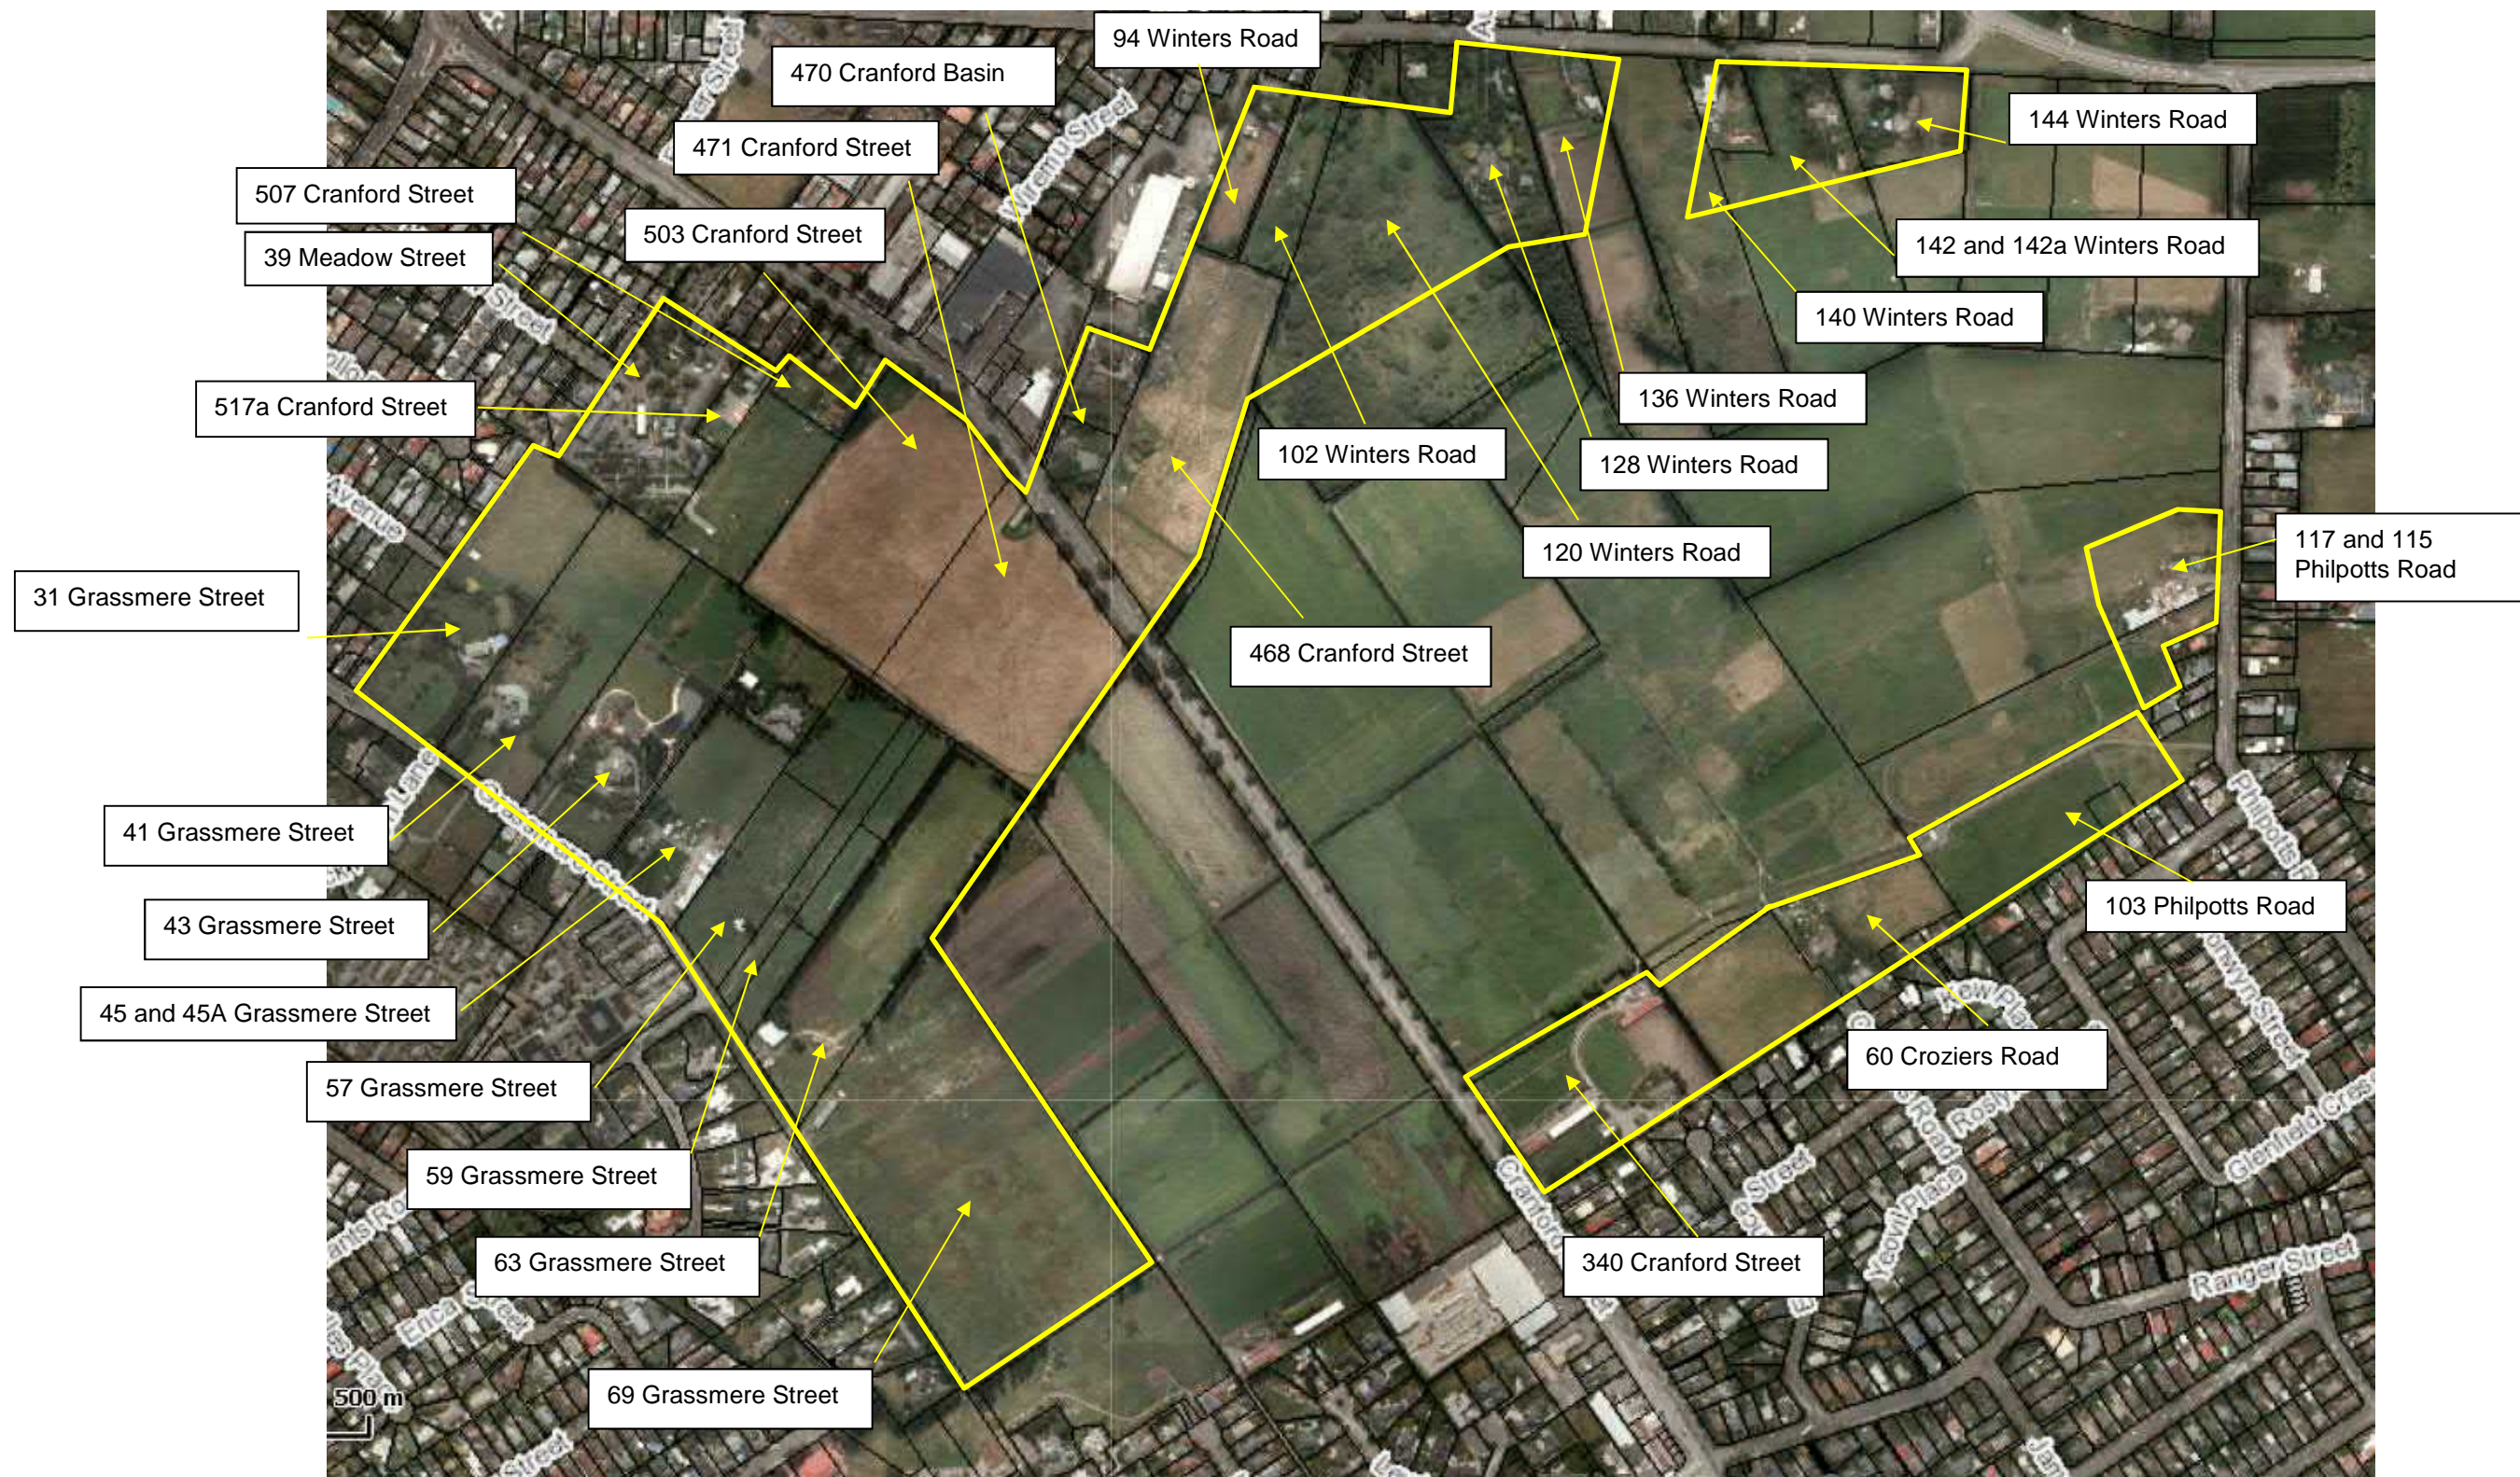
The site is situated 4km north of the Christchurch CBD. It is relatively flat and consists of a mixture of residential, rural / commercial properties. **Figure 1** below shows the location and properties within the 'site'.

Figure 1 - Location of the individual sites within the overall 'site' (Image source: ECan GIS)

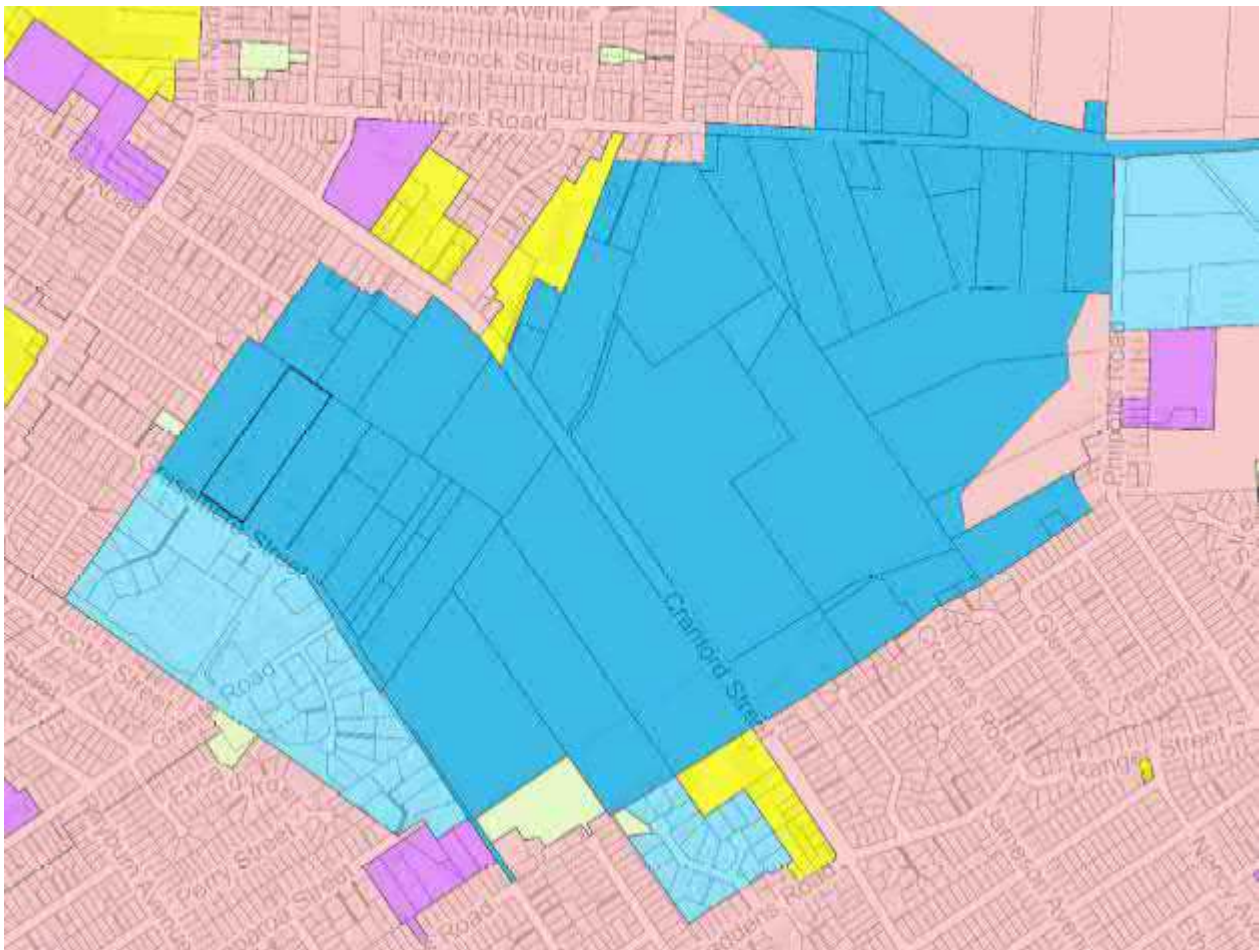
The site is zone 'rural' in the District Council Planning Zone Map on the ECan GIS. Neighbouring the site there are a number of different zoned uses such as rural residential (light blue), residential (pink), business (yellow), cultural (purple) and open space (light green). **Figure 2** below shows the zoning map.

Figure 2 - Planning zones of the site (Source: ECan GIS)
