Enviser Ref: 1004  
16 May 2017

# Preliminary Site Investigation

Harley Chambers Development

Lee Pee Ltd

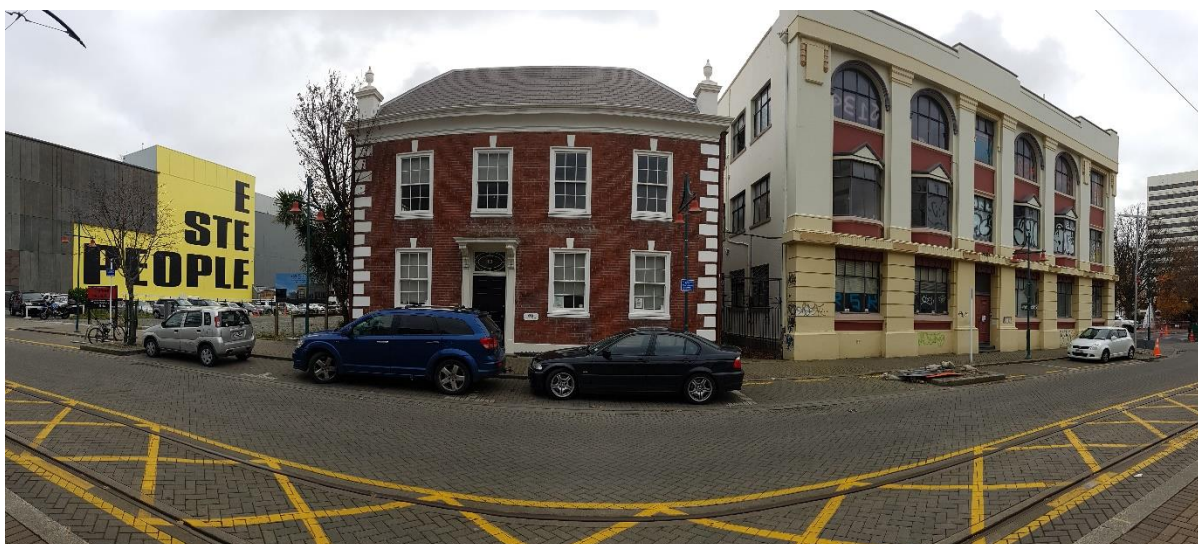
*Photograph 1 – View of site, 65-67 Worcester St on the left, 69 Worcester St centre (brick building) and 137 Cambridge Tce to the right.*

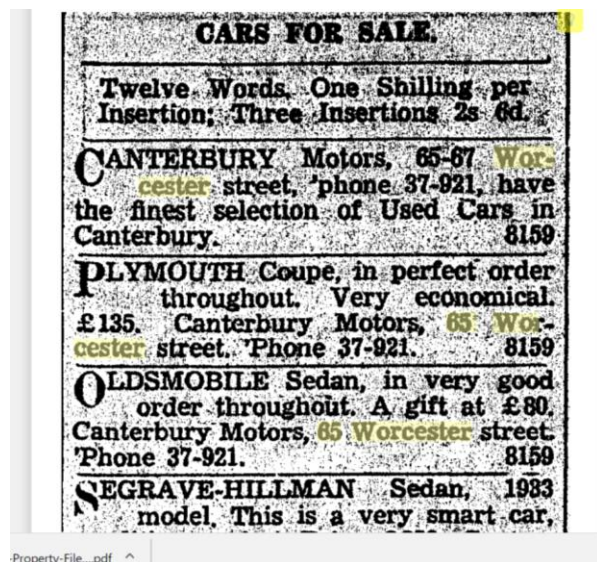
Figure 2 Press advert 15 February 1953 ([www.paperspast.natlib.govt.nz](http://www.paperspast.natlib.govt.nz))

Searching for the street address in the Papers Past online records revealed adverts (in the Press) from the 1930's for 'Canterbury Motors' selling used cars from 65-67 Worcester St (see **Figure 2**). It was, and still is, typical for car sales operations to also undertake some car repair/mechanic services. However, no records were found to confirm this did occur on the subject site.

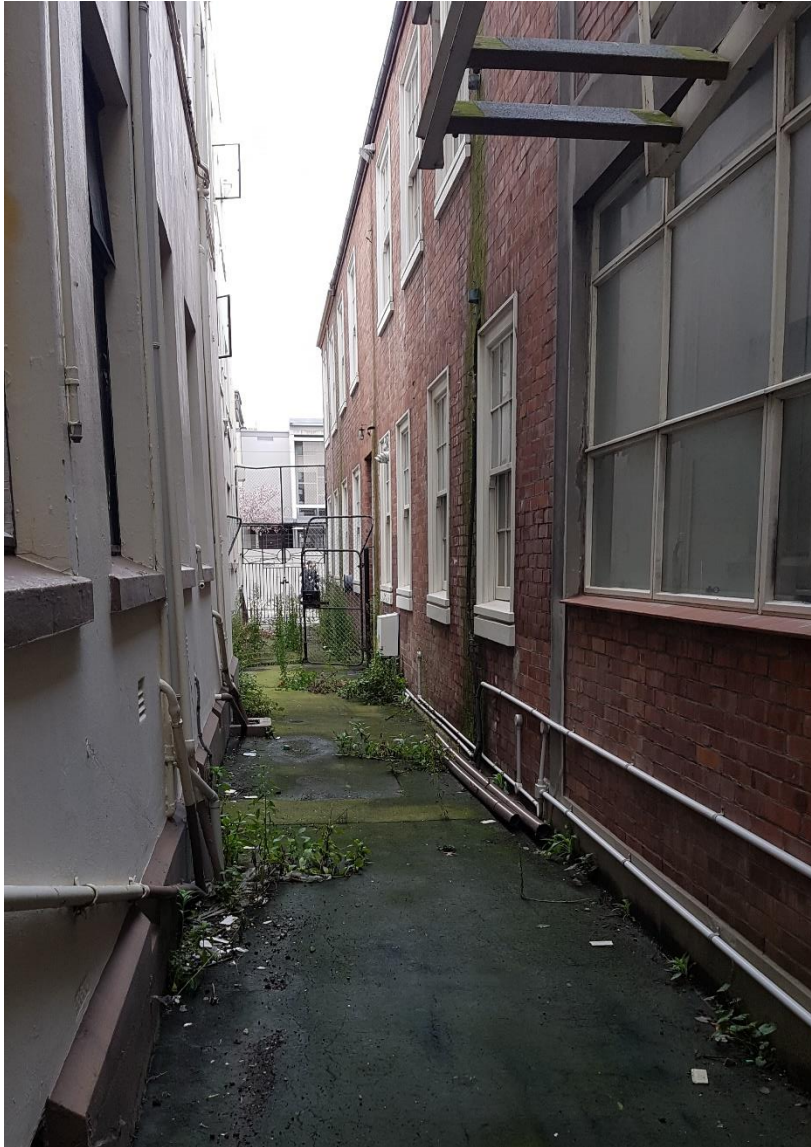
The access way is sealed (**Photograph 3**) and leads to a largely unsealed open area along the northern boundary, which has been used for informal storage. Items of note include a 3-4 drums previously used to store lubricants, various wooden and metal items and a tyres. A small brick

*Photograph 3 – Looking south (towards Worcester St) from the lane between 69 Worcester St and 137 Cambridge Tce.*

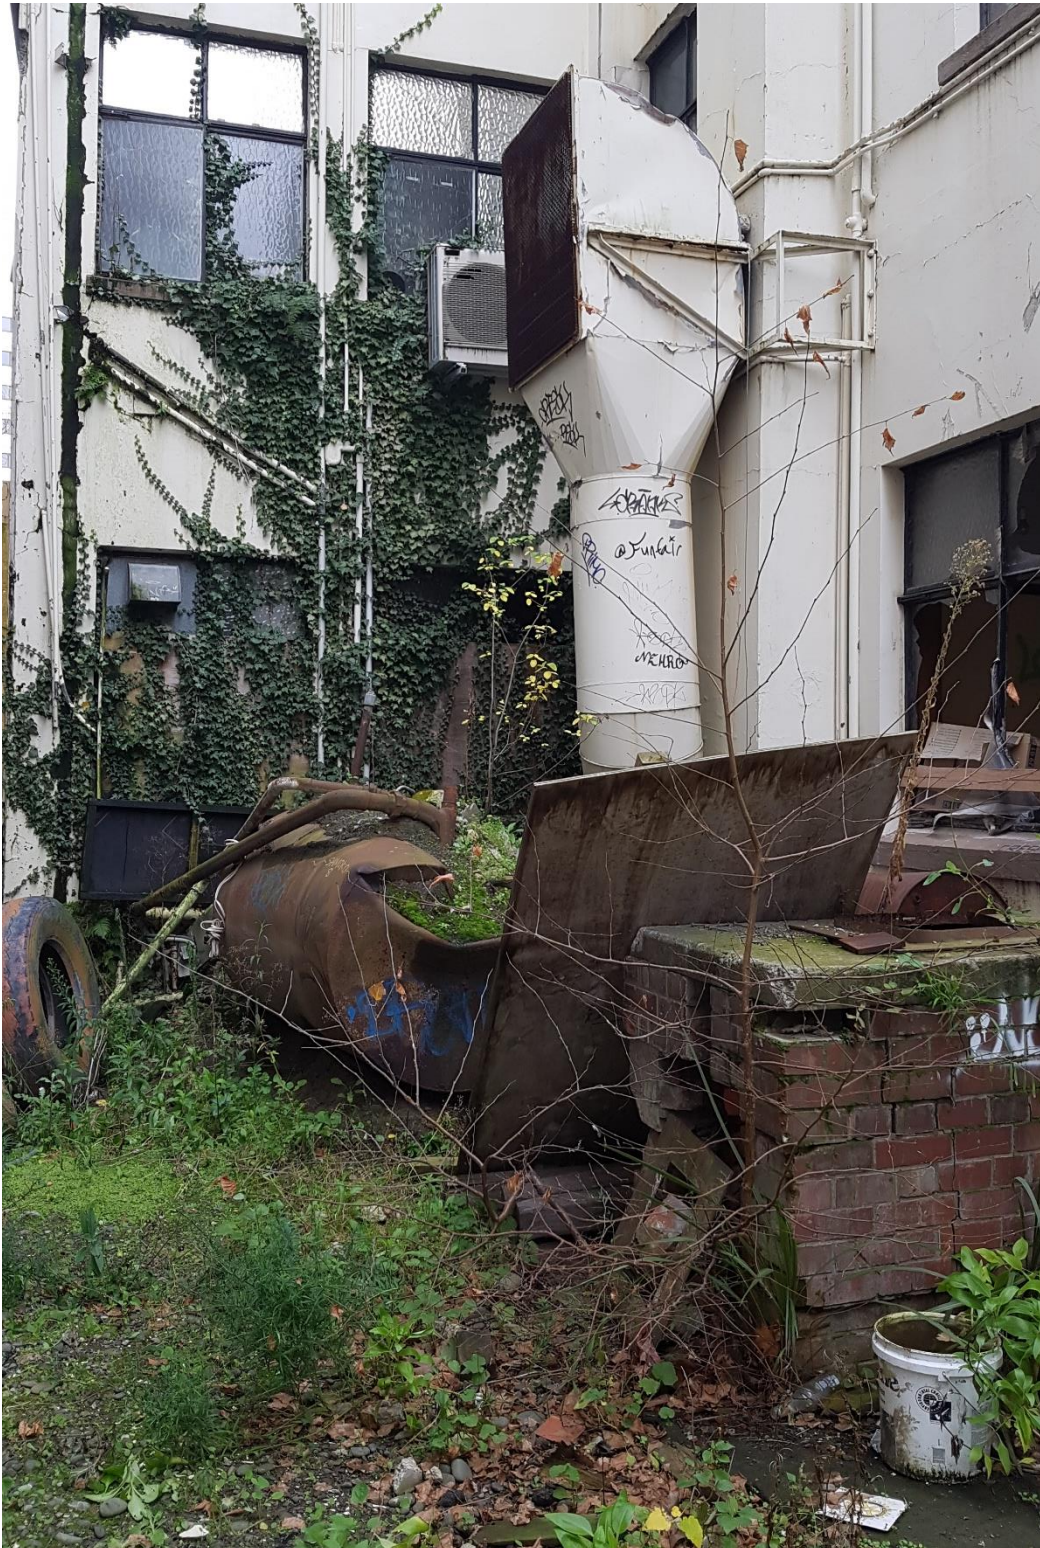
structure is also present, which lines up with the description and drawings of the incinerator noted in the property files.

A large cylindrical steel tank, with attached pipework, is also located in this area (**Photograph 4**). Based on the size of the tank (approximately 10,000L) the condition of the exterior (unpainted) and attached pipework, this tank is suspected to have been formerly underground.

*Photo 4 view looking east along vacant area at rear of 137 Cambridge Tce. Brick incinerator in right foreground, to the rear is the former underground storage tank.*

The arrangement of the pipework and paint colour of the pipes indicate the tank was likely associated with the Harley Chambers site. More than likely within 5-10m of its current position. The condition of the tank suggests it was removed relatively recently, possibly a result of the construction of the building immediately to the north. The new building (constructed 2014/15) has a basement and is sheet piled right to the boundary, which is within 3-5m of the tank.

Whilst no records exist of an underground storage tank on the site, one is currently present (above ground) at the rear of the site and was viewed during the site walkover. The associated pipework suggests that this tank was formerly located on, or directly adjacent to the site. Several drums (lubricants) were also stored at the rear of the site.

Both these activities mean that a HAIL activity (category A17 – storage tanks or drums for fuel etc) has occurred on the rear portion of the site. No records of any other HAIL activity having occurred elsewhere on the site have been found. Consequently, the rear portion of the site under and around the tank and drums is considered a HAIL site. The remainder of the site, for the purposes of the NES(soil) regulations, should not be considered potentially contaminated.

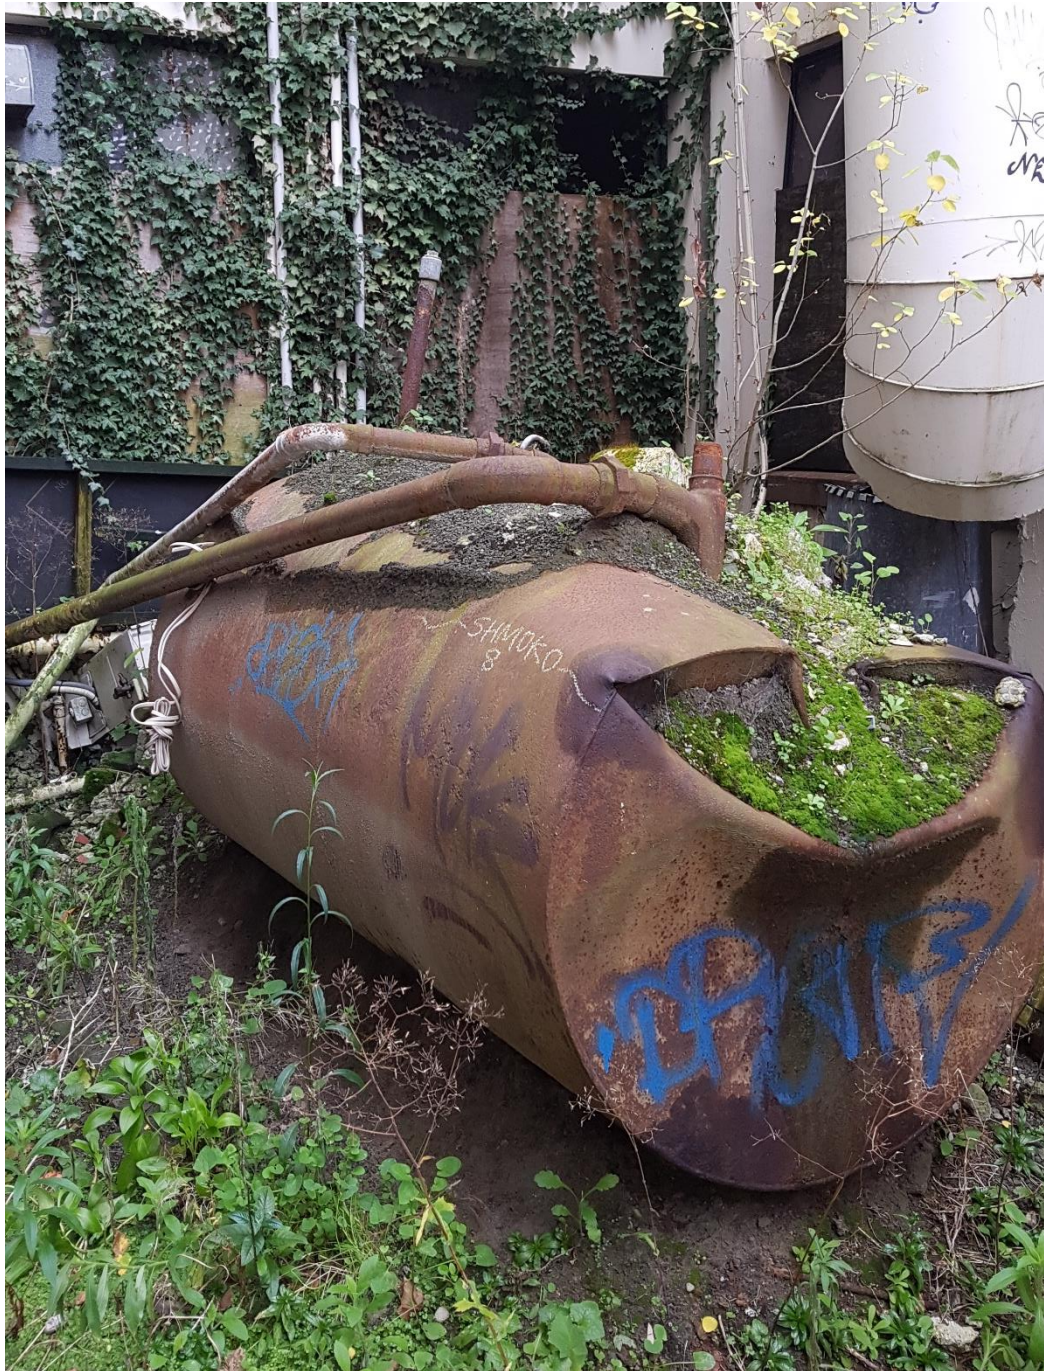
The tank has been ruptured during removal (**Photograph 5**), otherwise it appears to be in good condition. Only a very small amount of liquid, likely water, exists within the tank. A slight diesel or fuel oil odour was noted in the immediate vicinity of the ruptures.

*Photo 5- Close-up view of former underground tank*

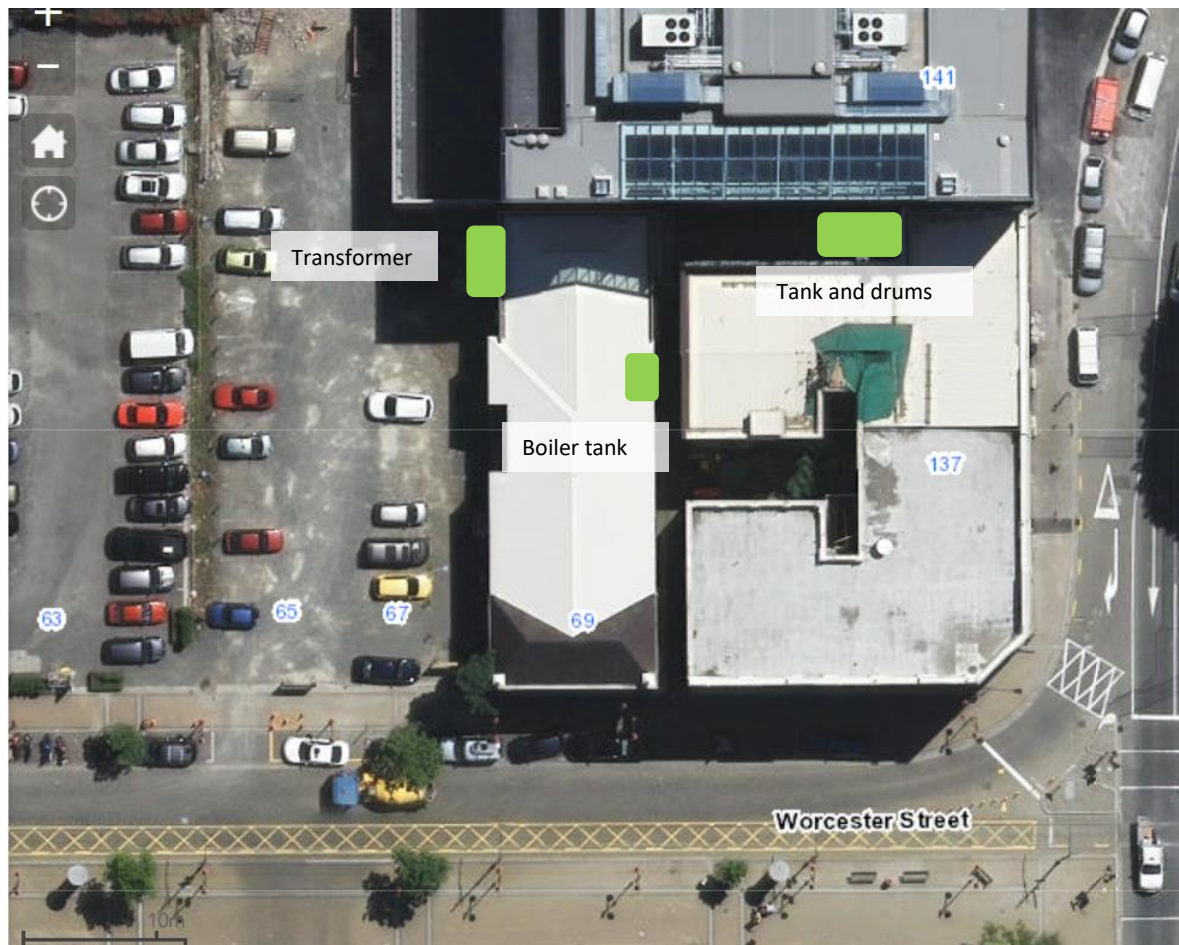
For the subject site, this would only apply to (see **Figure 3**):

- 69 Worcester St – location and immediate surrounds of the boiler tank and transformer
- 137 Cambridge Tce – location and surrounds of the tank
- 65-67 Worcester St – entire site

Figure 3 – Areas of site with HAIL activity ('pieces of land')

The regulations should not apply to other areas of these sites, unless new information comes to light or contamination is discovered during future works.
