Geotechnical Review and Options Report

PAK'n SAVE Papanui

PAK'n SAVE Papanui
Geotechnical Review and
Options Report

**Foodstuffs South Island
Limited**

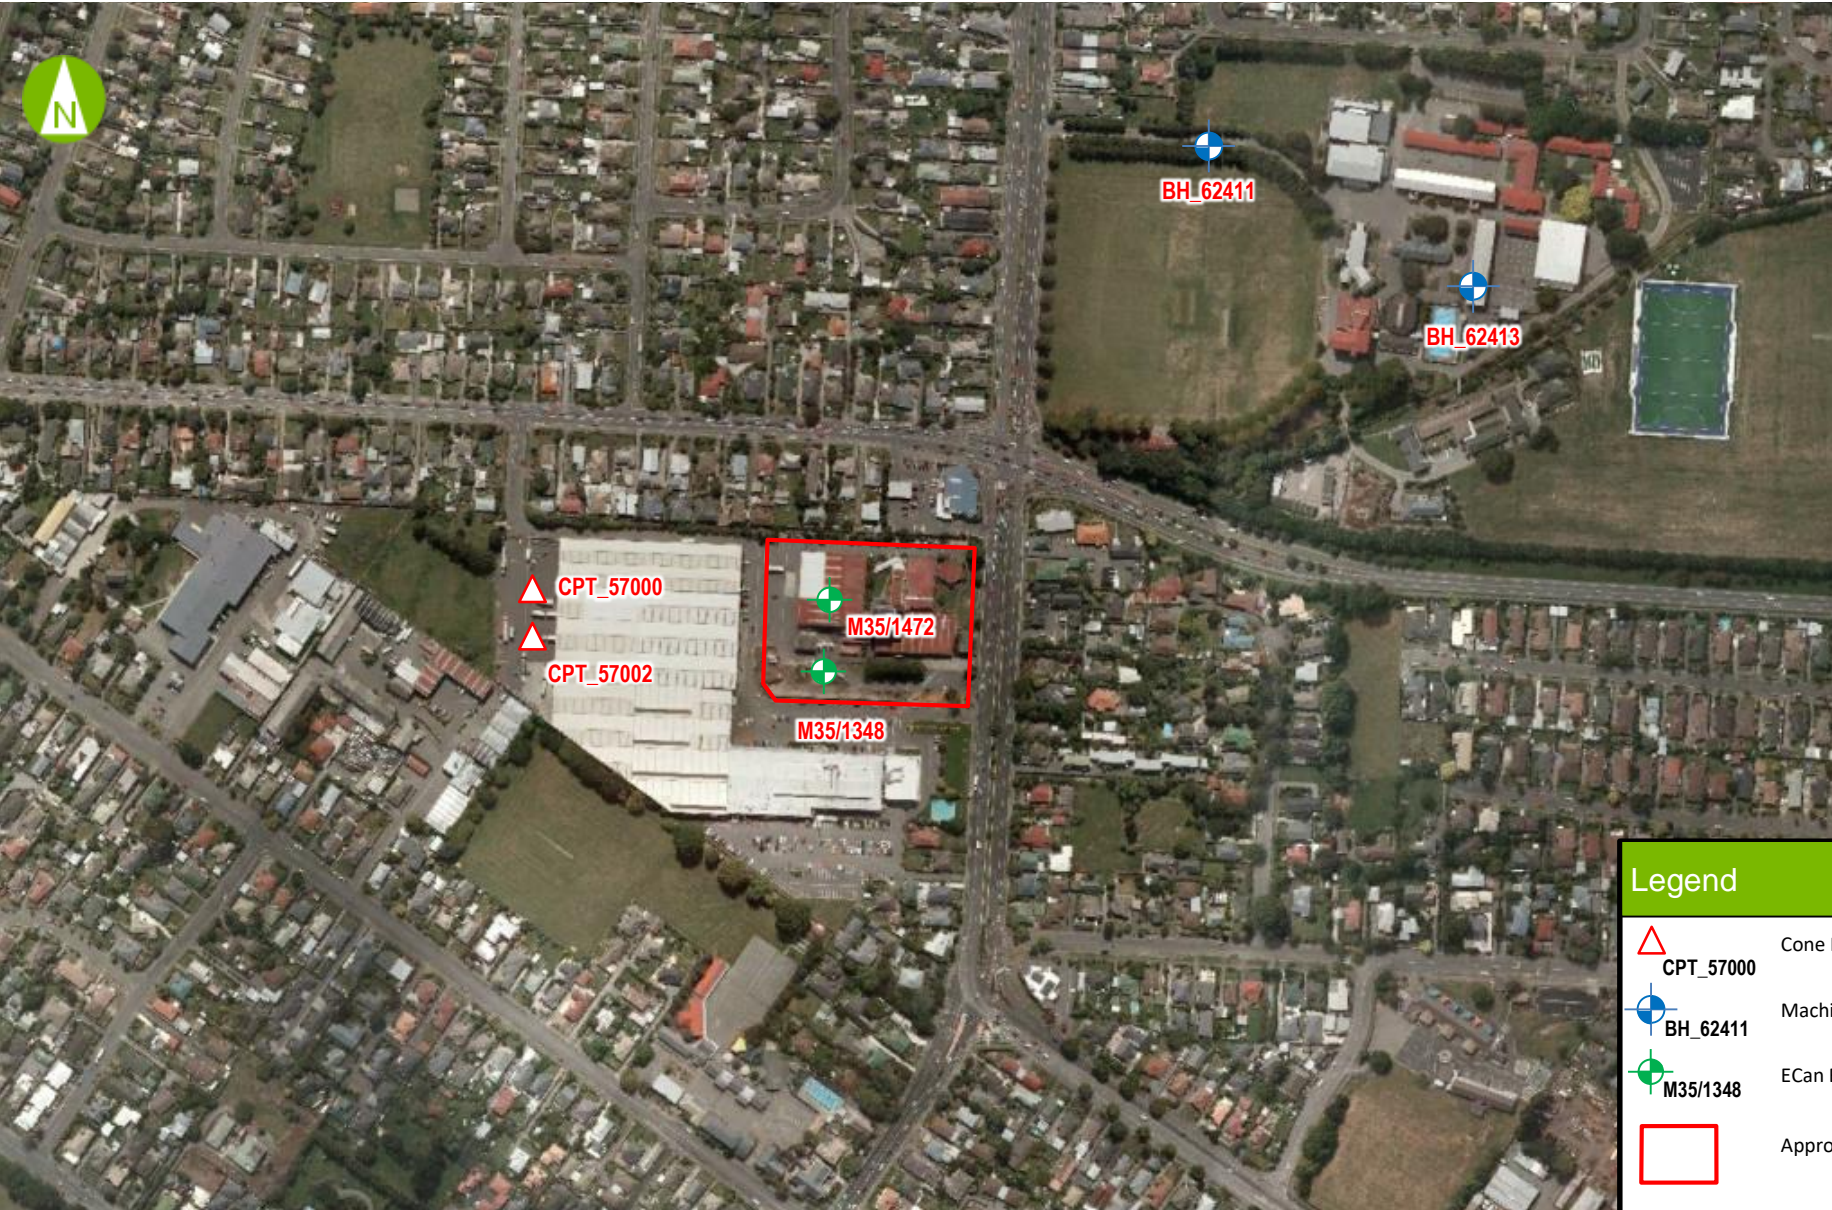
- CPT_57000** Cone Penetration Test
- BH_62411** Machine Borehole
- M35/1348** ECan Borehole
- Approx. site boundary**

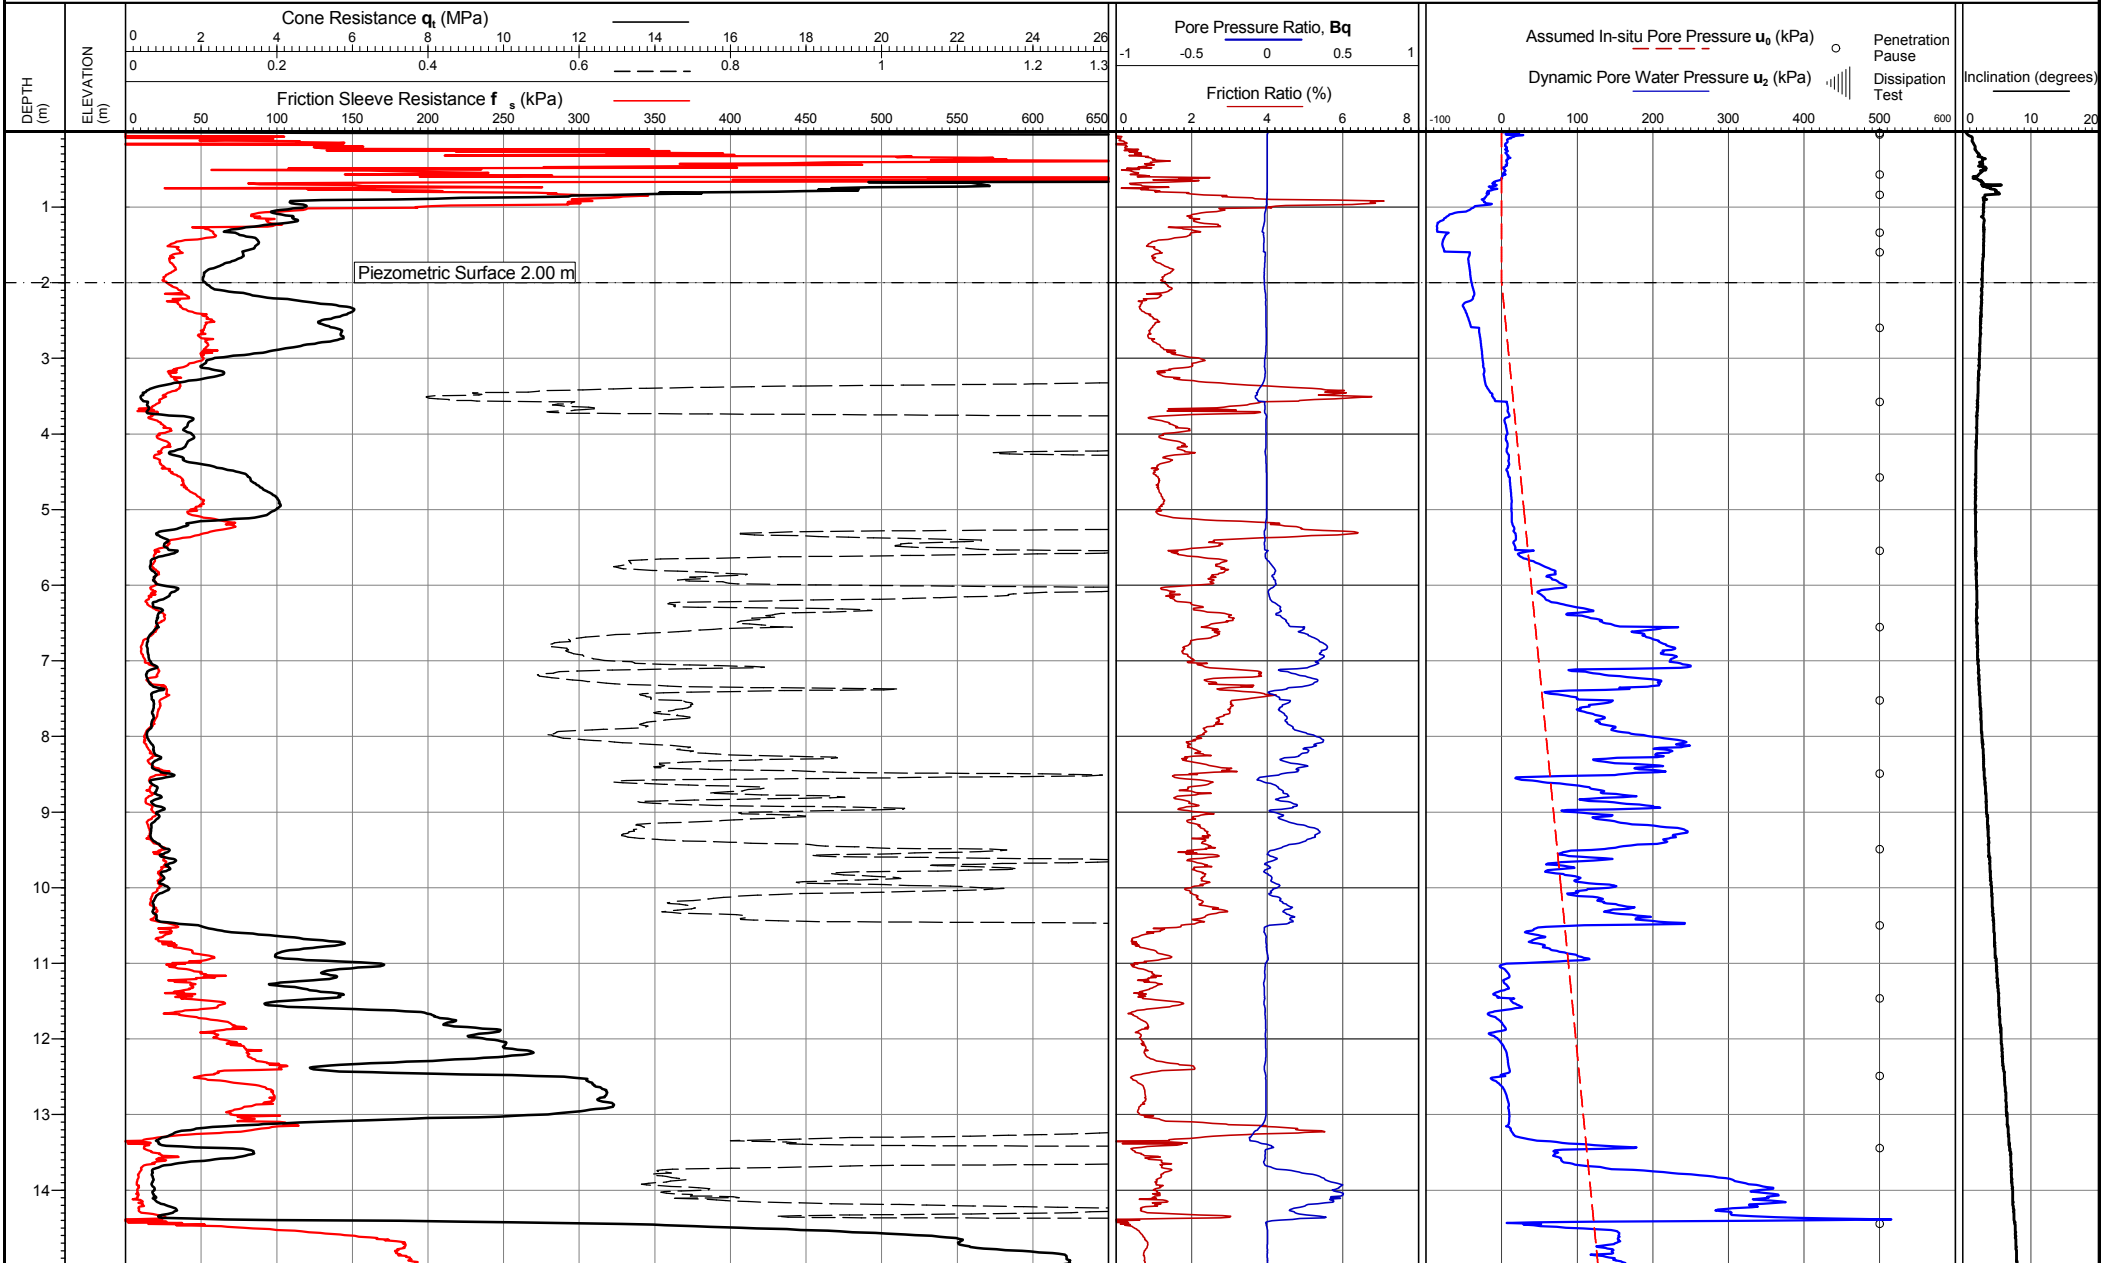
<p>Cone area (mm²): 1500 Cone ID: S15CFIIP.803 Operator: Javan Cassidy Rig Used: NZ1 Date of test: 06/07/2015 13:29:58</p>	<p>Zero drift (Pre/post test) q_c (MPa): 0.0000 f_s (kPa): -0.5 U_2 (kPa): -5.6</p>	<p>Location: Christchurch Coordinates: , Elevation: Coordinate system:</p>	<p>Remarks: *Piezometric surface origin: Est. from u_2 piezo data Termination Remark: Tip load</p>	<p>Date of plot: 07-07-15 Lankelma Project Ref: PNZ2397 Checked by: Emma Stickland</p>	<p>TEST ID: CPT 15203-B Page 1 of 2</p>
---	---	---	---	--	---
