Statement of evidence of **Alan Wayne Parker** on behalf of
Ryman Healthcare Limited

APPENDIX A – ROOT MASS INVESTIGATION

Significant Lime, T 271

Root Mass Investigation

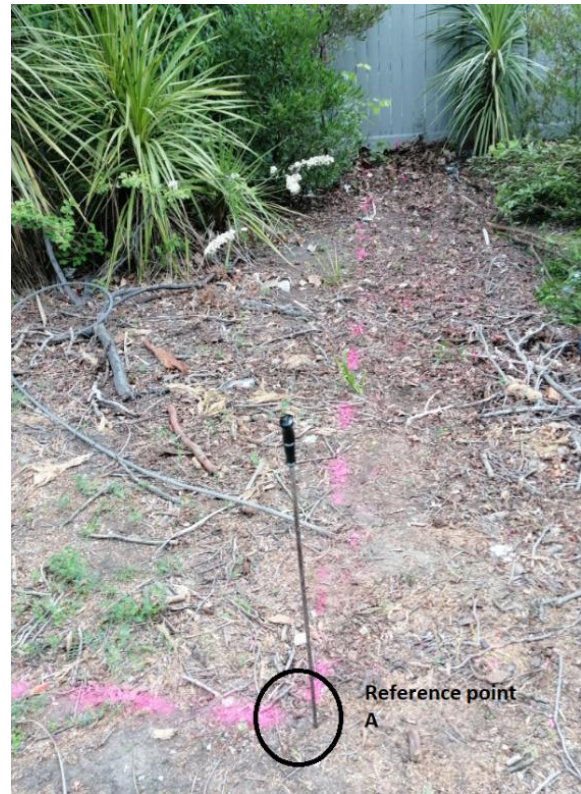
Mark-up on site as follows, Point A looking west;

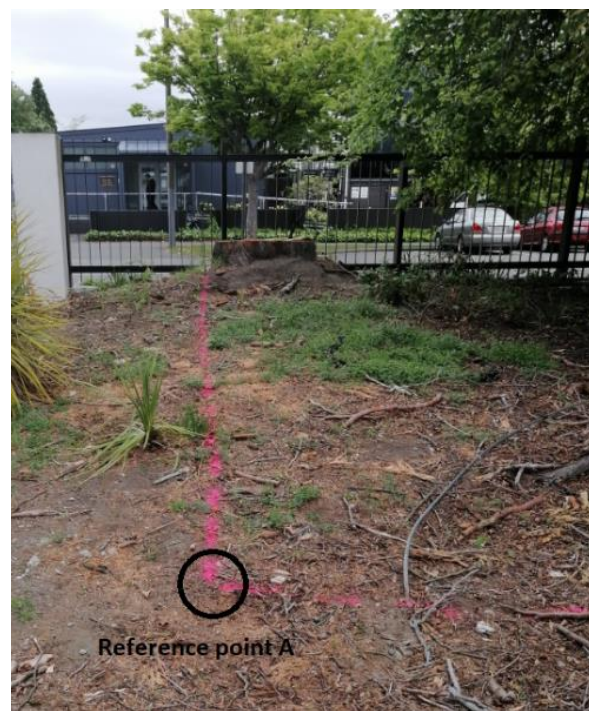
Mark-up on site as follows, Point A looking south;

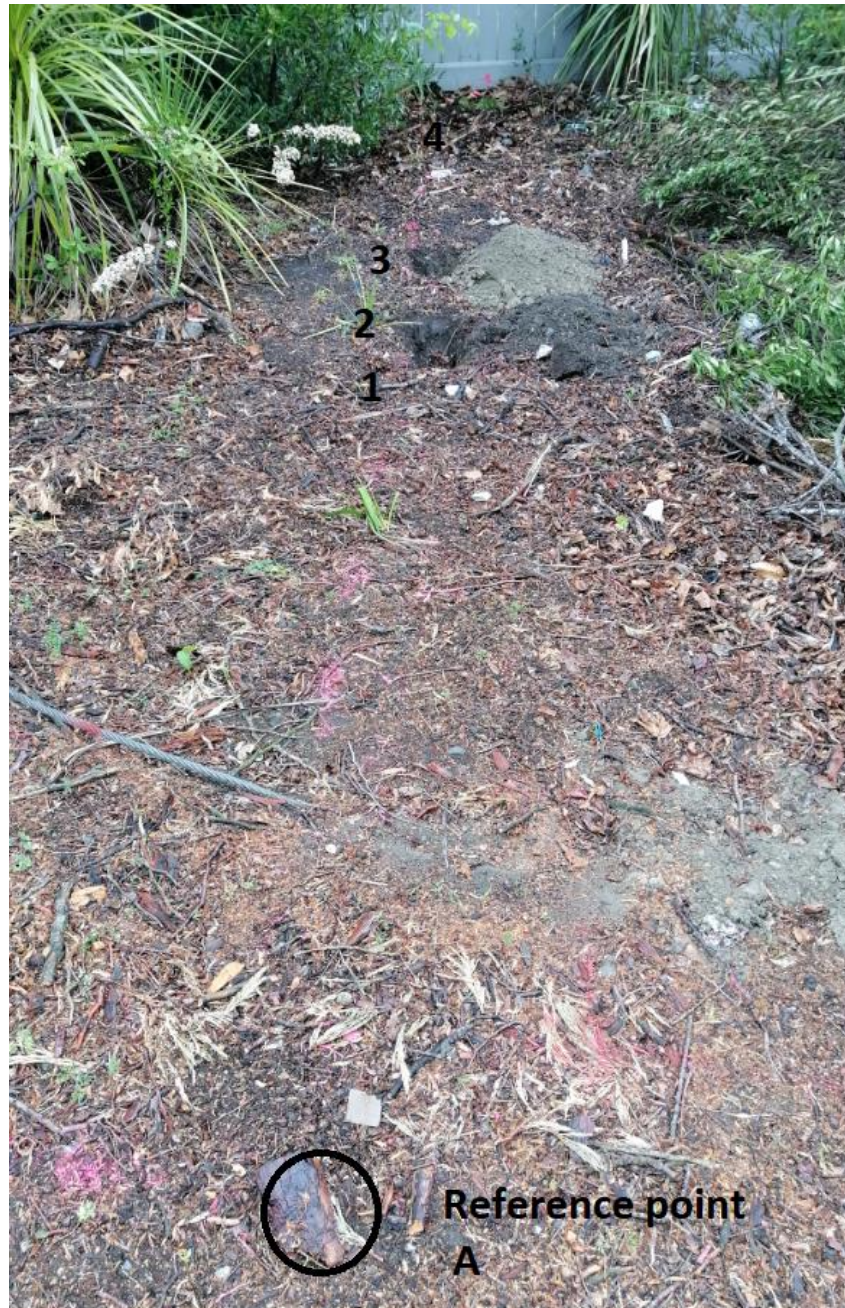
4 areas of interest were noted in the axis A looking west;

1 – Concrete and stone at 250 mm depth

2 - Concrete and stone at 250 mm depth

2 – Excavation to 550 mm, further probe to 650 mm depth overall, root mass found less than 10 mm diameter

4 – Root mass of 15 mm diameter found within the top 100 mm

- Point A looking west, sand was evident in all 4 excavations between 100 & 150-mm depth, below a layer of soil
- The GPR identified a general change in soil density over the areas scanned, at between 1.0 m and 1.2 m depth
- A large mass (approximately 1.0 m by 1.0 m) was encountered close to and surrounding Point A, assumed to be a concrete block as the mass was consistent around the steel cable.

It is possible that post earthquake demolition activities have removed peripheral root mass, considering that some of the rubble encountered (areas 1 & 2) was concrete, not naturally occurring river run.

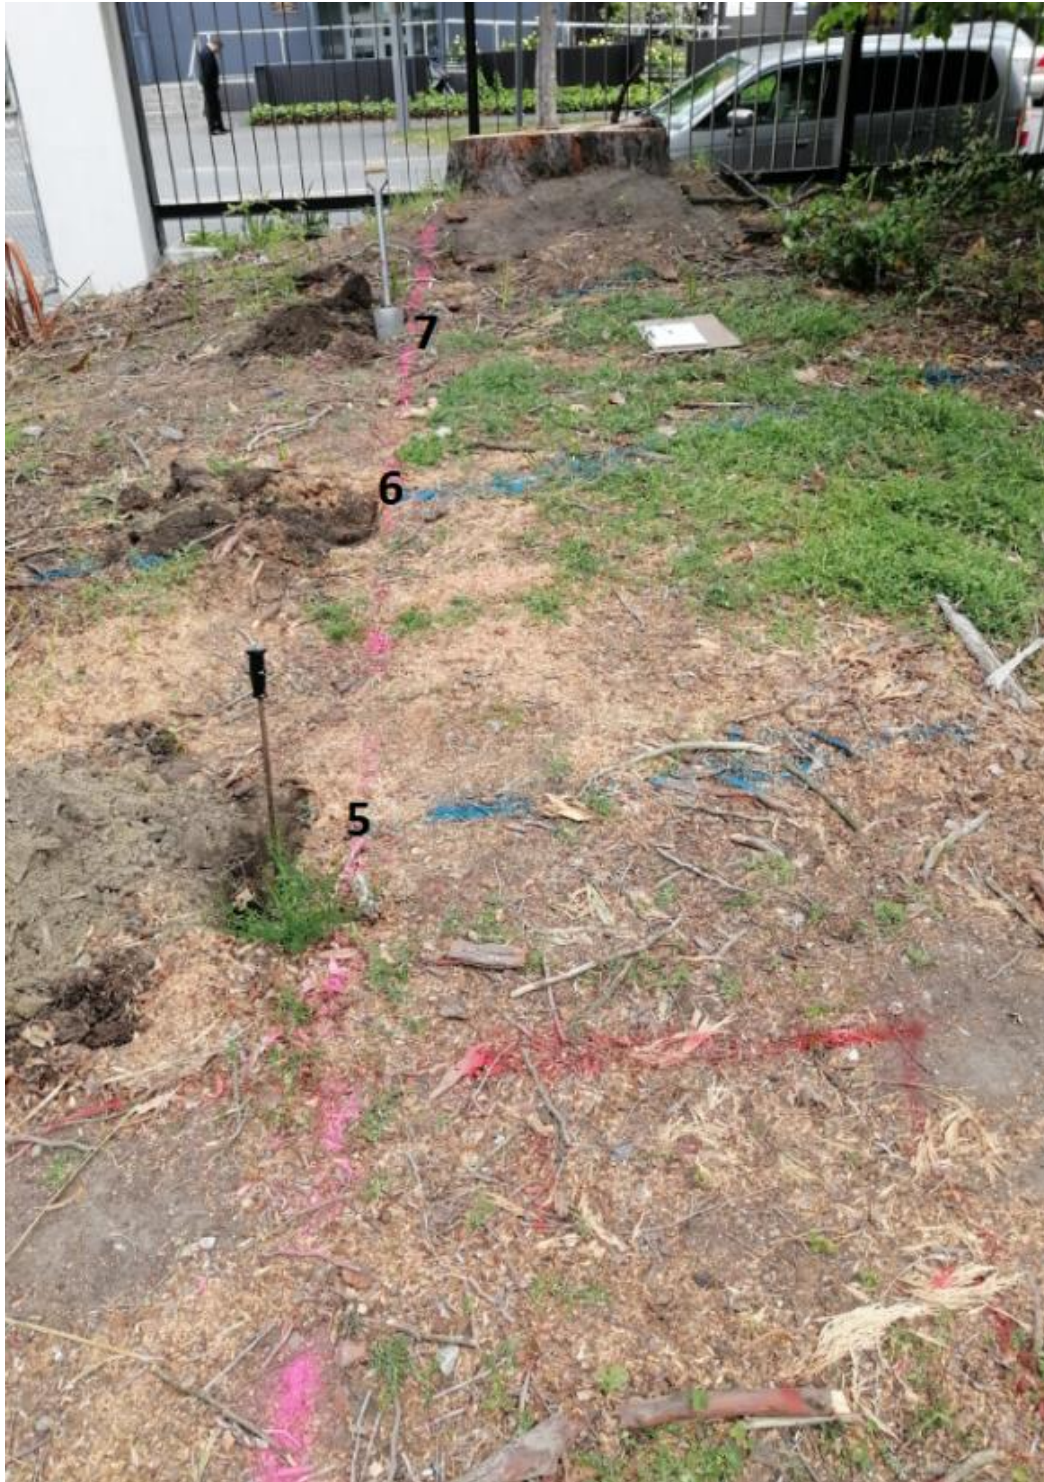
3 areas of interest were noted in the axis A looking south;

5 – Root mass of 20 – 25 mm diameter found at 400 mm depth

6 – Root mass of 80 mm diameter found at 50 mm depth, tracked back to the Lime

7 – Root mass less than 20 mm diameter found at 350 mm depth

The GPR and subsequent manual excavation has revealed insignificant root mass at the location of the proposed basement excavation and construction, therefore I conclude that the proposed basement excavation and construction will have a negligible effect on the Significant Lime tree.
