**Geotechnical Engineering
Assessment of
Environmental Effects**

**Ryman Village, Park Terrace,
Christchurch**

Prepared for
Ryman Healthcare Limited

Prepared by
Tonkin & Taylor Ltd

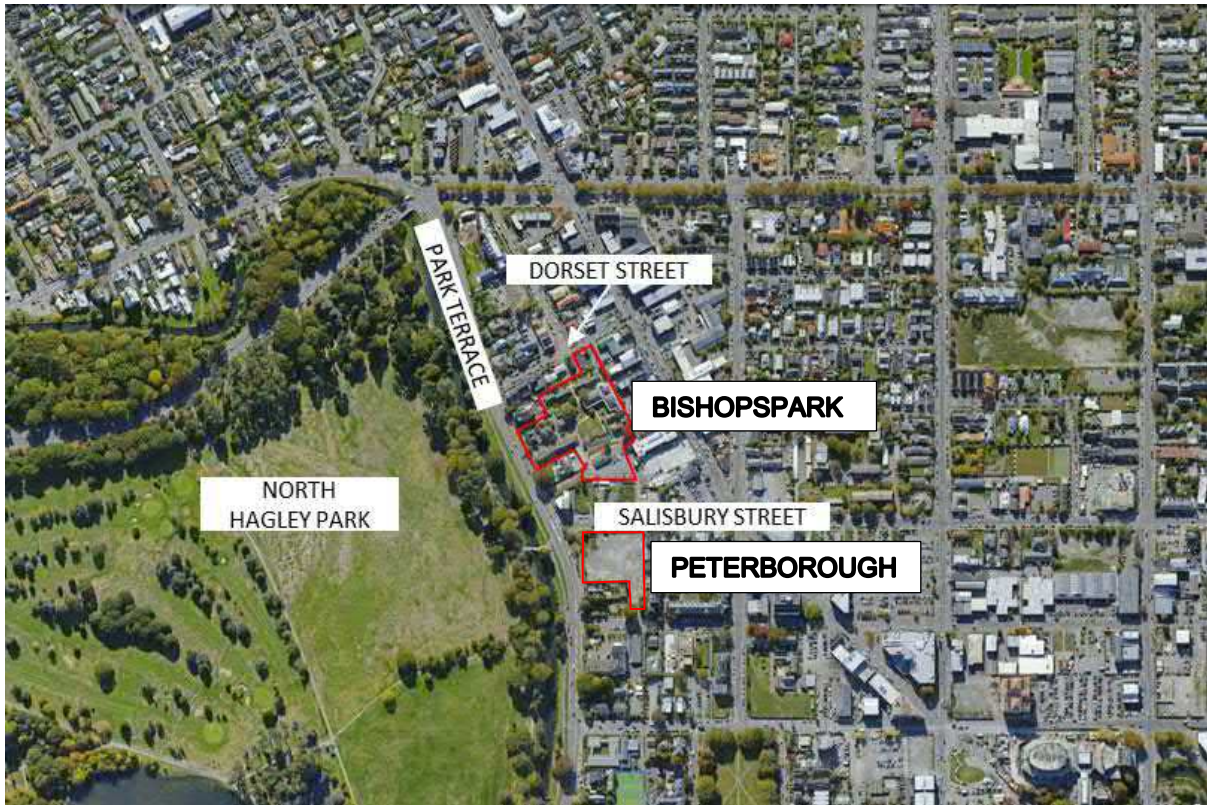
Figure 1.1: Proposed Village Site showing approximate boundaries in red. (Source: Google Earth Pro).

The Site is shown in Figure 1.1 below and is described in detail in the Assessment of Environmental Effects. In brief, the Bishopspark site covers an area of approximately 1.2 hectares and generally slopes gently to the west. The Peterborough site is typically flat and covers an area of approximately 5,078 m² (refer Figure 1.1). The Bishopspark site includes Lot 1 DP 46369, Lot 1, DP 46511 and Part Section 23 TN RES Christchurch and the Peterborough site includes Lot 1 DP 77997.

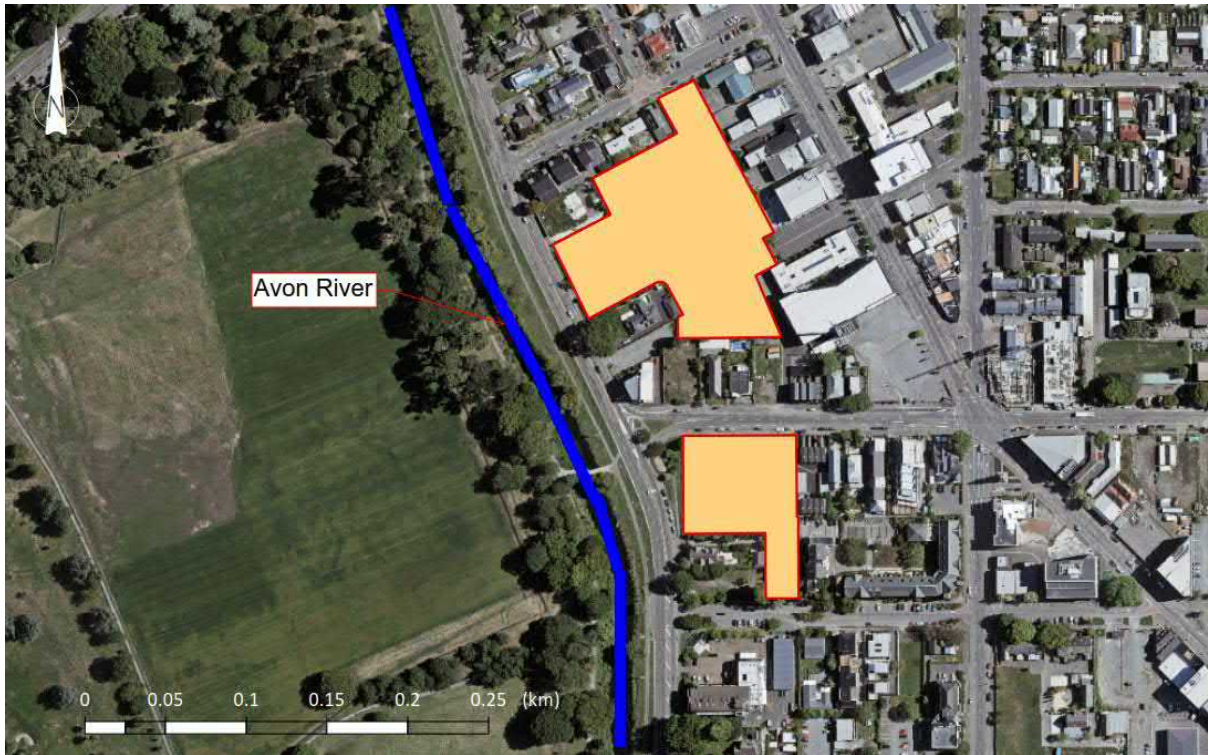
Figure C.1: Site outline of two sites; Bishopspark and Peterborough, and the close proximity of the Avon River.

Given the site locations and the close proximity to the Avon River (as shown in Figure A.1), there will be a relationship between the river, and the aquifer affected by the excavation. .
