Canterbury Museum Planning Advice Basement & Base Isolation Structural Feasibility

Basement and Base Isolation Structural Feasibility

Prepared For:
Canterbury Museum

Date: 24 November 2020
Project No: 137913.00
Revision No: 2.0

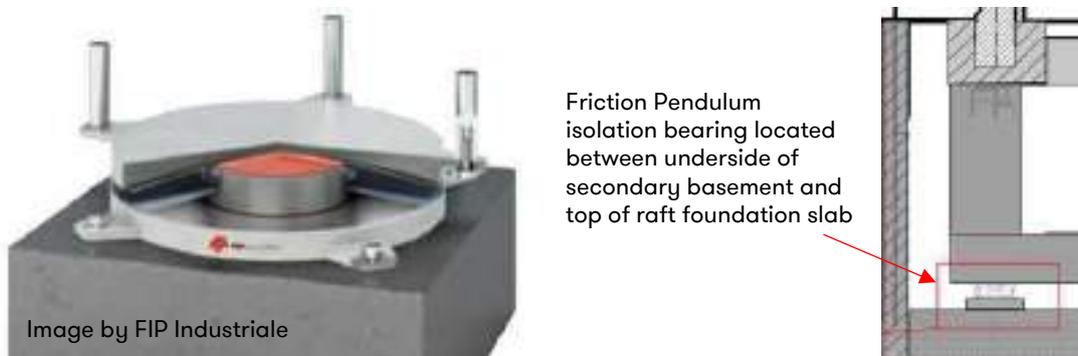
As the name suggests, these devices rely on a friction interface to resist the seismic forces. When using friction-based devices, the surface condition of the friction interface is critical, and maintaining this surface as close as possible to its original condition is important in-order to have reliable *as-designed* seismic isolation performance. This becomes an important consideration with respect to where the isolation plane is located, relative to sources of long-term moisture exposure.

Figure 1. (a) Example of a friction pendulum isolation bearing (b) schematic basement section indicating location of isolator and approximate structural element build-up.

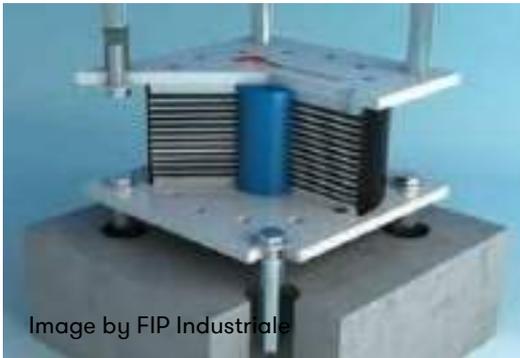
An alternative isolation scheme could be based around a Lead-Rubber Bearing system (historically the go-to bearing type used in New Zealand) which utilises the combined mechanical properties of lead and rubber to resist the seismic forces. These bearings are more resistant to atmospheric condition induced changes in properties over time, and might be considered more suitable for long-term moisture exposure. For the same level of seismic isolation effectiveness (as the friction pendulums), these bearings are likely to be 2-3x taller (~500mm high), which would influence the excavation depth (Figure 2). As noted above, we also see them presenting a more difficult system to tune appropriately, due to the very different loads we expect to see from the existing and new structures.

Lead-Rubber Bearing located between underside of secondary basement and top of raft foundation slab

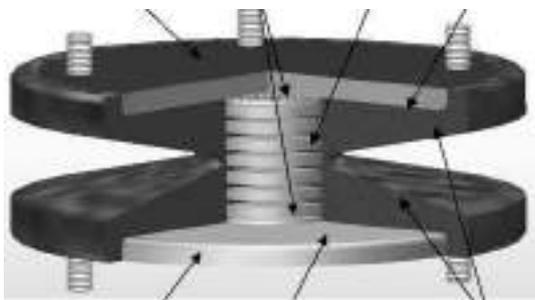
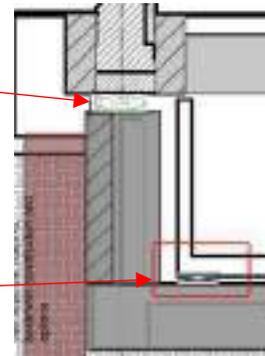
Within the concepts proposed for the museum seismic base isolation, a secondary system is being considered. This would be a specific floor isolation used to ‘float’ the collection storage floor (and secondary basement). We have identified an isolator bearing produced by a New Zealand company that is suitable for this “light-weight” application, along with an alternative proprietary isolated floor system. Utilising a secondary floor isolation for the collection storage would allow a more specific isolation design for the weight of the collection, which could provide better protection for the contents. With the depth of excavation in-mind, the key in providing a secondary isolation scheme is to minimise the depth of the “floating floor” + isolators (Figure 3).

Friction Pendulum (or LRB) located at underside of Ground Floor

Secondary isolation of Collection Storage with Ro-glider at underside of secondary basement and top of raft foundation slab

Figure 3. (a) Ro-glider isolation bearing for light-weight applications (b) schematic basement section indicating location of secondary isolator and approximate structural element build-up.

- The seismic isolation system for the collection storage floor would still face the same potential moisture issues if using a friction-based bearing (which these 'light-weight' systems often are). However, the NZ isolation bearing product (noted above) is protected by a rubber sleeve that is bond-sealed around its edge and would offer protection from long-term moisture exposure.

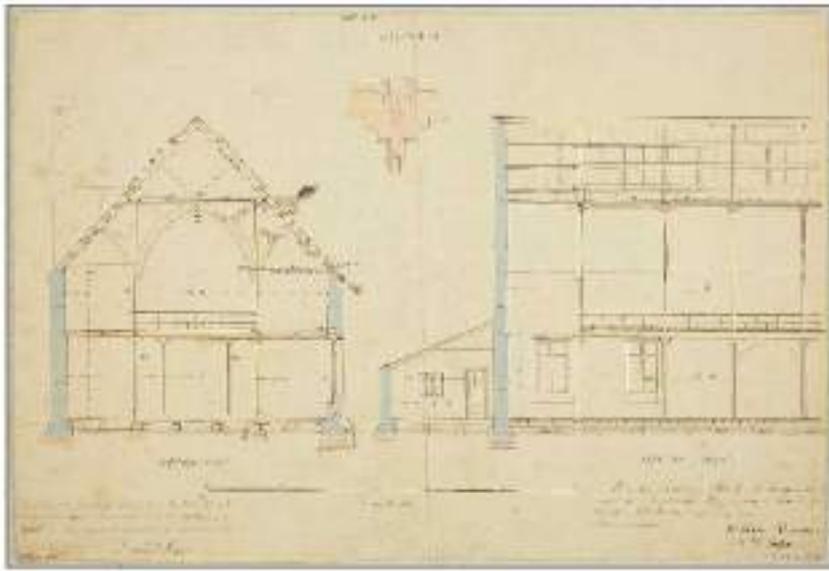
Figure 4. Mountfort's sectional drawing of the first museum building, 1869
(Source: Canterbury Museum)

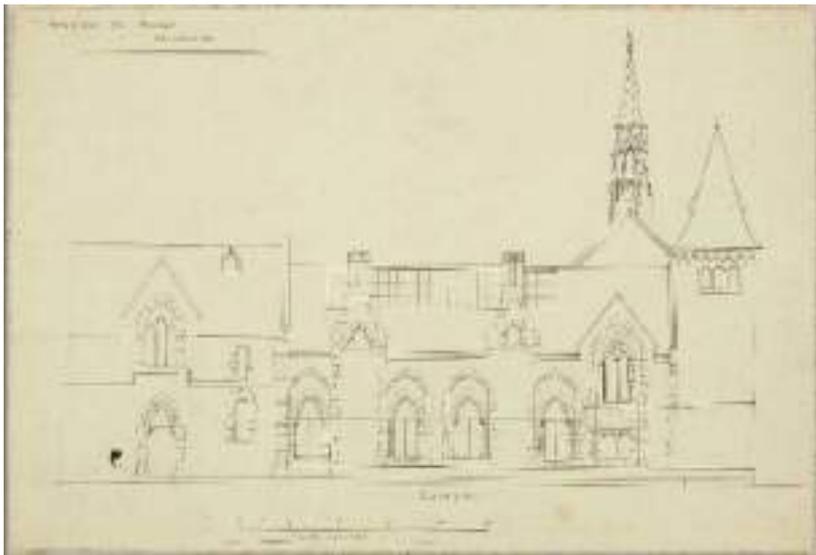
Figure 7. Original architectural drawing of the south façade of the 1872 and 1877 buildings
(Source: Canterbury Museum)

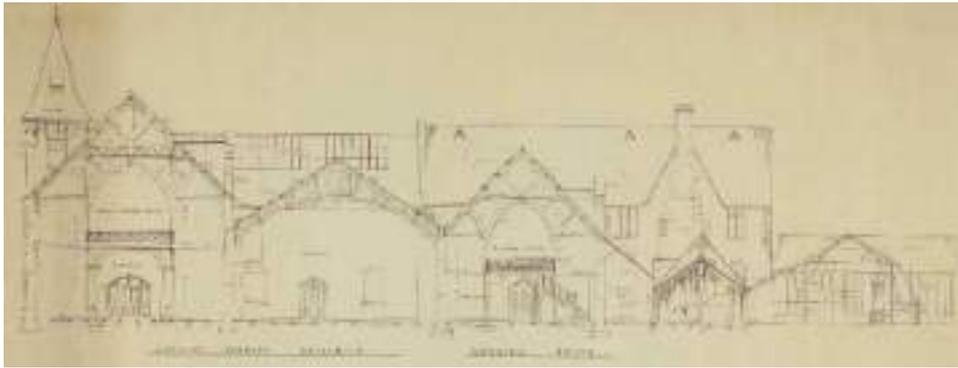
Figure 10. Section through Canterbury Museum from Rolleston Avenue, 1948 showing from L to R: 1877 building, 1882 building, 1870 building, 1872 building behind where in foreground. Structure to the far right may be the shelter for the blue whale
(Source: Canterbury Museum)

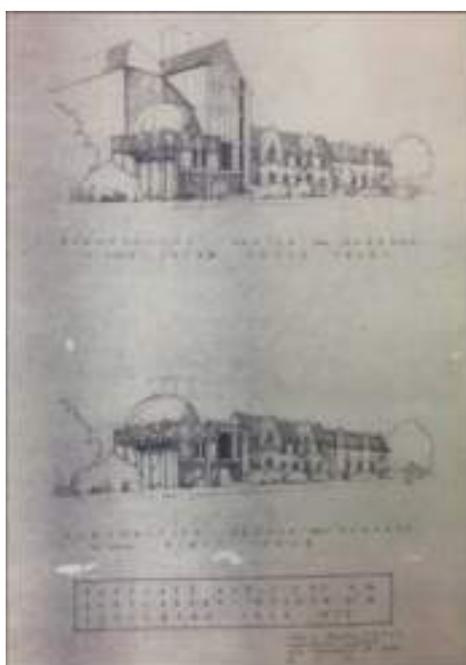
Figure 13. (left) Architect John Hendry's drawings for the proposed 1970 addition showing initial and proposed later stage of development.

Within four years of the Centennial Wing being opened, Duff was again agitating for further extensions. Plans and fundraising were underway by 1962 for a building to house a 'Rutherford Hall of Science.' The new wing (Figure 13) was designed by well-known Christchurch architect, John Hendry, who was a founding member of the New Zealand Historic Places Trust (now Heritage New Zealand Pouhere Taonga). It was hoped that the new wing would be ready for the museum's centennial in 1970;

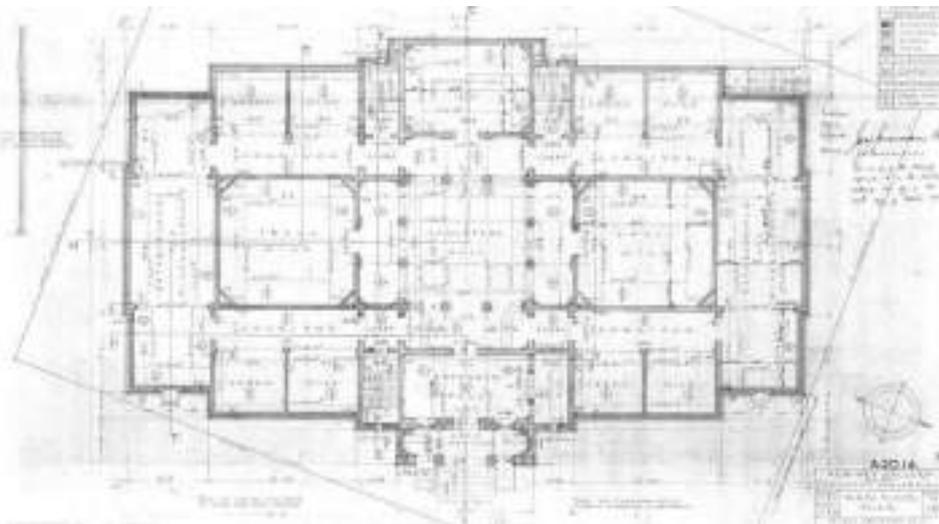
Figure 18. Main floor plan of the Robert McDougall Art Gallery, 1930
(Source: Christchurch City Libraries)

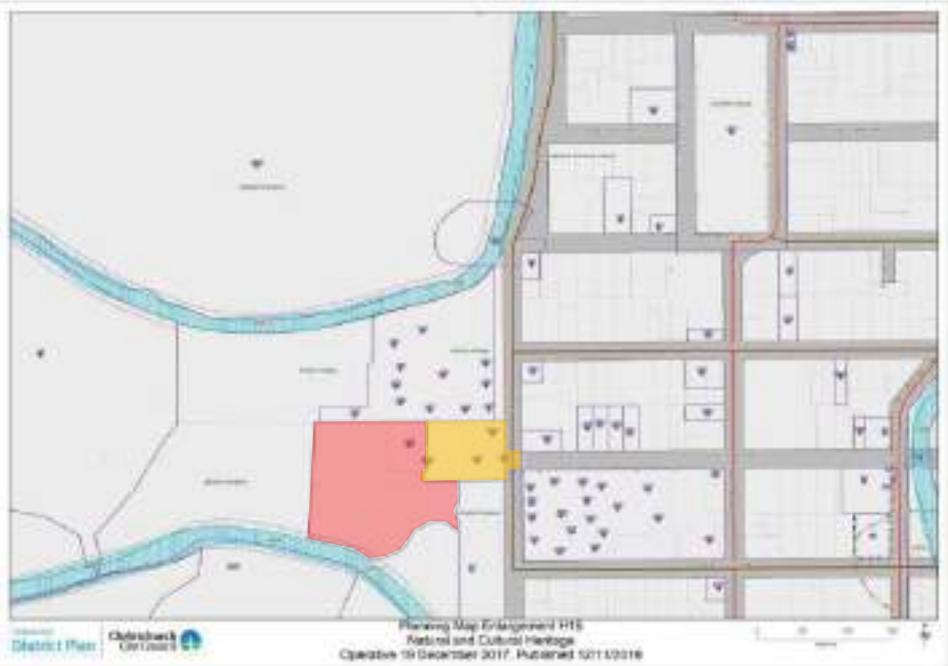
Figure 21. Planning Map Enlargement H15. HSN #256 shaded in red HSN #257 shaded in yellow (Adapted from: Christchurch District Plan)

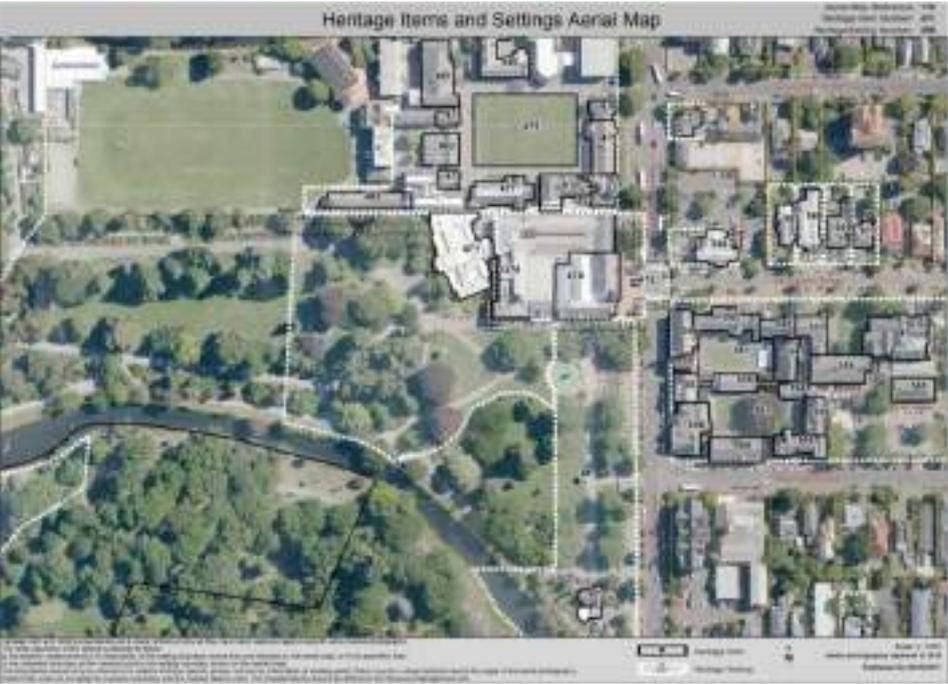
Figure 22. Heritage Items and Setting Aerial Map No. 118 showing the context of the Canterbury Museum (#474, #1378 & #1379) and the Robert McDougall Art Gallery (#471) (Source: Christchurch District Plan)

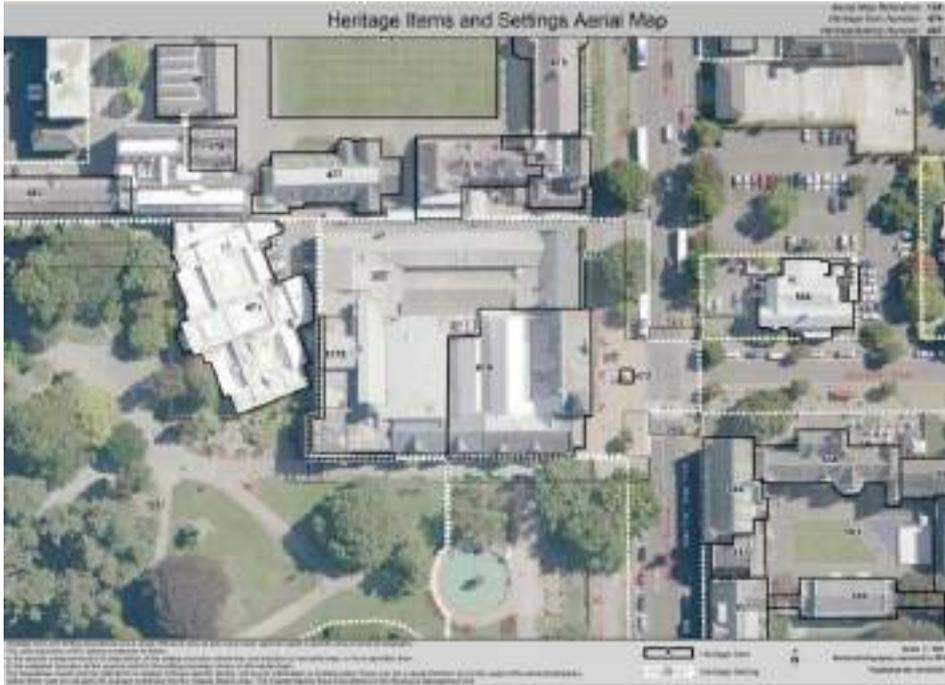
Figure 23. Heritage Items and Setting Aerial Map No. 124 showing the Canterbury Museum- nineteenth century buildings (#474), Canterbury Museum – Centennial Wing East Facade (#1378), Canterbury Museum – Roger Duff Wing South and West Facades (#1379) and Robert McDougall Art Gallery (#471) and their respective settings Canterbury Museum (#257) and Robert McDougall Gallery (#256). The Rolleston Statute (#472) is also located within setting #257. Note: Heritage Aerial Maps 124, 135, 808 & 809 are identical (Source: Christchurch District Plan)
