**Canterbury Earthquakes 2010/11 Port Hills Slope  
Stability: Risk assessment for Redcliffs**

**GNS Science Consultancy Report 2014/78  
August 2014 FINAL**

Massey, C. I.; Della Pasqua, F.; Taig, T.; Lukovic, B.; Ries, W.; Heron, D., Archibald, G. 2014. Canterbury Earthquakes 2010/11 Port Hills Slope Stability: Risk assessment for Redcliffs. *GNS Science Consultancy Report 2014/78*. 123 p. + Appendices

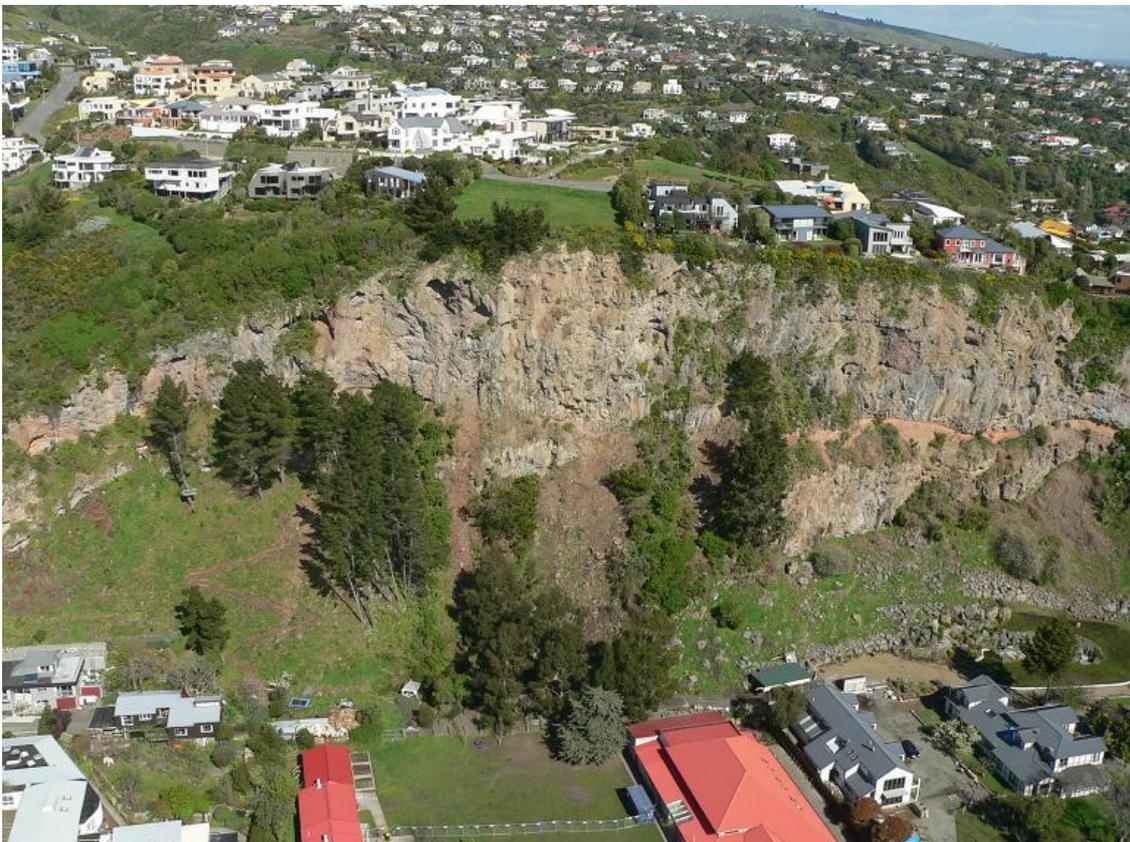
**Figure 3** Aerial view of the Redcliffs mass movement area after the 4 September 2010 (Darfield) earthquake and before the 22 February 2011 earthquakes. Photograph taken by M. Yetton.

During the 22 February 2011 earthquakes, within the Redcliffs mass movement area, significant volumes of debris fell from the steep rock slope (debris avalanches), inundating dwellings at the cliff bottom, along with localised recession and cracking of the cliff crest. These have been collectively termed cliff-collapse hazards (Figure 3–Figure 9). Previous investigations of the site comprised:

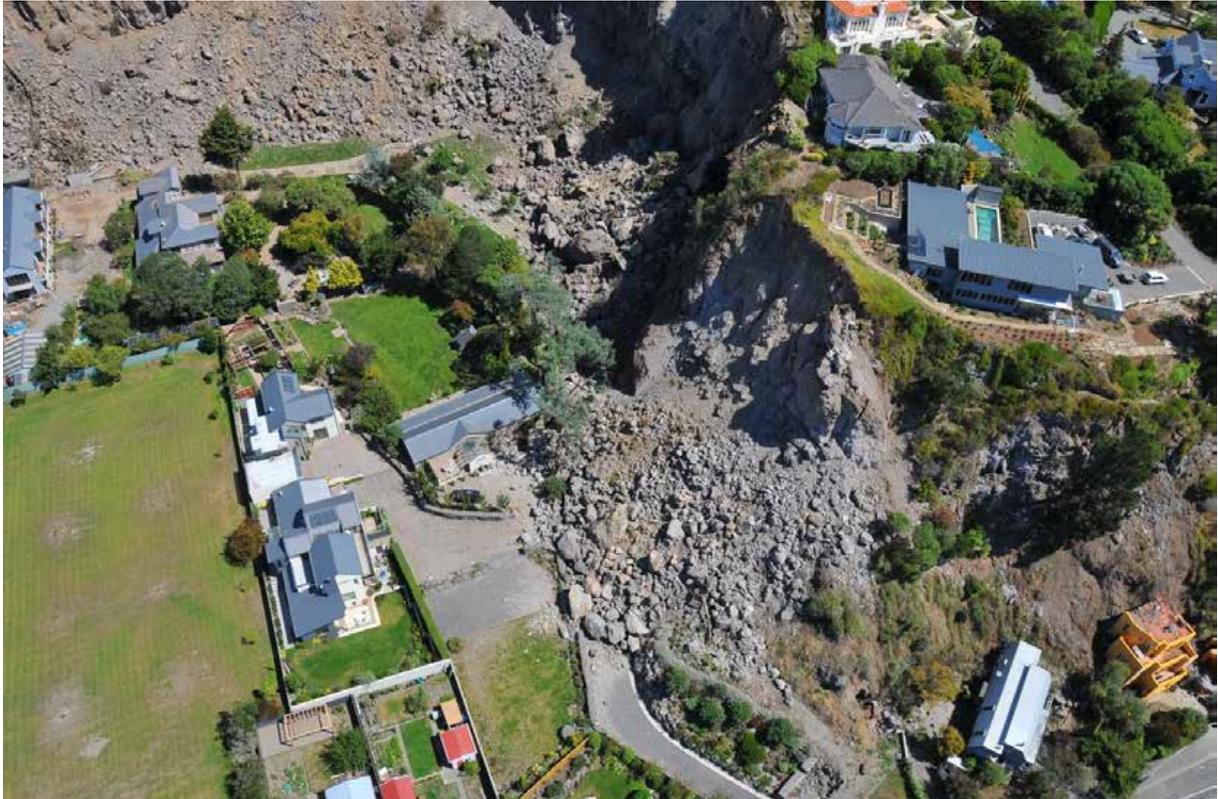
**Figure 5** Aerial view of the Redcliffs mass movement area after the 22 February 2011 earthquakes and before the 13 June 2011 earthquakes. Photograph taken by G. Hancox.

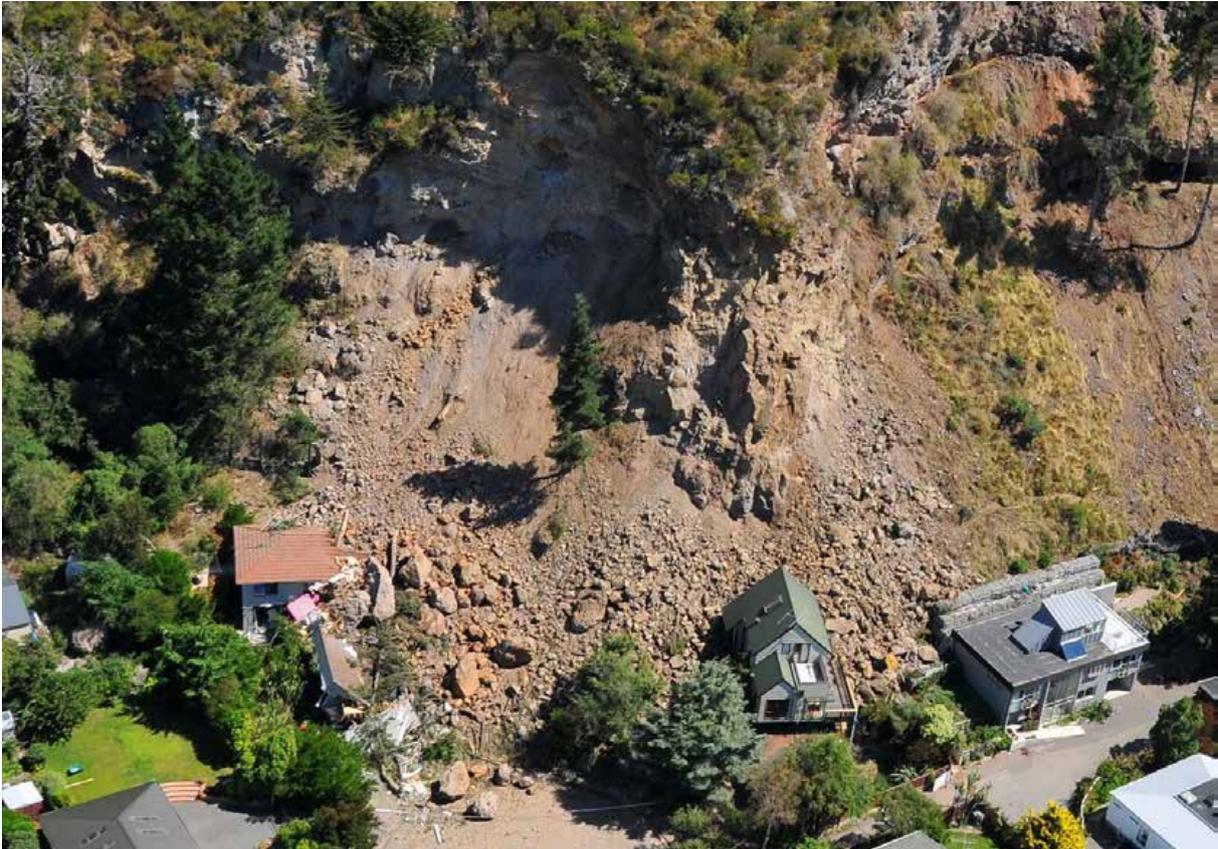
**Figure 6** Aerial view of the Redcliffs mass movement area after the 22 February 2011 earthquakes and before the 13 June 2011 earthquakes. Photograph taken by G. Hancox.

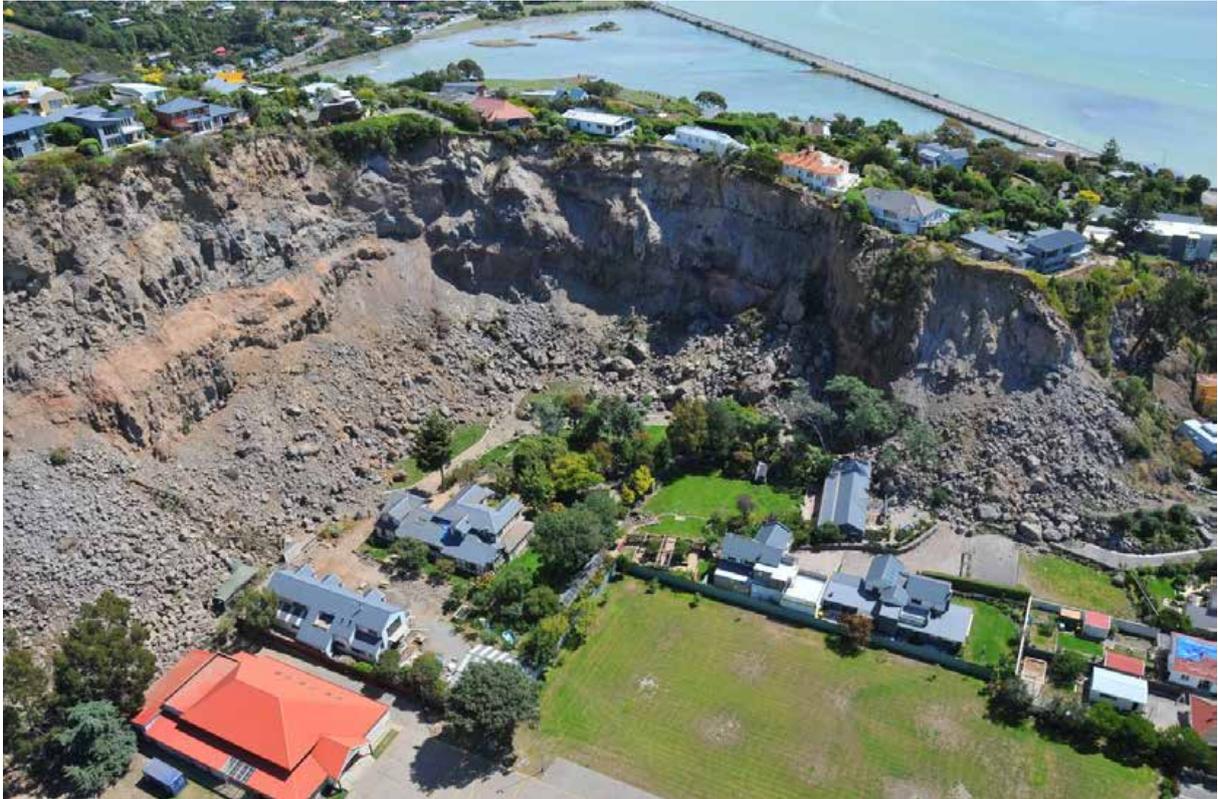
**Figure 7** Aerial view of the Redcliffs mass movement area after the 22 February 2011 earthquakes and before the 13 June 2011 earthquakes. Photograph taken by G. Hancox.

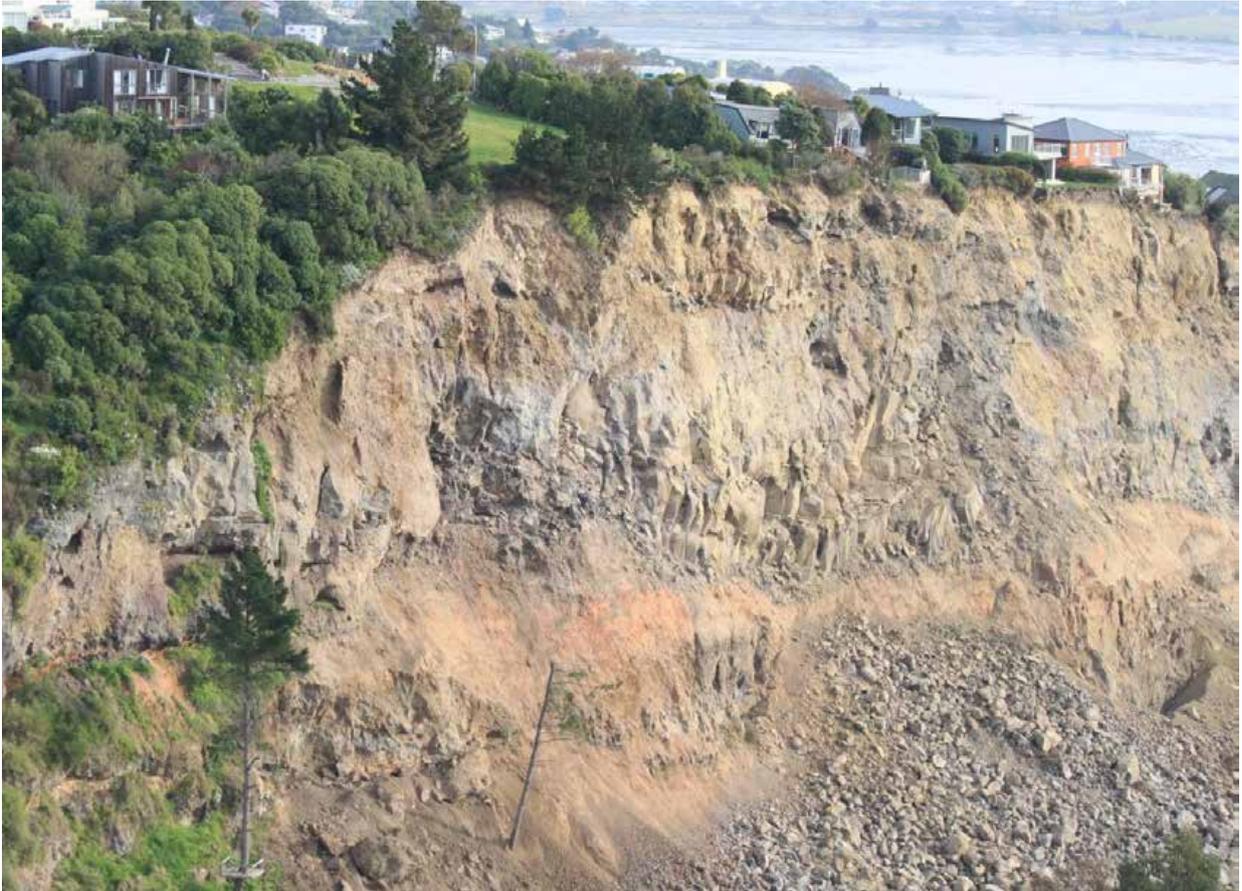
**Figure 9** Aerial view of the Redcliffs rock slope after the 13 June 2011 earthquakes. Photograph taken by C. Massey.

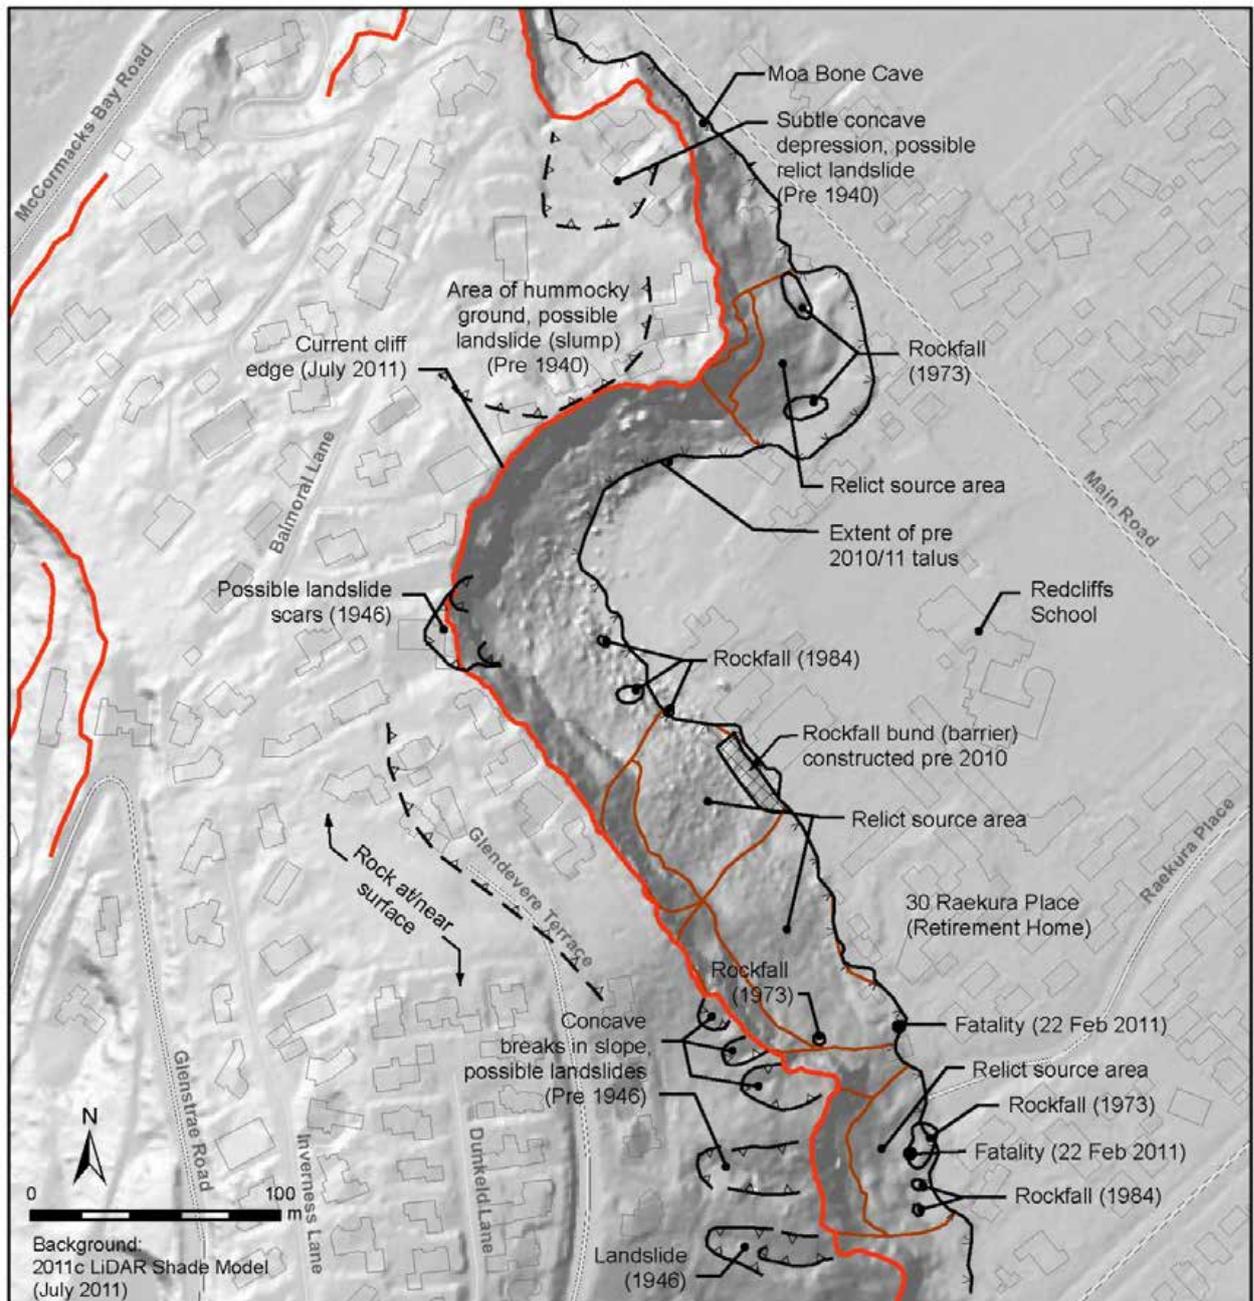
**Figure 10** Main features identified at the site from field mapping and the interpretation of historical aerial photographs.

- There are several possible rockfalls visible in historical aerial photographs (Figure 10).
- A rockfall bund (a barrier constructed of rock fill to prevent rockfalls from passing it) was constructed in 2010 behind the Redcliff School hall (Figure 10).

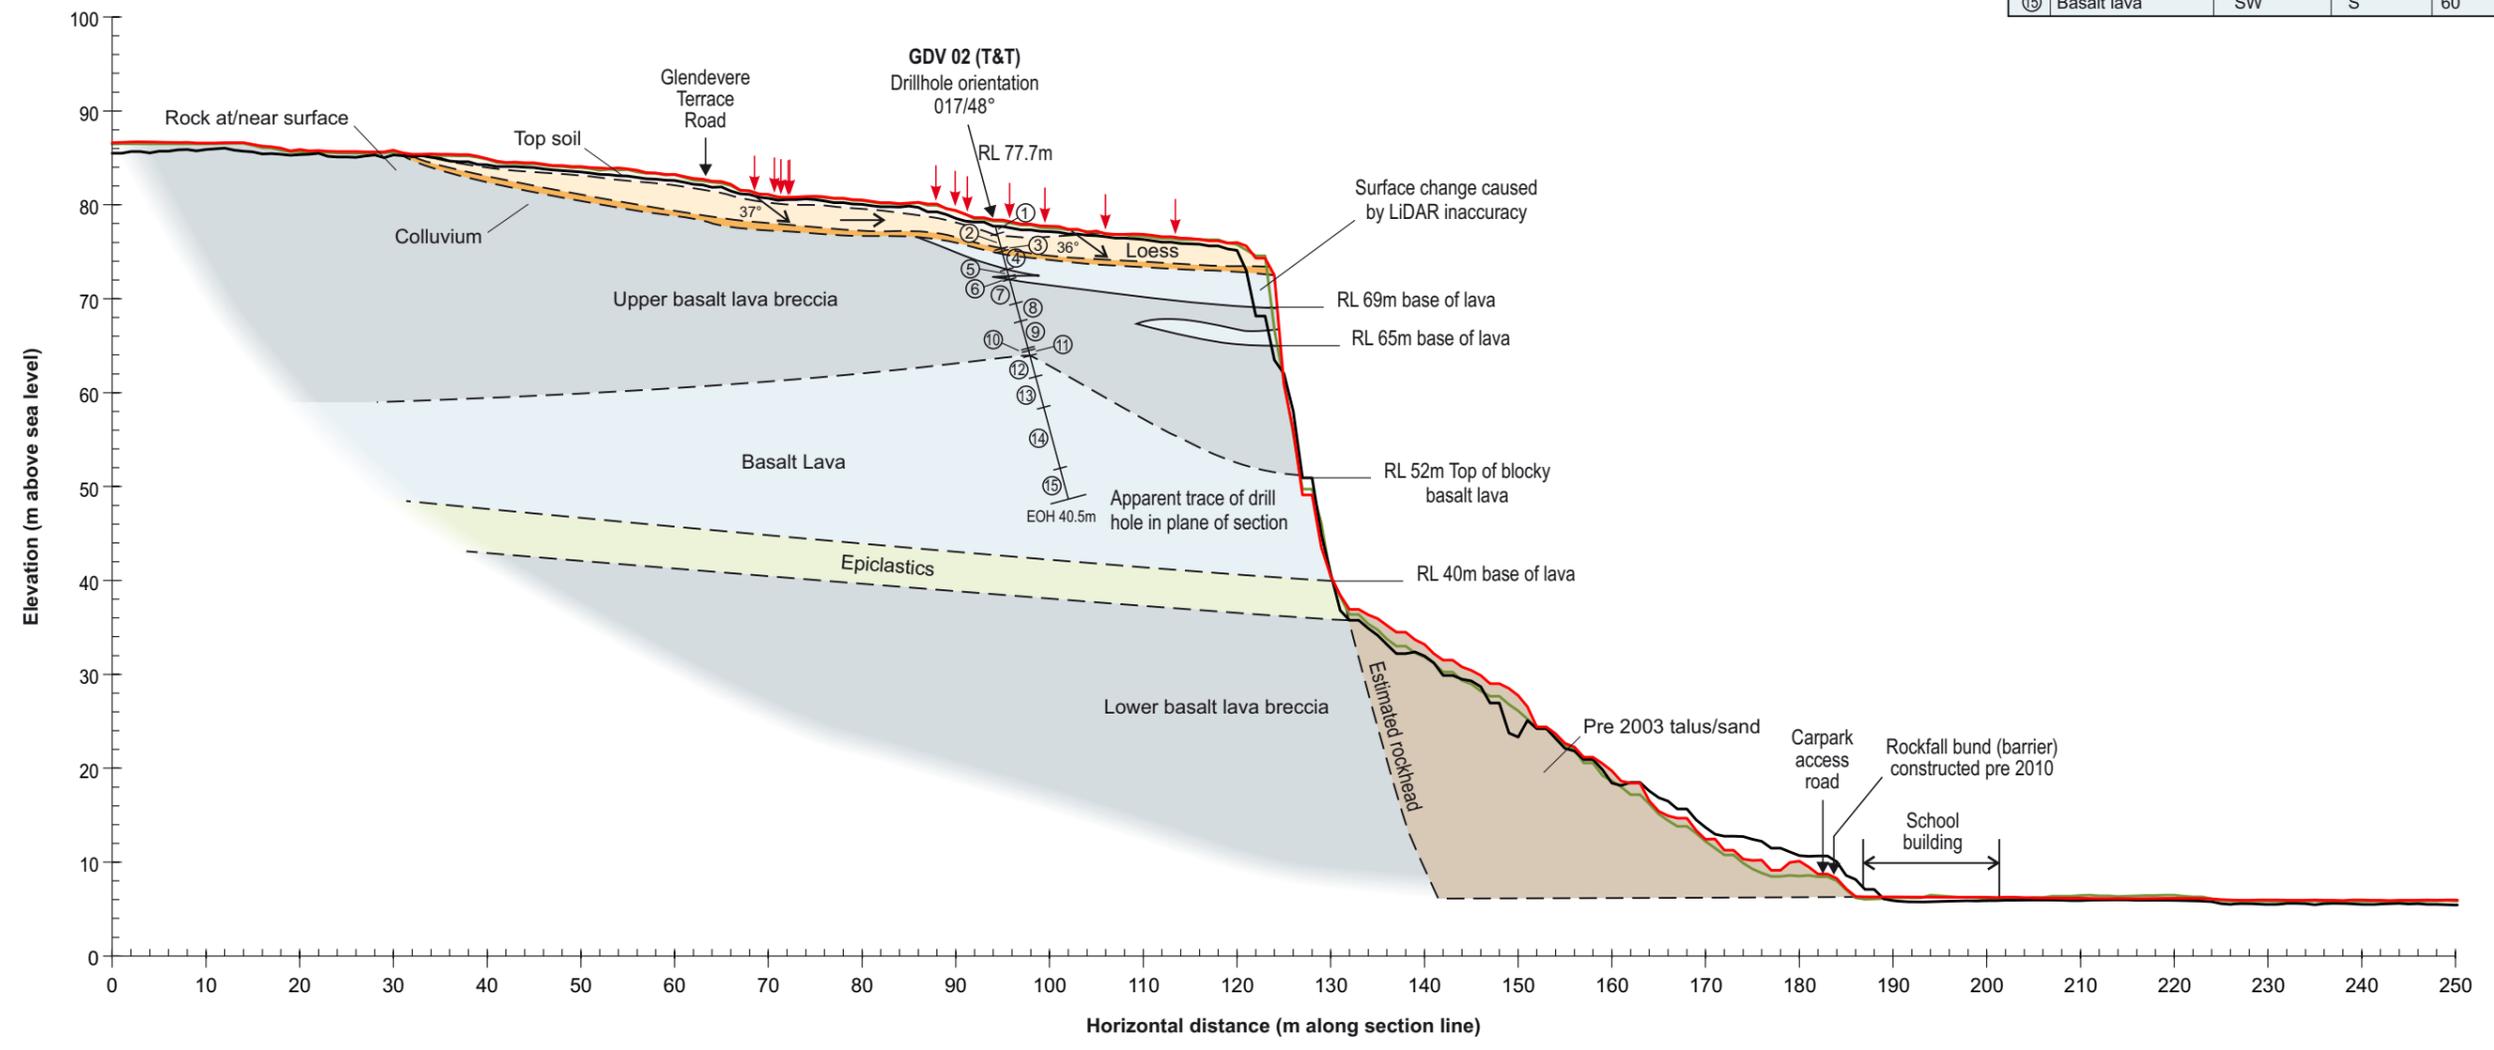
Material type	Weathering	Strength	RQD %
①	Top Soil			
②	Loess			
③	Colluvium			
④	Basalt lava	SW	MS	50-70
⑤	Basalt lava breccia	MW	W	50
⑥	Basalt lava	UW	MS	65-100
⑦	Basalt lava breccia	HW	VW-S	40-80
⑧	Basalt lava breccia	HW	W	50-80
⑨	Basalt lava breccia	HW	VW-W	65-100
⑩	Basalt lava breccia	HW	MS	30-75
⑪	Basalt lava breccia	MW	MS	75
⑫	Basalt lava	SW	S	65
⑬	Basalt lava	SW	S	60-100
⑭	Basalt lava	SW	S	50-90
⑮	Basalt lava	SW	S	60

Weathering (adopting NZGS (2005) terminology): CW completely weathered; HW highly weathered; MW moderately weathered; SW slightly weathered; UW unweathered.  
 Rock Strength (field strengths adopting NZGS (2005) terminology): EW extremely weak; VW very weak; W weak; MS moderately strong; S Strong; VS very strong; extremely strong.  
 Soil strength (field strengths adopting NZGS (2005) terminology): Coarse soils – VL very loose; L loose; MD medium dense; D dense, VD very dense. Cohesive soils – H hard; VSt very stiff; St stiff; F firm; So soft; VSo very soft.  
 RQD: Rock quality designation

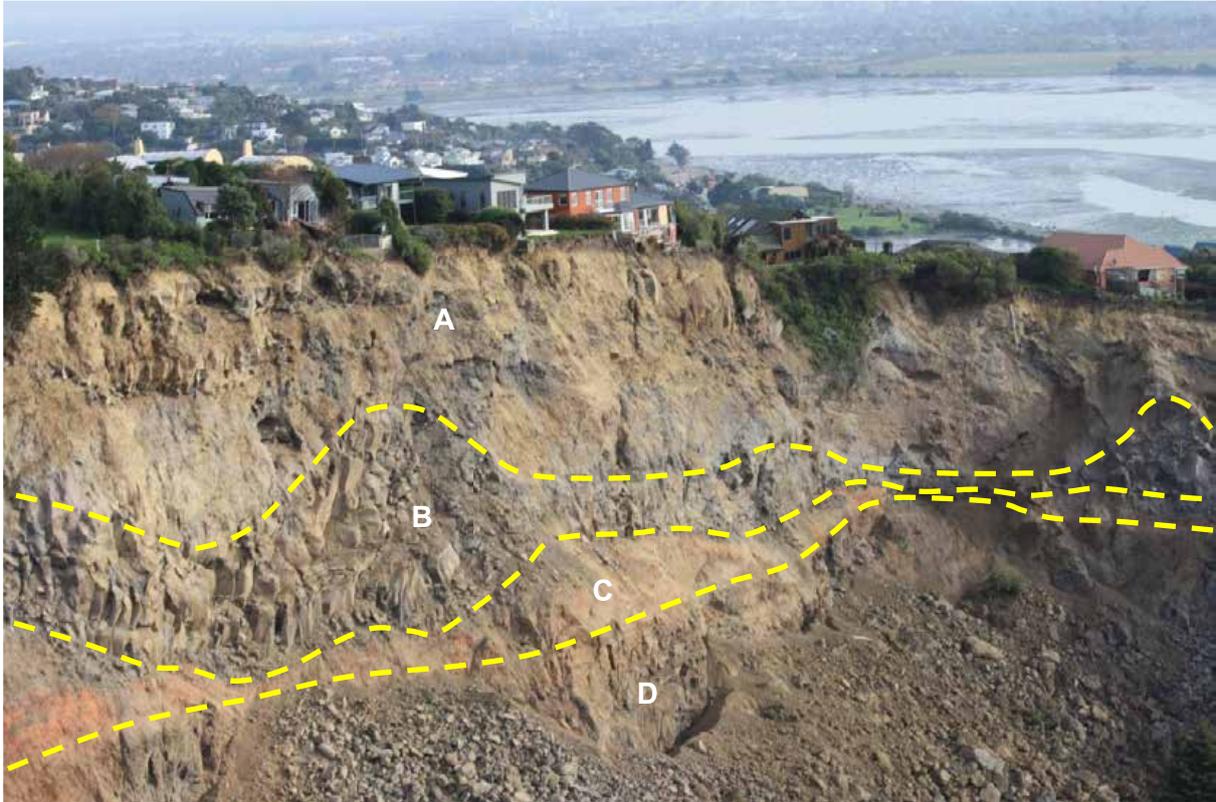
**Figure 14** View to the west onto the main cliff at Redcliffs. (A) is basalt lava breccia, (B) is columnar jointed basalt lava and breccia (C) is the epiclastic layer that generally forms a recessive slope, and the material below this is basalt lava breccia (D). Photograph by C. Gibbons (July 2011). For surveyed boundaries between materials refer to Appendix 3.

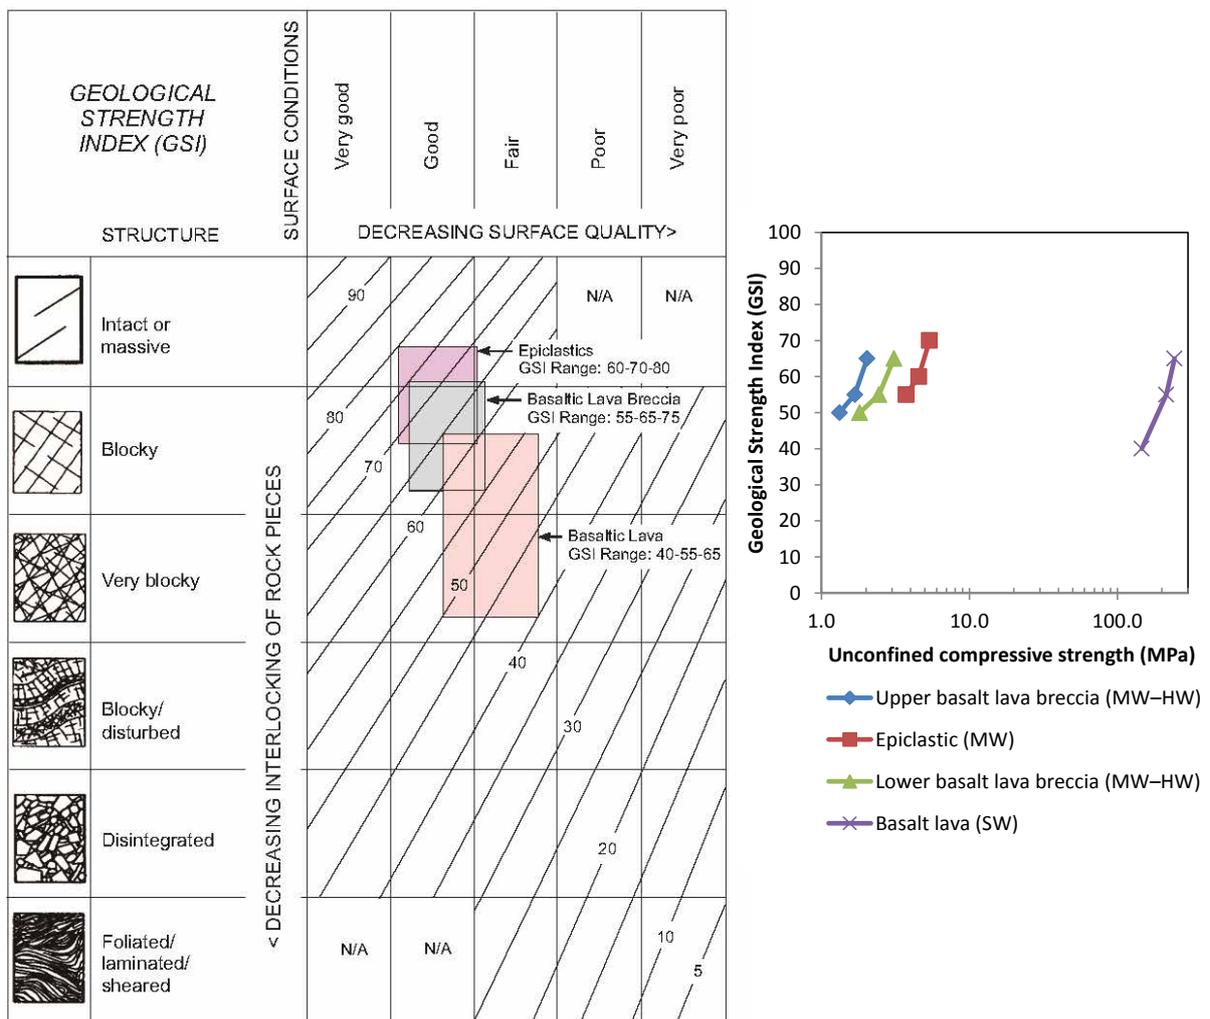
**Figure 15** Geological Strength Index plot for volcanic breccia and lava at Redcliffs (modified after Hoek 1999). B) The adopted lower, middle and upper estimates of GSI per given material type plotted against the corresponding lower middle and upper unconfined compressive strength from the laboratory testing (Table 12).

The Geological Strength Index values adopted for the main materials are shown in Figure 15. Strength tests of Redcliffs rock samples from drillholes BH-MB-01 and BH-MB-02 are shown in Table 13, and are taken from Carey et al. (2014). Mohr-coulomb parameters (cohesion and friction) were derived from Rocscience RocLab software by line fitting over the appropriate stress range of the slope.

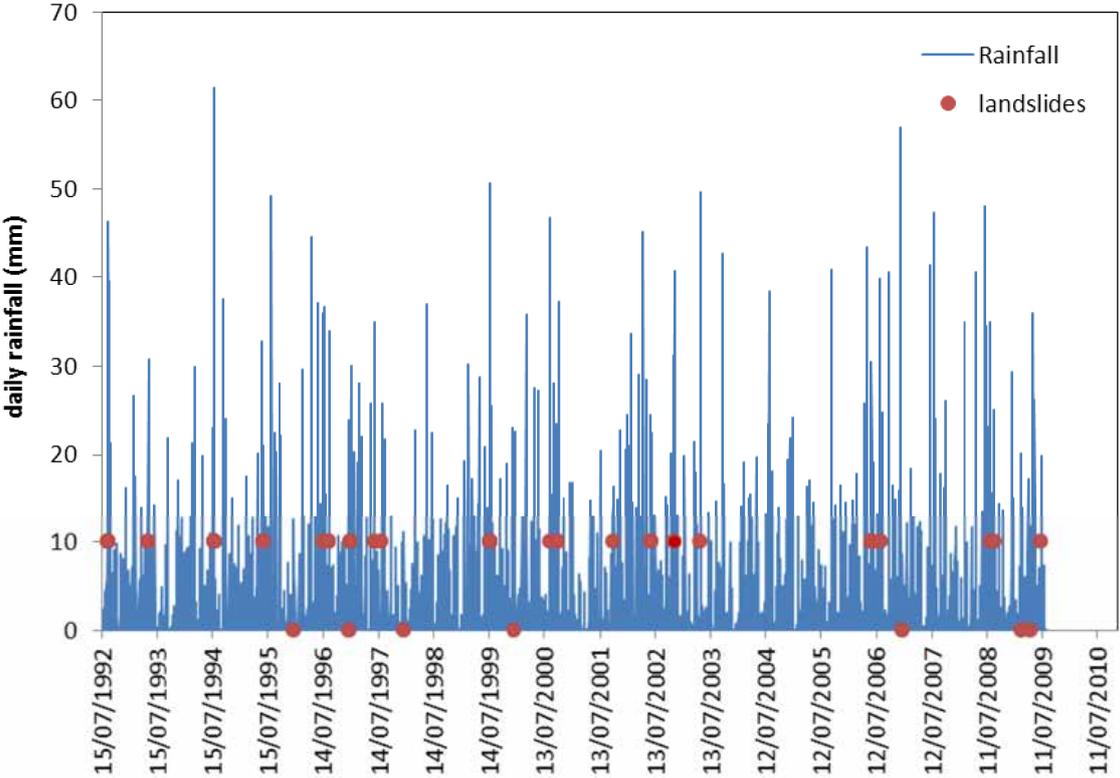
**Figure 16** Daily rainfalls at Christchurch Gardens and landslides in the Port Hills. Daily rainfalls at Christchurch Gardens and landslides in the Port Hills investigated by Geotechnical Consulting Ltd, or listed by the Earthquake Commission as causing damage to homes. Landslides without rain are plotted at 0 mm, all others are plotted at 10 mm of rain (the minimum rainfall for triggered landslides).

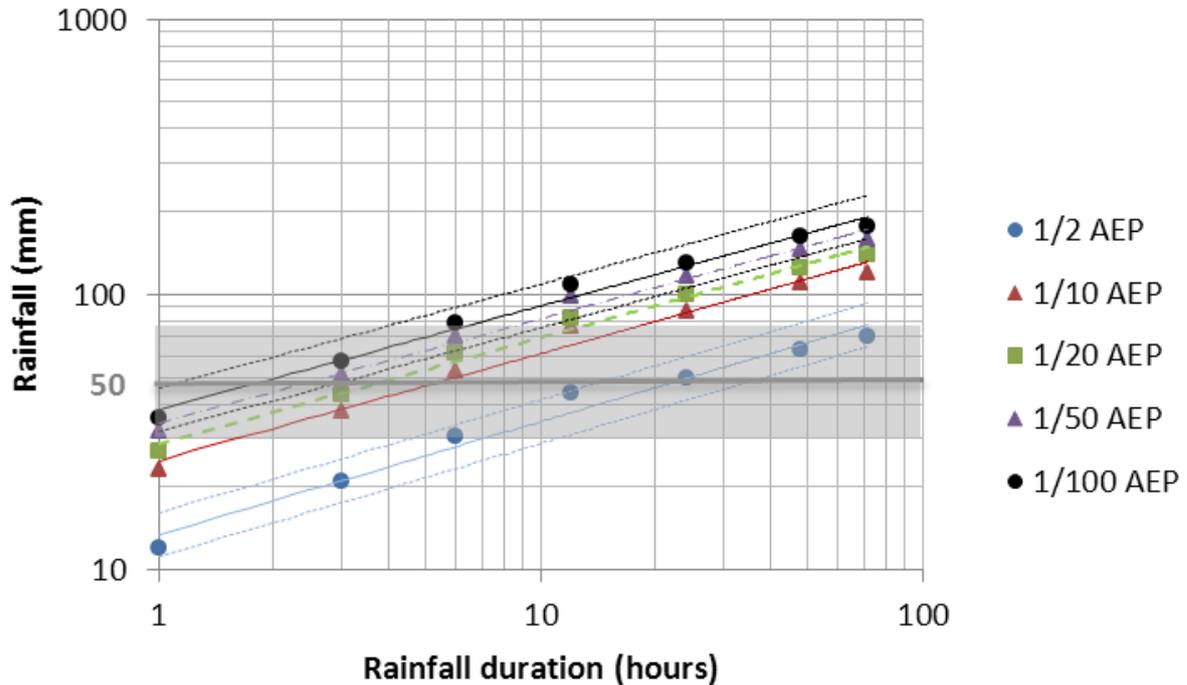
**Figure 17** Rainfall depth-duration-return period relations estimated for Christchurch Gardens by Griffiths et al. (2009) using recorded rainfall data. Error limits of 20% are shown by dotted lines for the 1/2 and 1/100 AEP curves. Shaded area covers the range of 30–75 mm of rainfall over which the expected number of soil landslides in the Port Hills rises from very few to many. Rockfalls can occur without rain, but the probability of rockfalls occurring increases with increasing intensity of rainfall.

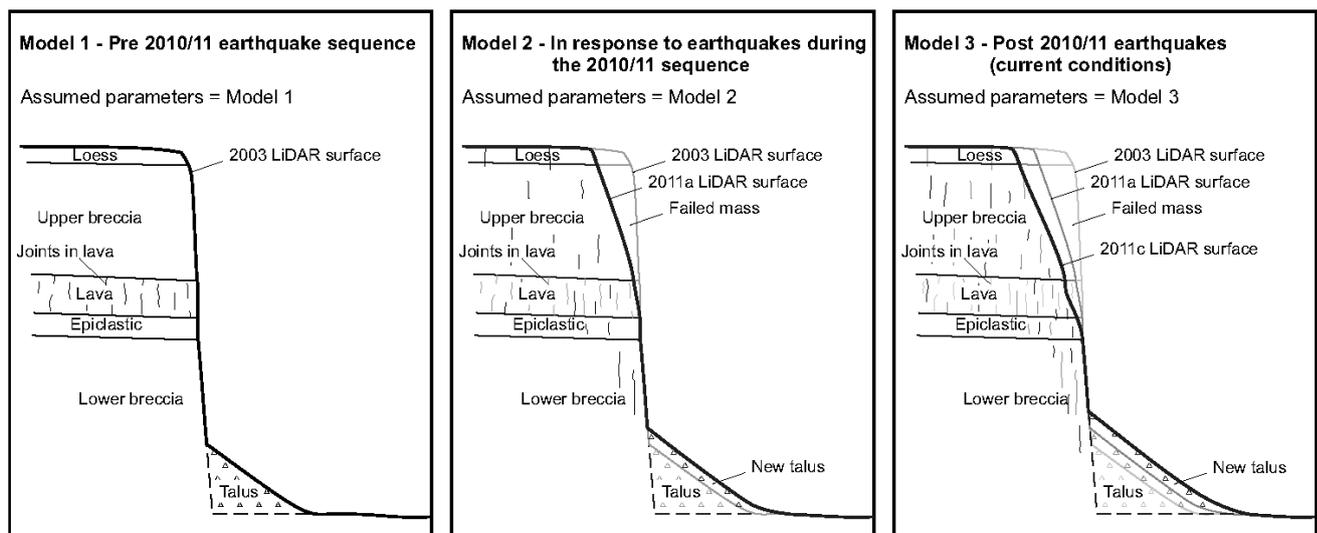
**Figure 19** Schematic diagram showing the increasing frequency of defects in the slope in response to the successive 2010/11 Canterbury earthquakes.

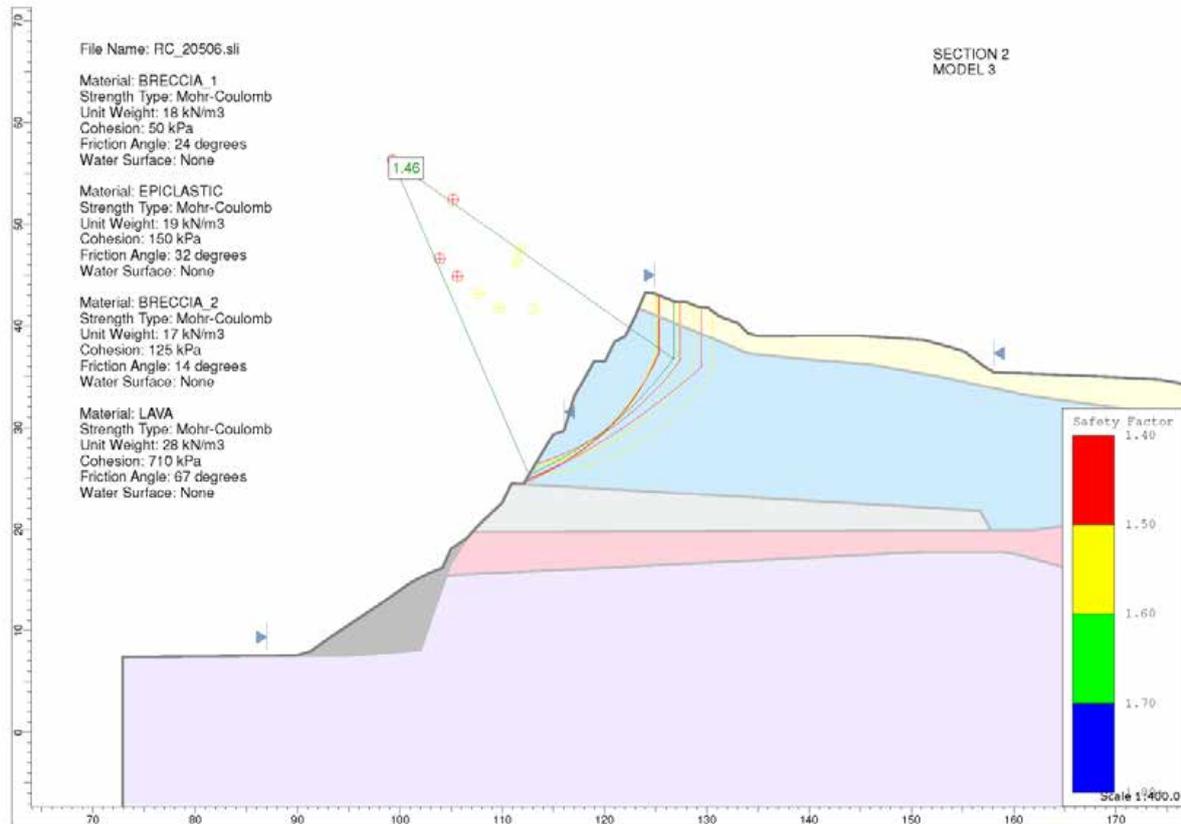
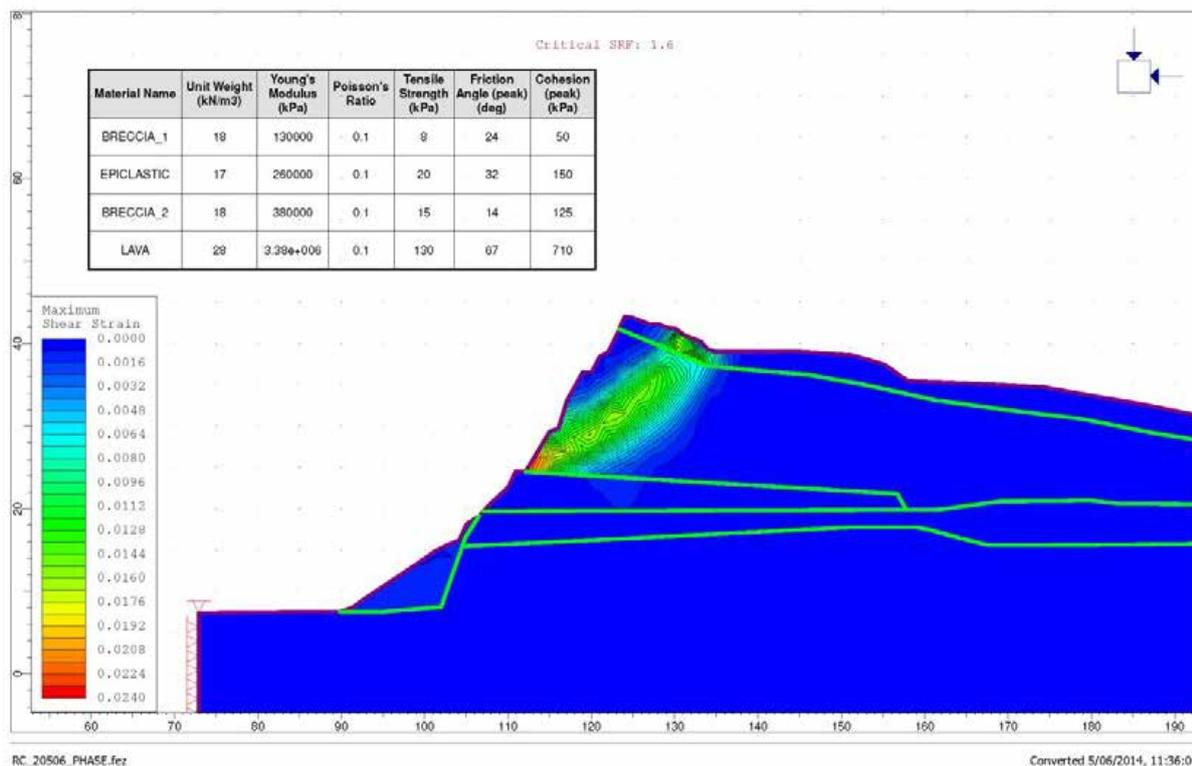
**Figure 20** Example of limit equilibrium and finite element modelling results for cross-section 2 representing assessed source area 2, and adopting model 3 material parameters.

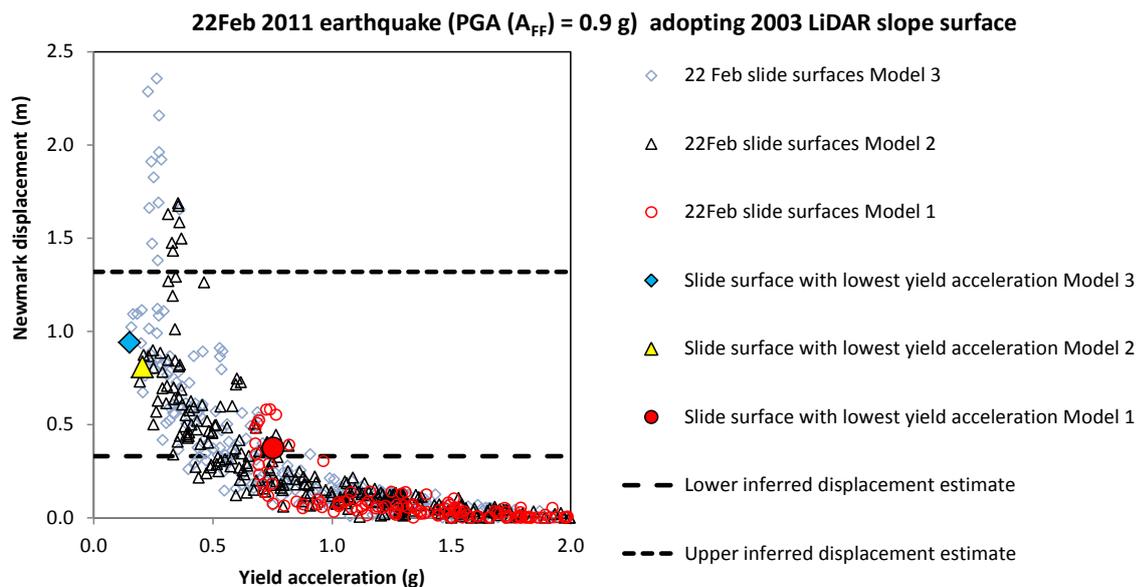
**Figure 23** Modelled Slope/W decoupled displacements of cross-section 4 for the 22 February 2011 earthquake and adopting variable estimates of the material strength. Each datapoint represents a modelled slide surface and the corresponding estimate of its displacement as a result of the 22 February 2011 earthquake – adopting the synthetic free-field rock outcrop earthquake acceleration time histories.  $A_{FF}$  is the peak horizontal ground acceleration of the free field motion used in the assessment. The dashed lines represent the total inferred coseismic permanent displacement of the slope along the cross-section during the given earthquake.

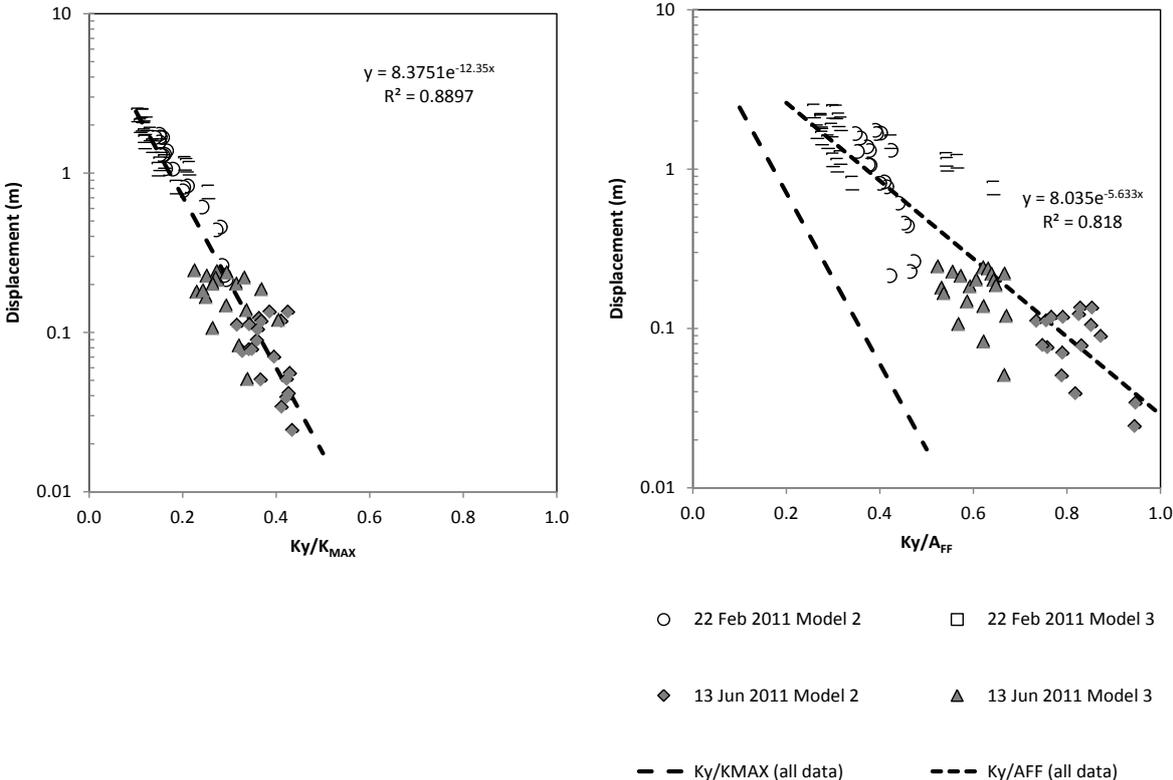
**Figure 27** Decoupled Slope/W displacements calculated for cross-section 4, for different ratios of yield acceleration to maximum average acceleration of the mass ( $K_y/K_{MAX}$ ), and maximum acceleration of the mass ( $K_y/A_{MAX}$ ), for selected slide-surface geometries, and given material shear strength parameter models 2 and 3.  $A_{MAX}$  is the peak acceleration of the input earthquake time acceleration history. Synthetic rock outcrop time acceleration histories for the 22 February and 13 June 2011 earthquakes were used as inputs for the assessment (N = 79). The dashed lines are exponential trend lines fitted to the semi-log data. The formula and the coefficient of determination ( $R^2$ ) for the trend lines are shown.

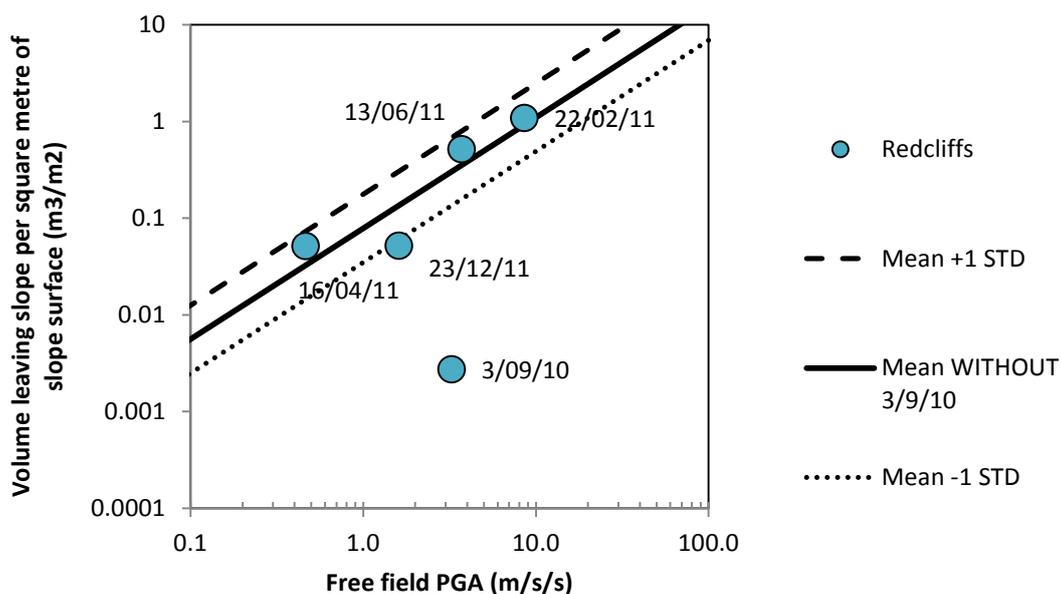
**Figure 28** Relationship between free field peak ground accelerations at Redcliffs and the volume of debris leaving the Redcliffs slope.

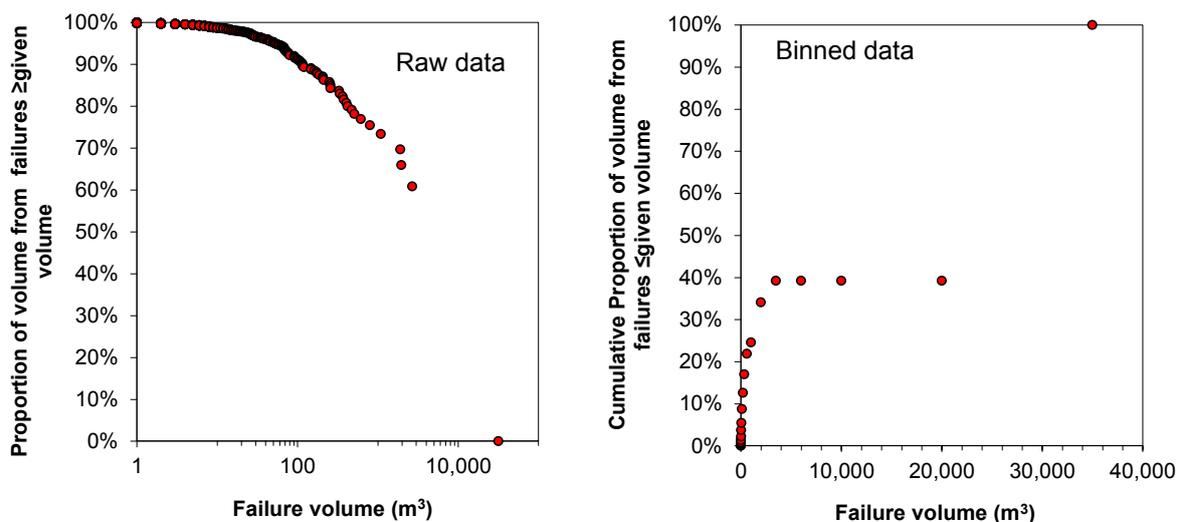
**Figure 29** Proportion and cumulative proportion of volume from cliff collapses in the Port Hills greater than or equal to a given volume. Data from the 2011 cliff collapse volumes triggered by the 13 June 2011 earthquakes, derived from terrestrial laser scan change models of Richmond Hill, Shag Rock Reserve and Redcliffs. The different plots represent raw data and binned data.

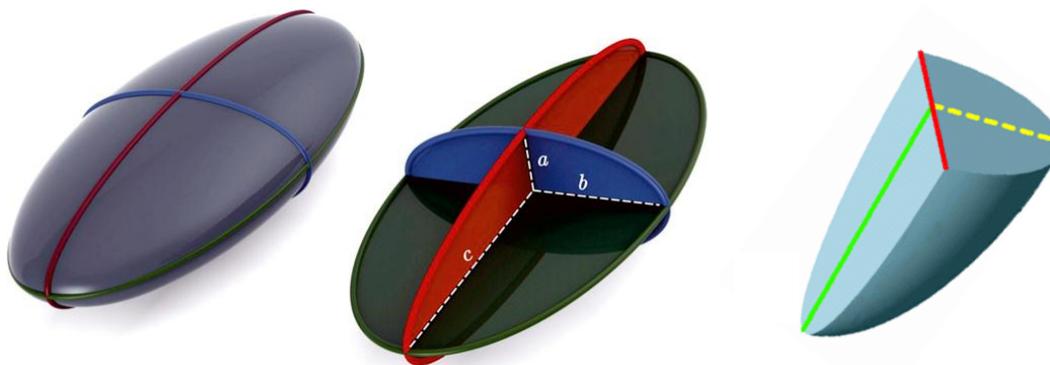
**Figure 30** Estimation of landslide volume assuming a quarter-ellipsoid shape.

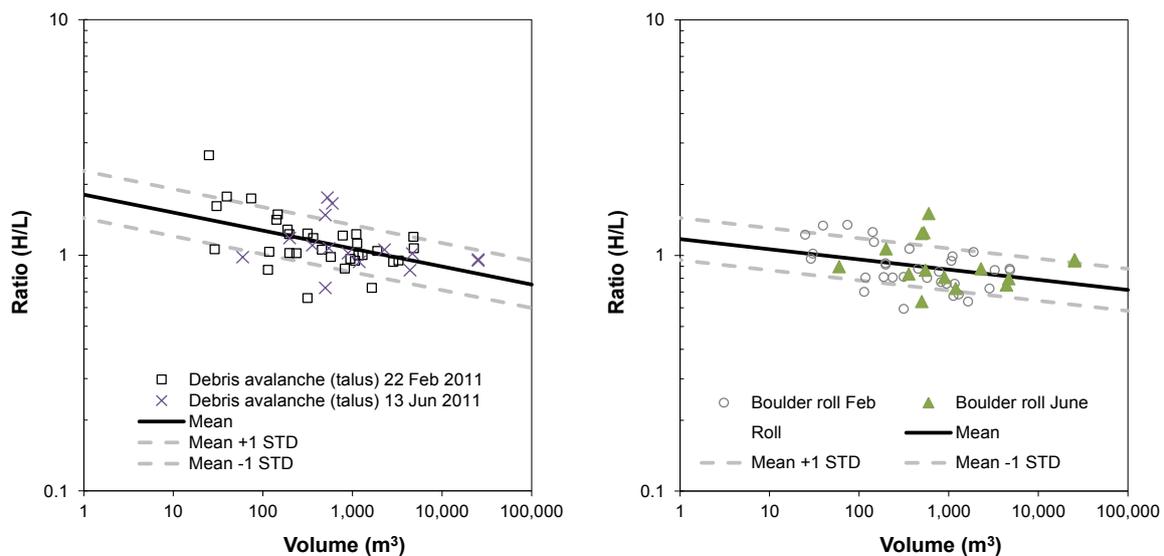
**Figure 32** The empirical fahrboeschung relationships, expressed as the ratio of height (H) to length (L) for debris avalanche talus and boulder roll (rockfalls), recorded in the Port Hills. N = 45 sections. Errors are expressed as the mean  $\pm$  one standard deviation (STD).

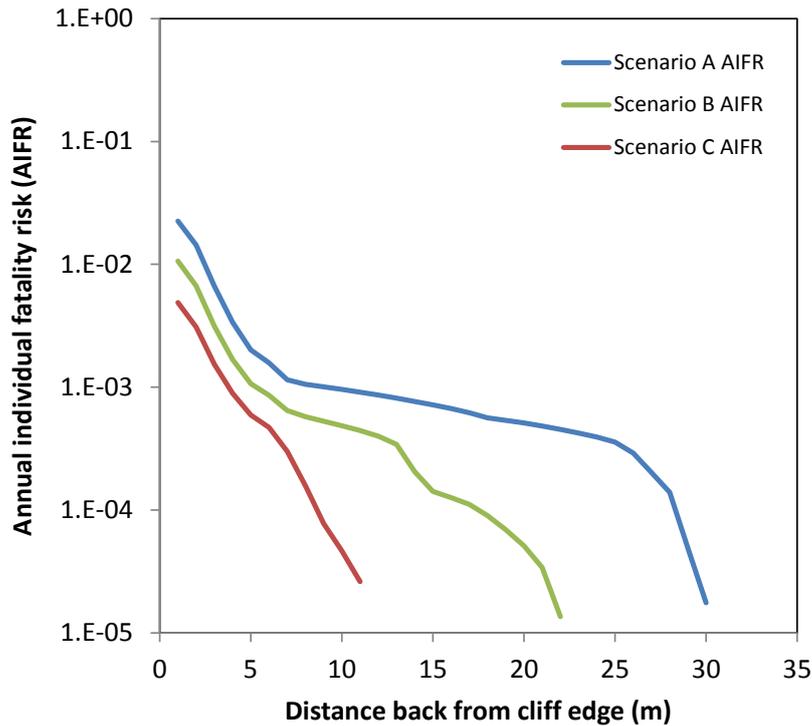
**Figure 41** Results from the cliff top recession risk assessment, per scenarios A, B and C (dwelling occupant).

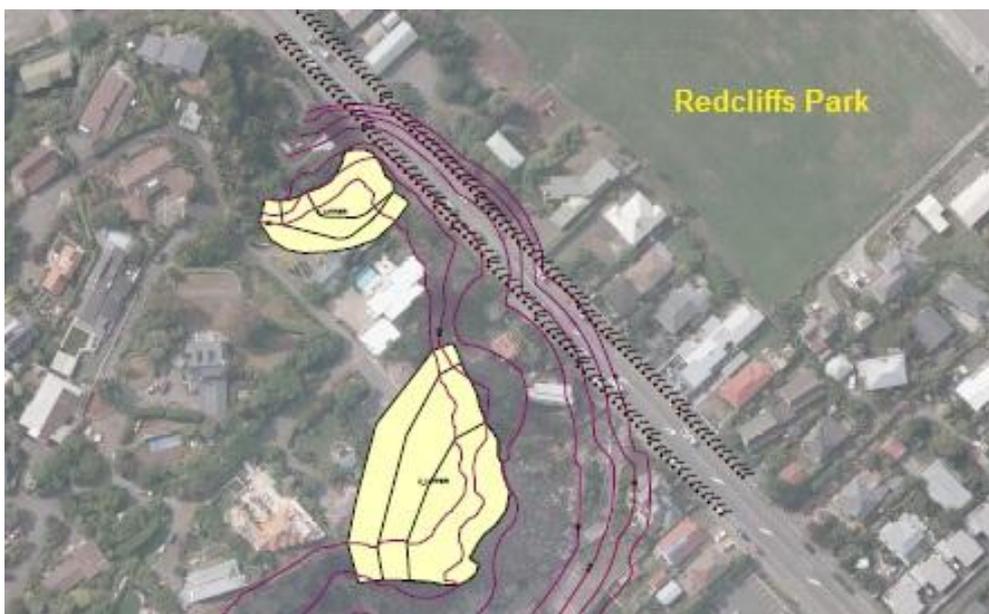
**Figure A1.2** Main Road section modelled (opposite Redcliffs Park).

The section of Main Road modelled is shown in Figure A1.2 (and Figure 2 of the main report), and a Google Street View image, looking northwest along the road section modelled is shown in Figure A1.3.
