**Canterbury Earthquakes 2010/11 Port Hills Slope  
Stability: Risk assessment for Redcliffs**

**GNS Science Consultancy Report 2014/78  
August 2014 FINAL**

Massey, C. I.; Della Pasqua, F.; Taig, T.; Lukovic, B.; Ries, W.; Heron, D., Archibald, G. 2014. Canterbury Earthquakes 2010/11 Port Hills Slope Stability: Risk assessment for Redcliffs. *GNS Science Consultancy Report 2014/78*. 123 p. + Appendices

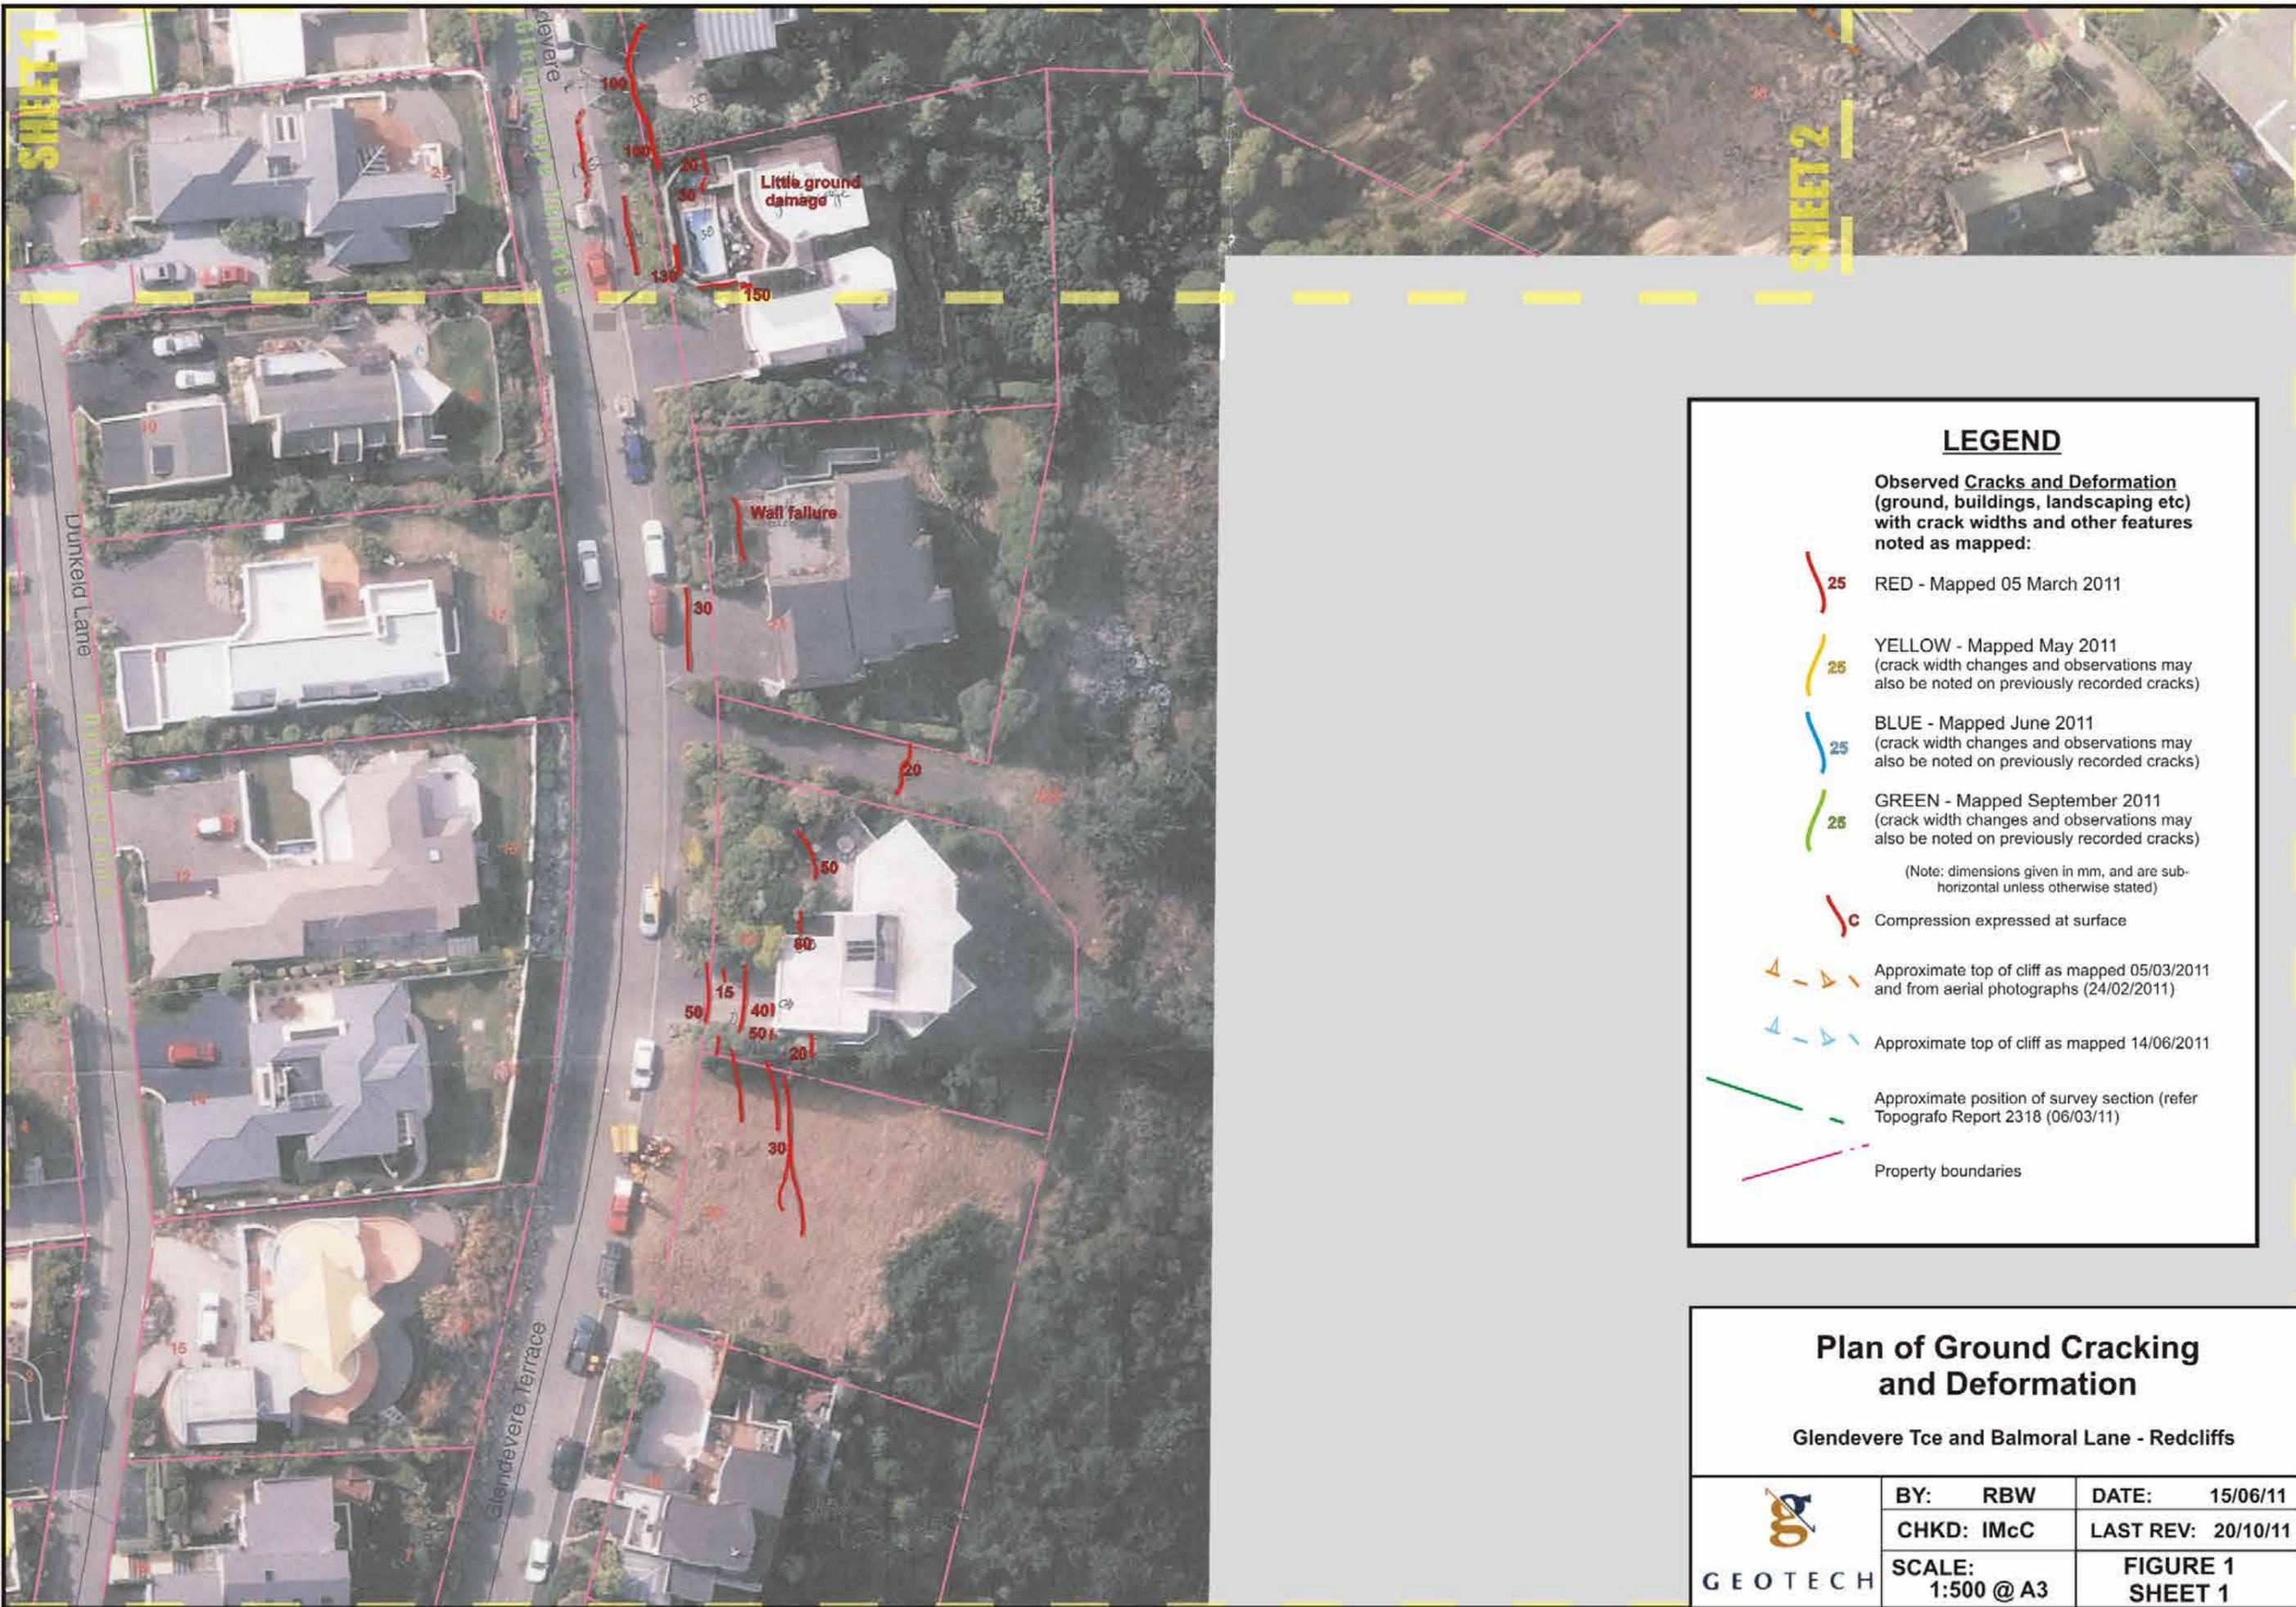
SHEET 1

**A5 APPENDIX 5: FIELD MAPPING OF CRACKS FOLLOWING THE MAIN EARTHQUAKES (CARRIED OUT BY M. YETTON, GEOTECH LTD)**

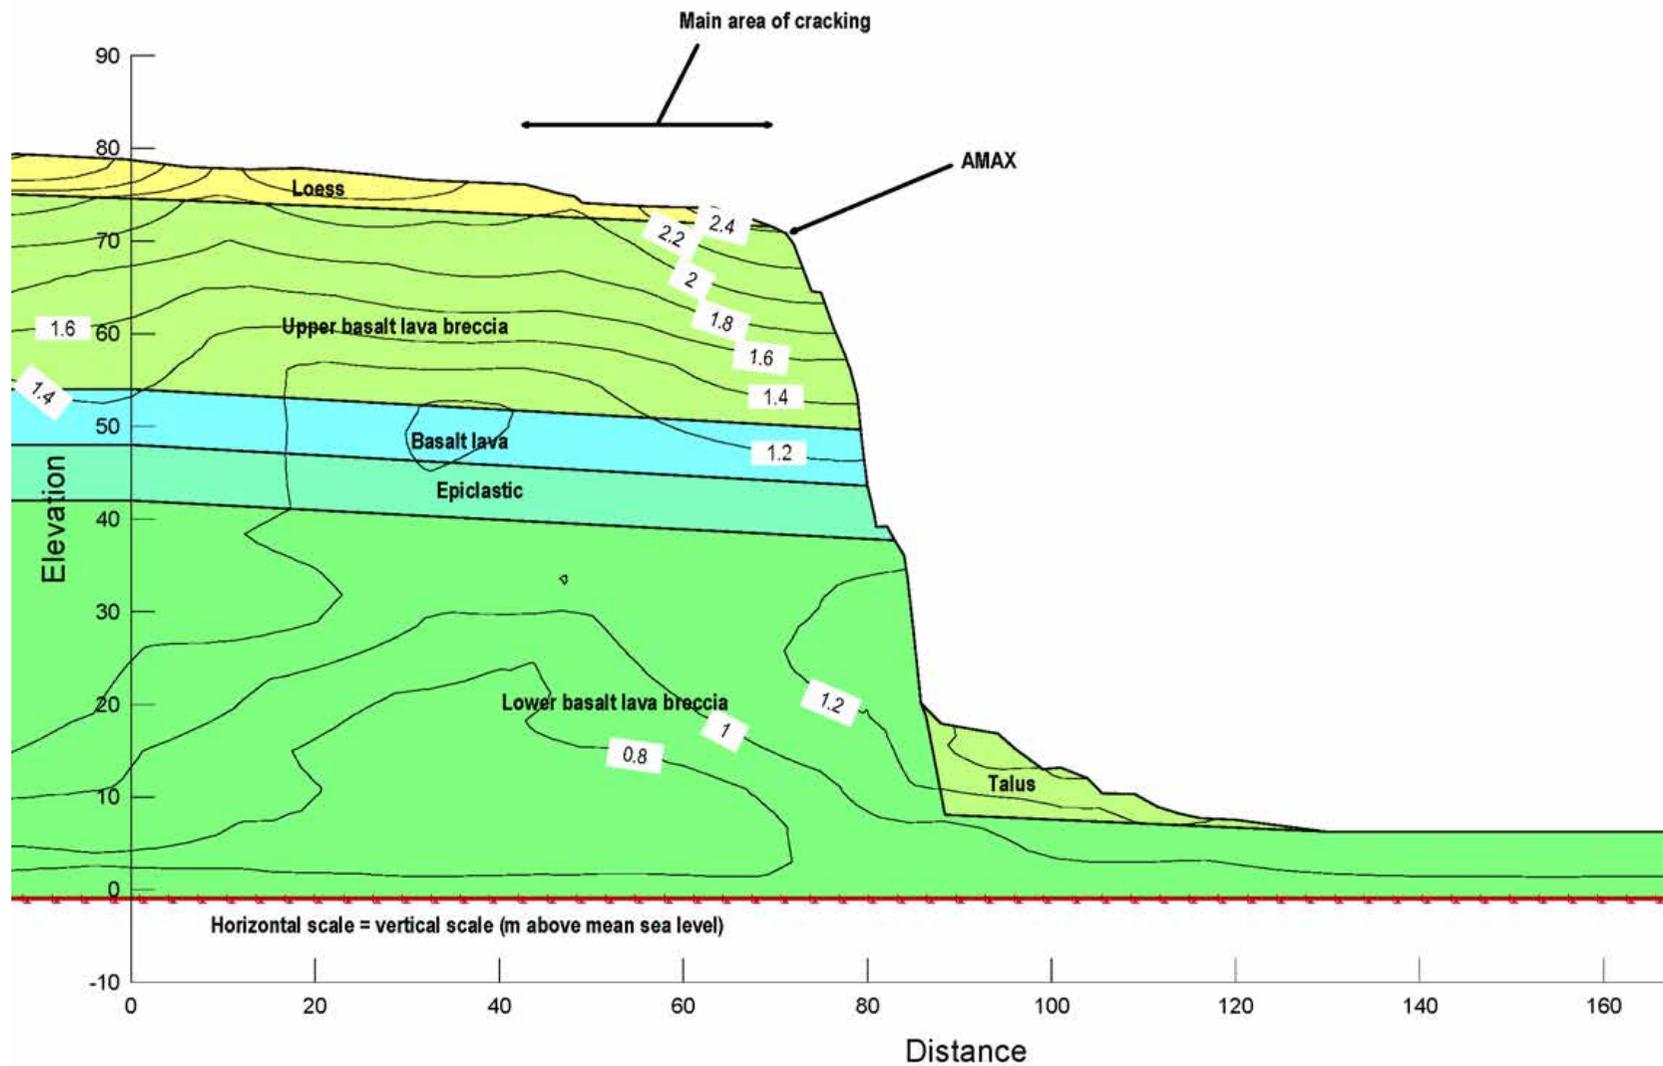
**Figure A6.2** Modelled peak horizontal ground acceleration contours for the 22 February 2011 earthquake at Redcliffs, cross-section 4, adopting the 2003 airborne LiDAR slope surface geometry. Contours are peak horizontal ground accelerations (g).

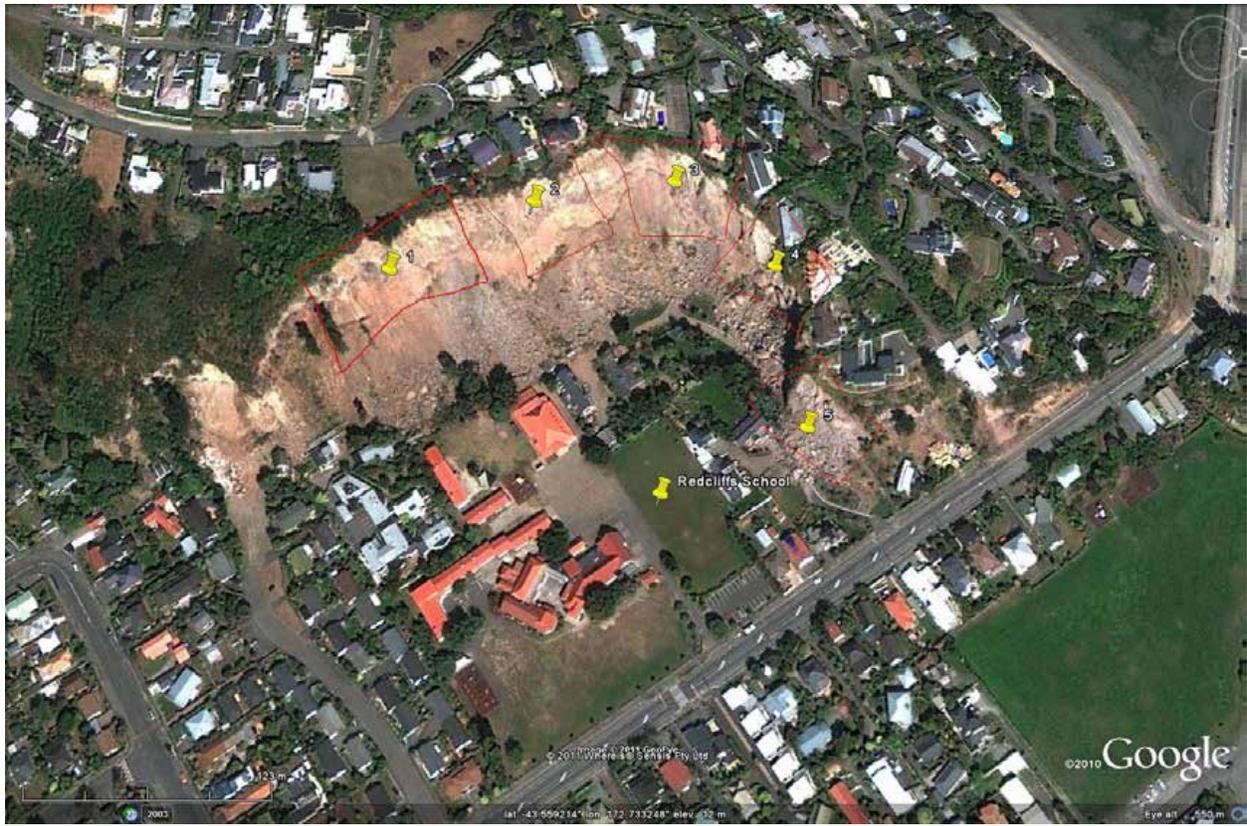
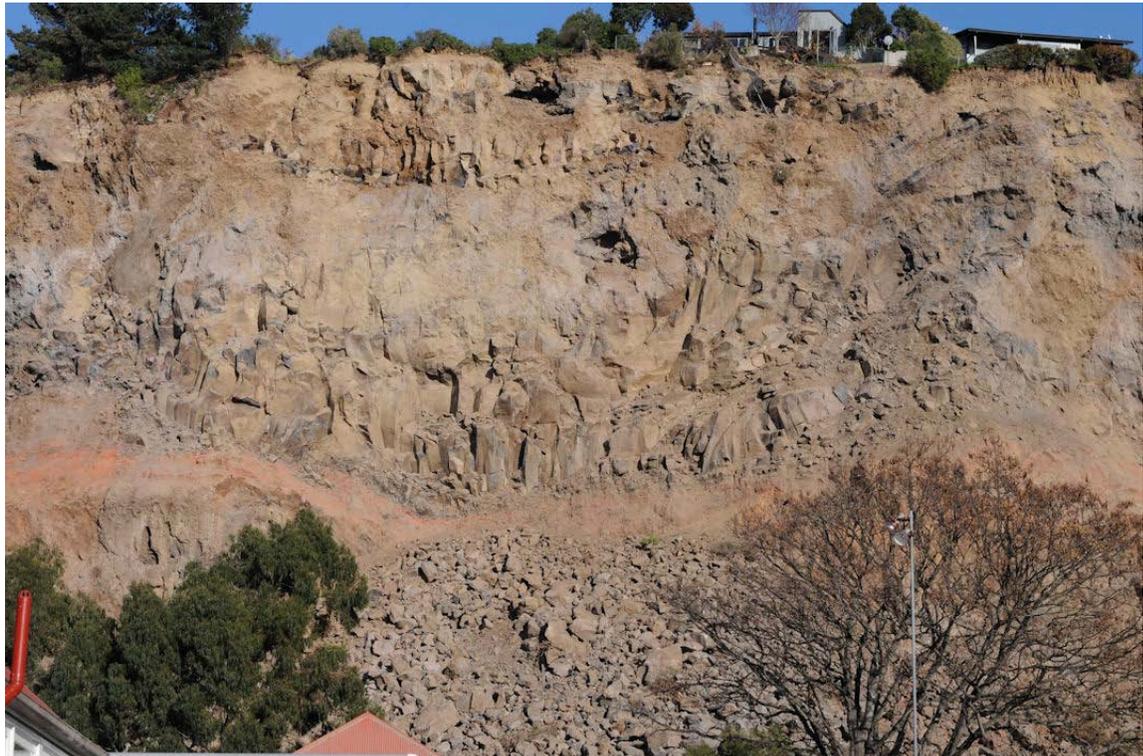
**Redcliffs School image pair 1: Structural data – July 19 2011**

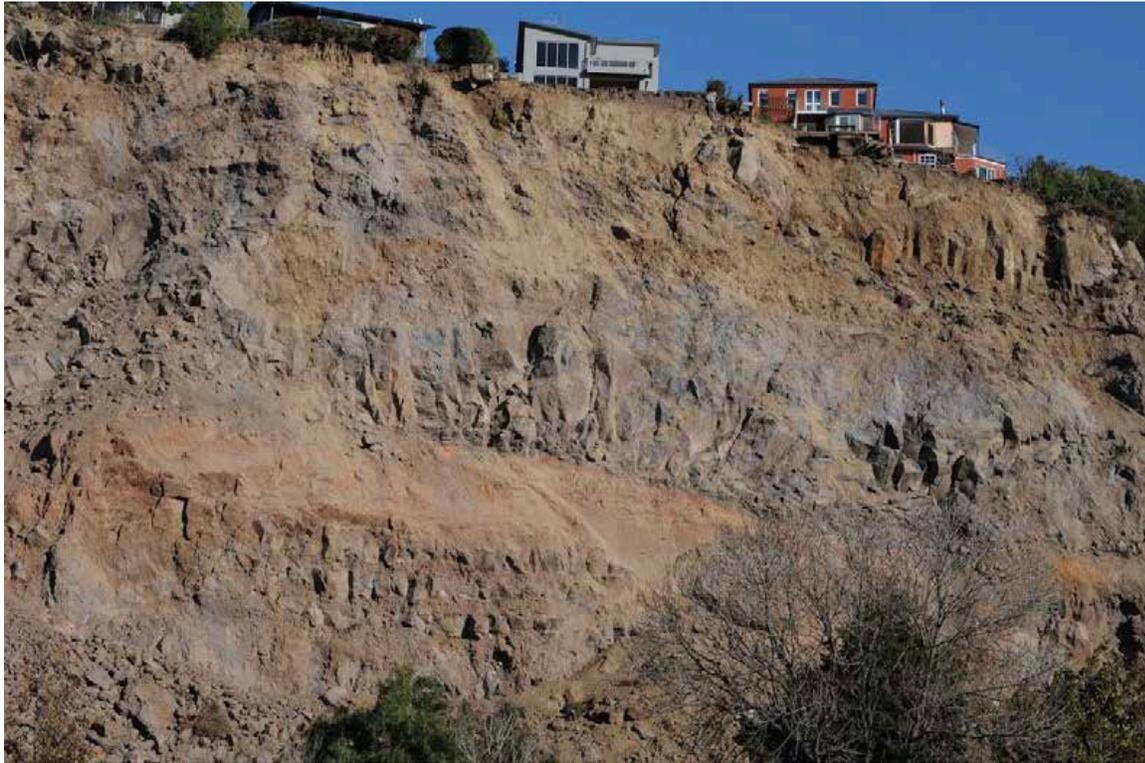
**Redcliffs School image pair 2: Structural data – July 19 2011**

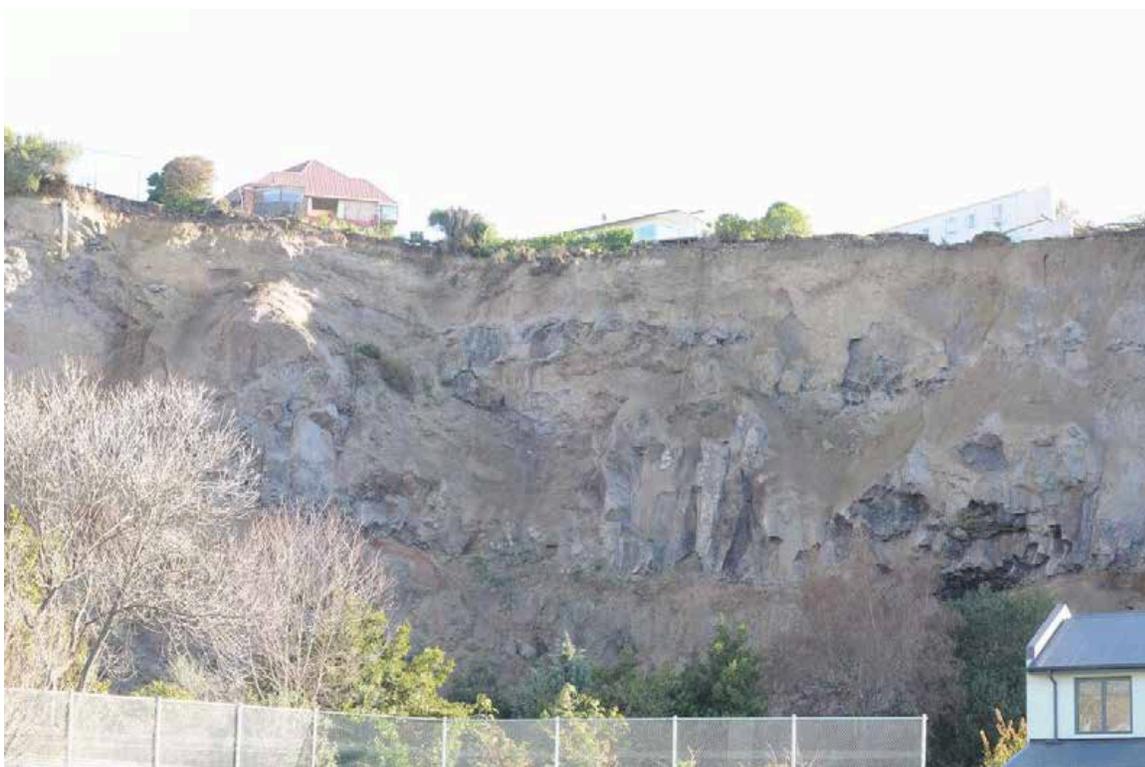
**Redcliffs School image pair 3: Structural data – July 19 2011**

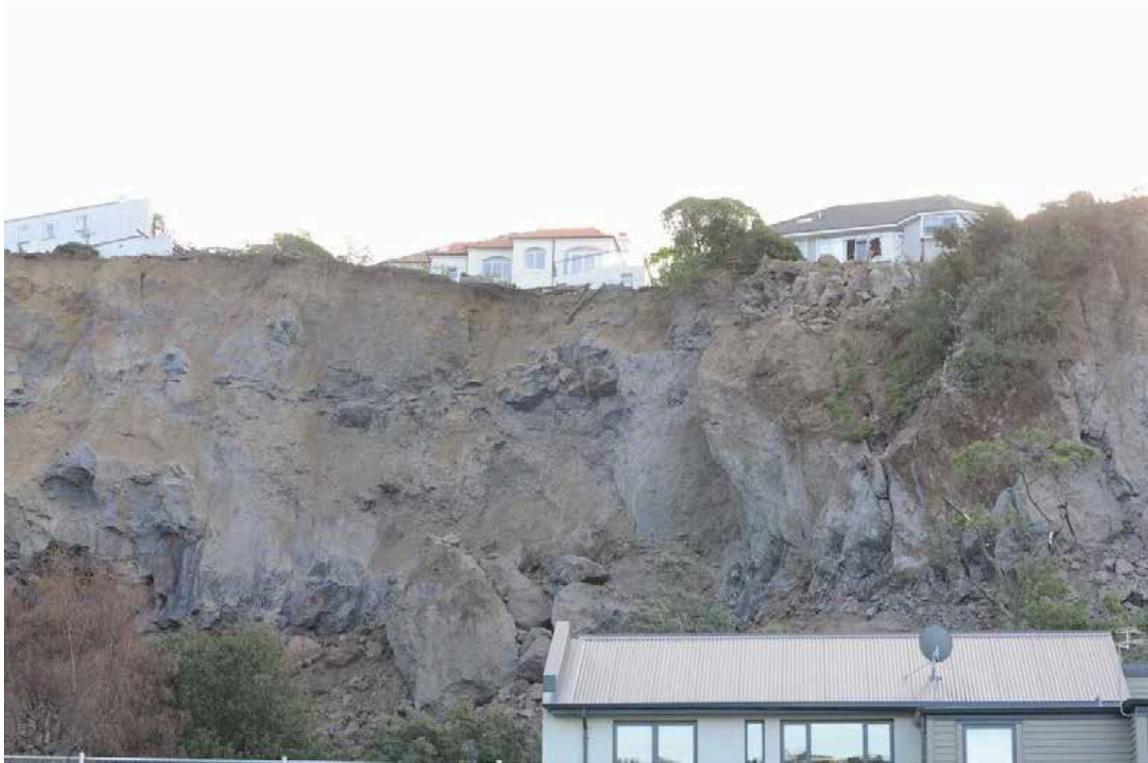
**Redcliffs School image pair 4: Structural data – July 19 2011**

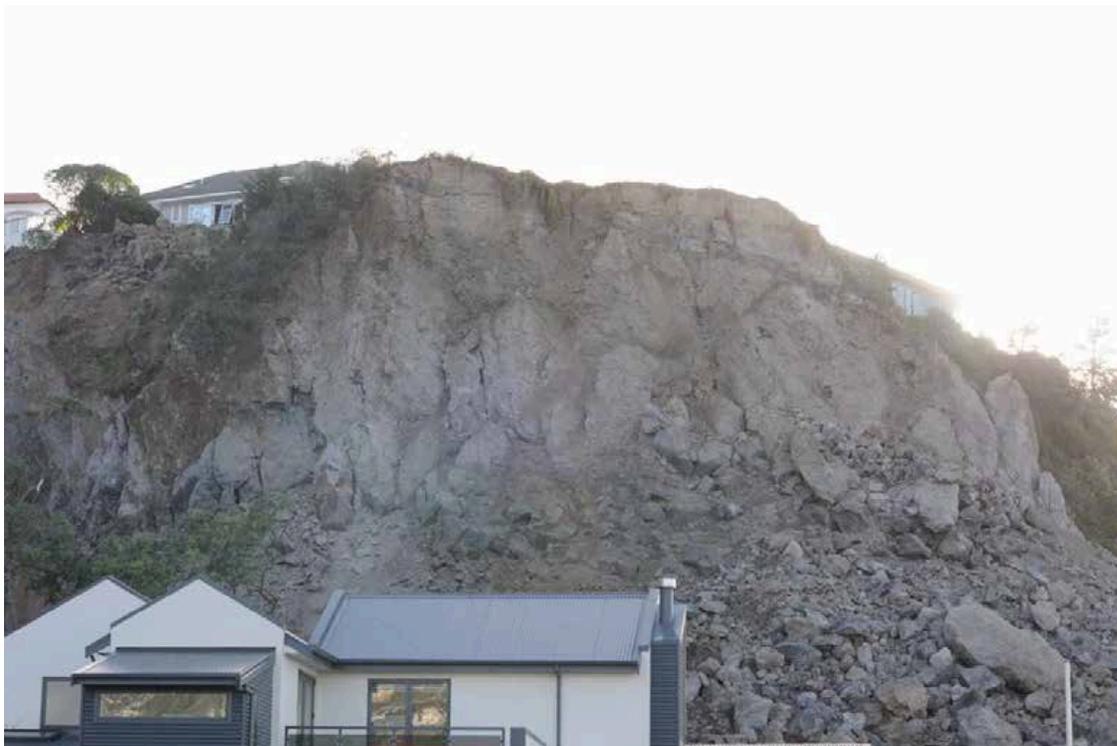
**Redcliffs School image pair 5: Structural data – July 19 2011**

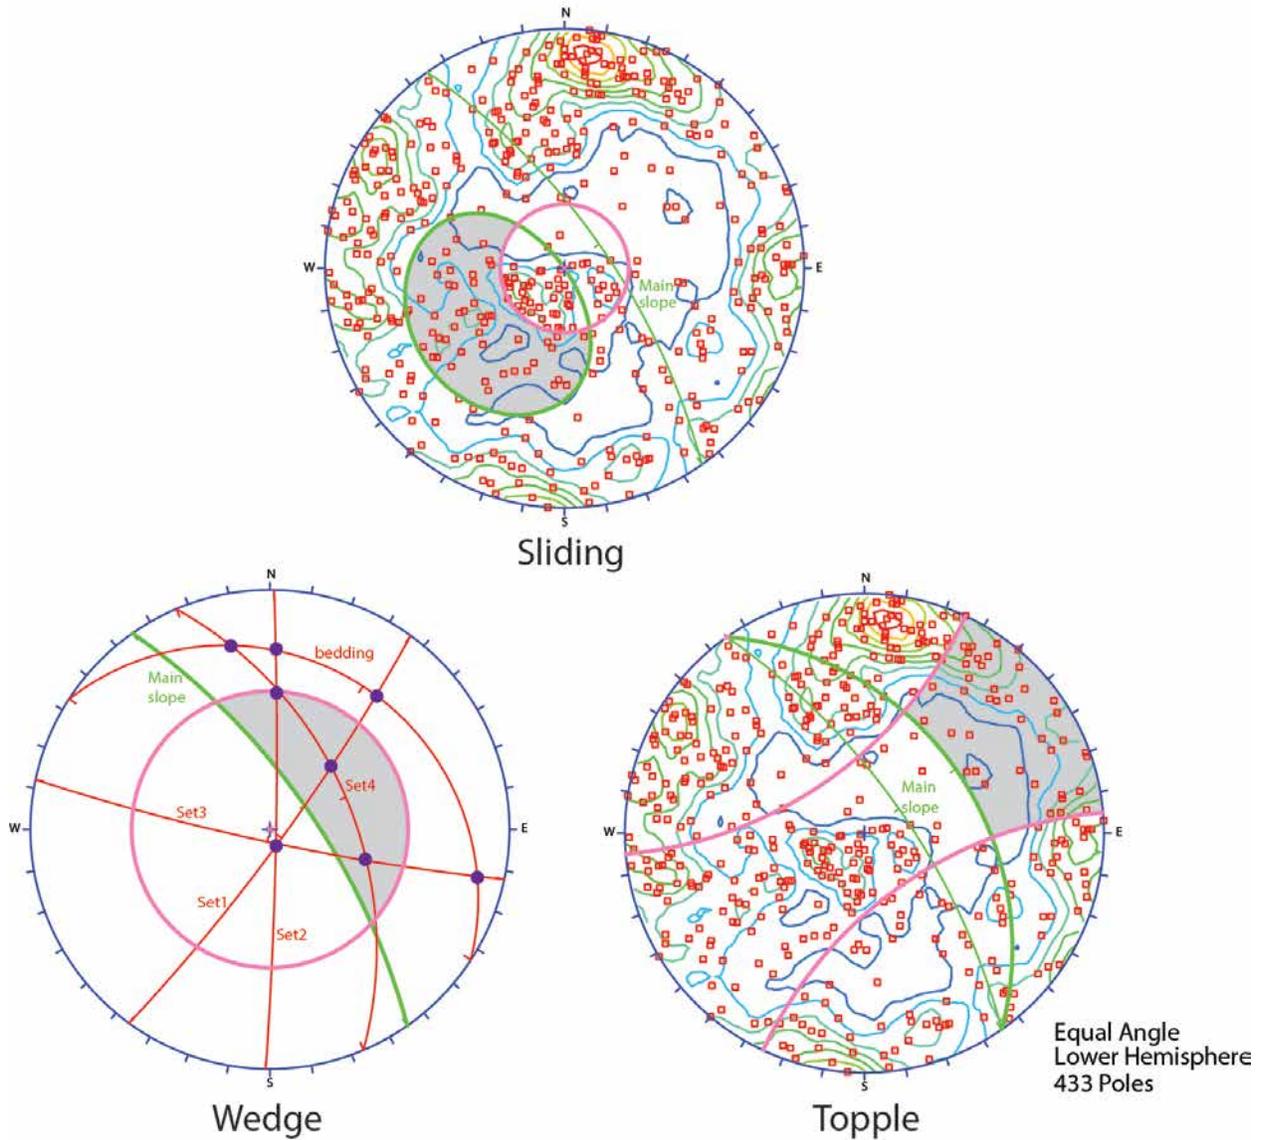
**Preliminary kinematic analysis of the Redcliffs School. Assumed slope of 70°/125° (dip/dip direction) and friction angle of 30°.**
