Appendix G: Site specific assessments of the
Lyttelton and Akaroa Harbour
environments

1.1 Site inspections and assessment of aerial photographs

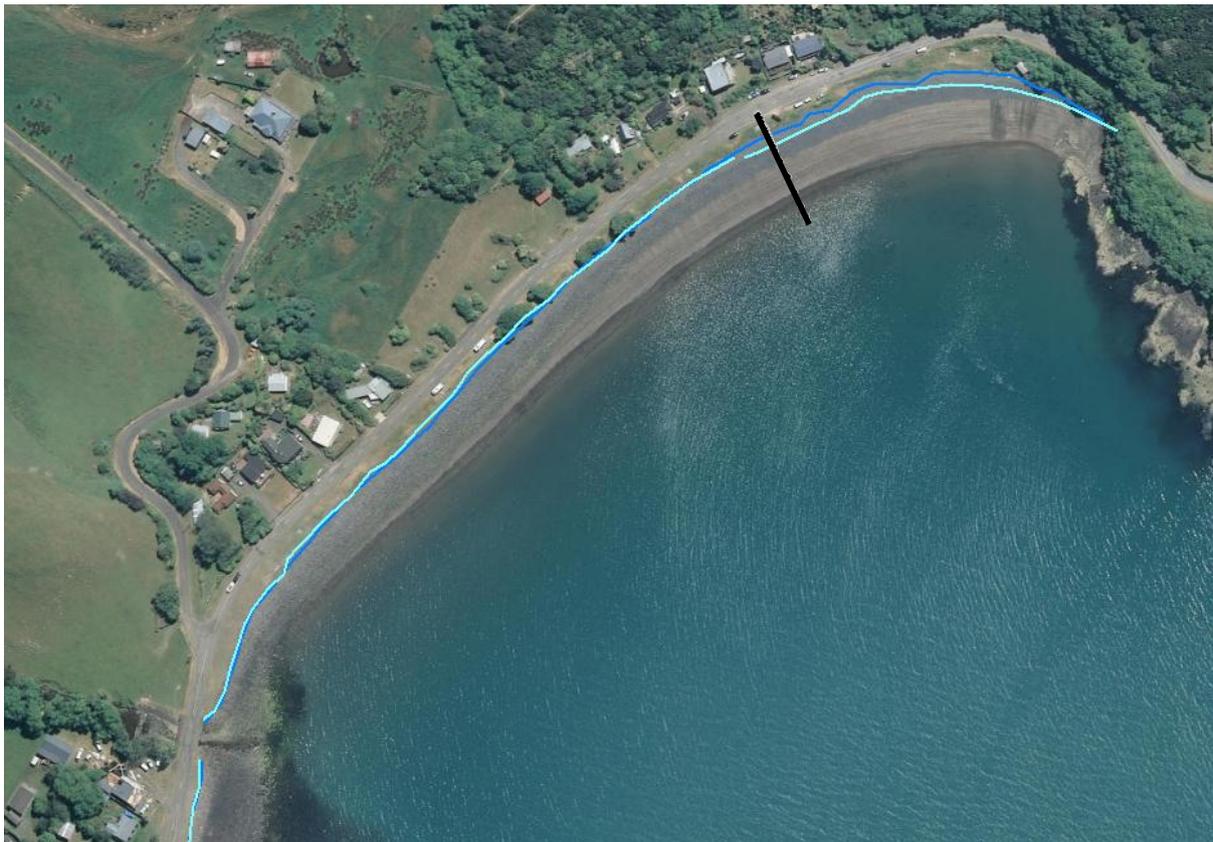
Figure G1 Aerial view of Wainui Beach from the stream at the southern end of the beach to the rocky headland to the east with the location of the survey transect (black line) indicated and the 1980-1984 (light blue line) and 2005-2017 shoreline (dark blue line) derived from aerial imagery (source: Canterburymaps.govt.nz)

Based on the aerial photograph assessment there appears to have been around 4 m of retreat at the northern end of the bay from the early 1980's to the present, although the recent photograph shows this area is grassed over, so it may just indicate a fluctuating shoreline responding to shorter term fluctuations. The remainder of the shoreline appears reasonably stable.

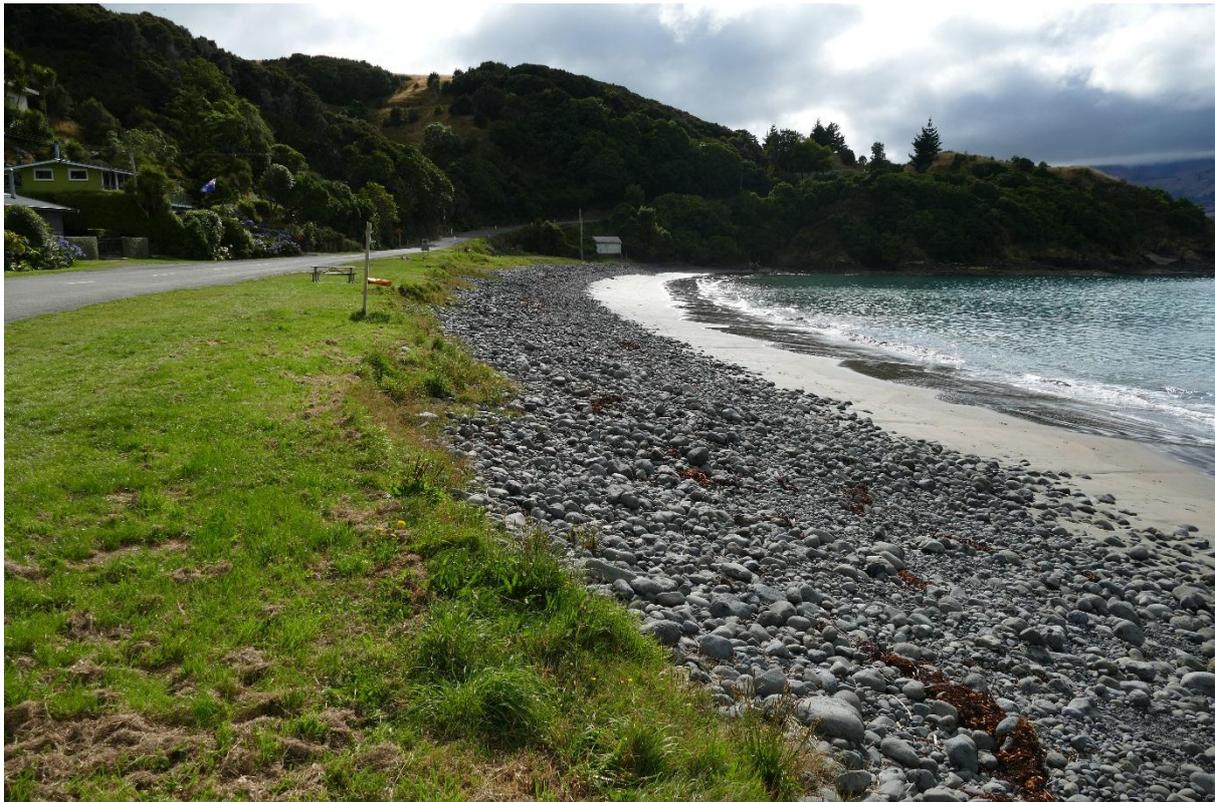
Figure G2 Wainui Beach

It is a composite beach fronting a narrow grass road reserve. The upper intertidal and subaerial beach is gravel with a more sandy mid and lower intertidal area (refer Figure G2). A typical section through the beach is shown in Figure G3. Road levels vary from around 3 m RL in the vicinity of the stream outlet to around 4.5 m RL at the location of the beach profile. There is around an 0.5 m high steep bank down to the top of the gravel beach and the gravel beach zone is around 10 m wide with a slope of around 1(V):5(H) and the slope flattens to around 1(V):15(H) within the intertidal sand zone.

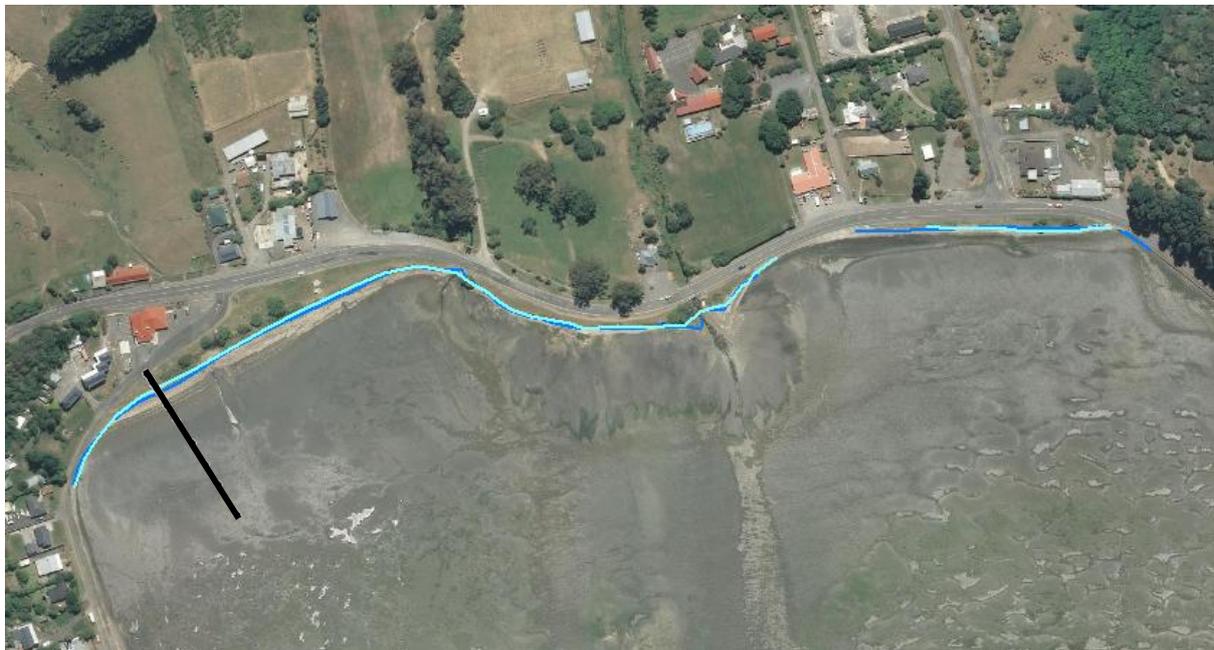
Duvauchelle comprises two south-south-east facing bays situated at the northern extent of Akaroa Harbour. The bays are fronted by extensive intertidal flats (Figure G4).

Figure G4 Aerial view of Duvauchelle with the location of the survey transect (black line) indicated and the 1980-1984 (light blue line) and 2005-2017 shoreline (dark blue line) derived from aerial imagery (source: Canterburymaps.govt.nz)

Based on the aerial photograph assessment there appears to have been no significant change in the vegetation line position from the early 1980's to the present.

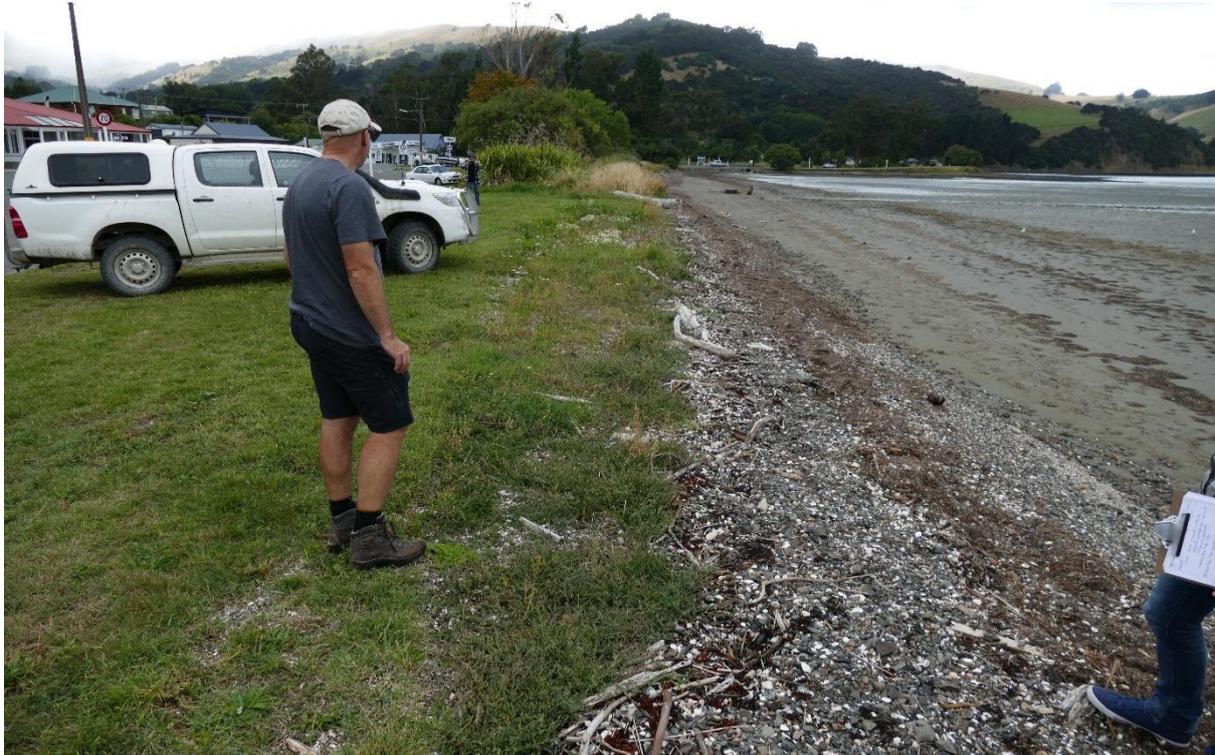
Figure G5 Grass Reserve and beach at Duvauchelle

It is a predominantly fine sand beach with a narrow shelly/gravel band fronting a low lying grass/road reserve. On the grass areas a raised area of the reserve acting as a low bund is evident (Figure G5). A typical section through the beach is shown in Figure G6. A low concrete seawall is evident along much of the coastline and in some locations accretion has occurred burying the seawall.

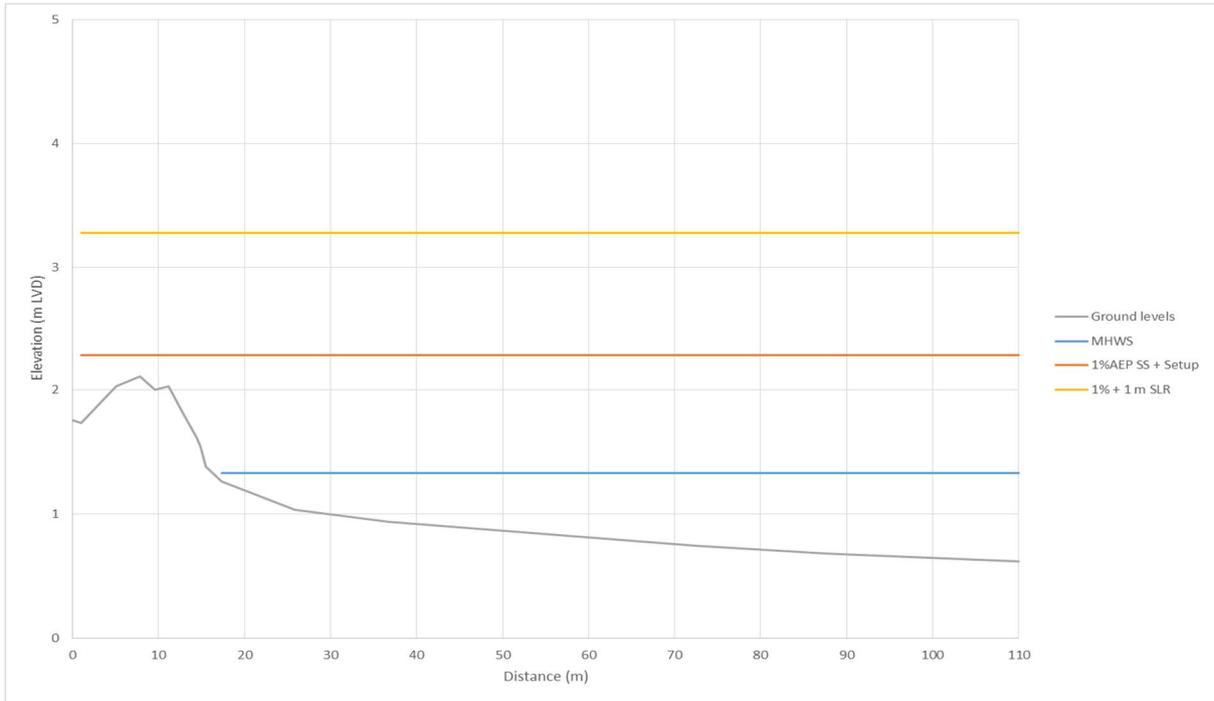
Figure G6 Section through beach at Duvauchelle

Reserve levels close to the beach are generally less than 2 m RL while road levels increase up to 3m RL. The narrow gravel/shell zone has a slope of around 1(V):6(H) and the slope flattens to around 1(V):30(H) on the fine sand and further flattens to 1(V):200(H) within the intertidal sand zone.

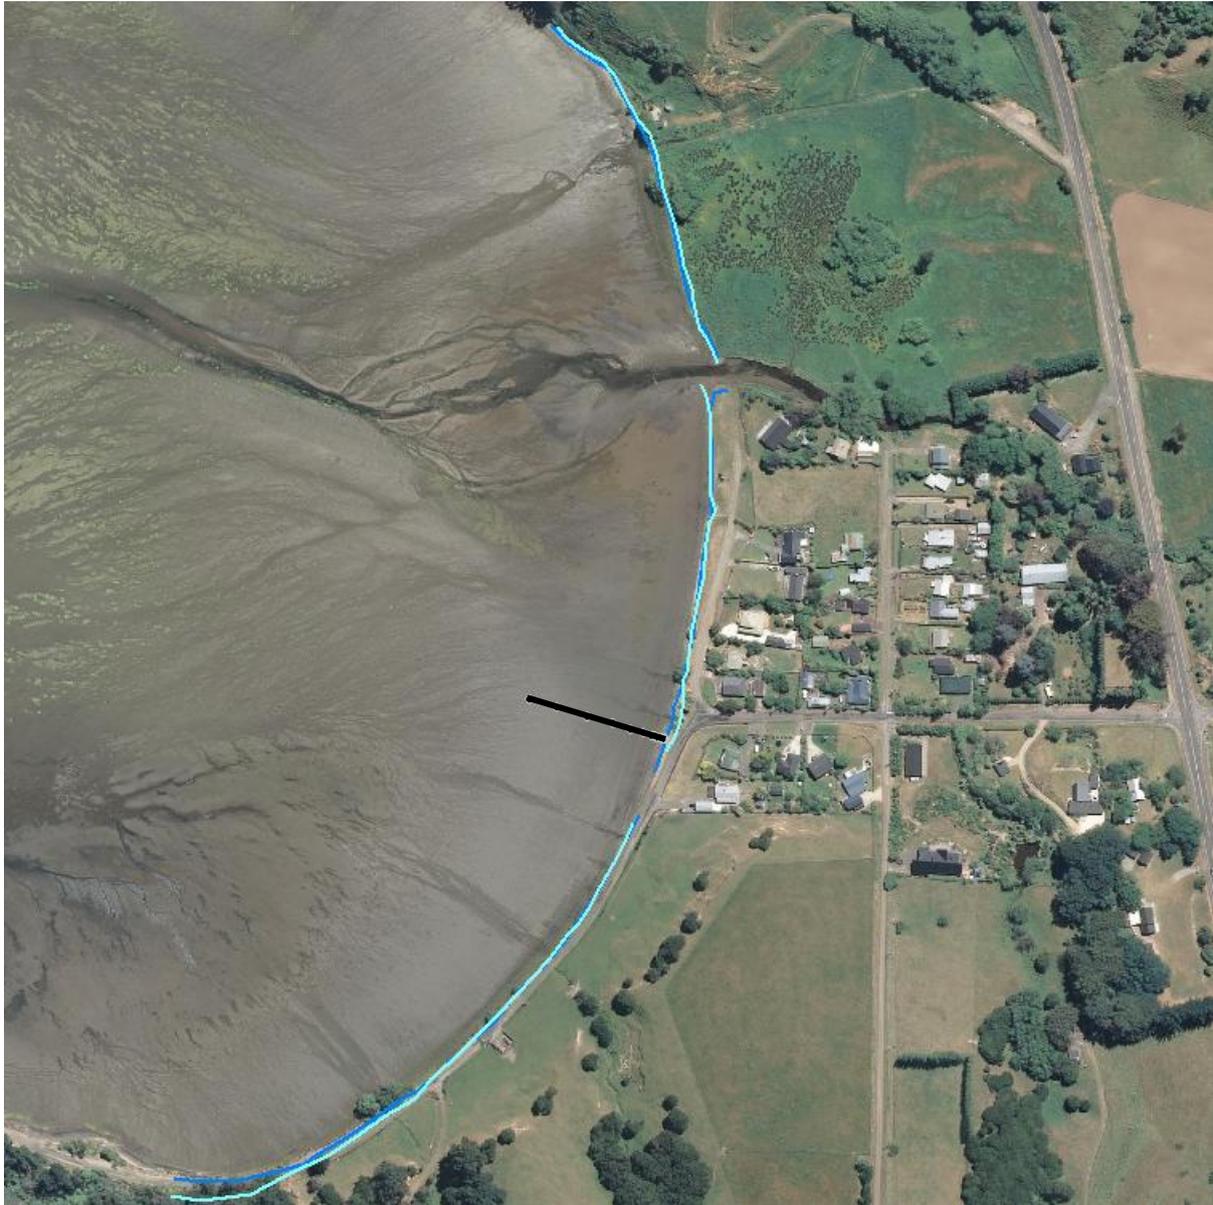
Figure G7 Aerial view of Takamatua Bay with the location of the survey transect (black line) indicated and the 1980-1984 (light blue line) and 2005-2017 shoreline (dark blue line) derived from aerial imagery (source: Canterburymaps.govt.nz)

Based on the aerial photograph assessment there appears to have been no significant change in the vegetation line position from the early 1980s to the present.

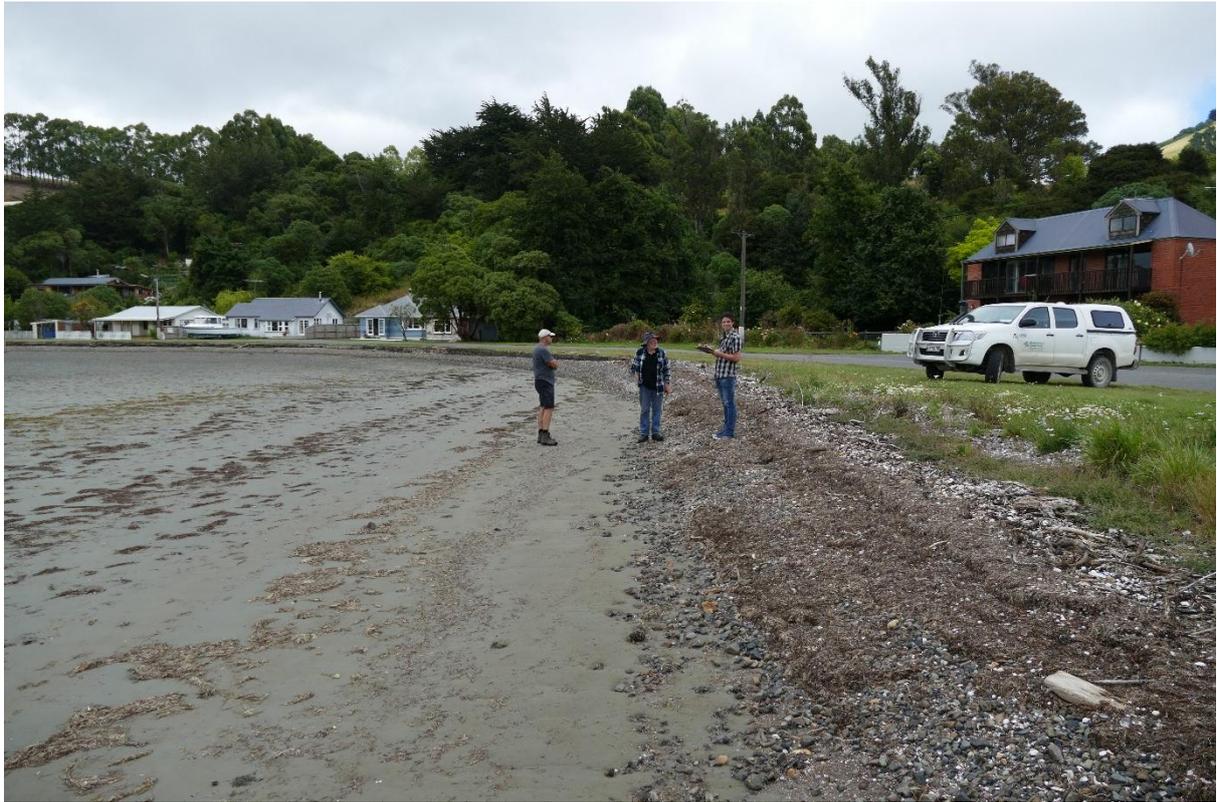
Figure G8 Grass reserve and beach at Takamatua

It is a predominantly fine sand beach with a narrow shelly/gravel band fronting a low lying grass/road reserve (Figure G8). A typical section through the beach is shown in Figure G9. A low concrete seawall with a level of around 1.5 m RL is evident along some of the coastline and in some locations accretion has occurred burying the seawall.

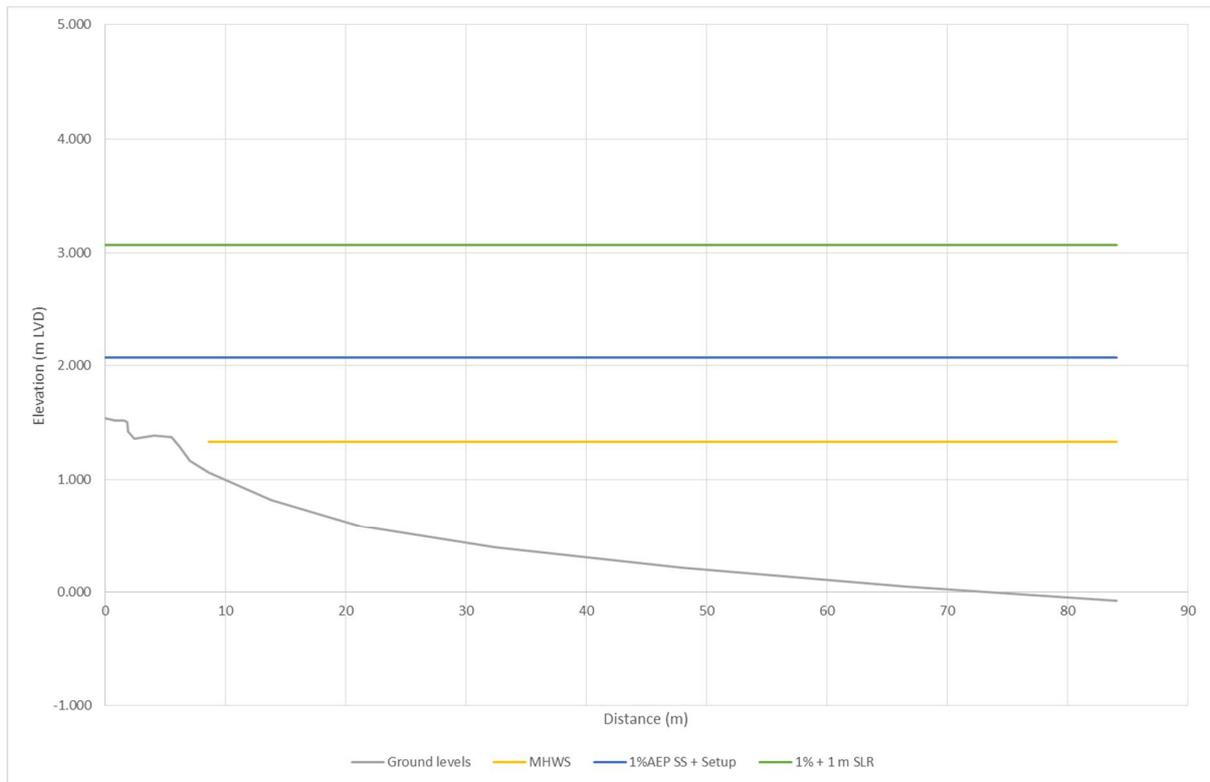
Figure G9 Section through beach at Takamatua

Reserve levels close to the beach are generally less: between 1.5 and 2 m RL. The narrow gravel/shell zone has a slope of around 1(V):8(H) and the slope flattens to around 1(V):27(H) on the fine sand and further flattens to 1(V):95(H) within the intertidal sand zone.

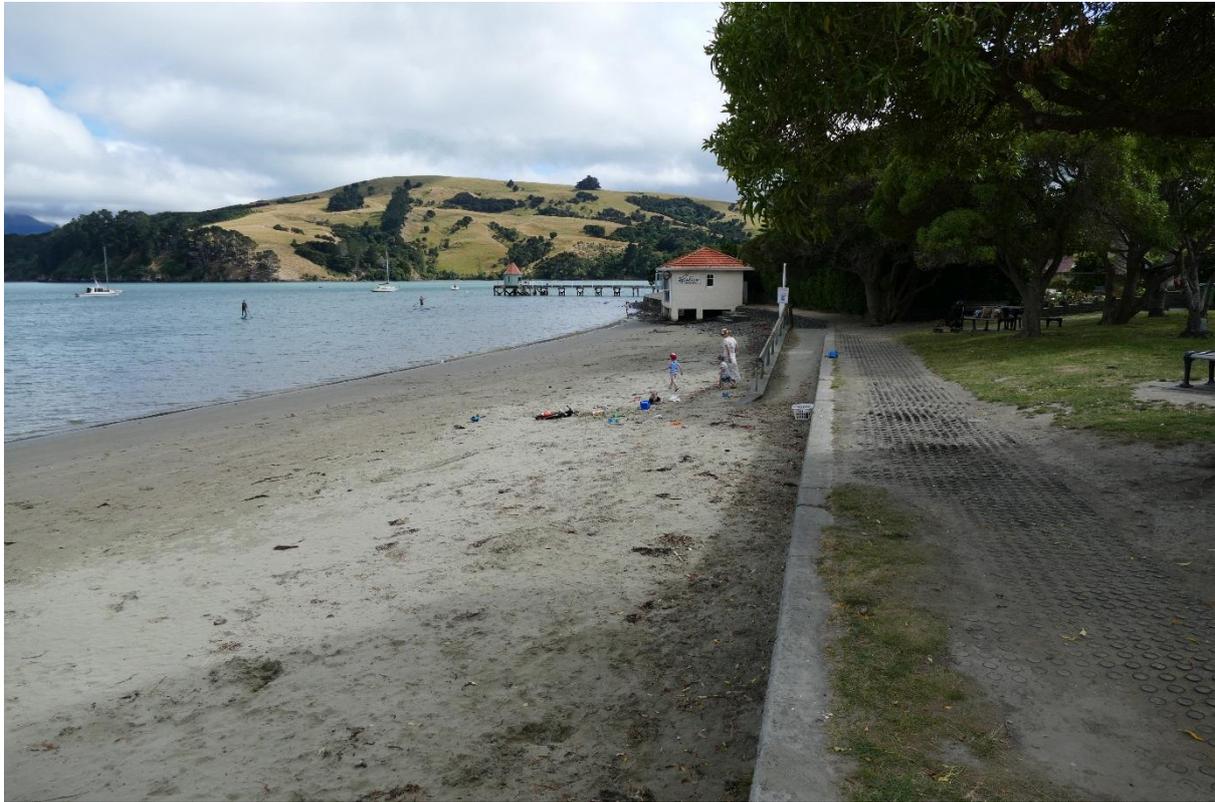
Figure G10 Akaroa foreshore

Akaroa is located along the eastern shores of French and Childrens Bay. There are natural beaches backed by cliffs at the northern end of the bay and seawalls along the main settlement comprising vertical seawalls (see Figure G10) with some rock armour revetments protecting a largely cliff coast. Due to the extensive seawalls extending along the coast at this location no survey or aerial photograph analysis was carried out.

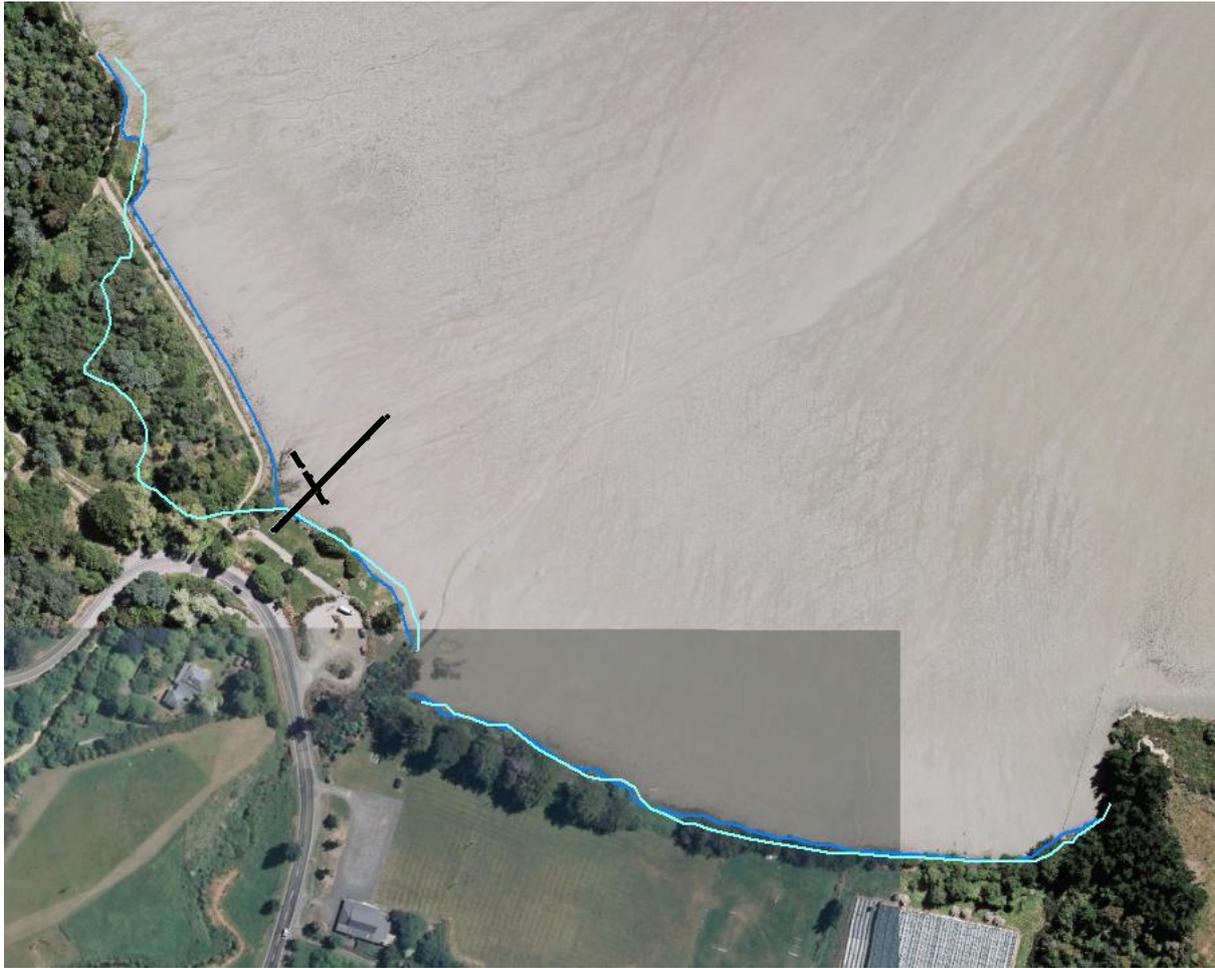
Allandale is a north-easterly facing foreshore in Governors Bay between two cliff promontories extending into upper reaches of Lyttelton Harbour with two small streams discharging to the coast. Part of the bay was historically used as a landfill and this can be seen by the seaward movement of the shoreline in Figure G11. The shoreline north of the northern stream outlet has been armoured with a sloping rock revetment. Erosion is evident between the two streams. Based on observations made during the site inspection, it is likely that landfill extended south of the stream outlet has adjusted to a more natural shoreline position over time. The remaining shoreline comprises a low bank (1(V):2(H)) to a flat foreshore (1(V):280(H)) and no significant evidence of change based on the historic aerial photograph assessment.

Figure G11 Aerial view of Allandale with the location of the survey transect (black line) indicated and the 1970-1974 (light blue line) and 2005-2017 shoreline (dark blue line) derived from aerial imagery (source: Canterburymaps.govt.nz)

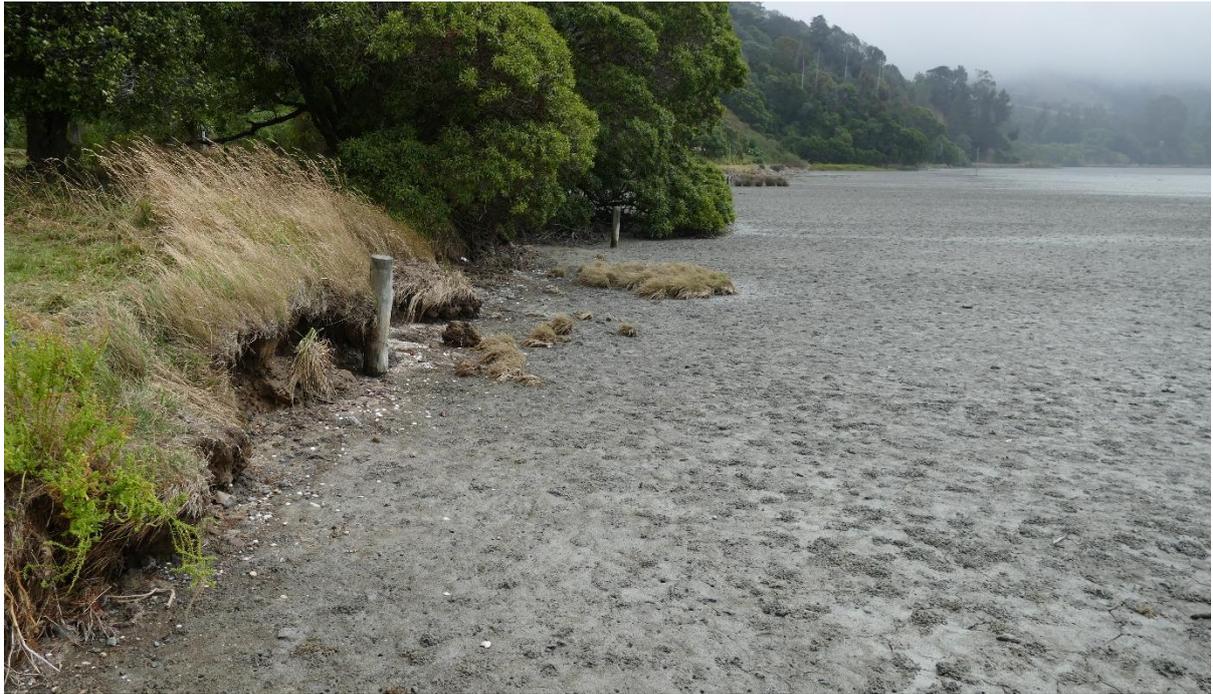
Figure G12 Allandale foreshore between the two streams showing a steep bank with some evidence of erosion and a flat muddy/sandy intertidal area

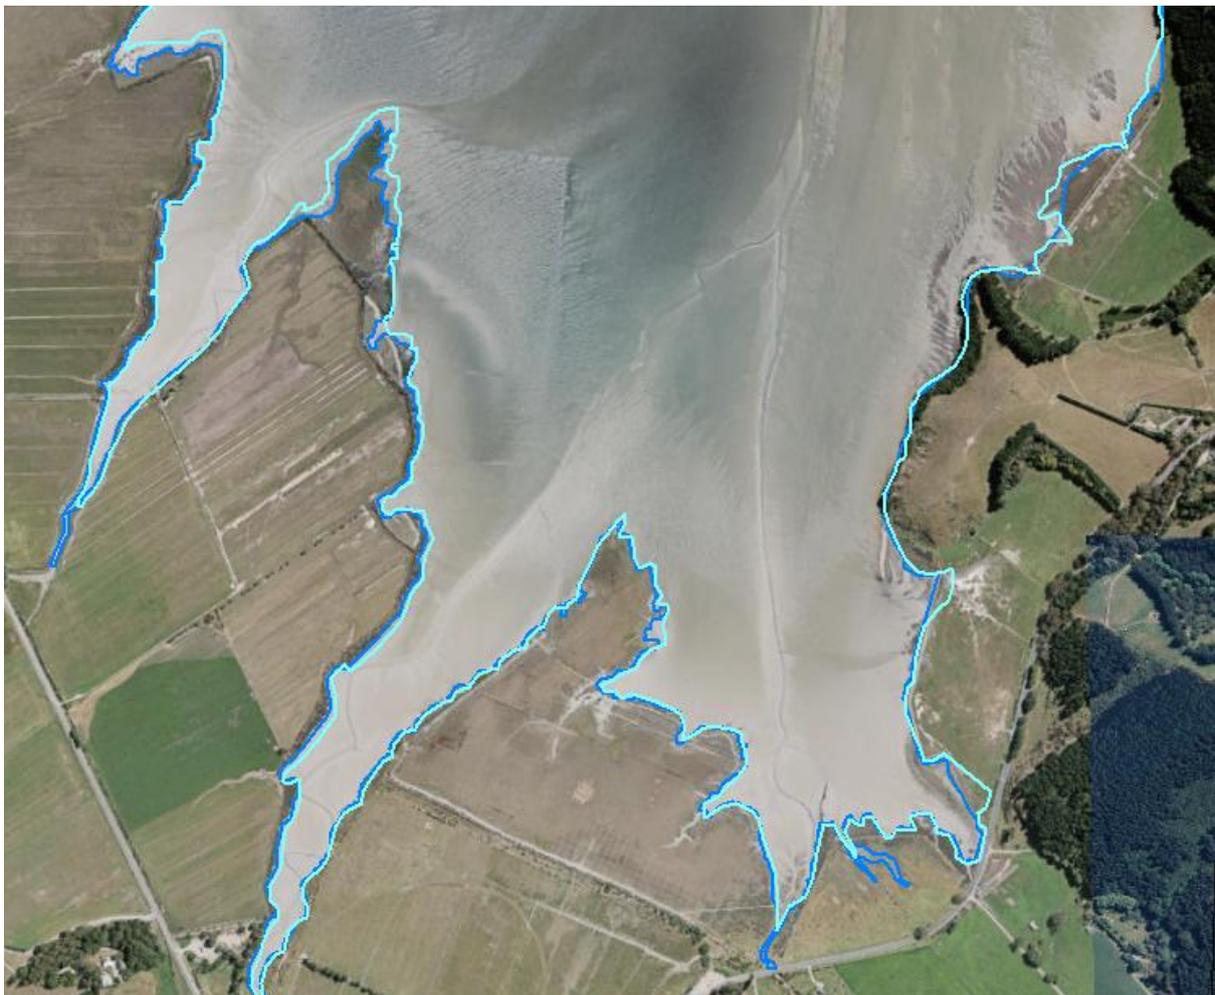
Teddington has a northerly facing foreshore in Head of the Bay between two cliff promontories extending into the upper reaches of Lyttelton Harbour (Figure G14). The intertidal flats extend up to 1 m RL with the land area only marginally higher (1.2 to 1.5 m RL). The land area is predominantly comprised of extensive salt marshes and farm land with evidence of flood bunds around the farmed area. The aerial photograph analysis shows generally little shoreline change, although there are areas both of localised accretion and erosion. The bank along the edge of the coast is steep (around 1(V):2(H)) and low (refer Figure G15).

Figure G14 Satellite image of the Teddington shoreline with the 1970-1974 (light blue line) and 2005-2017 shoreline (dark blue line) derived from aerial imagery (source: Canterburymaps.govt.nz)

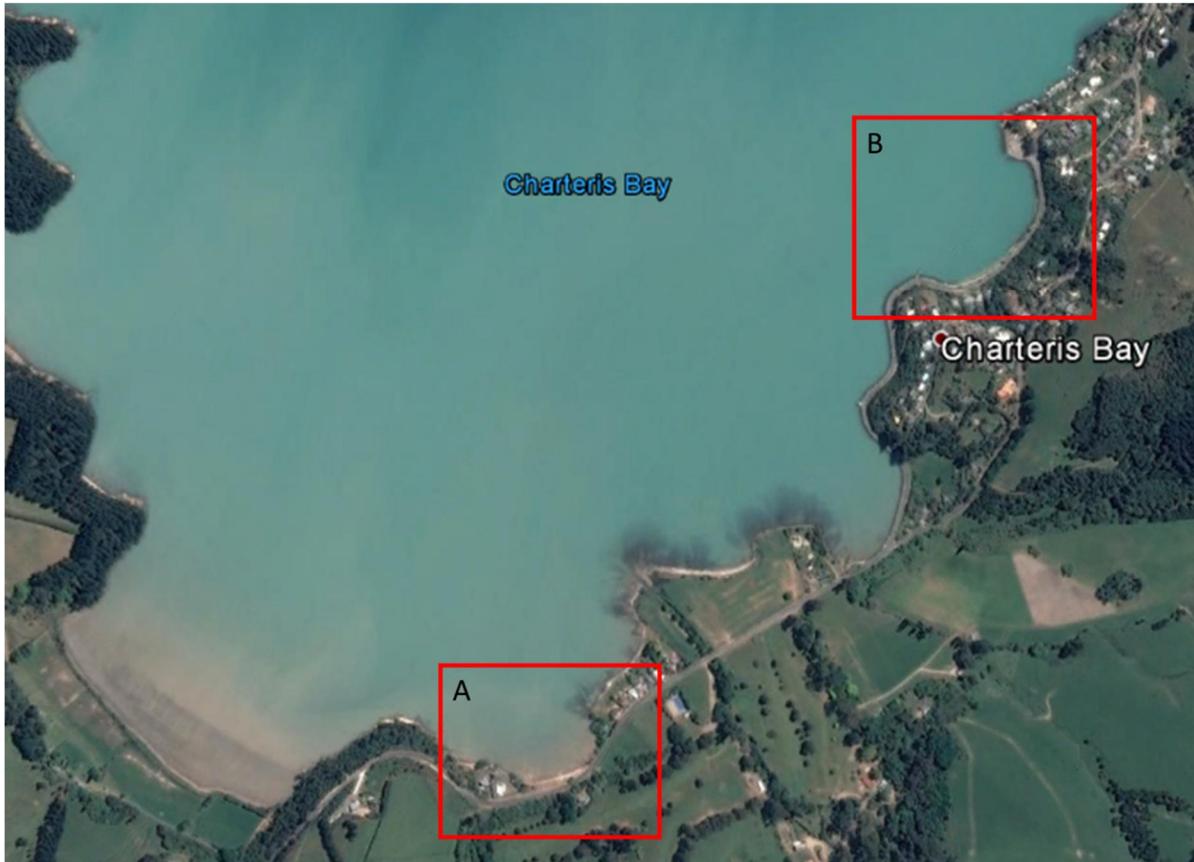
Figure G16 Charteris Bay (Source: GoogleEarth)

The coastline along Charteris Bay is predominantly cliff coast with some small indented alluvial coastal areas between rocky outcrops and headlands. The main alluvial area adjacent to the road reserve is northerly facing towards the bottom of the bay (refer Site A, Figure G16), but there is also a shallow embayment with rock armour adjacent to the road in the centre of the bay (refer Site B, Figure G16).

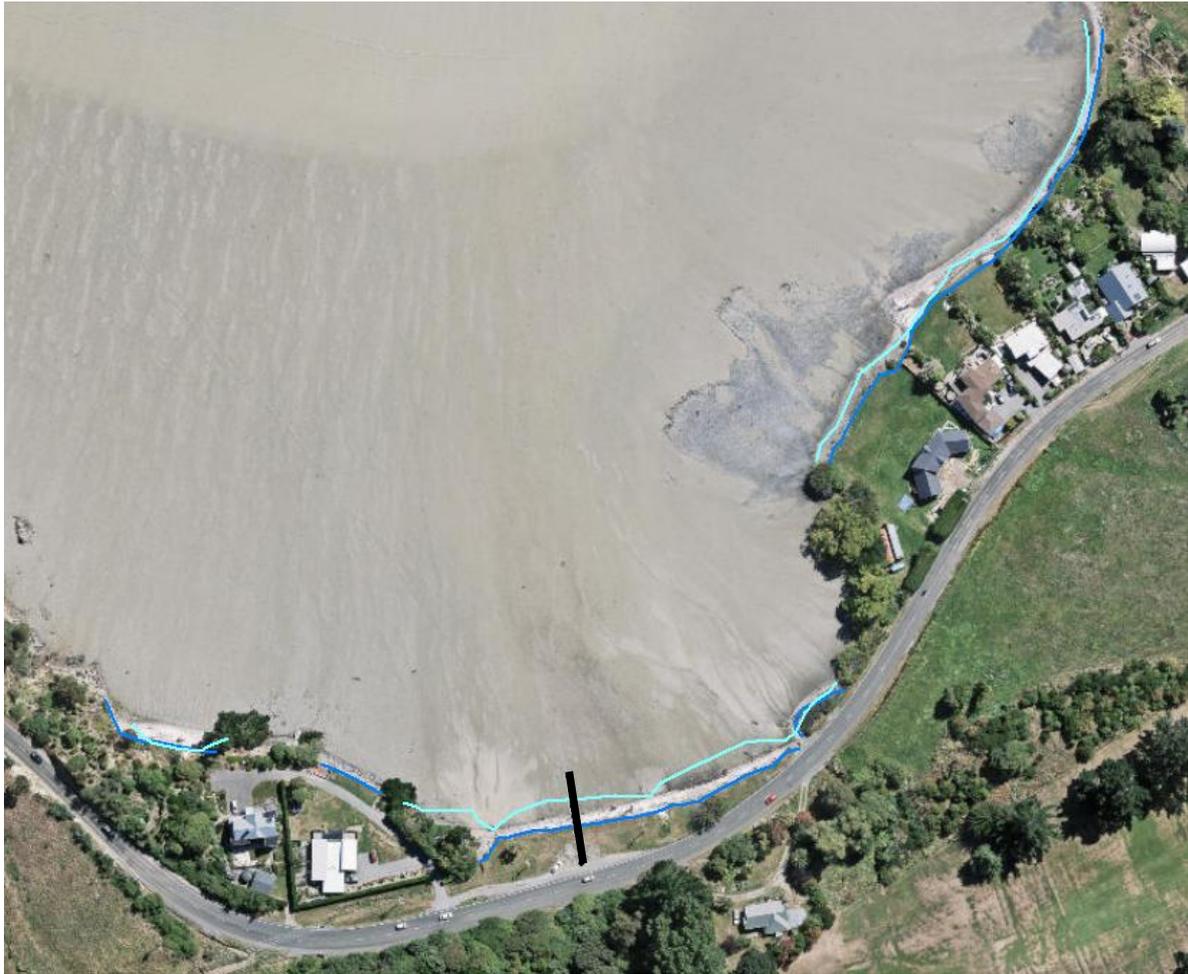
The results of the analysis of historic aerial photographs is shown in Figure G17 for Area A. This shows that shorelines have eroded 5 to 10 m over 35 to 45 years (in the order of 0.1 m to 0.2m per year of erosion). Based on visual assessment, erosion is also evident along the cliff coast where rock platforms are evident in the intertidal area. However, some of the higher rates of erosion appear to be occurring in areas of fill and it is possible that these higher rates are occurring where there has been historic reclamations and ground raising. Based on the survey section in Area A (see Figure G20) the upper beach slope is around 1(V):8(H) and the foreshore slope is around 1(V):70(H). From visual inspection the beach slope in Area B was similar to that in Area A.

Figure G17 Southern embayment in Charteris Bay with the location of the survey transect (black line) indicated and the 1970-1974 (light blue line) and 2005-2017 shoreline (dark blue line) derived from aerial imagery (source: Canterburymaps.govt.nz)

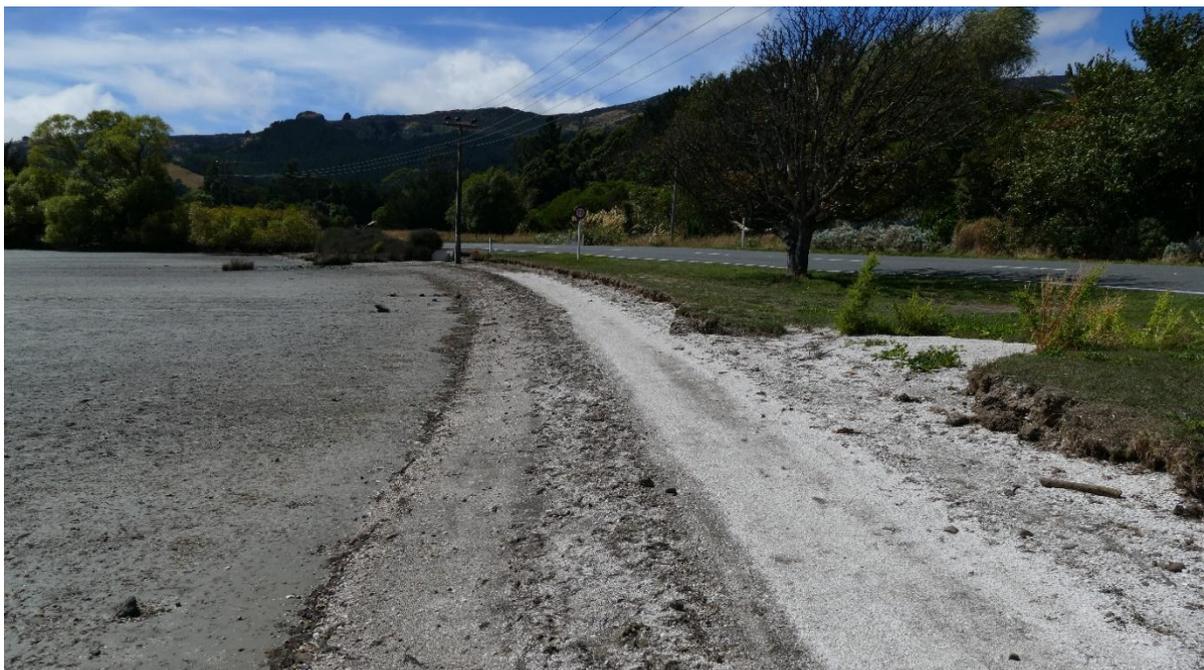
Figure G18 Eroding bank in southern area of Charteris Bay (Area A of Figure G16)

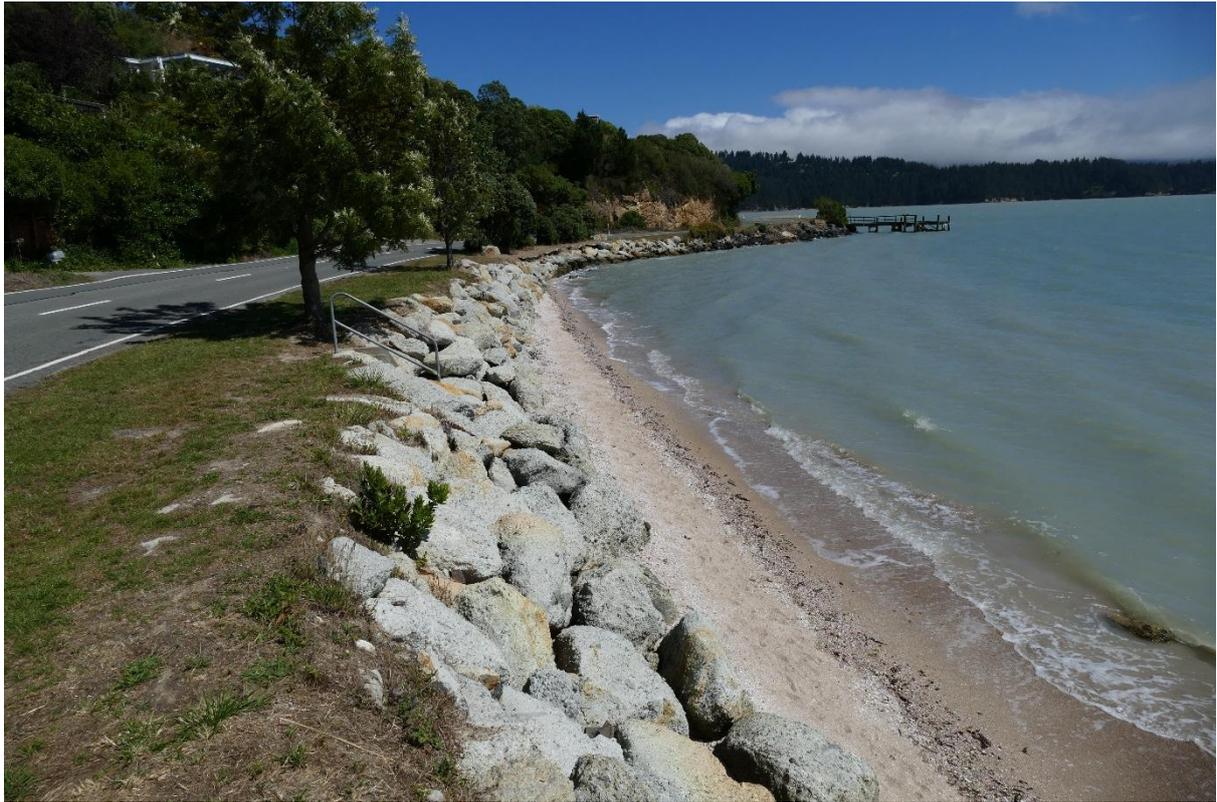
Figure G19 Rock revetment protection along road reserve in Charteris Bay (Area B in Figure G16)

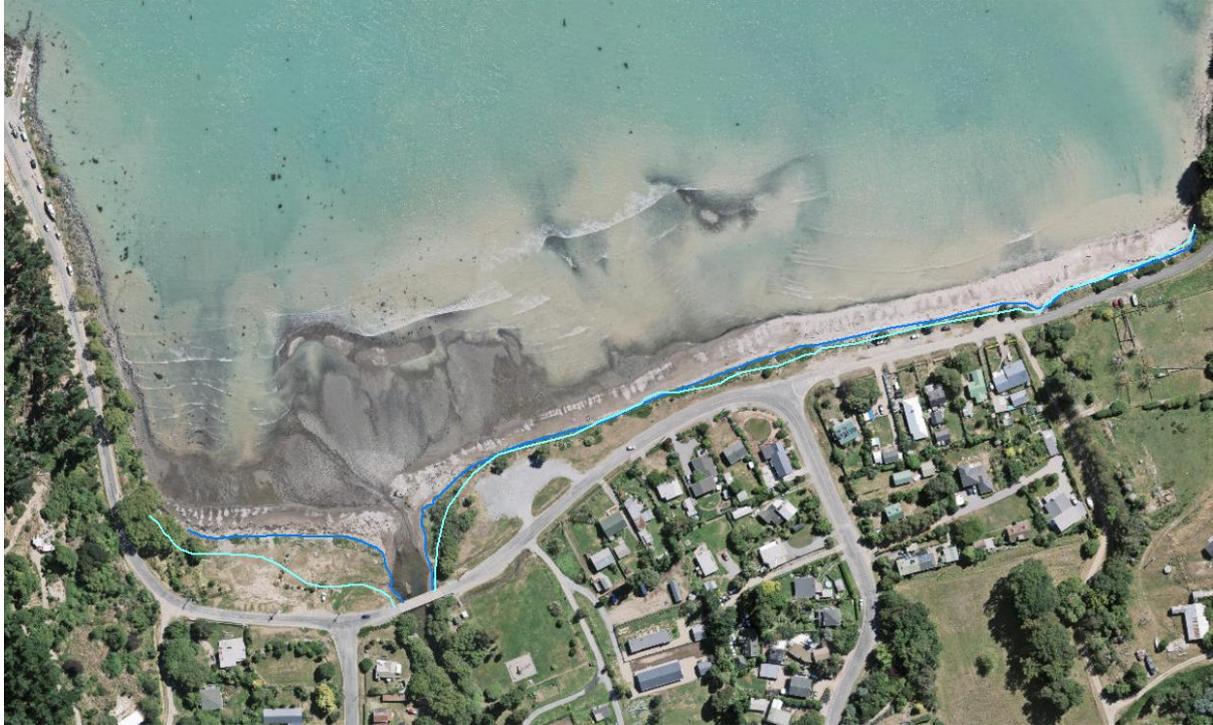
Figure G21 Purau Bay with the 1970-1974 (light blue line) and 2005-2017 shoreline (dark blue line) derived from aerial imagery (source: Canterburymaps.govt.nz)

The results of the analysis of historic aerial photographs is also shown in Figure G21. This shows that shoreline is stable, to slightly accretional, over the majority of the shoreline. There is evidence of greater accretion to the west of the stream outlet.

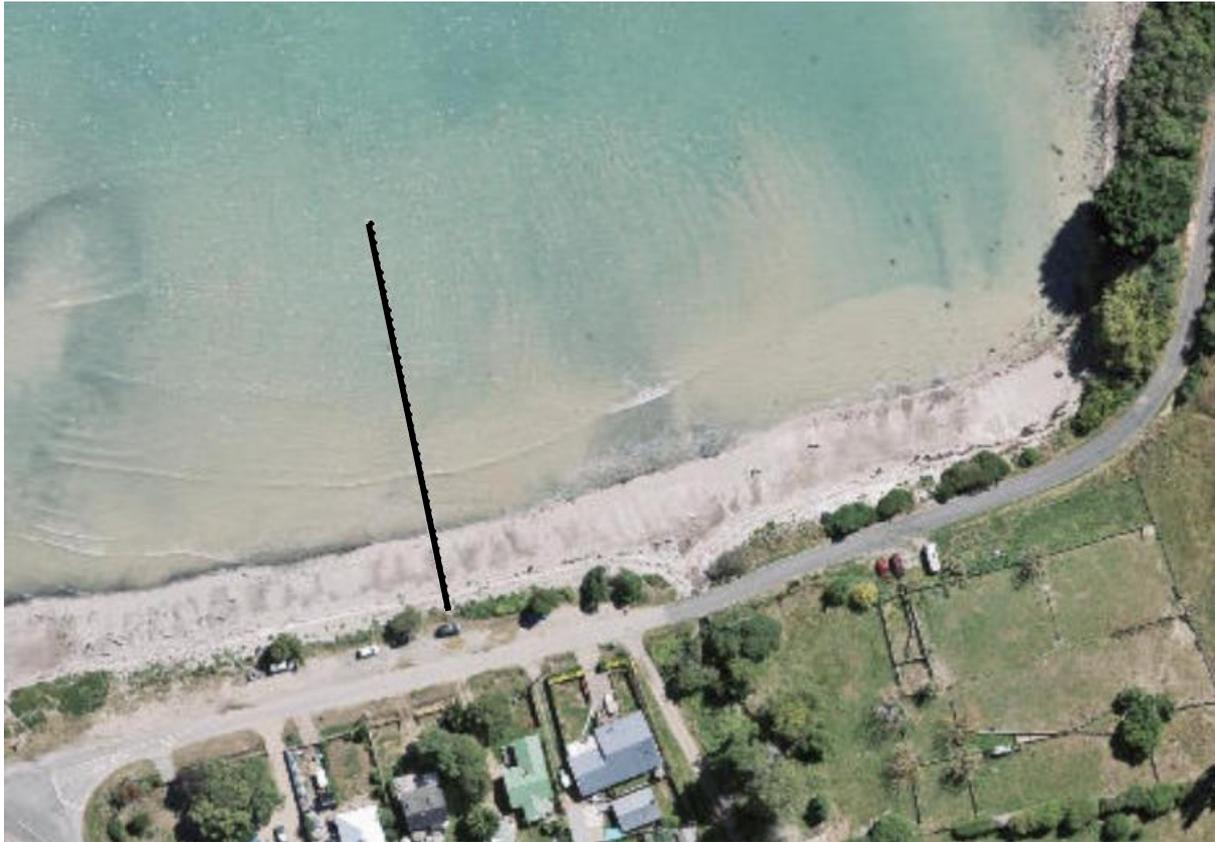
Figure G22 Purau Beach transect location

Based on the survey section situated along Camp Bay Road (see Figure G22 for the transect location and Figure G23 for the transect) the upper beach slope is around 1(V):9(H) and the foreshore slope is around 1(H):70(V). From visual inspection the beach slope in Area B was similar to that in Area A.
