Appendix D: CEHZ result maps

CHRISTCHURCH CITY COUNCIL
Coastal Hazard Assessment
South New Brighton Spit
Coastal Erosion Hazard Zone

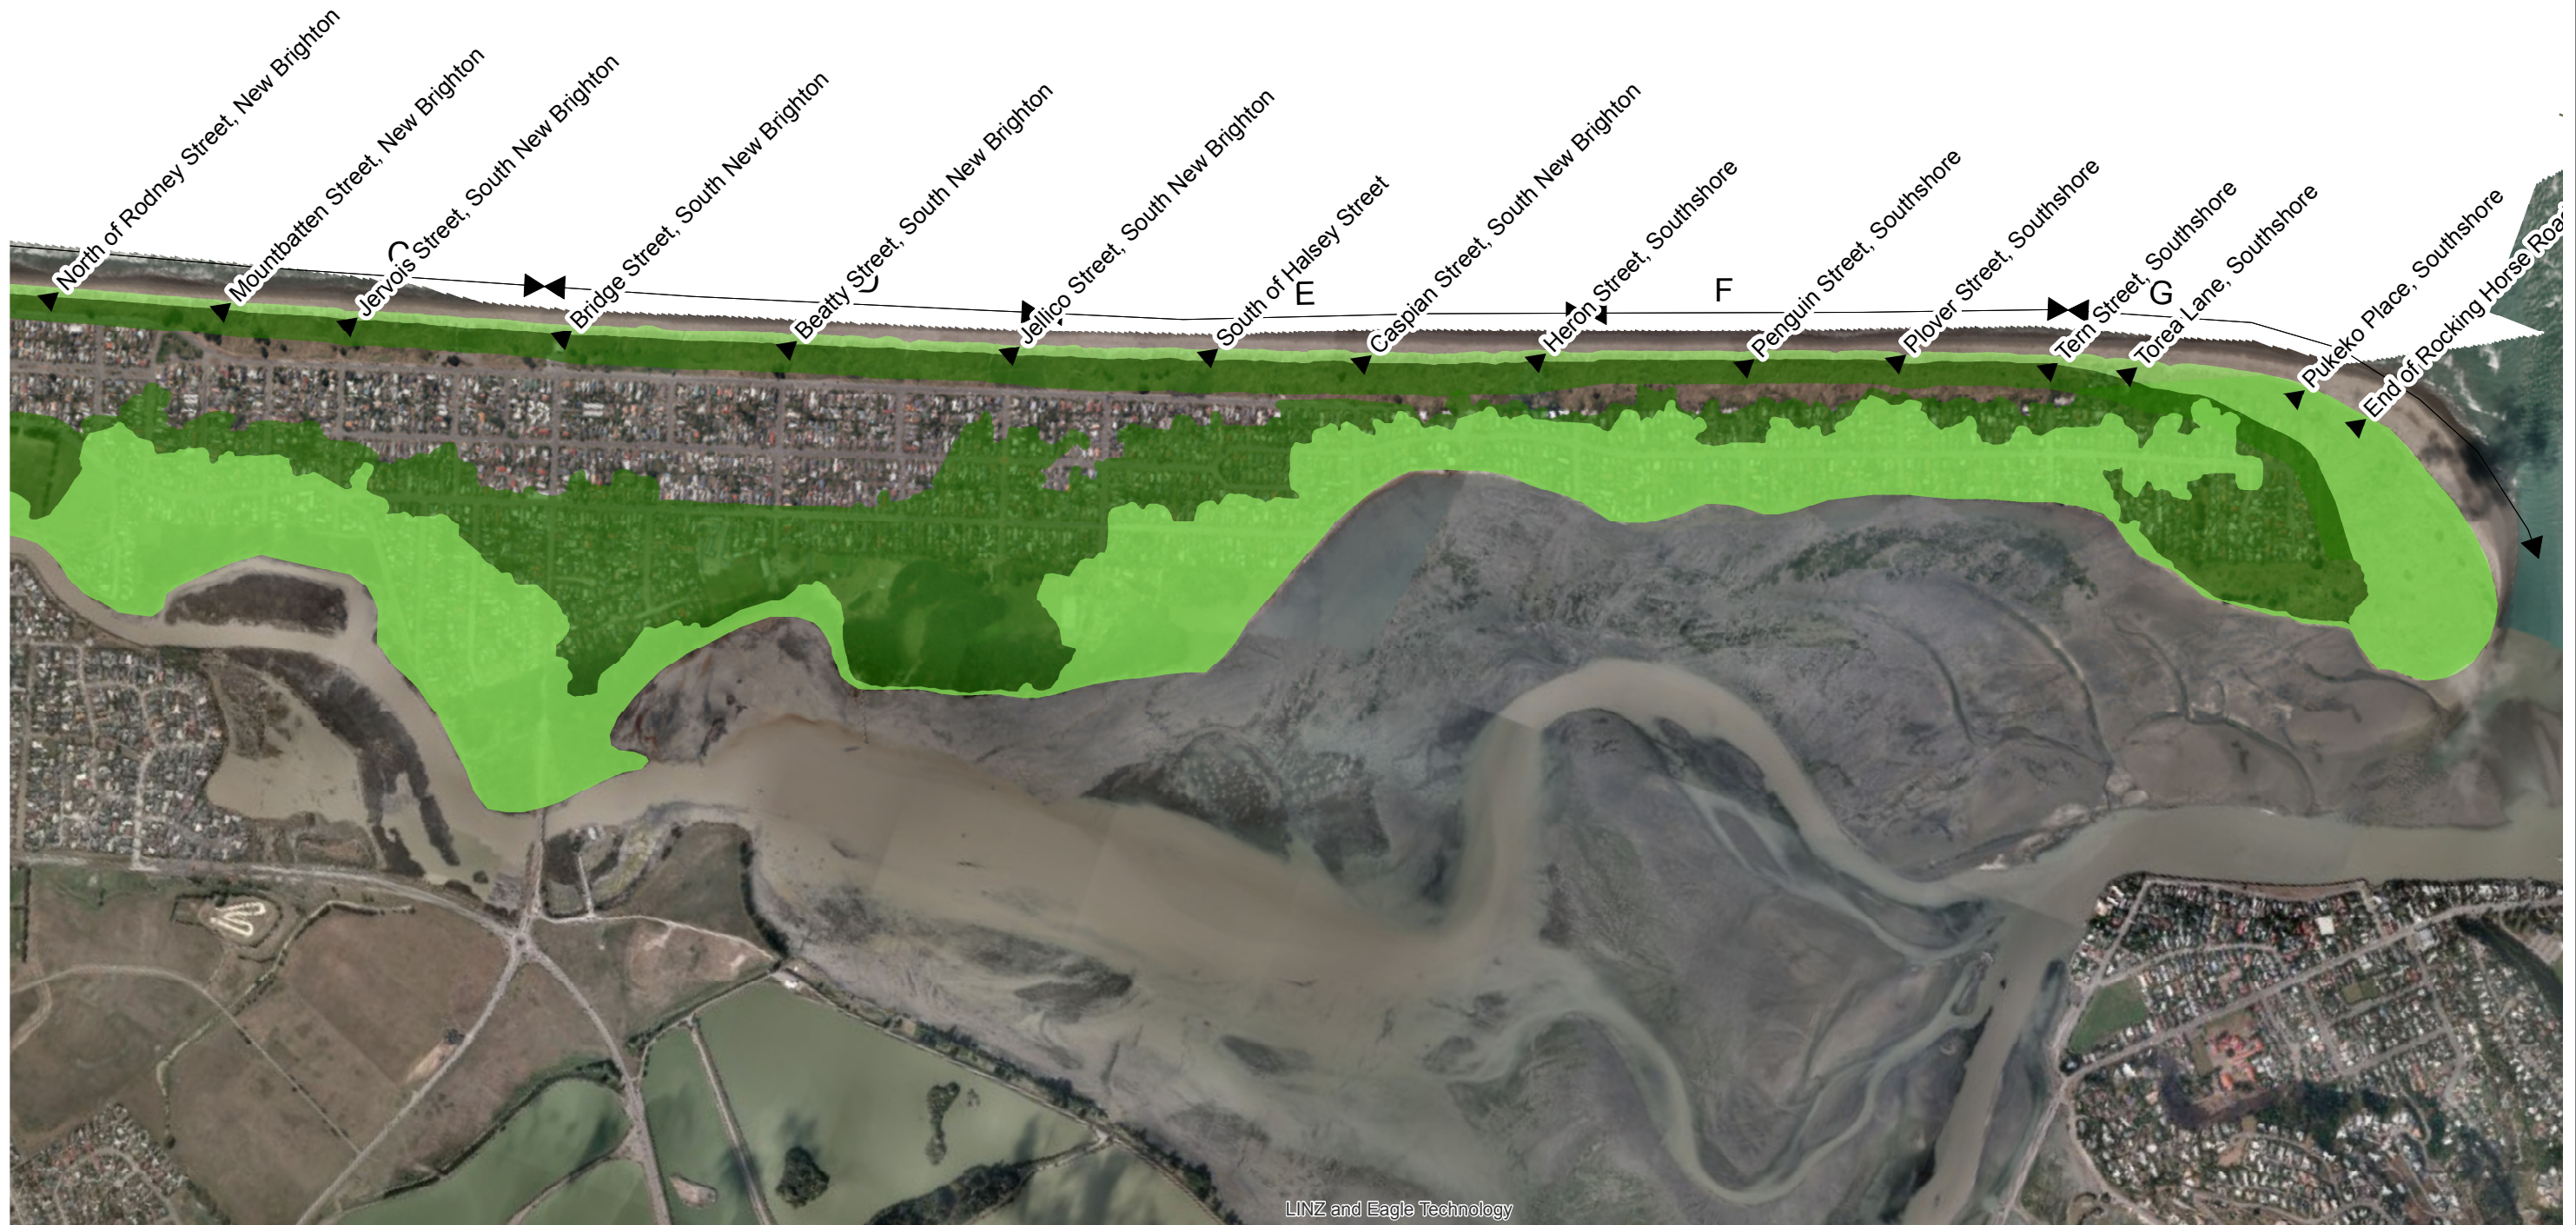
FIGURE No. Appendix D 7	Rev. 0
----------------------------	-----------

- ▲ Beach Profile Benchmark
- 2011 Shoreline
- ↔ Cells
- 2065 Coastal Erosion Hazard Zone
(Area Susceptible to Coastal Erosion Hazard to 2065)
- 2115 Coastal Erosion Hazard Zone
(Area Susceptible to Coastal Erosion Hazard to 2115)

Notes: Aerial photograph taken in 2011

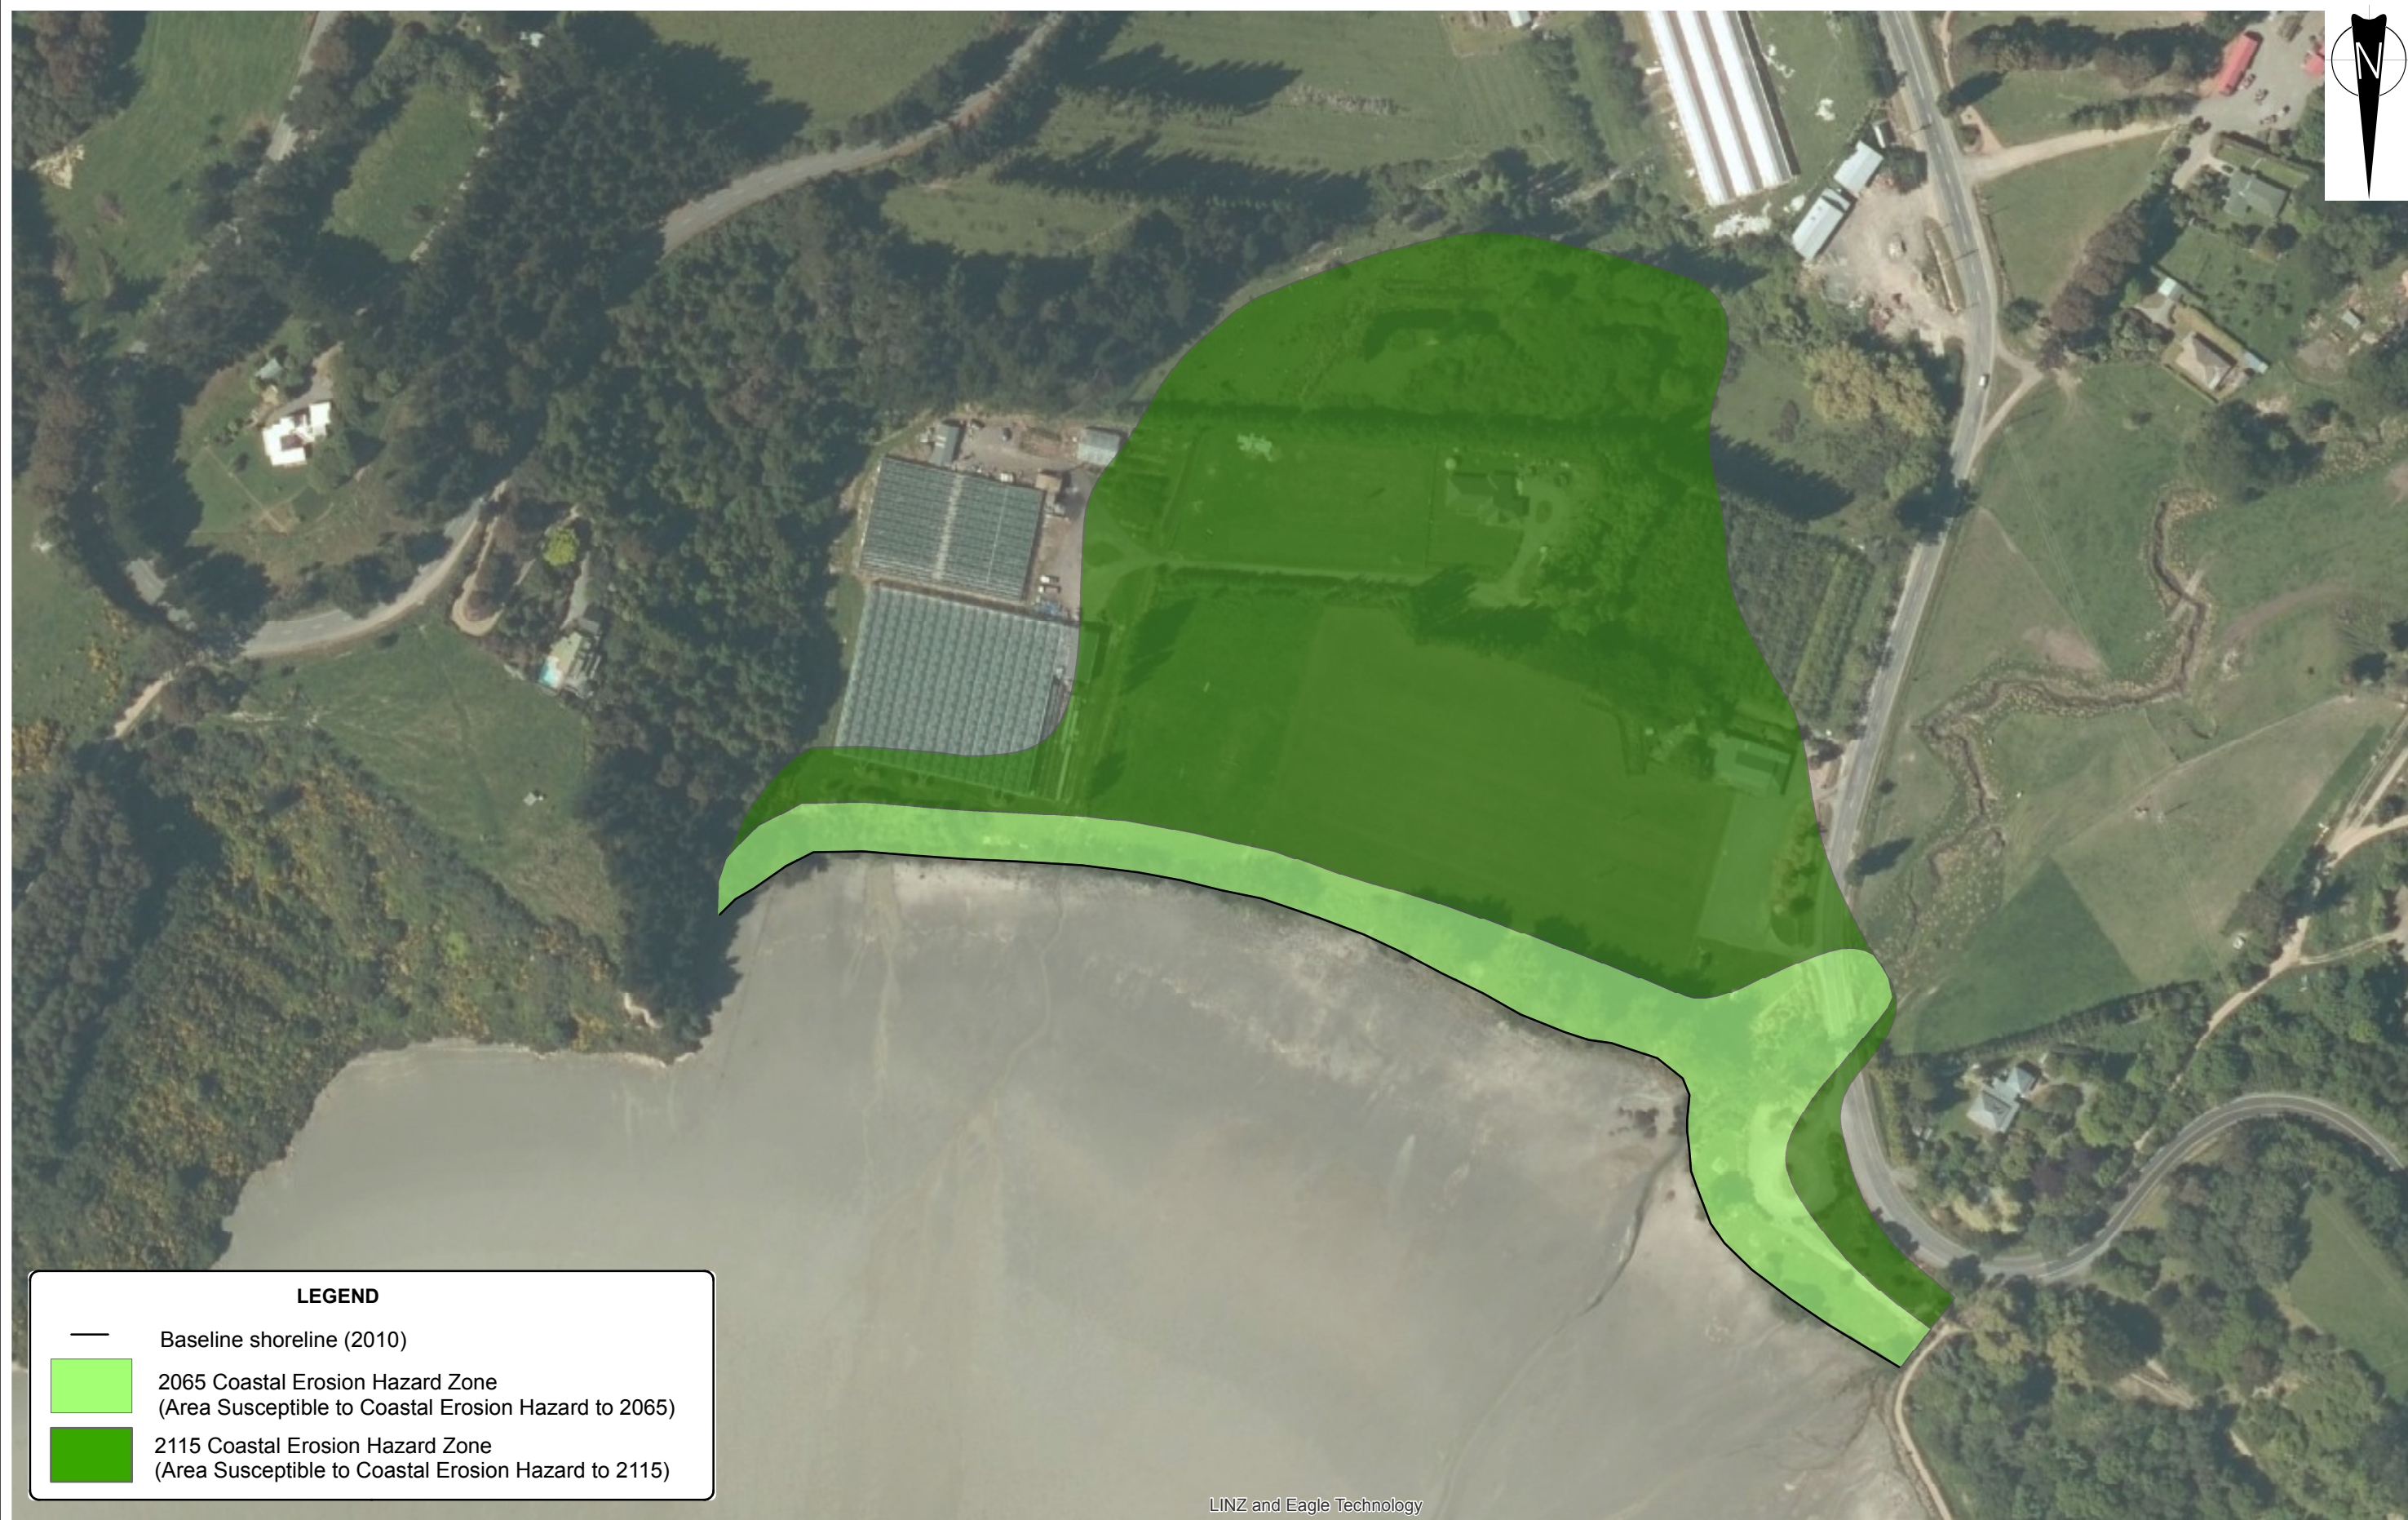
FIGURE No. Appendix D 8. Rev. 0

- Baseline shoreline (2010)
- 2065 Coastal Erosion Hazard Zone
(Area Susceptible to Coastal Erosion Hazard to 2065)
- 2115 Coastal Erosion Hazard Zone
(Area Susceptible to Coastal Erosion Hazard to 2115)

CHRISTCHURCH CITY COUNCIL
COASTAL HAZARD ASSESSMENT
Alandale
Coastal Erosion Hazard Zone
