AMI Stadium - East Stand Development Demolition

Introduction to the Project

This waste reduction case study demonstrates that with careful planning and management close to 100% of demolition waste can be separated for recycling and reuse.

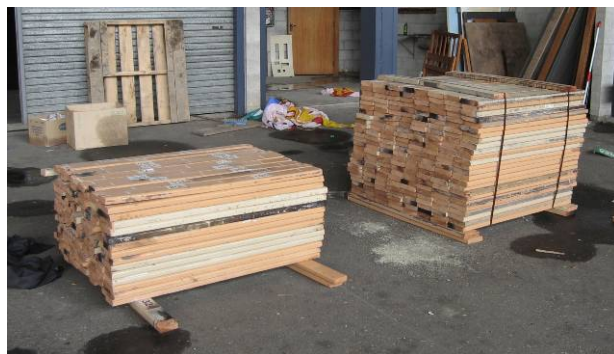
Wooden floor boards recovered for resale © Copyright

- Prepared a waste management plan with clear waste targets.
- Inducted all staff to the waste management plan.
- Held daily meetings to plan the days salvage activities.
- Initially removed materials by hand e.g. wooden floor boards and then bought in a high reach arm to remove steel and concrete as they deconstructed.
- Separated materials and stored them on-site in neat piles.
- Removed re-bar from the concrete and crushed the concrete on-site using a mobile concrete crusher.

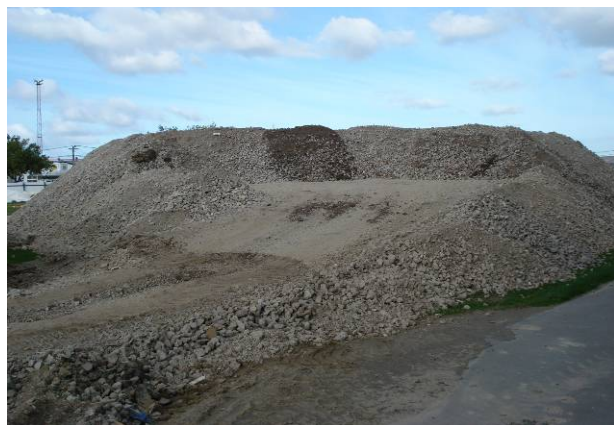
Concrete crushed for reuse on-site © Copyright

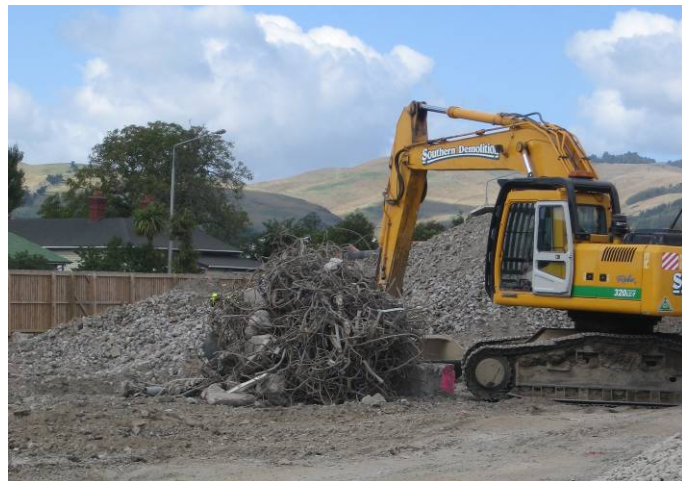
Re-bar being removed from the crushed concrete prior to crushing © Copyright
