Graham Condon Leisure Centre

Christchurch City Council

Introduction to the Project

The Graham Condon Leisure Centre construction started in August 2010 and was completed in September 2011.

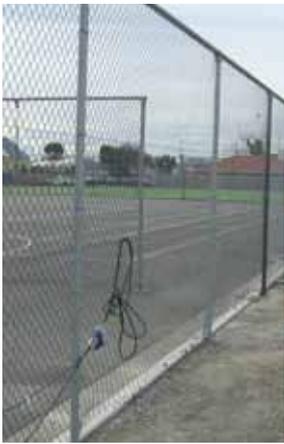
Fence line that has been reused from another part of the site © Copyright

- Reused excavated material on-site including a metal chain link fence and 508 tonnes of aggregate.
- Ensured the site induction procedure included instruction on waste management and minimisation and the location and use of the central waste area. The education linked practices on-site with those at home “separate waste – just like you would do at home”.

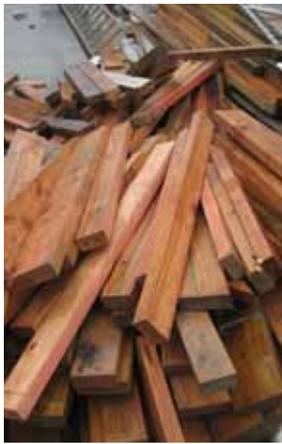
Timber off-cuts stacked for reuse © Copyright

- Timber off-cuts were kept in a separate pile for on-site reuse.
- Ensured the site was kept tidy thereby encouraging staff and sub-contractors to deal with waste at the time rather than letting waste build up.

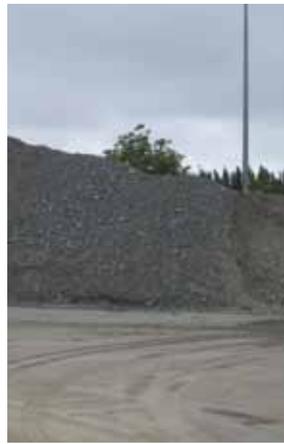
Hardfill that has been dug up and stockpiled for reuse © Copyright

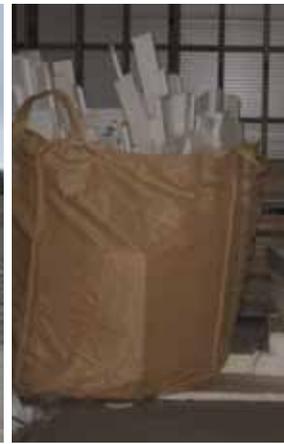
Sorted roof material ready for recycling © Copyright

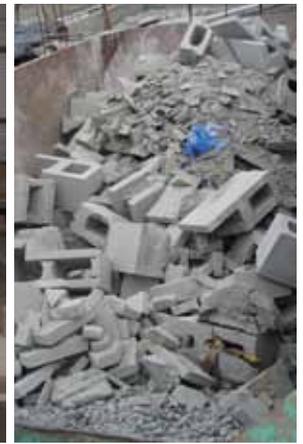
Block laying waste in a dedicated collection unit © Copyright

- Ensured that appropriate collection units would be placed near the source of the waste (i.e. if blocks were being laid a collection unit for concrete was provided next to this area).
