Mahaanui Kurataiao Ltd

# Ōtūkaikino Monitoring Report

January 2023

This report details monitoring undertaken to assess mana whenua values in the Ōtūkaikino catchment as required under the conditions of the Comprehensive Stormwater Network Discharge Consent (CSNDC; CRC214226) held by Christchurch City Council.

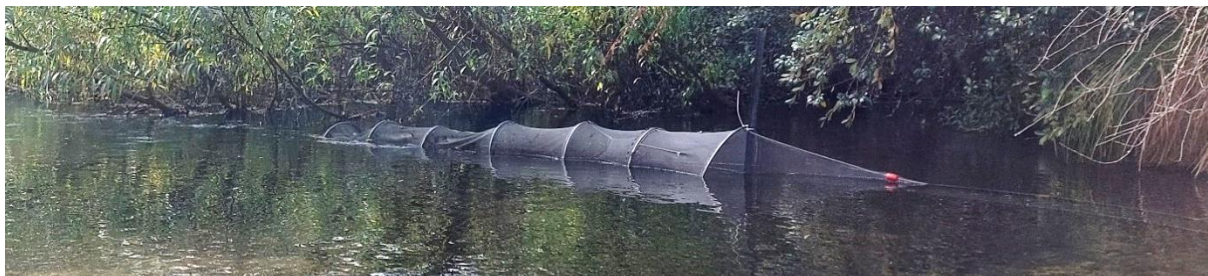
**Figure 2: Hīnaki/fyke net in situ at OTU04. The leader was staked upstream in low flow conditions and downstream in high flow conditions.**

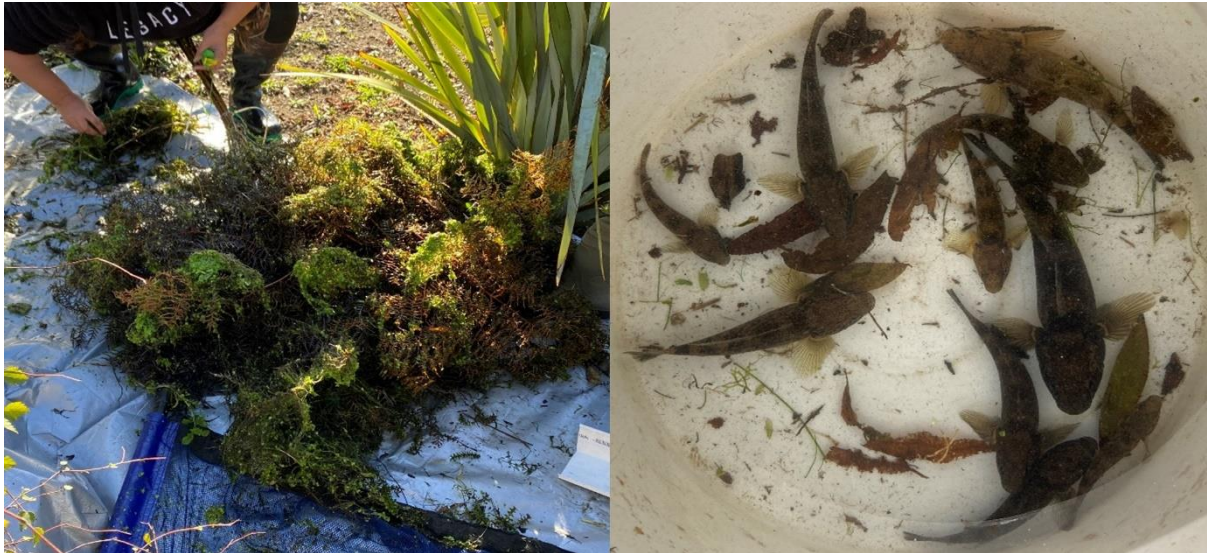
**Figure 3: LEFT: Tau kōura are bundles of aruhe/bracken fern that become colonised by instream fish and macroinvertebrate species. RIGHT: Fish species found in tau kōura at site OTU03.**

Tau kōura were also placed at five sites. These are traditional fishing traps made from aruhe/bracken fern bundles and are used to collect wai kōura/crayfish and other small fish (tuna/elvers, tīpokopoko/species of bully and īnanga/whitebait; Figure 3). These were left in-situ for a month to allow colonisation before being pulled up and the community analysed.

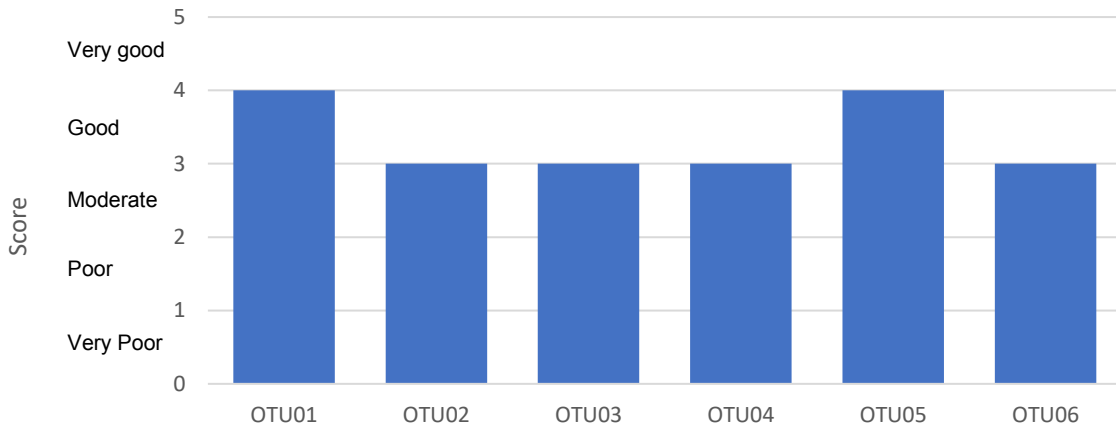
The Takiwā overall health assessment identifies the general site condition and categorised four sites as moderate and two sites as good (Figure 5). No sites were rated as very good. These scores aligned closely with the degree of site modification and reflect the rural and reserve land use within this catchment.

Figure 5: Takiwā overall health assessment.

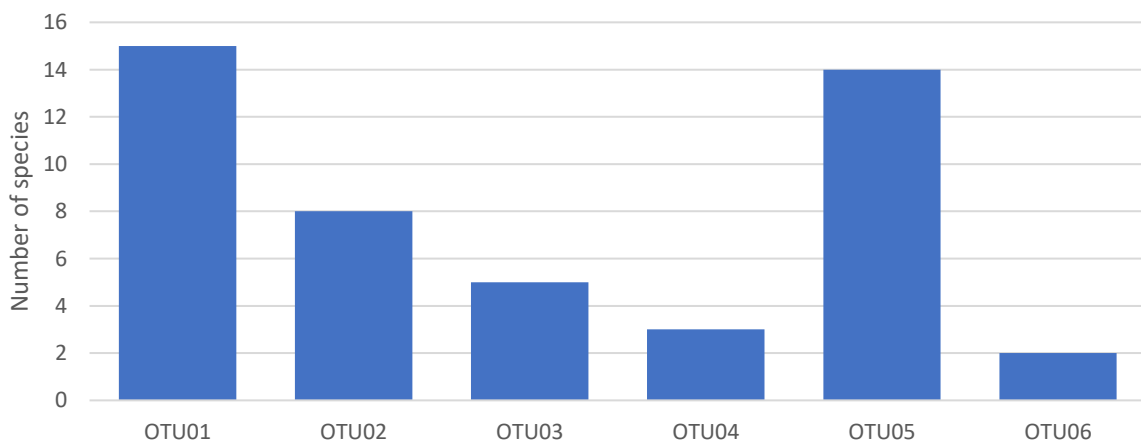
Mahinga kai/indigenous vegetation diversity varied across the sites monitored, with the Ōtūkaikino wetland (OTU01) having the greatest number of mahinga kai and/or indigenous species (15), followed by the Issacs Conservation Reserve (OTU05). The other four sites had much lower plant species diversity, being dominated by willows, blackberry, and other exotic invasive species (Figure 8).

Figure 8: Mahinga kai and/or indigenous diversity across the sites.

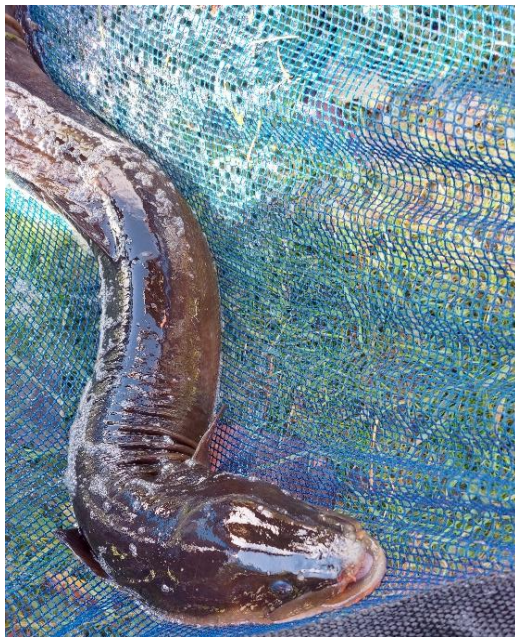
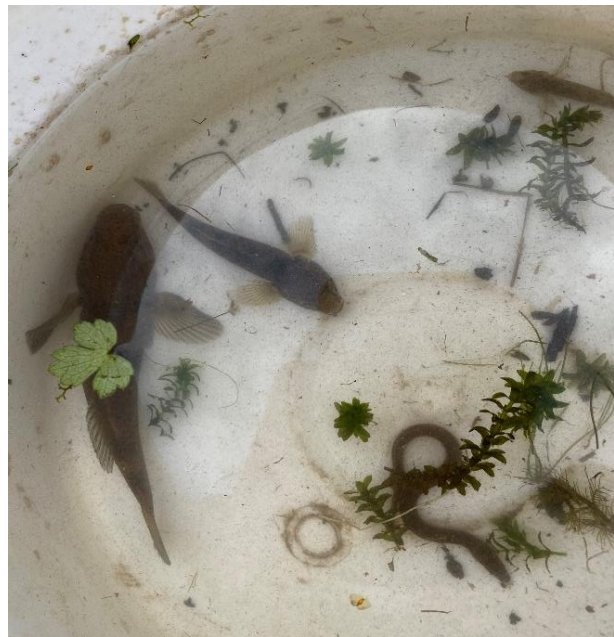
Gee minnows and hīnaki/fyke nets were used at three sites. At the Dickeys Road bridge site (OTU02), ten tīpokopoko/common bully were caught in the gee minnow traps and the hīnaki/fyke nets caught a single tūnanga/whitebait. No tuna/longfin or shortfin eels were caught at this site, despite undercuts and pools being present. Nothing was caught in the gee minnow traps at OTU03, however heavy sedimentation was occurring from willow clearance works up stream on the day of monitoring. This may have impacted catch rates. Nine tuna/longfin eel were caught at this site in the hīnaki/fyke nets (Figure 11). The two hīnaki/fyke nets set at the Groynes picnic area (OTU04) caught different species. The first net contained 16 tuna/longfin eel, and the second net contained 3 tīpokopoko/common bully and an elver (juvenile eel). A pātiki/flounder was also observed at this site while bringing in the nets.

**Figure 11: LEFT: Tuna/longfin eel caught using a hīnaki/fyke net. RIGHT: Tipokopoko/common bully) and an elver caught using a gee minnow trap.**

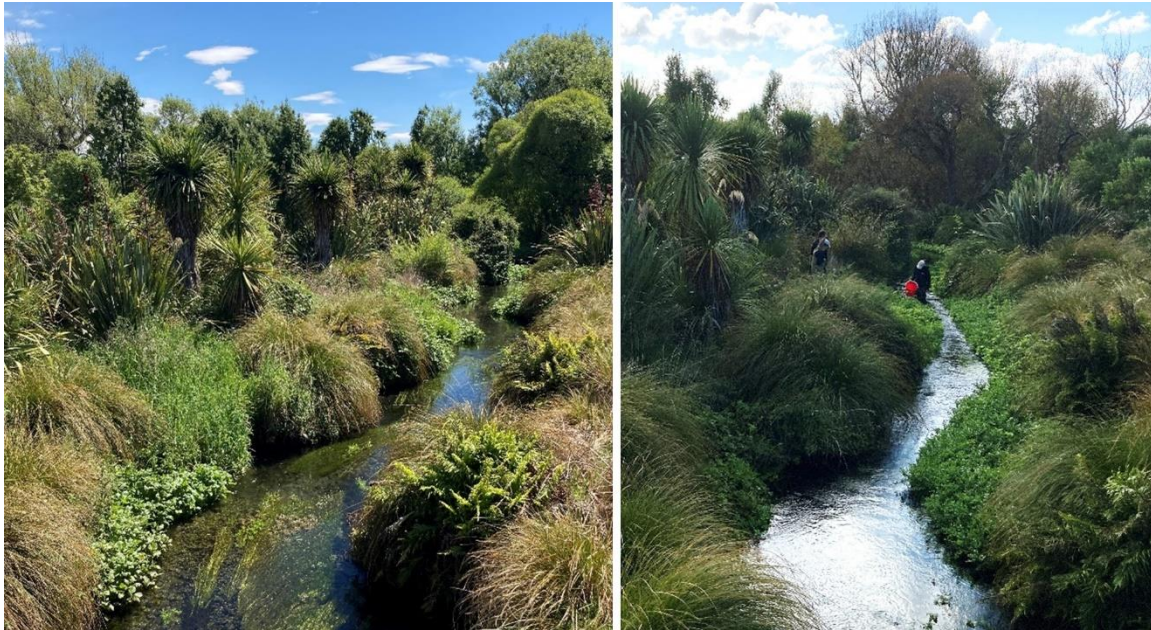
Issacs Conservation Reserve (OTU05) was the only site at which electric fishing was conducted as the other sites were too wide or deep. Eight tīpokopoko/upland bully were caught at this site, alongside three tīpokopoko/common bully, two elver (juvenile eel) and one tuna/shortfin eel. Significant macrophyte growth had occurred at this site since the initial survey, restricting the channel and making electric fishing difficult (Figure 12). The electric fishing results reported during this monitoring are likely to represent species diversity, but not species abundance.

Figure 12. Issacs Conservation Reserve (OTU05). LEFT: November 2021 showing a clear channel. RIGHT: May 2022 showing significant macrophyte growth.

This site has had significant extant restoration planting occur with along the riparian margins of the stream conducted by the Issacs Conservation Trust (see Figure 12), and therefore had the second greatest plant species abundance of all sites surveyed, with many mahinga kai and rongoā species present. The abundance of native plant species, lack of stream sedimentation, and the abundance of watercress gave this site the second highest score of cultural health. However, willow regrowth and blackberry vine were observed at this site, and planting is setback from the stream resulting in extensive macrophyte growth. Number of bird species were low. Pīwakawaka/fantail and kotare/kingfisher were observed at this site on the day of monitoring, and korimako/bellbird were observed during the initial site selection.

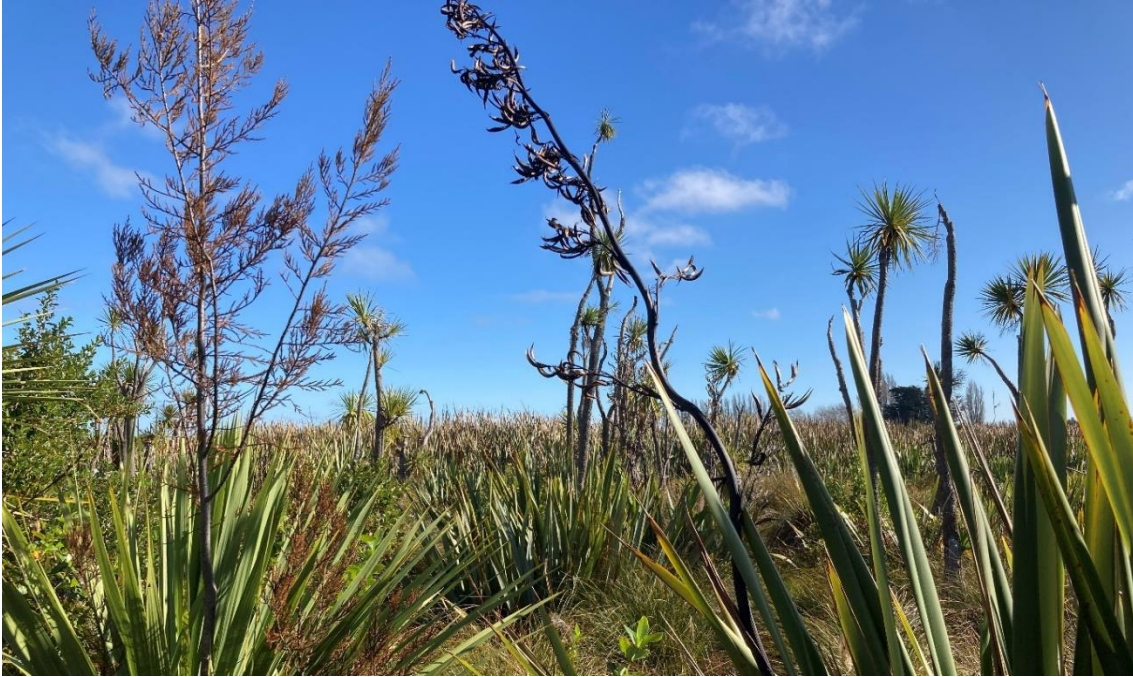
The site with the best cultural health was the Ōtūkaikino wetland (OTU01) reflecting its status as a restored remnant wetland (Figure 14) and wāhi tapu site. This site is utilised as a modern wāhi tapu/cremation memorial garden and good cultural health is necessary for these activities. However, despite scoring highly in most areas, this site was identified as being under significant pressure due to being bound by the motorway on two sides. This site also had the greatest diversity of native bird and plant species (8 and 15 respectively). *E. Coli* levels were elevated at this site and is likely due to the large number of waterfowl that inhabit the wetland but should be investigated further. Nitrate-nitrogen was also elevated at this site and is likely due to upstream agricultural land use.

**Figure 14: Ōtūkaikino wetland (OTU01) with raupō/bulrush and tī kouka/cabbage tree swamp and regenerating kahikatea forest.**

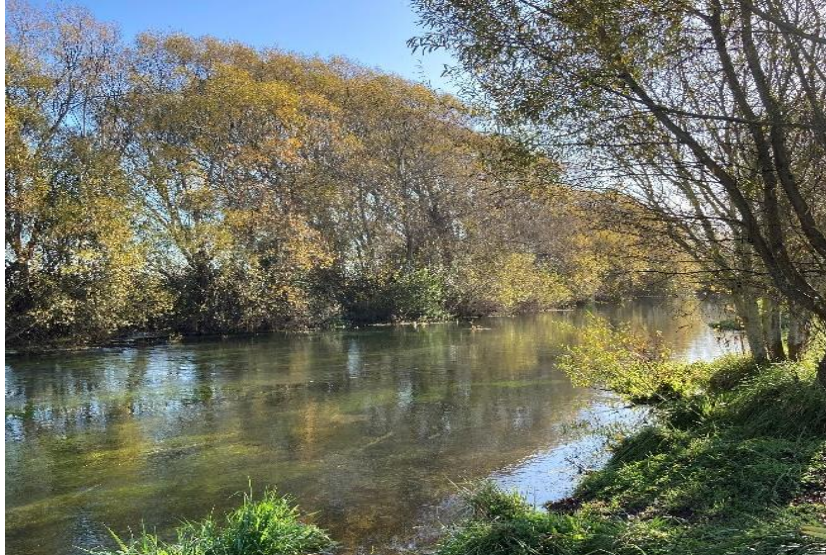
This site scored poorly in site modification and pressure due to the motorway and bridge, but has good access for whānau and a small patch of riparian planting (Figure 15). The number of indigenous vegetation species identified was low overall. Phosphorous was elevated at this site and likely reflects the surrounding agricultural land use. The fish population of this site was dominated by tīpokopoko/common bully. No tuna/short or longfin eel were caught. This differs from a previous survey where tīpokopoko/giant bully and tuna/longfin eel were caught at this site (Noakes, 2017). The number of bird species observed overall was low, with pīwakawaka/fantails and rakiraki/mallard ducks the dominant species observed at this site. Further planting of the riparian margins of this site would increase bird diversity, mahinga kai and cultural values.

**Figure 15. Downstream of Dickey's Road bridge (OTU02) showing willow dominated riparian margins.**

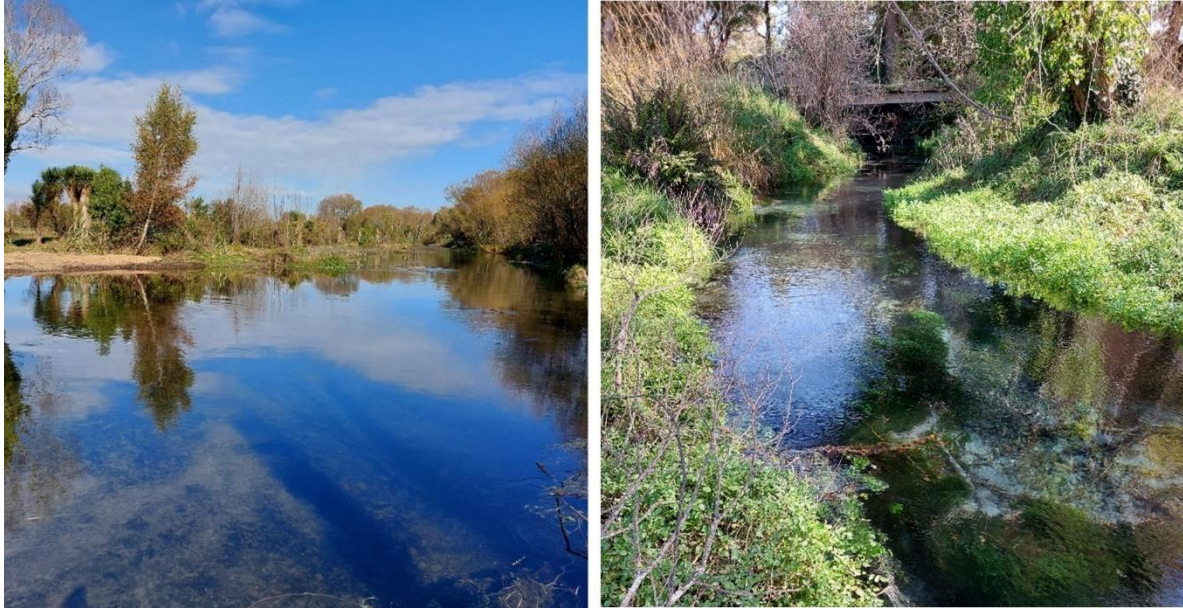
This site had second lowest cultural health score as willow clearance work was underway during the period of monitoring, meaning the site had little riparian vegetation and channel shading (Figure 16). Furthermore, an increase in sediment was evident along the banks of the stream and benthic macroinvertebrate abundance was decreased. This site scored poorly in site modification and pressure due to minimal planting on the riparian margins and adjacent agricultural land use. A tau kōura was placed at the confluence of the Ōtūkaikino stream and Kaikanui Creek, and caught ten tīpokopoko/common bully. Tuna/longfin eel were also caught at this site in hīnaki/fyke nets and substantial wātakirihi/watercress beds were present in Kaikanui creek (Figure 16). Phosphorous and *E. coli* were elevated at this site, indicative of the surrounding agricultural land use and the proximity of the dog park respectively. Birdlife was low in number of species overall, but slightly more varied at this site, consisting of a single kōtare/kingfisher, kahu/harrier hawk and pāpango/scaup. Restoration riparian planting will increase the bird diversity and cultural health of this site.

**Figure 16: LEFT: Downstream from Groynes dog park showing significant willow removal works on the true right bank of Ōtūkaikino stream. RIGHT: Kaikanui creek where it enters the Ōtūkaikino stream with large wātakirihi/watercress beds evident.**

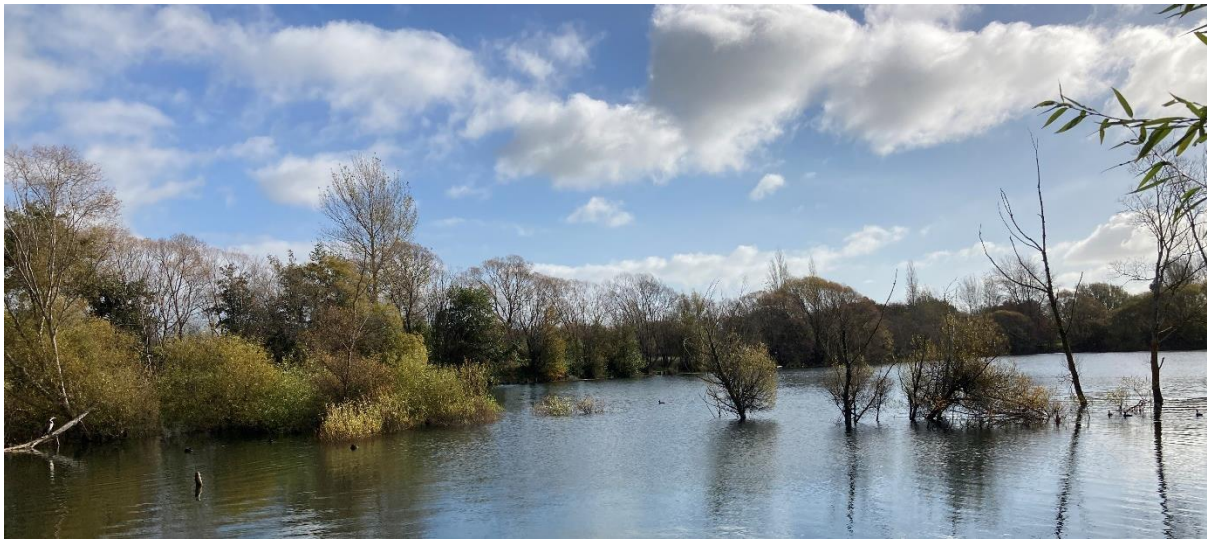
The site with the poorest cultural health was Lake Rua reflecting the lack of native plantings and the surrounding industrial land use (Figure 18). Furthermore, these lakes are former gravel pits and were created when gravel mining activities encountered groundwater. The lakes also do not have a direct connection to Ōtūkaikino stream and its tributaries, and therefore there is no pathway for the recruitment of migratory fish species. This site however is a very popular swimming and waka ama site, and is frequented by whānau. It is therefore a good candidate for additional restoration planting and remediation. Only two mahinga kai plant species were identified at this site; raupō/bulrush and wātakirihi/watercress. Multiple bird species were present, including pāpango/scaup, kāruhiruhi/pied shag, tārapuka/black billed gull, pīwakawaka/fantail, kāmana/crested grebe, and kawaupaka/little cormorant.

**Figure 18: Lake Rua site (OTU06).**
