# Targeted wet weather monitoring of Curlett and Haytons Streams 2021

Report on results and recommendations for future  
monitoring

*Prepared for Christchurch City Council*

NIWA CLIENT REPORT No: 2022041AK  
Report date: July 2022  
NIWA Project: CCC22102

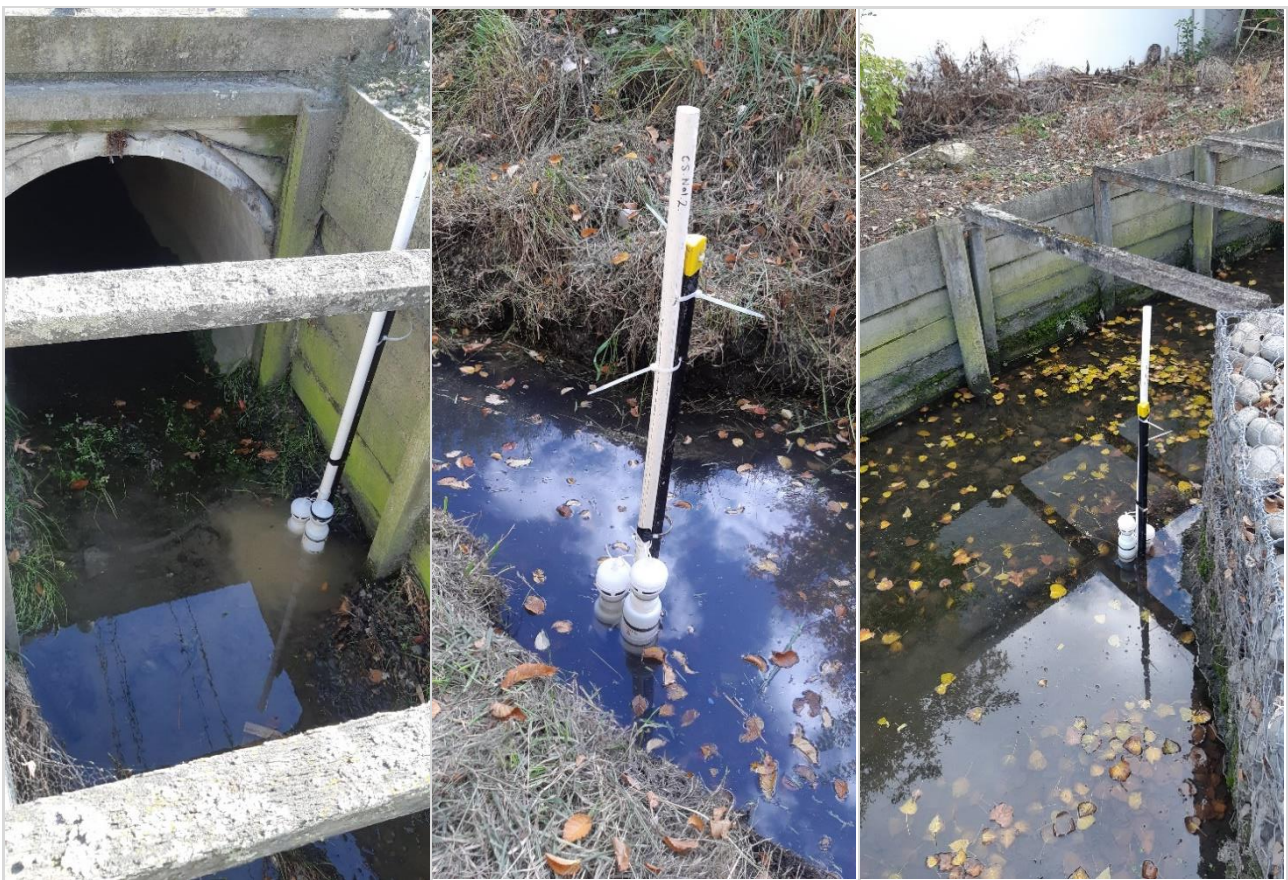
**Figure 2-2: Waratah with two Nalgene sampling bottles installed at the three sampling sites. From left to right: CSNa1, CSNa2 and CSNa3.**

The bottles were deployed above the baseflow water level prior to each storm event with Hobo water level loggers installed at the same time. Two bottles were deployed at each site, one at 50-60 mm above baseflow to target the early part of the event, and potentially a first-flush; and the second bottle at 150-300 mm above baseflow to target the peak water level. The installation heights (Table 2-2) were determined by NIWA staff based on observations of water levels at the sites and the height for the second bottles (targeting peak flows) was increased from the first event for all subsequent events. Both bottles and the Hobo water level loggers were attached to a section of PVC pipe which was then placed over a waratah that had previously been driven into the stream bed. This enabled the bottles to be quickly installed and safely removed even during high flows as the pipe could be reached from the bank eliminating the need to enter the water.

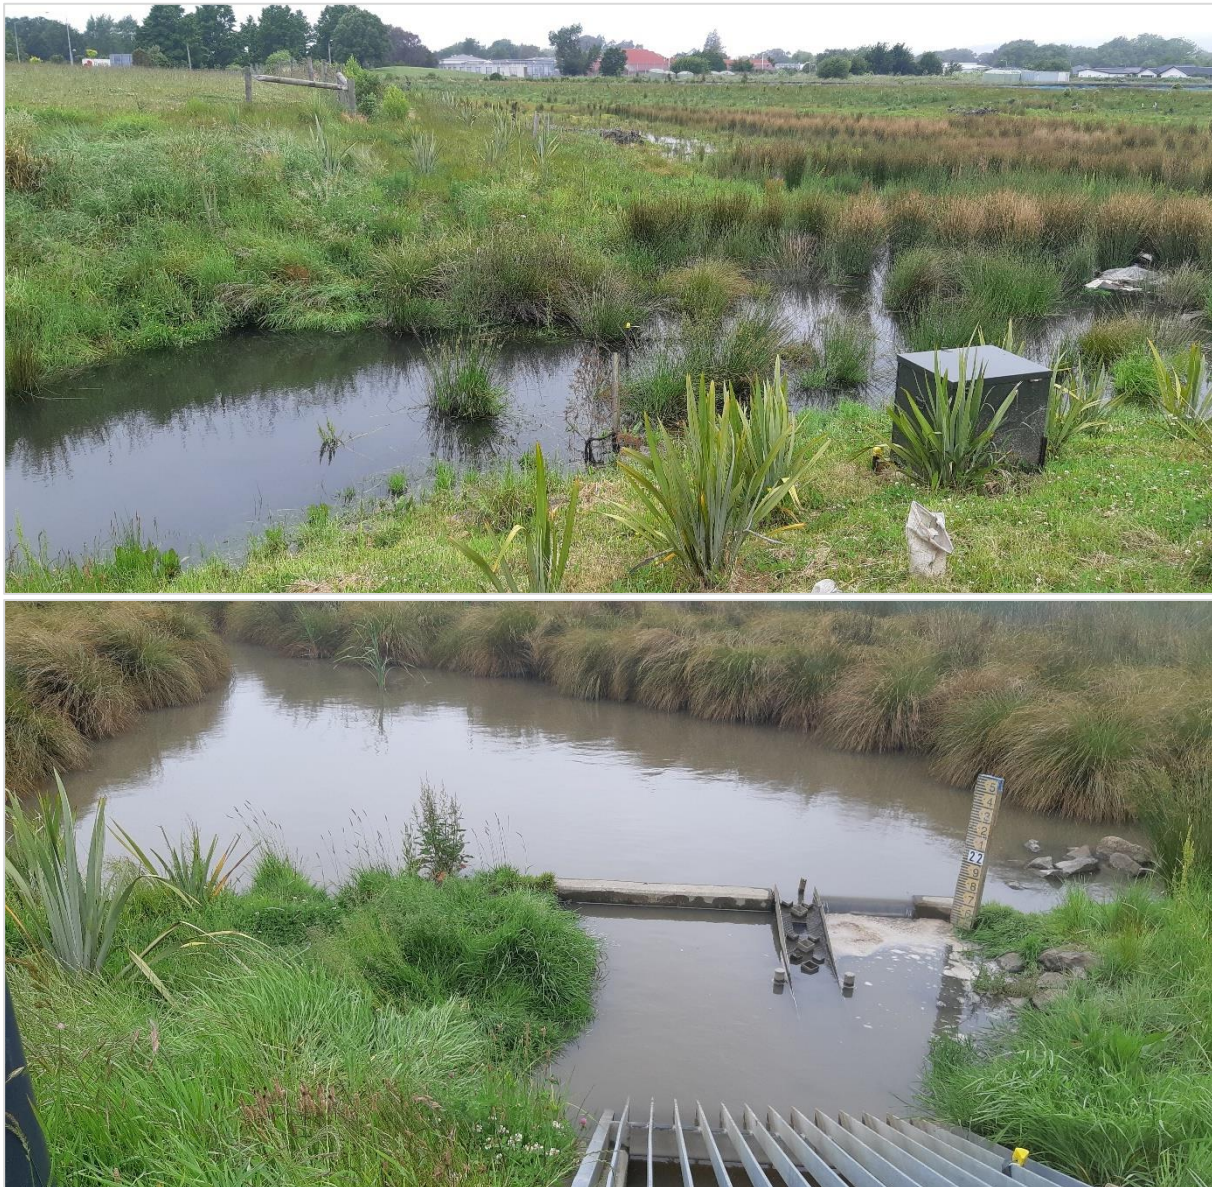
**Figure 3-5: Curlett wetland inlet (top) and outlet (bottom).** Photos taken 28 November 2021 (the day after Event 4). Note water is more turbid at the outlet than the inlet.

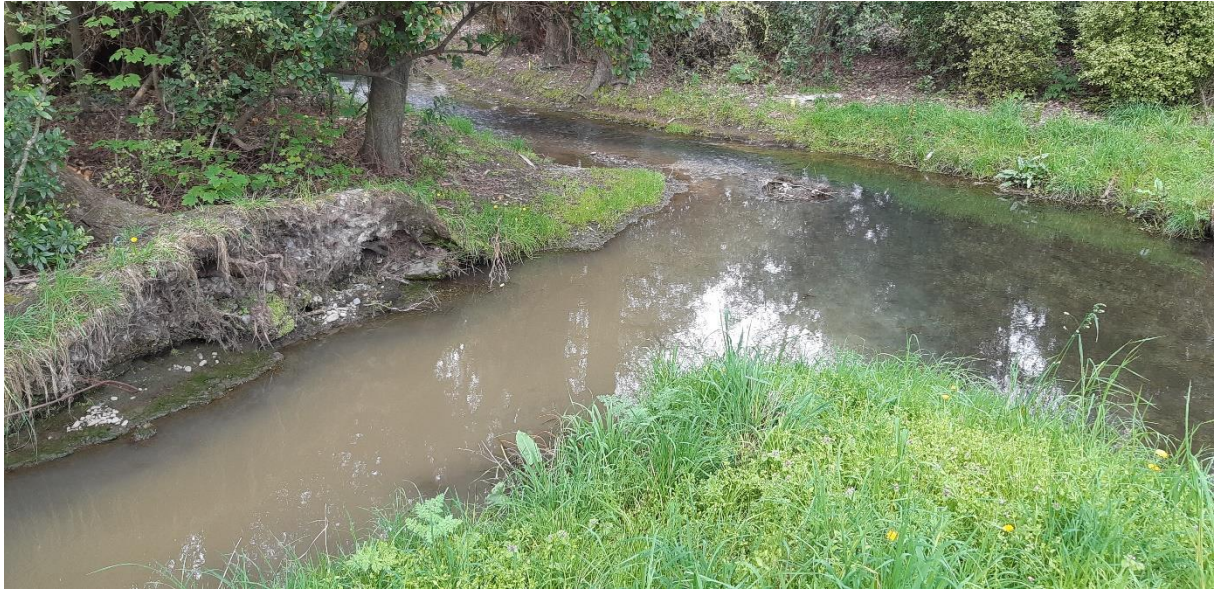
**Figure 3-6: Sediment-laden Curlett Stream at confluence with Ōpāwaho/Heathcote River on 23 September 2021.** Photo taken during dry weather conditions, prior to event 3. HRAuto2 site is approximately 400 m downstream of this confluence (to the left of the photo).

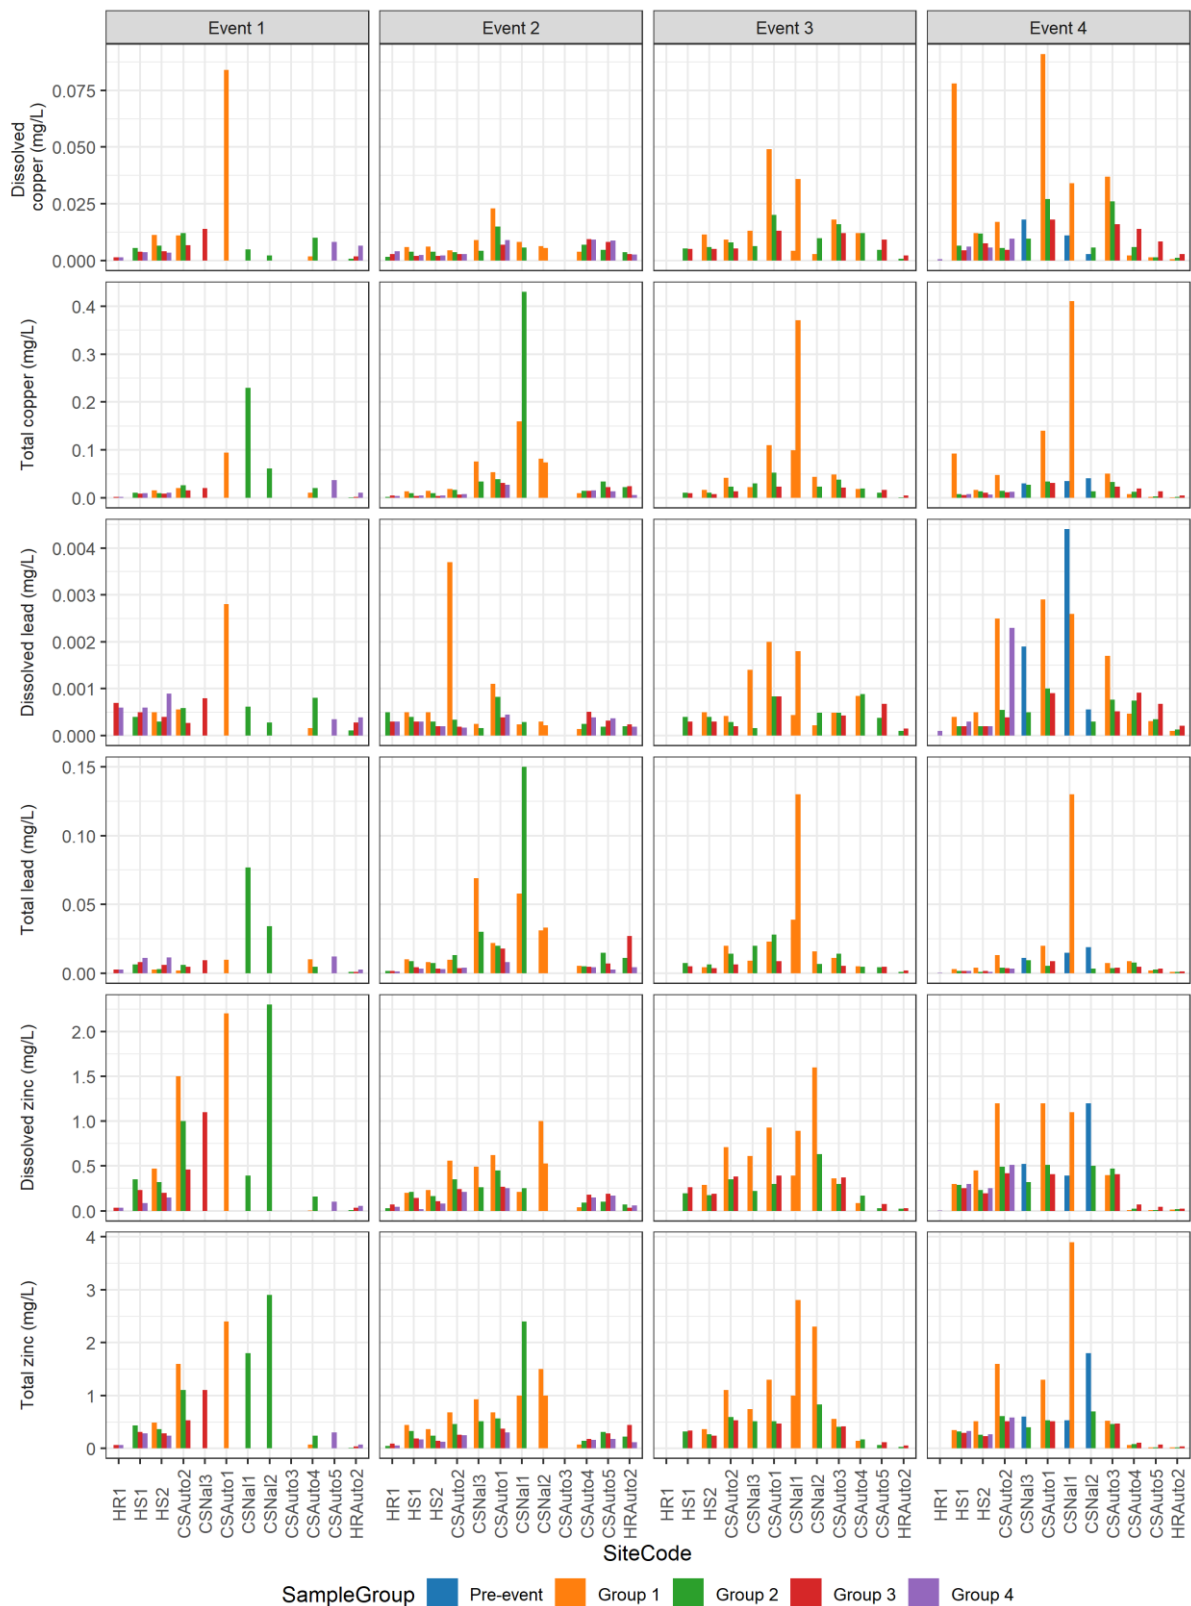
**Figure 3-8: Copper, lead and zinc concentrations for each site, each event and sample group.** Colour of bar represents the sample group (i.e., the composite group made of multiple samples collected by the autosampler). Reduction in height of bar from group 1 to 4 represents a declining concentration, i.e., a first-flush effect.

The presence of a first-flush for the metals was investigated by plotting the samples collected at each site in order of collection (Figure 3-8). A first flush pollution effect was visible at most sites (except for CSAuto4 and downstream sites) with the first composite sample being on average 1.4 to 1.7 higher than the second sample, and as high as 12 times higher at HS1 (Event 4 for DCu). This phenomenon was particularly visible at CSNa3, CSAuto2, CSAuto1 and CSNa2 (for Cu, Zn, Pb; Figure 3-8). The combined effect of the hydrological buffer provided by the Curlett wetland and dilution in Ōpāwaho/Heathcote River most probably diminished this phenomenon for sites CSAuto4 to HRAuto2.

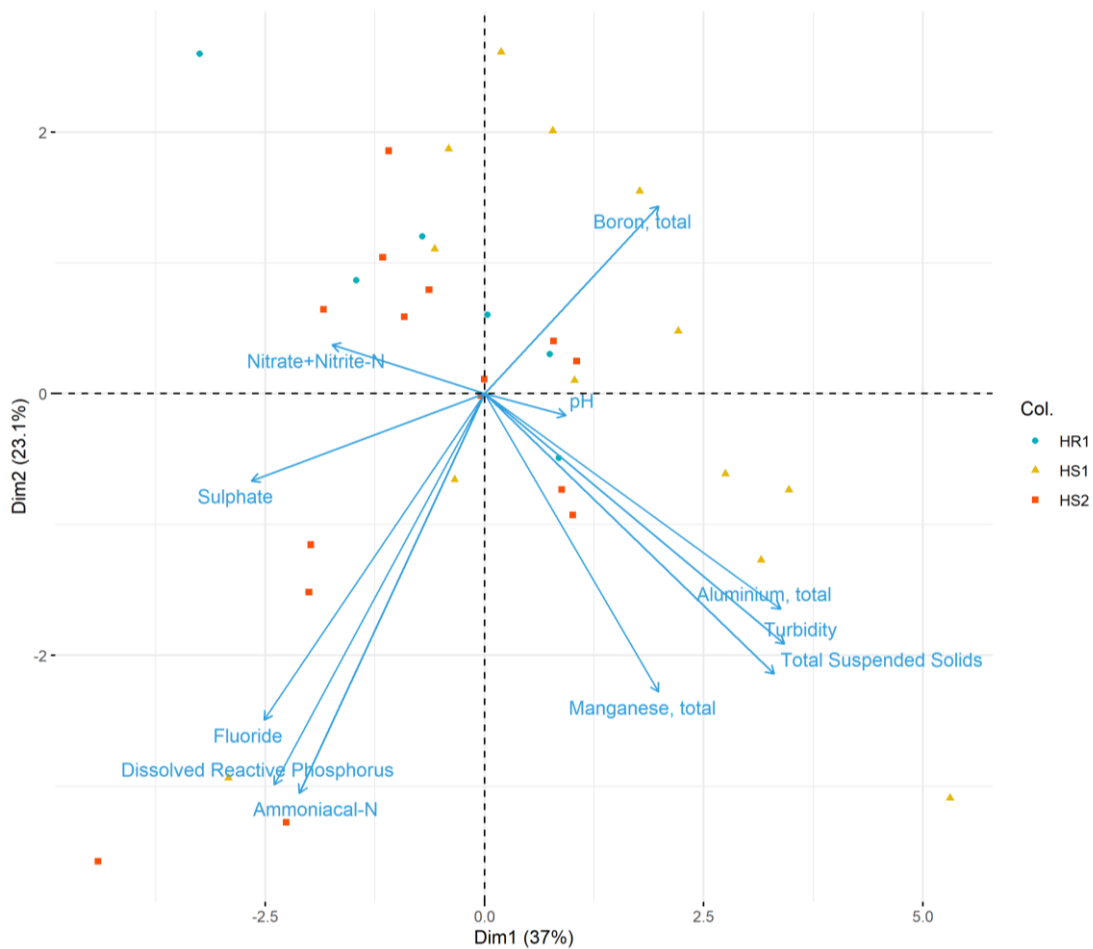
**Figure 3-14: Principal component analysis (PCA) of nutrients and fertiliser indicators at sampling sites in Haytons Stream (sites HS1 and HS2) and upstream in Ōpāwaho/Heathcote River (site HR1).** Different sites are indicated by different coloured key. Most samples from HR1 are grouped near top of plot, HS1 to the right and samples from HS2 are scattered around, showing there are not clear differences between the sites in terms of these water quality parameters. Arrows indicate how strongly each water quality parameter influences each principal component. Fluoride, DRP and ammoniacal-N are positively correlated, and negatively correlated to boron. Samples associated with higher DRP, ammoniacal-N and fluoride are mostly found at HS2 but sometimes at HS1.
