Mahaanui Kurataiao Ltd

Pūharakekenui Cultural Monitoring Report

October 2023

This report details monitoring undertaken to assess mana whenua values in the Pūharakekenui catchment as required under the conditions of the Comprehensive Stormwater Network Discharge Consent (CSNDC; CRC231955) held by Christchurch City Council (CCC).

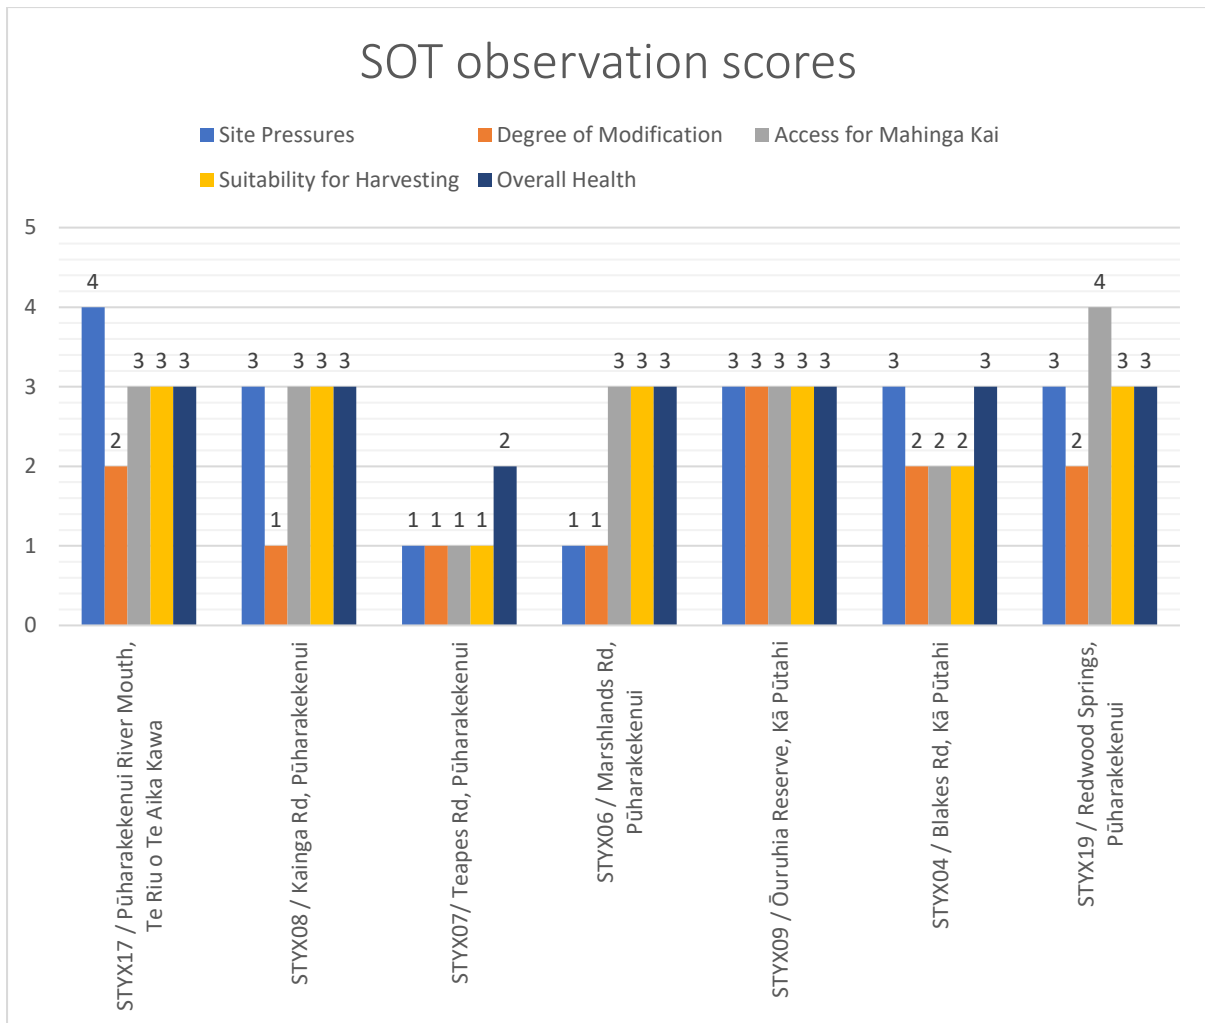
Figure 3. The scores for each category in the SOT for each surveyed site.

Most of the scores ranged from 1 (poor values) to 3 (moderate values) for each category and site. The lowest scores were recorded at STYX08 / Kainga Road, Pūharakekenui, STYX07 / Teapes Road, Pūharakekenui and STYX06 / Marshland Road, Pūharakekenui, particularly for degree of modification and site pressures. At STYX08 / Kainga Road, Pūharakekenui, recorded observations for degree of modification included the drainage of the wetlands, the flood/tidal gates and the bridge/road. At STYX07 / Teapes Road, Pūharakekenui, every category except overall health scored a 1. Reasons for the scoring include: the surrounding farms creating site pressure, modification of the site through drainage of the wetlands, the bridge, straightening of the channel and earthquake repairs, and limited access for harvesting mahinga kai due to the river being fully fenced off and surrounded by farms. At STYX06 / Marshland Road, Pūharakekenui, recorded site pressures included the main road and bridge, heavy traffic and the urban area. Recorded observations for the degree of modification at this site included the bridge, rebattering of banks, and straightening for the river channel.

Scores of 4 (high value) were recorded for site pressure at STYX17 / Pūharakekenui River Mouth, Te Riu o Te Aika Kawa and for access for mahinga kai at STYX19 / Redwoods Springs, Pūharakekenui. Boating was the main site pressure noted at STYX17 / Pūharakekenui River Mouth, Te Riu o Te Aika Kawa. Access for mahinga kai at STYX19 / Redwoods Springs, Pūharakekenui was considered good due to the public reserve at the site. Further recorded observations are detailed in Section 4.2 as part of the CHA.

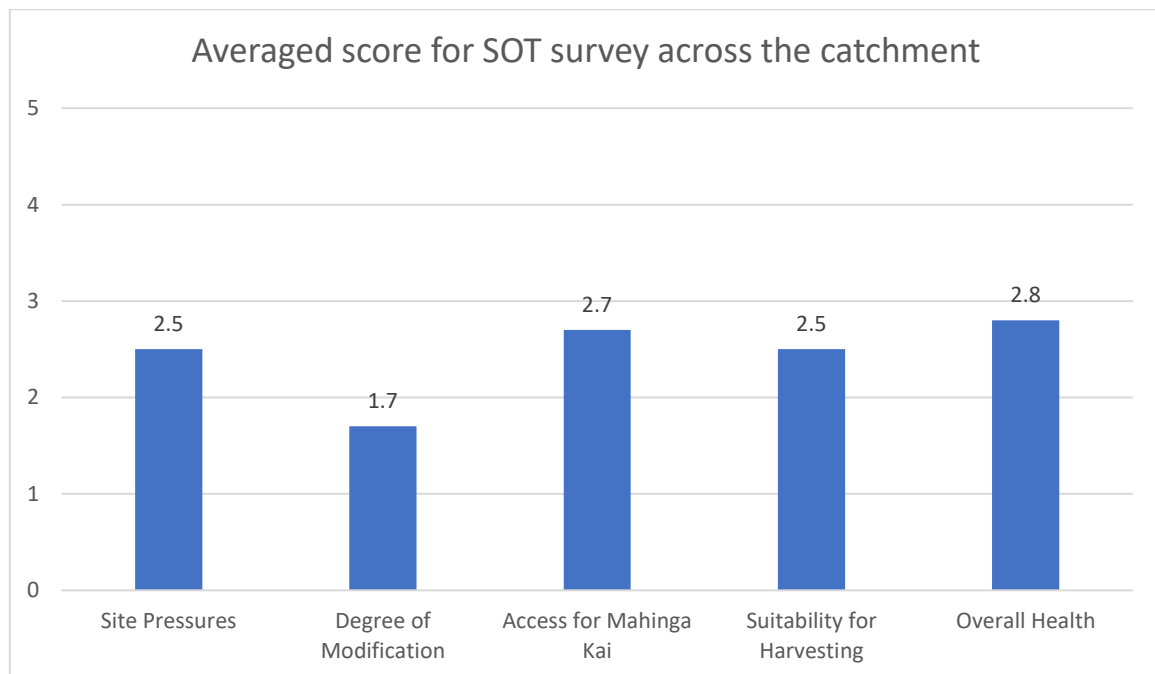
Figure 4 below shows the average score from all sites for each category. These numbers illustrate the score at the catchment level, including the overall health score. The average scores for the catchment are all under 3 (moderate values), with the lowest score for degree of modification (1.7 – low value).

Figure 4. The averaged scores for the SOT survey for each category across the catchment.

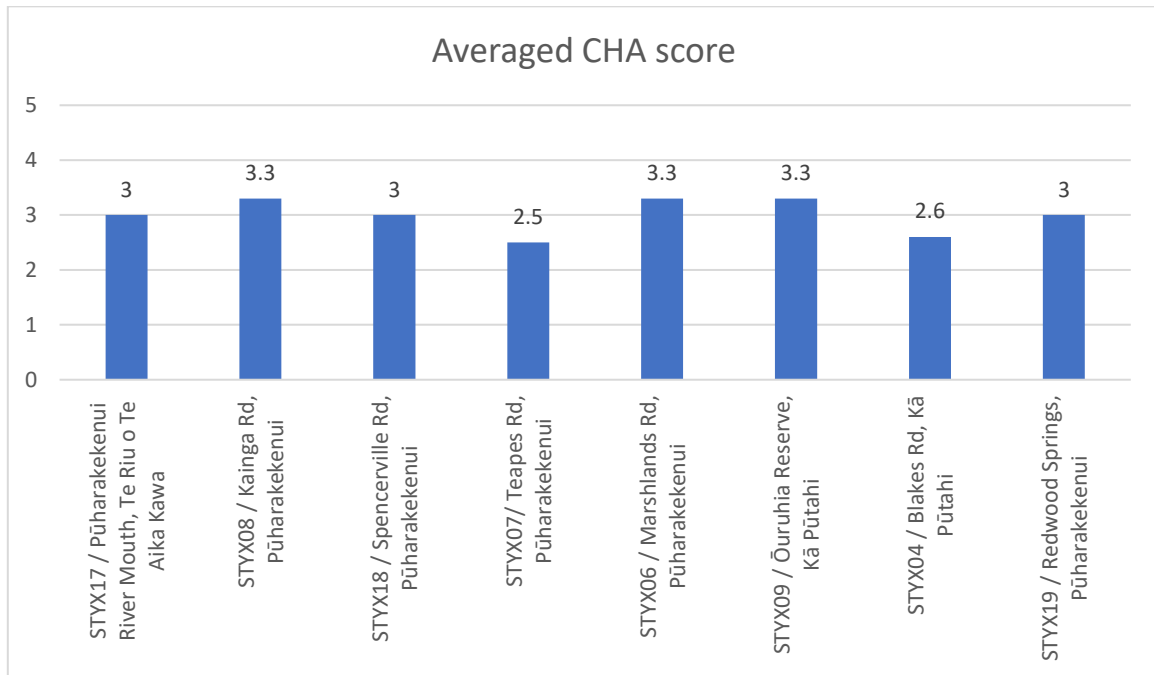
(Figure 5). The overall results show a trend of scores around 2 (poor values) and 3 (moderate values).

Figure 5. The averaged CHA score for overall health across the catchment.

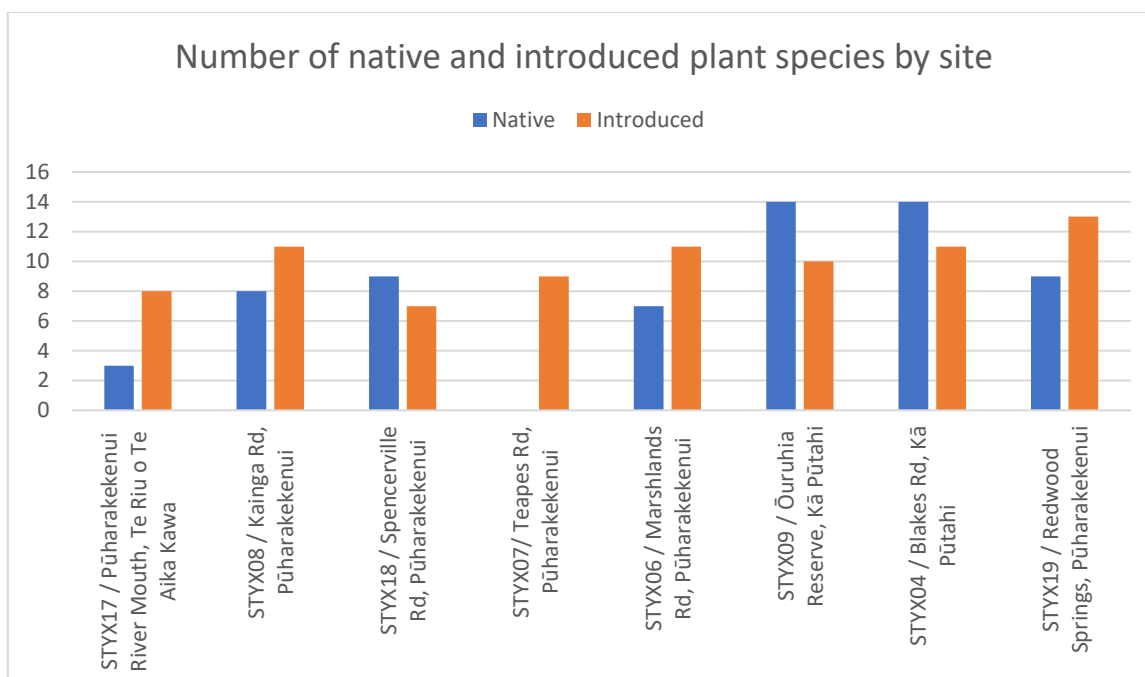
The full list of observed species can be found in Appendix B. Figure 6 below shows the numbers of native and introduced plant species observed and identified during the survey by site. Across the catchment, 45% of the recorded vegetation is native and 55% is introduced.

Figure 6. The numbers of identified native and introduced plants species by site recorded in the vegetation survey.

The number of introduced plant species recorded was high across the catchment with percentage cover ranging from 40% to 70%. At site STYX07 / Teapes Road, Pūharakekenui the percentage was 100% introduced species. Recorded species included willow (including dead trees), gorse, oxygen weed, pine, macrocarpa, poplar, old mans beard, monkey musk, blackberry, grasses and weeds. Comments recorded by the monitors included a specific mention of the old mans beard overgrowth at STYX08 / Kainga Road, Pūharakekenui; blackberry at STYX09 / Ōuruhia Reserve, Kā Pūtahi; and swamp willow and celery at STYX04 / Blakes Road, Kā Pūtahi.

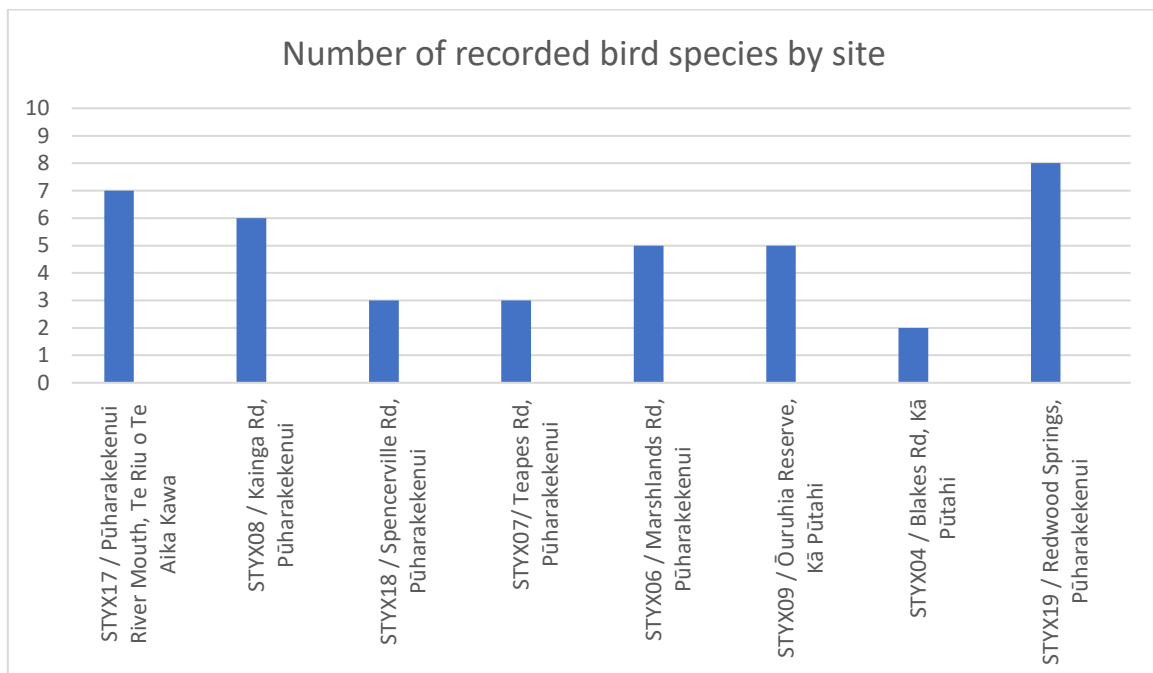
Figure 7 below shows the number of observed species of bird by site. The highest number of bird species was recorded at STYX19 / Redwood Springs, Pūharakekenui with a total of eight. Species recorded here included pūtangitangi, pūkeko, pīwaiwaka, kakīānau (black swan), unidentified geese, unidentified ducks, manu pango (blackbird) and swallow. These species were some of the most common species recorded across the catchment, with the only common species not recorded at STYX19 being sparrow. The next highest was at STYX17 / Pūharakekenui River Mouth, Te Riu o Te Aika Kawa with a total of seven recorded species. The coastal location of this site meant that there were records of different, more coastal dwelling species such as unidentified seagulls, tōrea (oystercatcher) and shag. Low numbers of bird species were recorded at STYX18 / Spencerville Road, Pūharakekenui, STYX07 / Teapes Rd, and Pūharakekenui and STYX04 / Blakes Road, Kā Pūtahi.

Figure 7. Numbers of bird species recorded at each site.

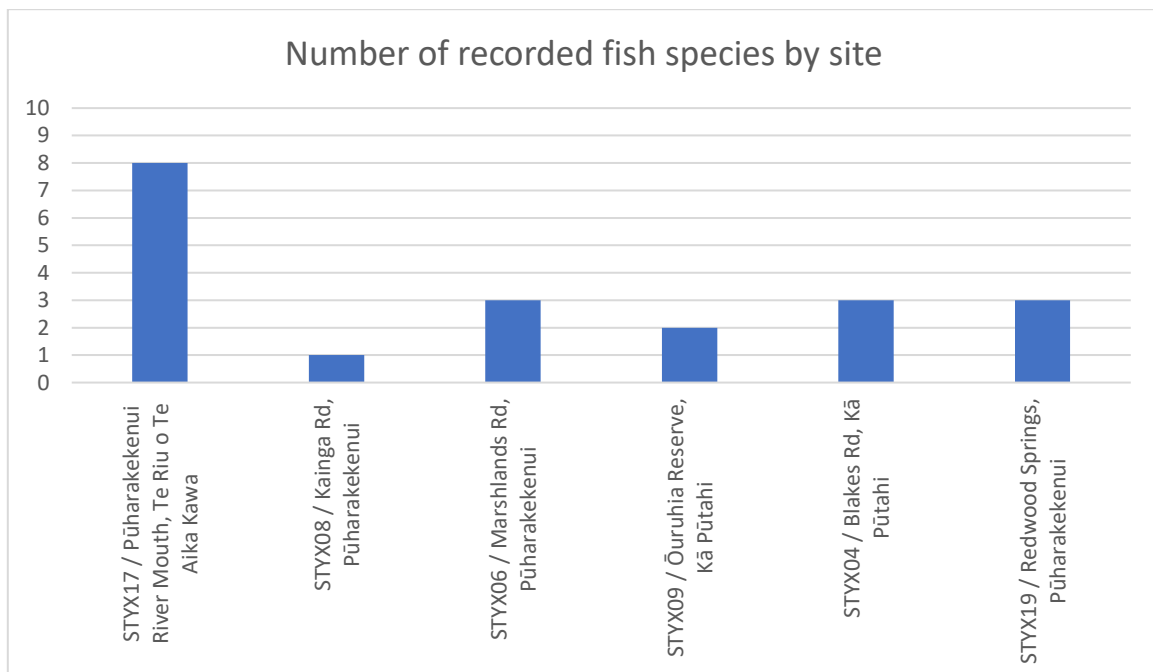
No species were recorded at STYX18 due to the destruction of the nets in place, although unidentified trout species were observed during the CHA monitoring. No species were recorded at STYX07 as the depth of the river was unsafe to enter and set nets, but an unidentified trout was observed during the monitoring for the CHA. Monitors also noted observations of kākahi at the same location (abundance was not recorded). These have not been included in the results below as they did not constitute part of the fish survey (Figure 8).

Figure 8. Numbers of fish species recorded at each site.

The site at Pūharakekenui River Mouth, Te Riu o Te Aika Kawa (STYX17) recorded the highest number of fish species (eight). The location of this site on the coast and at the mouth of the river is a factor in the range of species found here, as species such as tunnelling mud

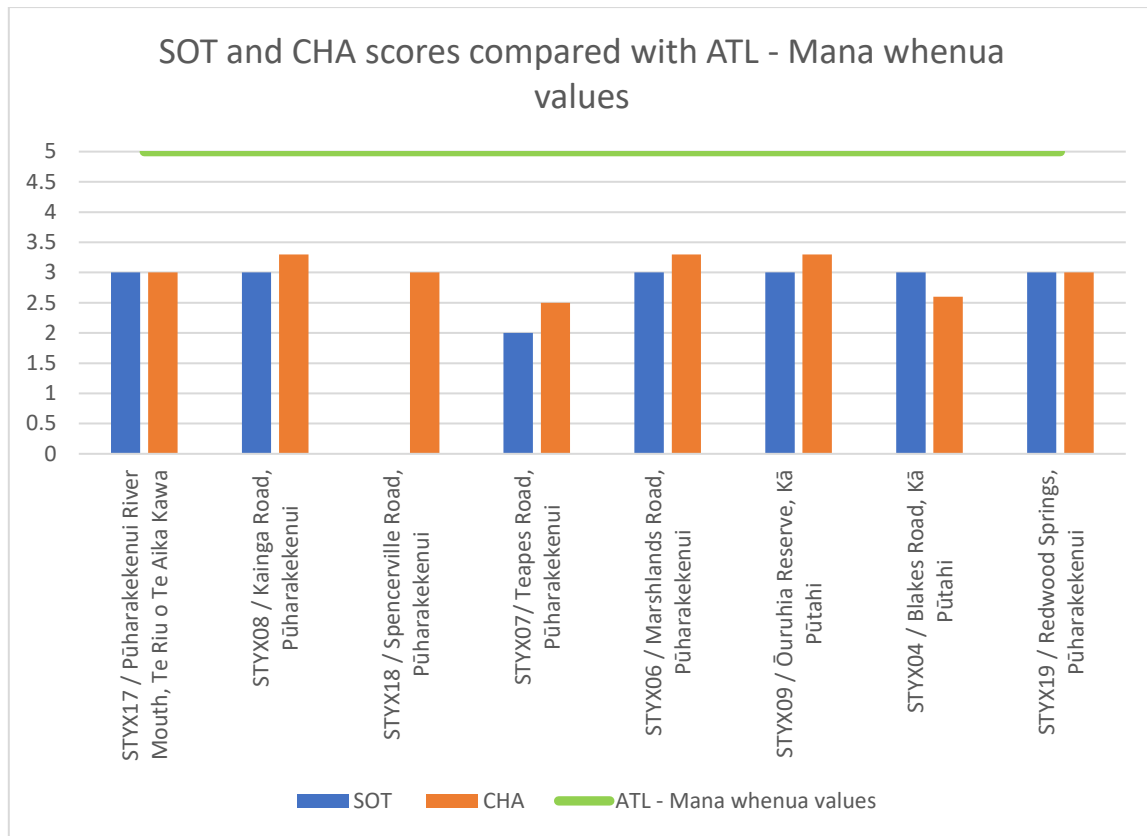
For the Pūharakekenui catchment, the average score of overall health from the SOT survey of the monitored sites (excluding STYX18 / Spencerville Road, Pūharakekenui) was 2.8. The average score from the Cultural Health Assessment survey (based on the score for overall health) for all sites was 3. These scores do not meet the set target level of 5 (Figure 9). This score demonstrates that there is still significant work to be done to improve the cultural health of sites in the catchment, as well as the catchment overall.

Figure 9. The SOT and CHA scores for overall health by site in comparison to the attribute target level for mana whenua monitoring as per Condition 54 of the CSNDC.

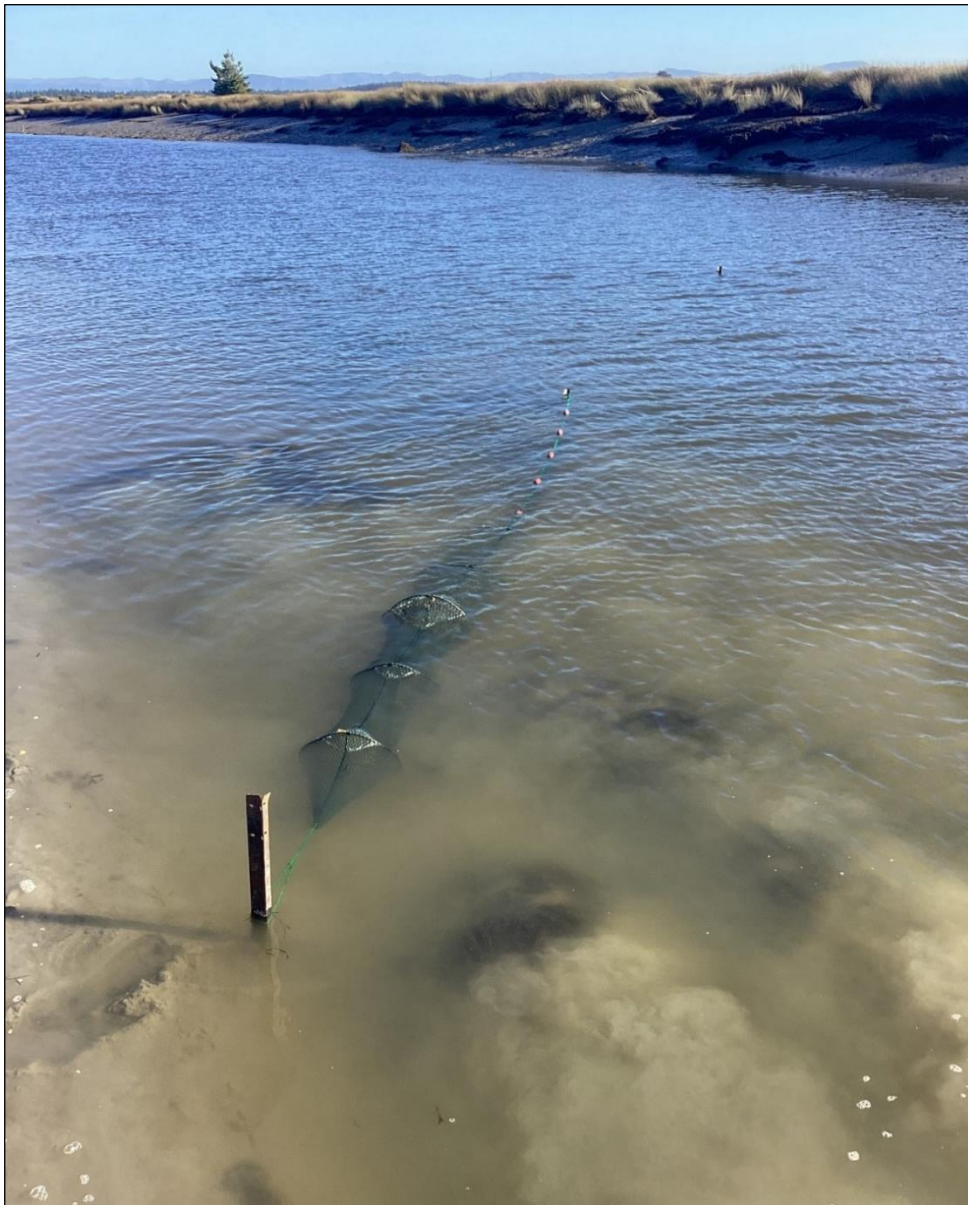
The SOT scores for STYX17 / Pūharakekenui River Mouth, Te Riu o Te Aika Kawa were 4 (high values) for site pressures, 2 (poor values) for degree of modification and 3 (moderate values) for all other categories. The overall health for the site as recorded in the CHA monitoring was 3 (moderate values). Scores across the CHA categories were largely under at or below this score, with a higher score of 4.6 (high values) for no barriers and fish passage, and a score of 5 for safe access. Many of the results for STYX17 / Pūharakekenui River Mouth,

Te Riu o Te Aika Kawa reflect the different coastal environment of the site (Figure 10). This includes high levels for electrical conductivity, thicker deposits and lower recorded clarity in the SHMAK records. There were high numbers and abundance of fish and bird species with many coastal-dwelling types recorded. However, there were low numbers of native vegetation, with higher numbers of introduced plant species indicating further work for restoration of indigenous biodiversity at this site. Monitors commented on the presence of boats and jet skis as concerns specific to the site. Identified issues of concern shared with other sites included: discharge from industries (specifically Belfast Freezing Works) and rubbish. Actions to restore mahinga kai include: riparian planting/restoration of native plant species, controlling discharge, improve water quality, rubbish bins.

Figure 10. Looking northwest at the hīnaki placed during monitoring at STYX17 / Pūharakekenui River Mouth, Te Riu o Te Aika Kawa.

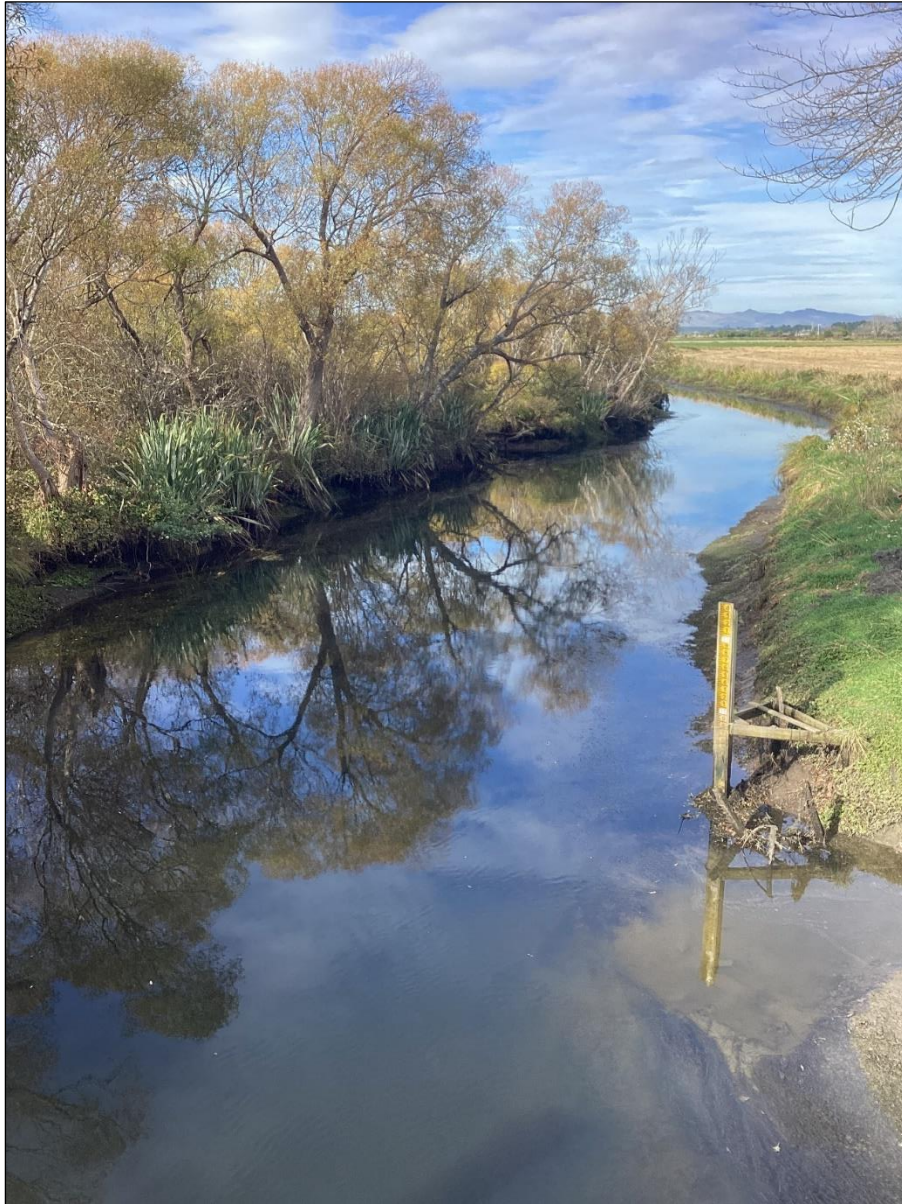
The SOT scores for STYX08 / Kainga Road, Pūharakekenui were consistent at 3 (moderate values) for most categories. A low score of 1 for degree of modification is due to the drainage of the wetlands, the flood/tidal gates and the bridge/road. The overall health for the site as recorded in the CHA monitoring was 3.3 (moderate values). Scores across the CHA categories were largely under at or below this score, with a higher score of 4 (high values) for riverbank vegetation and a score of 4.3 (high values) for in-stream habitats. *E. coli* levels were elevated but not above the guideline limit level. The number of native plant species was mid-range but there was a higher number of introduced species (Figure 11). Only one fish species was

observed at the site. The site had the third highest number of bird species recorded. Identified concerns specific to the site include a lack of flow when the floodgates are closed and dead willows. Identified issues of concern shared with other sites included: cows close to the river/effluent runoff from stock, rubbish, no or minimal birds, and direct stormwater discharge to river. Actions to restore mahinga kai include: riparian planting/restoration of native plant species, rubbish bins, controlling discharge and improving water quality.

Figure 11. Looking upstream at STYX08 / Kainga Road, Pūharakekenui.

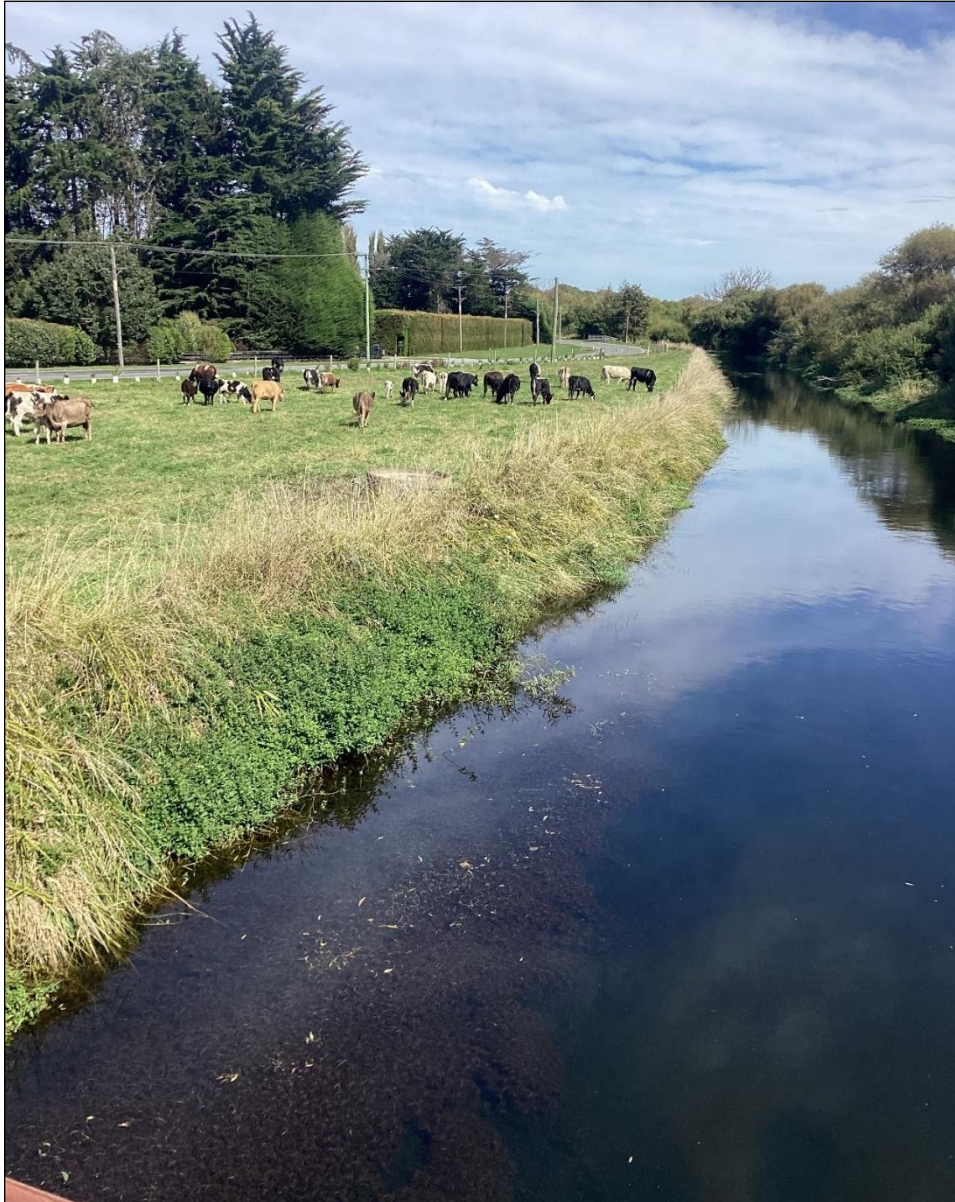
The SOT scores for STYX07/ Teapes Road, Pūharakekenui were very low across all categories, with ratings of 1 and 2 (poor values). The average overall health score of 2.5 (poor to moderate values) was recorded for the CHA monitoring. Scores across other CHA categories were at or under this rating, apart from the slightly higher score of 2.6 (poor to moderate values) for in-stream habitats, a score of 3.3 (moderate values) for barriers and 4 (high values) for fish passage. The depth of the river at this site prevented some recording methods being undertaken. No native plant species were recorded, and there was a low number of bird species. The greatest issue of concern noted by monitors is that the site was heavily farmed on all sides with cows next to the water and that there was no native riparian planting to act as a filter for the effluent runoff from the livestock (Figure 12). There were also concerns about runoff of fertilisers from crops planted close to the river (Figure 13). Other identified issues of concern shared with other sites included: fencing for stock too close to the river, land use related runoff (e.g., fertilisers), minimal access, weeds and plant overgrowth, sediment and silt (including as result of earthquakes) and generally insufficient riparian and/or native planting. It was noted that monitors had heard that the land use, runoff and nitrates going into the water was “killing off the ecosystem of the river here”. At the time of recording one of the monitors noted that the water looked “polluted”. These issues were significant enough that the monitors recorded that they would not use this site. The monitors noted that

trout and kākahi were observed in the river. No native plants were recorded from this site and minimal birds were recorded. Actions to restore mahinga kai include: riparian planting with native plant species, ensuring stock fencing and farming activities are further away from the river (i.e., increasing the buffer) and improving access.

Figure 12. Looking upstream at the river and riverbank, showing the lack of buffer between livestock and the river.

- Mahinga kai sites should be developed throughout the catchment in conjunction with mana whenua.
- The location of stock fencing, buffers and riparian margins should be consistent with recommended waterway setbacks in the Mahaanui Iwi Management Plan 2013 (refer **WM12.5**).

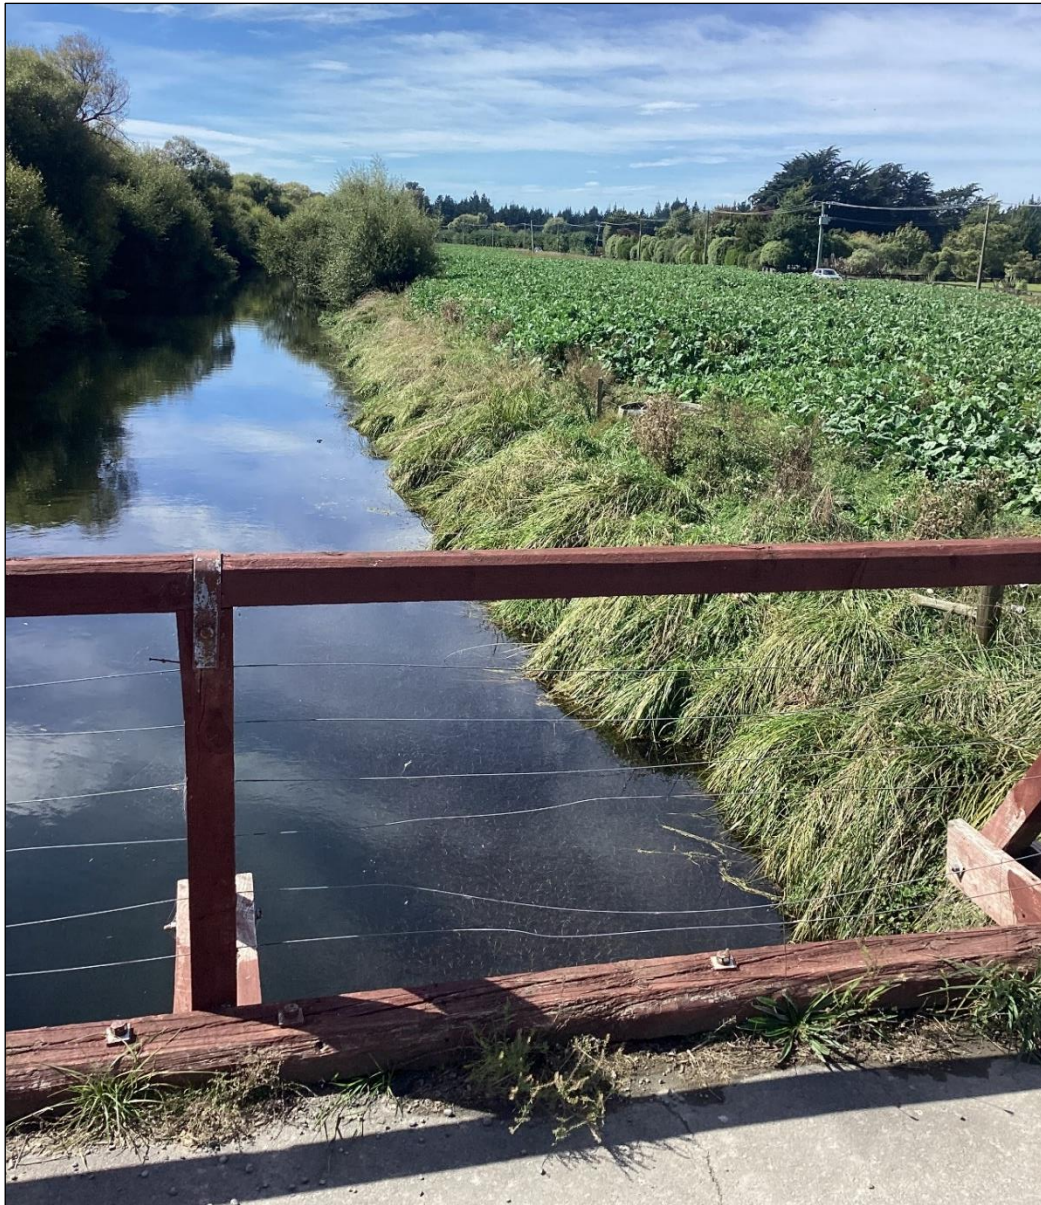
Figure 13. Looking downstream at the river and riverbank, showing the lack of buffer between crops and the river.

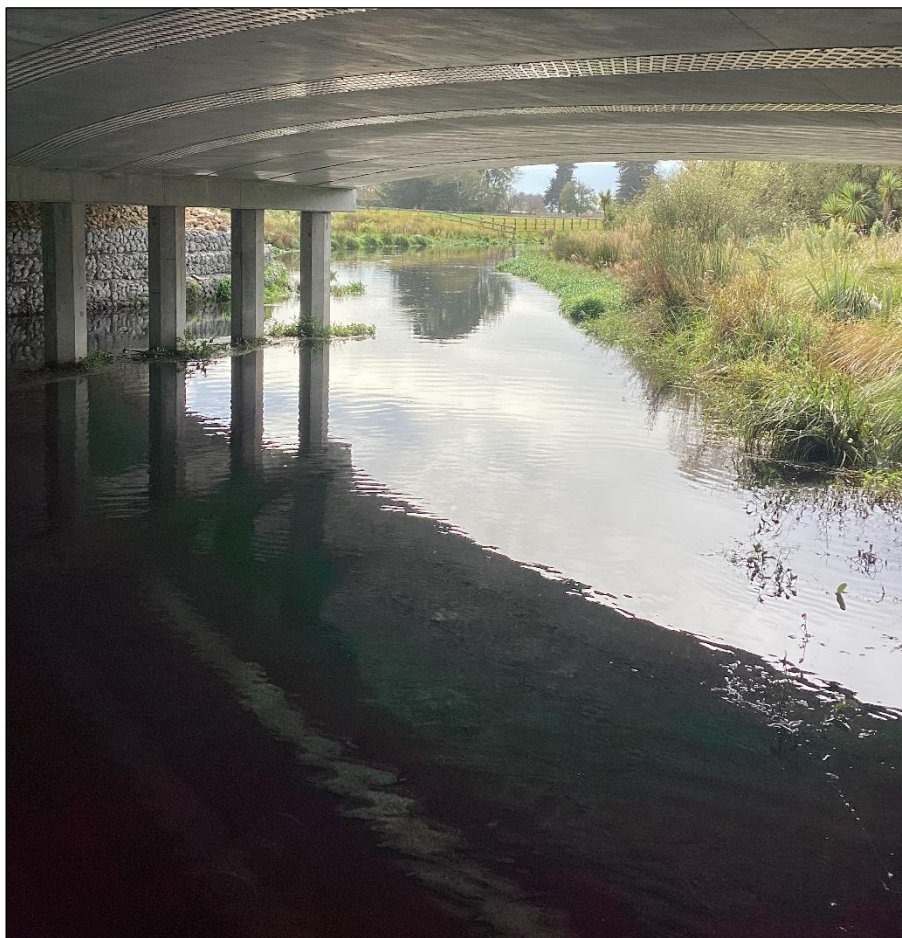
The SOT scores for STYX06 / Marshlands Road, Pūharakekenui ranged from 1 (poor values) for site pressures and degree of modification, to 3 (moderate values) for the remaining categories. The overall health for the site as recorded in the CHA monitoring was 3.3 (moderate values). Scores across the CHA categories were largely at or under this score, with a higher score of 3.6 (moderate to high values) for water quality and safe access, and 4.6 (high values) for fish passage. *E. coli* rates were above safe guidelines for swimming, but not over the limit value under the Canterbury LWRP. Recorded vegetation comprised native and introduced plant species, but there was a higher number of introduced plant species. Number

of fish species recorded was low but on par with two other sites. Bird numbers were roughly mid-range. Identified issues of concern shared with other sites included: discharge from industries (specifically Belfast Freezing Works), minimal access, no or minimal birds and insufficient riparian planting (native). Also noted for this site was concern for runoff from the road. Monitors noted that the riparian zone was well planted and established on the southern end but not yet established on northern end (Figure 14). The water quality was described as “nice and clear” at confluence with Kā Pūtahi. The Pā harakeke on site was also noted with the harakeke described as “beautiful”. Actions to restore mahinga kai include: riparian planting with native plant species, improved access and protection from road runoff.

Figure 14. Looking downstream at STYX06 / Marshlands Road, Pūharakekenui.

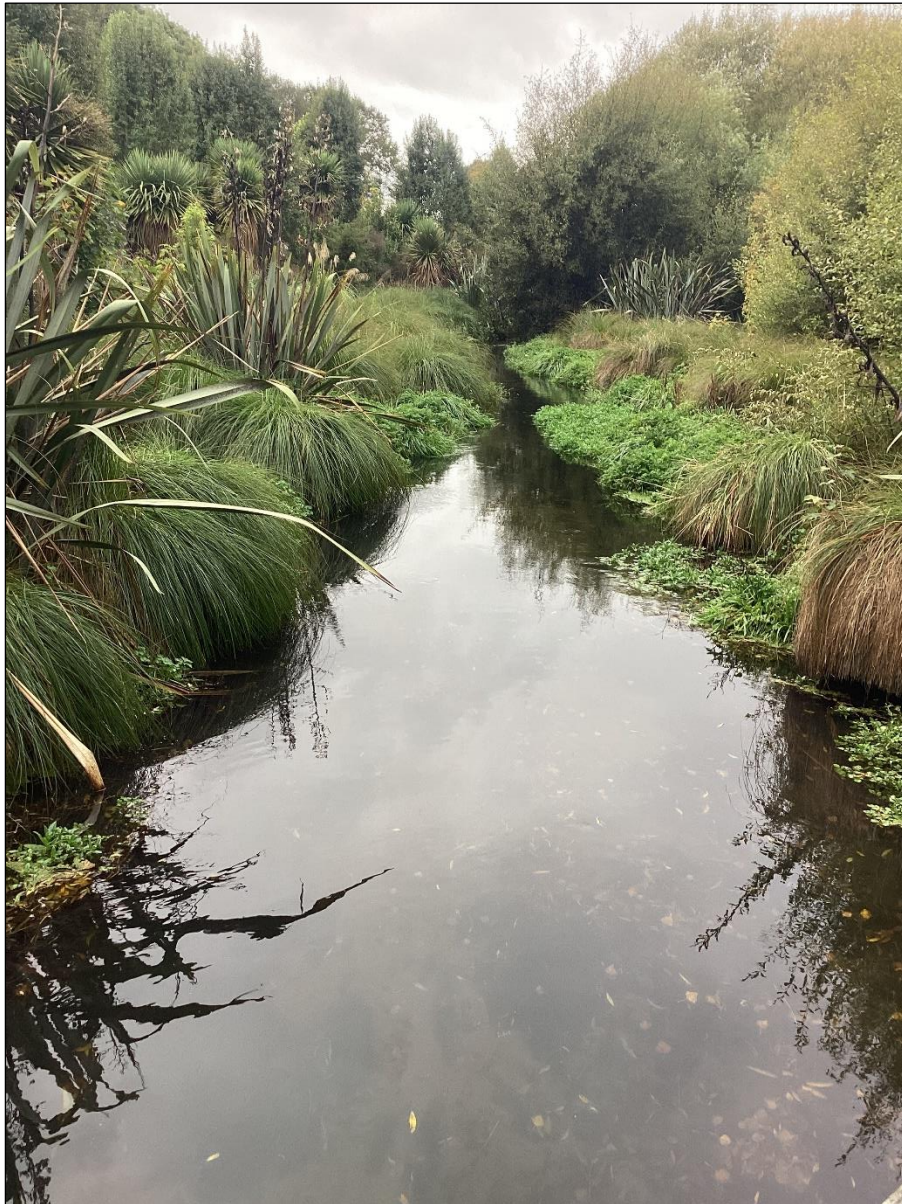
Council (2023) long-term monitoring sites upstream and downstream of the site. The reported long-term median *E. coli* value upstream of this site is below the 550 MPN/100 mL limit. However, the long-term median *E. coli* value at the monitoring site downstream of STYX09 exceeded 1,200 MPN/100 mL. The measured *E. coli* in the present report is below the long-term maximum measured upstream and downstream of the site. Further monitoring of *E. coli* and the investigation of possible sources may be required.

Recorded vegetation comprised high rates of native plant species due to the planted reserve, but also reasonable number of introduced plant species due to private land located alongside the site. Numbers of fish species recorded were low and numbers of bird species were roughly mid-range. Identified issues of concern shared with other sites included: rubbish, minimal access, weeds and plant overgrowth, sediment and silt (including as result of earthquakes), and insufficient riparian planting (native). Monitors noted that the reserve was nice and well planted, but that sediment was of particular concern for this area, as was the untidiness of the paths (Figure 15). Blackberry was noted to be strangling some areas. Actions to restore mahinga kai include: monitoring and maintaining weeds and other plantings, removal of sediment and keeping walkways tidy.

Figure 15. Looking downstream at STYX09 / Ōuruhia Reserve, Kā Pūtahi.

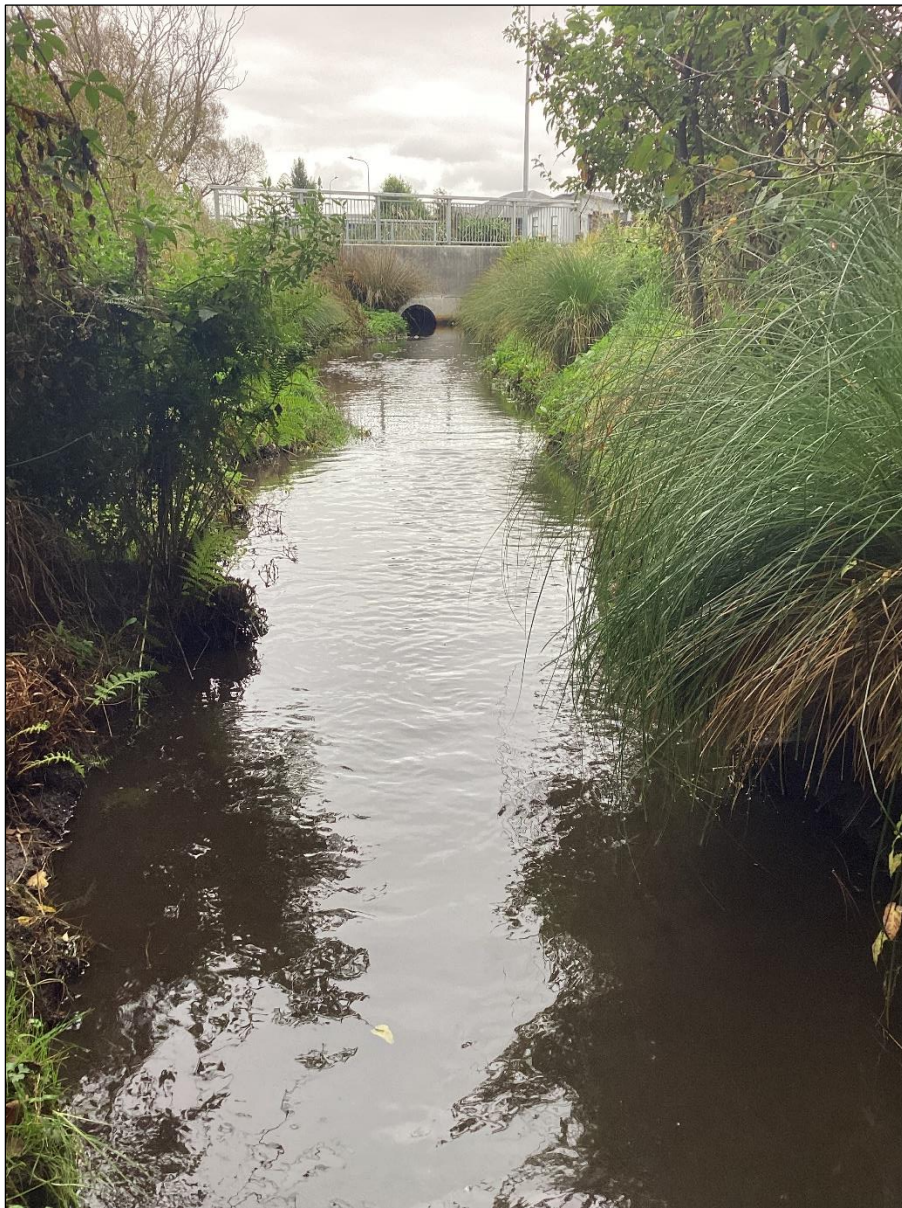
The SOT scores for STYX04 / Blakes Road, Kā Pūtahi were either 2 (poor values) or 3 (moderate values). The overall health score from the CHA monitoring was 2.6 (poor to moderate values). Scores across the other CHA categories were at or below this rating, with a higher score of 3 (moderate values) for habitats and riverbank use/development. Recorded vegetation comprised high rates of native plant species due to the planting associated with the establishment of the recent subdivision, but also a reasonable number of residual introduced plant species due to the former land use as farmland (Figure 16). Numbers of fish species recorded was low but on par with two other sites. Numbers of bird species were the lowest recorded and the reason for this is unclear. Identified issues of concern shared with

other sites included: perceived discharge from industries (specifically noted as Belfast Freezing Works; no specified discharge point was recorded), cows close to river and/or effluent runoff, spraying of grass and weeds, land use related runoff (fertilisers), weeds and plant overgrowth and discharge from construction sites (ongoing as part of the subdivision development). Monitors noted that there was minimal canopy cover and it was particularly concerning that the waterway is overgrown with swamp willow and celery. Actions to restore mahinga kai include: monitoring and maintaining weeds and other plantings, and improved access.

Figure 16. Looking upstream at STYX04 / Blakes Road, Kā Pūtahi.

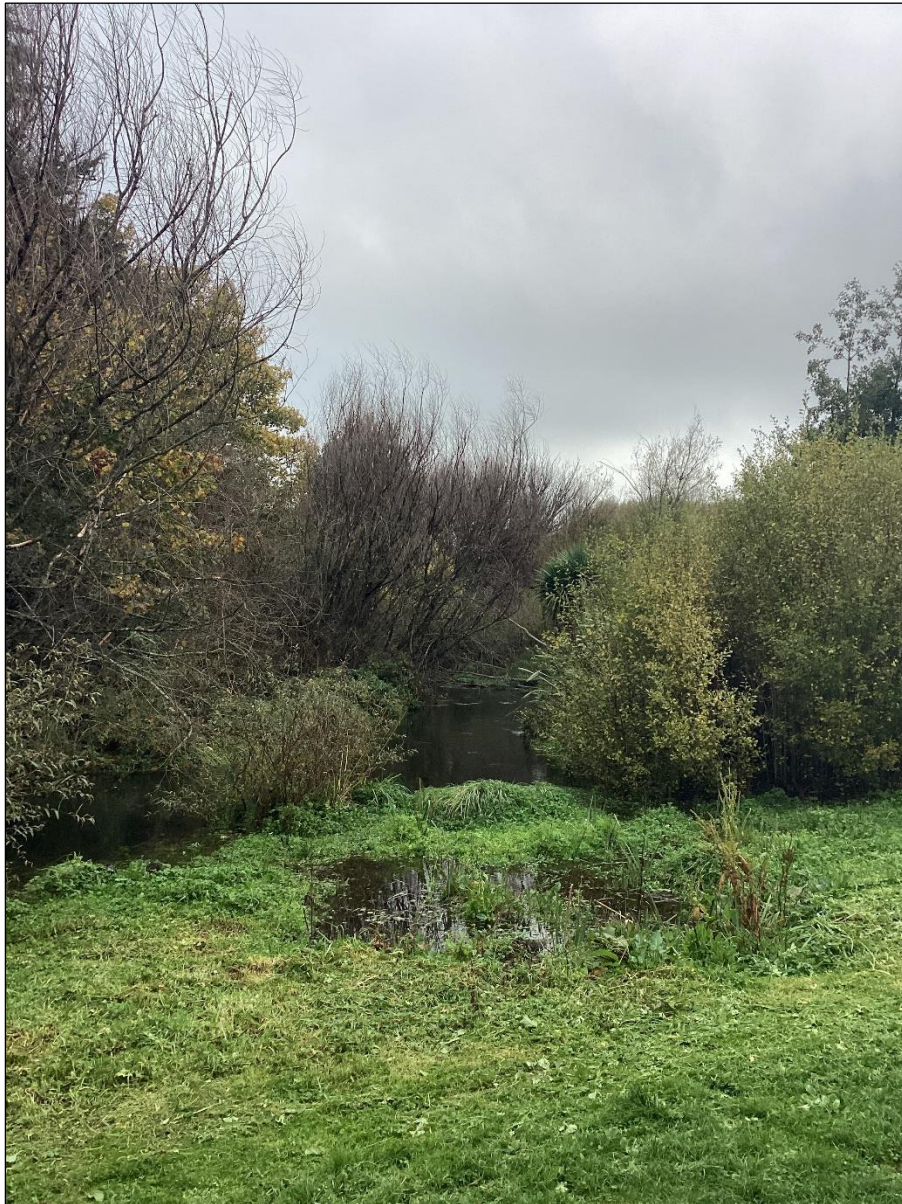
The *E. coli* measured was 816 MPN/100 mL, over the limit value of 550 MPN/100 mL in the LWRP. This value is comparable to the Christchurch City Council (2023) long-term monitoring sites upstream and downstream of the site. The reported long-term median *E. coli* values upstream and downstream of the site are below the 550 MPN/100 mL limit. However, the measured *E. Coli* in the present investigation is below the long-term maximum measured upstream and downstream of the site. Further monitoring of *E. coli* and the investigation of possible sources may be required.

Recorded vegetation comprised mid-range rates of native plant species and higher numbers of introduced plant species, with a lot of exotic grasses and weeds observed in riparian margins, and oxygen weed in the river (Figure 17). The number of fish species recorded was low but on par with two other sites (STYX06 / Marshlands Road, Pūharakekenui and STYX04 / Blakes Road, Kā Pūtahi). The number of bird species was the highest recorded in the catchment. Identified issues of concern shared with other sites included: weeds and plant overgrowth, construction sites (discharge), direct stormwater discharge into river, and insufficient riparian planting (native). Monitors noted an unknown discharge of water 5 m west of the railway bridge as well as potential sediment runoff from the construction site occurring on the north side of the site. Monitors also noted that there was good access to natural springs. Actions to restore mahinga kai include: monitoring and maintaining weeds and other plantings, improved access, and investigation of the source of the discharge near the railway bridge.

Figure 17. Looking downstream at STYX19 / Redwood Springs, Pūharakekenui.

- The source of the discharge observed near the railway at STYX19 / Redwood Springs, Pūharakekenui must be identified and investigated.
- Discharge from construction sites must be regularly monitored for compliance with erosion and sediment control plans and any relevant contamination control plans.
