Annual Monitoring of Cashmere Stream: South-West Christchurch Monitoring Programme 2017

EOS Ecology Report No. CHR01-12025-04 | May 2017

Prepared for
Christchurch City Council

Prepared by EOS Ecology
Alex James

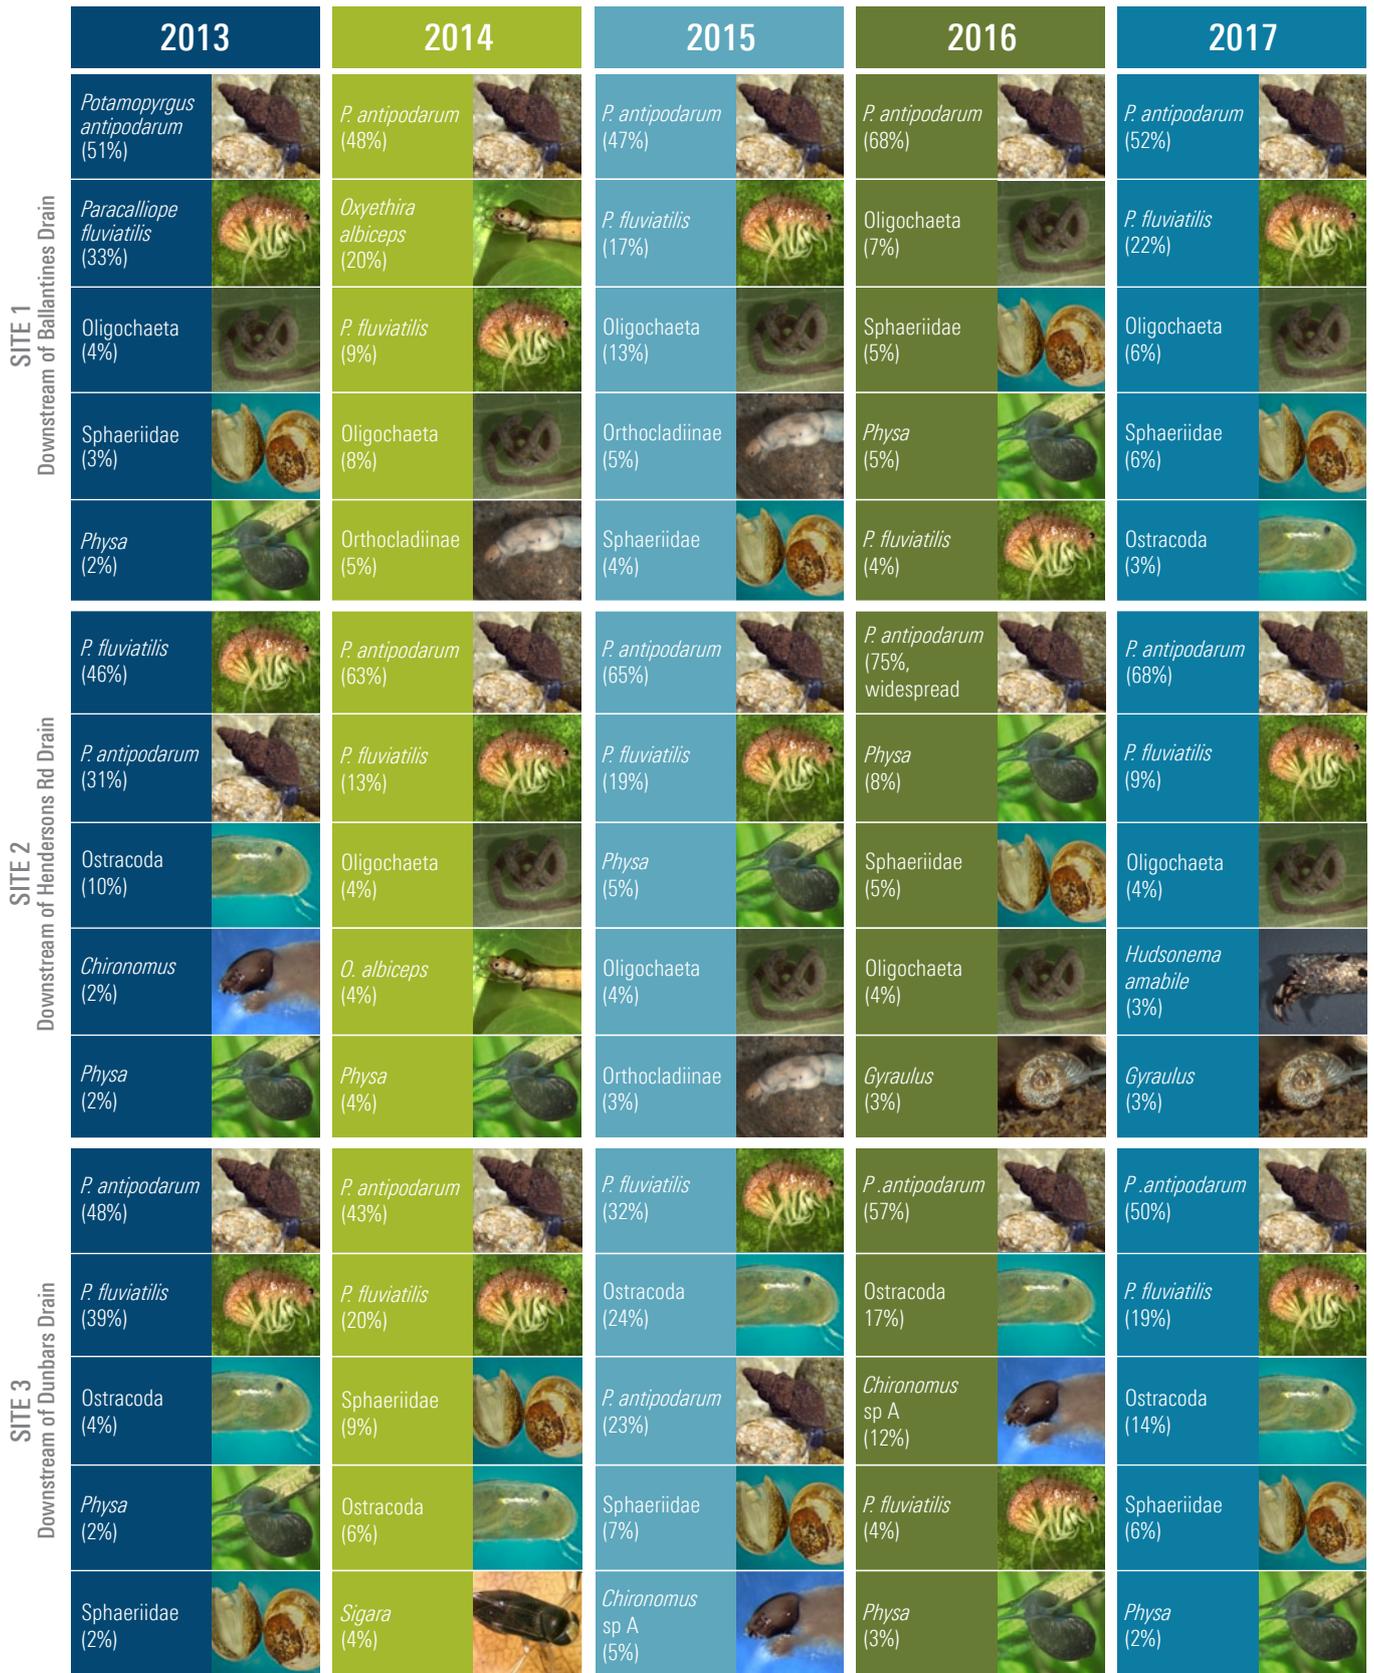
FIGURE 3 Photographs of the five most abundant taxa (% relative abundance per site indicated) from the three monitoring sites for 2013–2017.

In terms of the five most abundant taxa, the communities of all three sites in 2017 were similar and dominated by mostly non-insect taxa that are common in lowland Canterbury waterways (e.g., *P. antipodarum*, *P. fluviatilis*, ostracod crustaceans, oligochaete worms, and Sphaeriidae pea-clams (Figure 3). However, it was notable the cased caddis *H. amabile* appeared among the five most abundant taxa at Site 2; the first time an EPT taxon (with the exception of the pollution-tolerant *O. albiceps*) has done so since the current monitoring scheme began in 2013 (Figure 3).

In terms of the five most abundant taxa, the communities of all three sites in 2017 were similar to previous years with the same core taxa dominating (Figure 3). The snail *P. antipodarum* typically dominated numerically, being the most abundant taxon for 13 of the 15 site/year combinations (Figure 3). The amphipod *Paracalliope* is also often among the top three most abundant taxa at all sites. Ostracods were particularly prevalent at the soft-bottomed Site 3 (Figure 3).

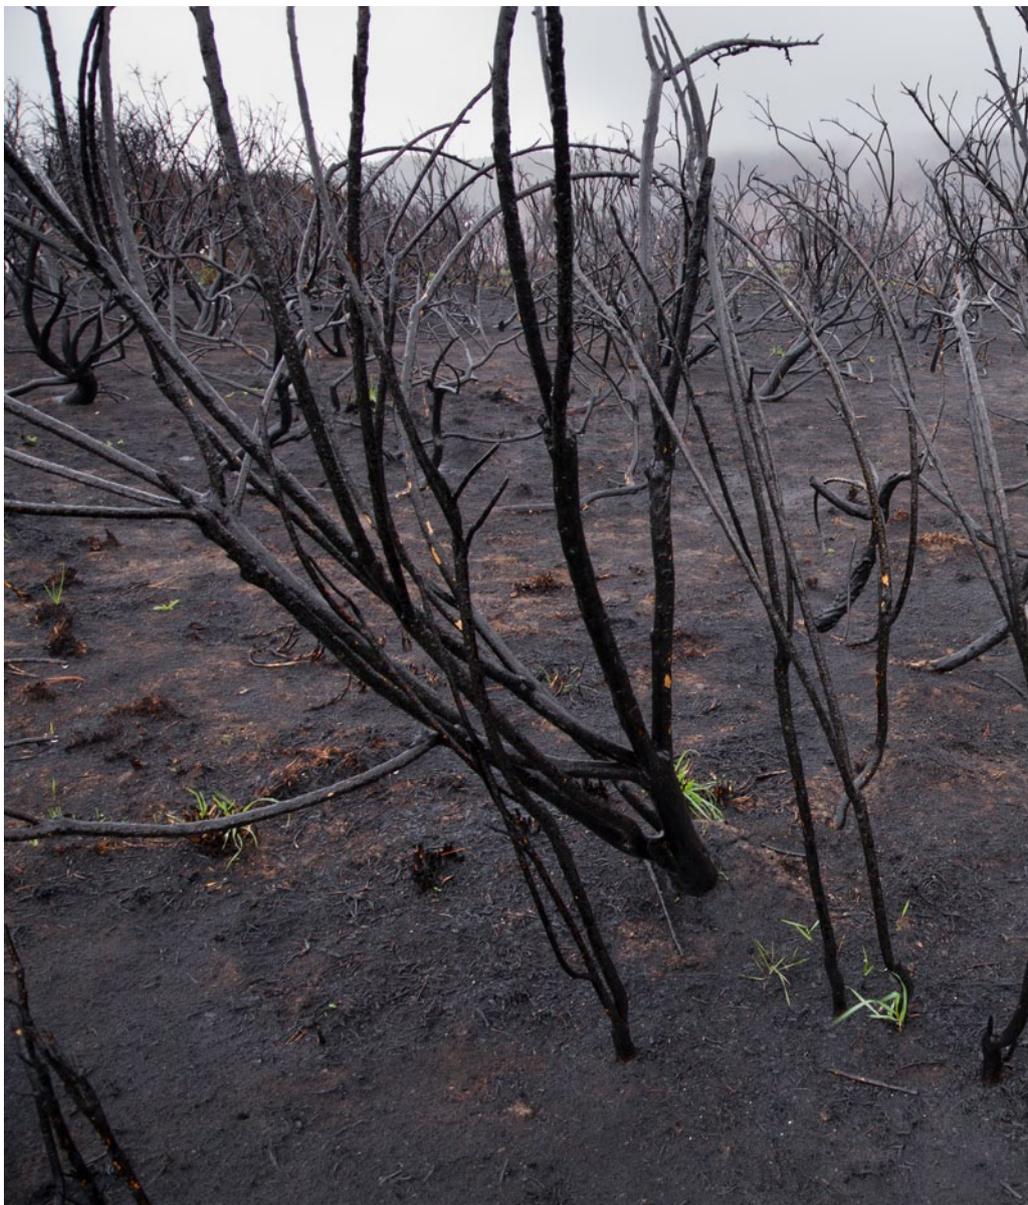
FIGURE 6 An example of fire-scorched earth in the Port Hills following the February 2017 fire. Note grass is already growing. Photo taken on 14 March by EOS Ecology.

The Port Hills fires commenced burning three days after the completion of the 2017 surveys, and burned a significant area within the Cashmere Stream catchment (Figure 6, Appendix 8.2). Given the presence of erodible loess soils in the catchment there is considerable concern in the community that fine sediment runoff from this area will increase and potentially have adverse effects on Cashmere Stream until vegetation becomes re-established. If sediment inputs are large, then this is likely to override any effects that may be caused by stormwater discharges. Thus undertaking of immediate strategies to reduce erosion in these burnt areas is recommended. Consequently the CCC Port Hills Recovery Group has identified this as a priority and is focussing on re-vegetation of erosion prone areas and detention/treatment of sediment-laden runoff in burnt catchments (Greg Burrell, CCC, pers. comm).

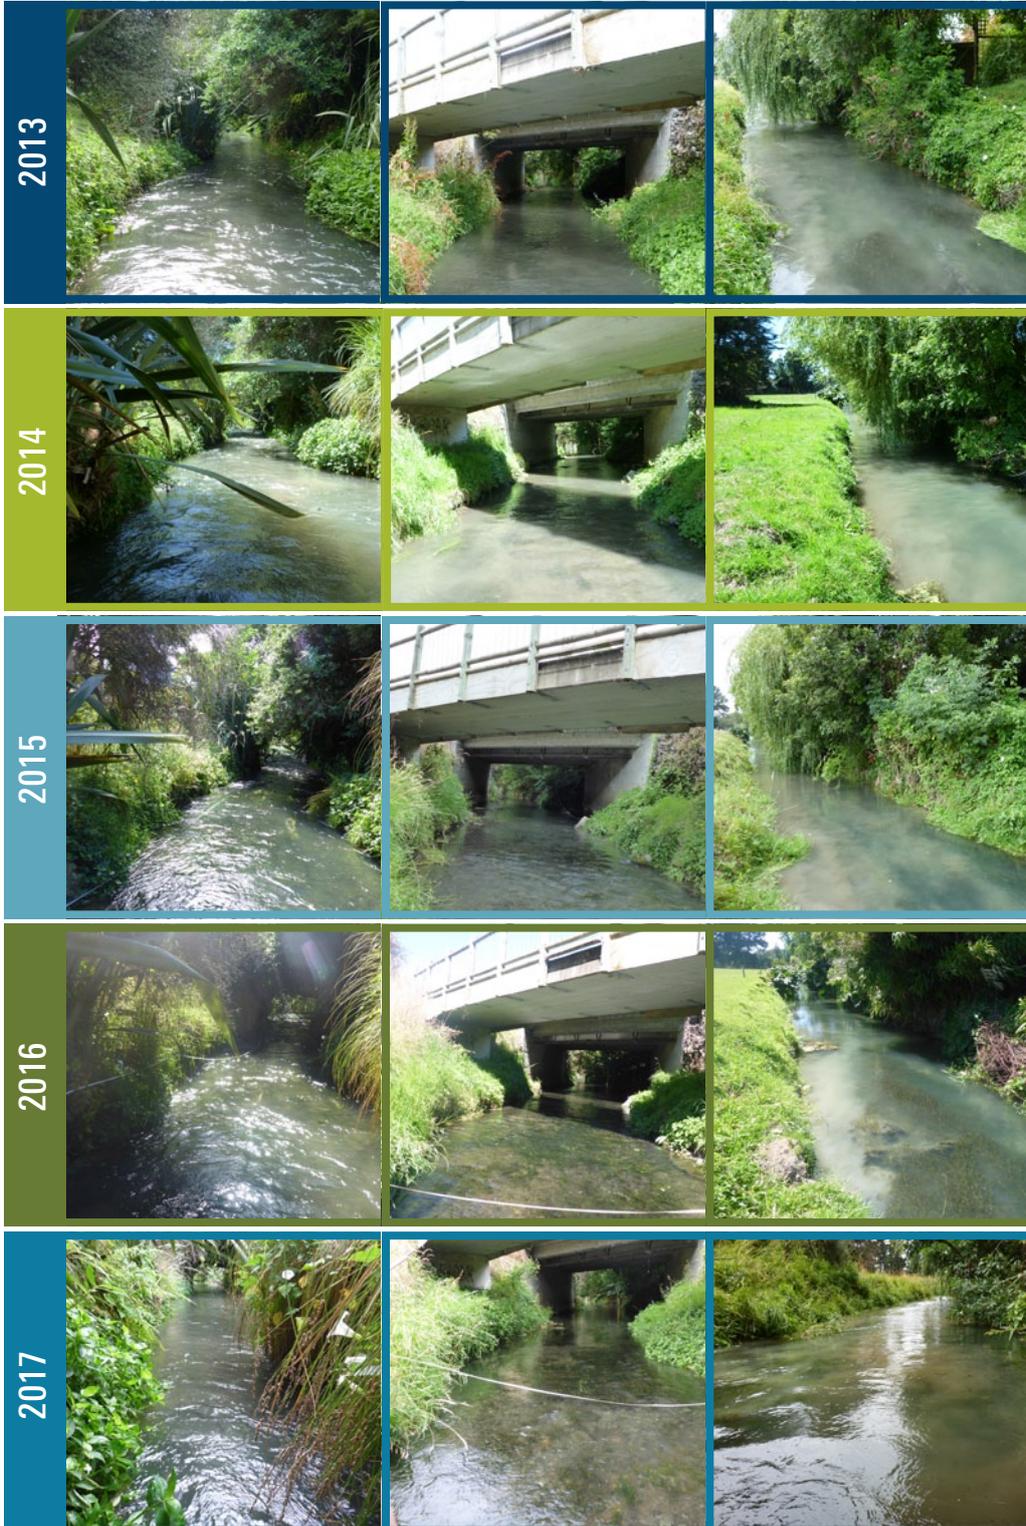
SITE 2
Downstream of Hendersons Rd Drain,
looking upstream

SITE 3
Downstream of Dunbars Drain,
looking downstream
