Avon River Precinct Aquatic Ecology

Three years' post-rehabilitation activities
Prepared for the Christchurch City Council

10 July 2017

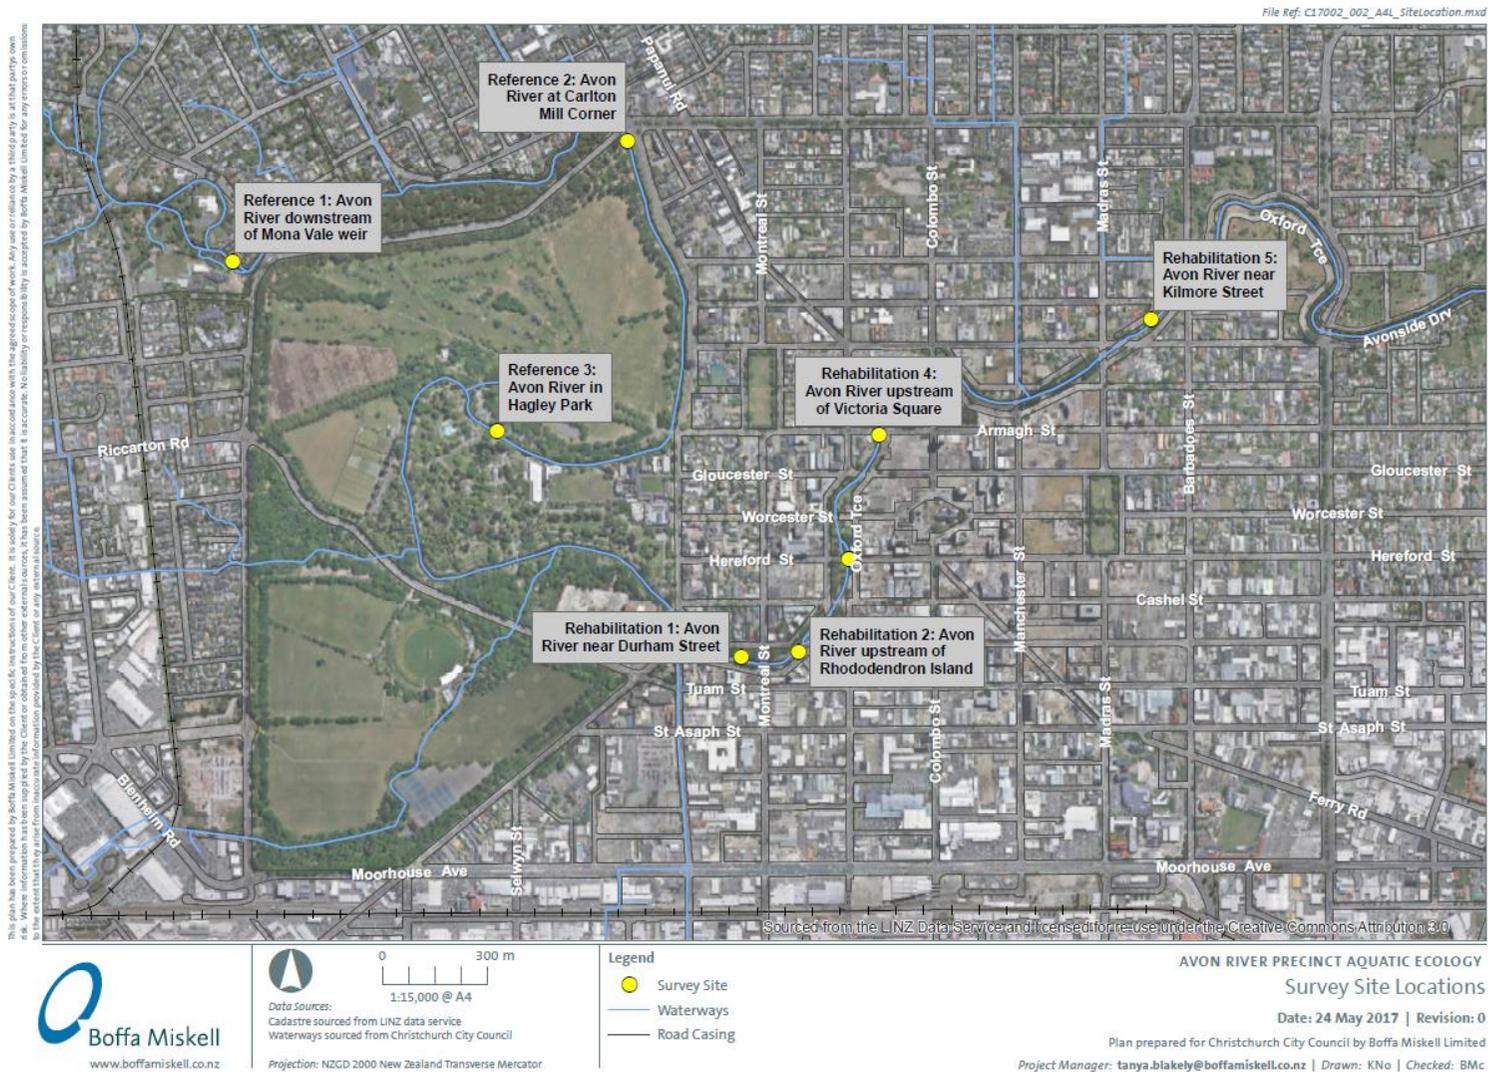
Figure 1. Location of the 3 reference sites and 5 rehabilitation sites surveyed, as part of the ARP project, in March 2017.

Riparian and in-stream habitat conditions, and macroinvertebrate and fish communities were assessed at 8 sites along the Avon River, during base-flow conditions in March 2017. The same field methods were used in this survey as during the baseline and one-year post-rehabilitation. Sites included 3 'reference' sites upstream of the ARP and where no rehabilitation works had been conducted; and the 5 'rehabilitation' sites within the ARP (Table 1; Figure 1).

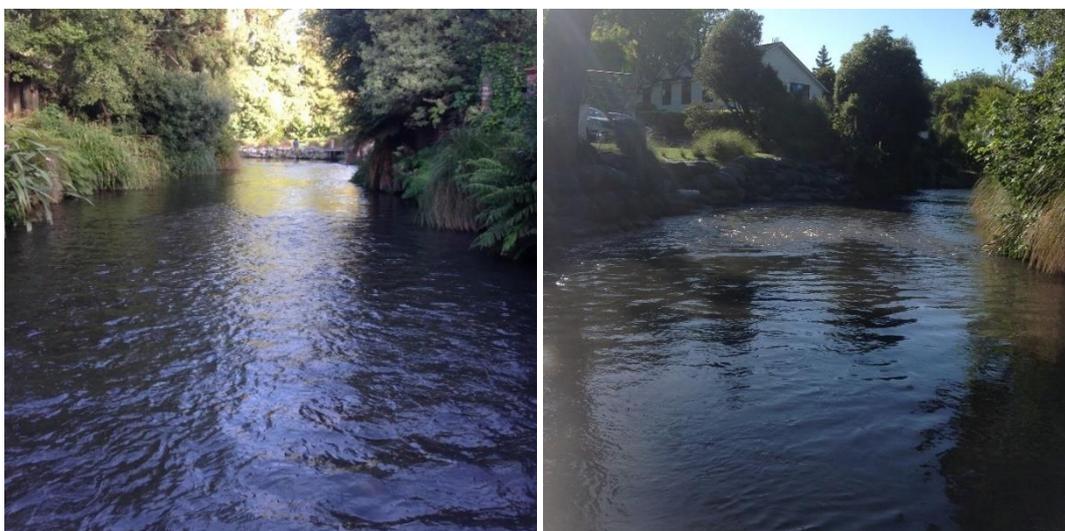
The river bed was dominated by smaller cobbles and pebbles giving an overall average SI of 2.5. These substrates were only slightly embedded (average embeddedness score of 2) and moderate to loosely packed (average compactness score of 2).

Photo 1: Reference Site 1 – Avon River downstream of Mona Vale weir, looking upstream (left) and downstream (right).

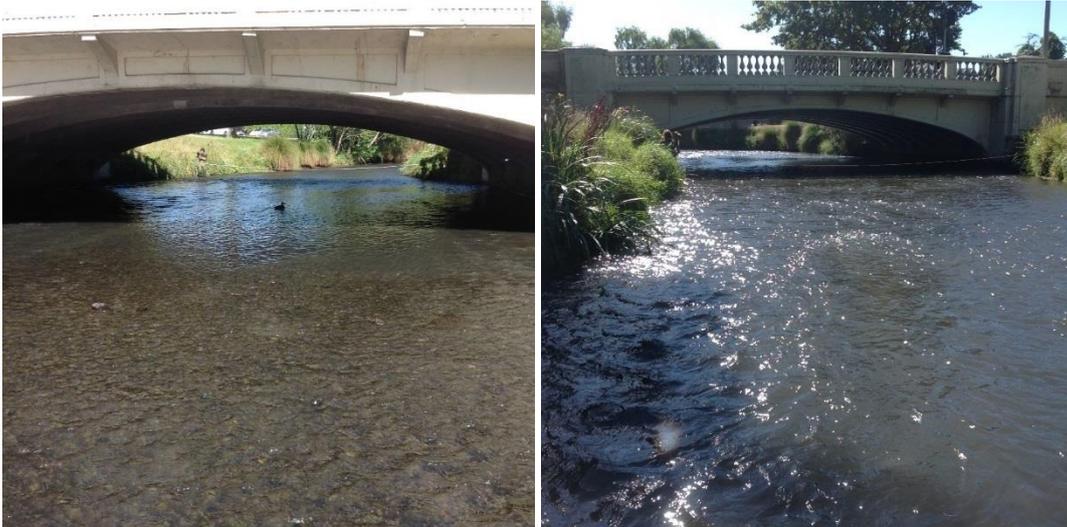
The only macrophyte present at this site was curly pondweed, which occurred in patches across the stream bed. There were no filamentous algae present at this site with only 20% coverage of thin green algae being recorded. The substrate here was dominated by cobbles and pebbles giving an overall SI of 2.3. These substrates were only slightly embedded (embeddedness score of 2) and moderate to loosely packed (compactness score of 2).

Photo 2: Reference Site 2- Avon River at Carlton Mill Corner looking downstream (left) and upstream (right).

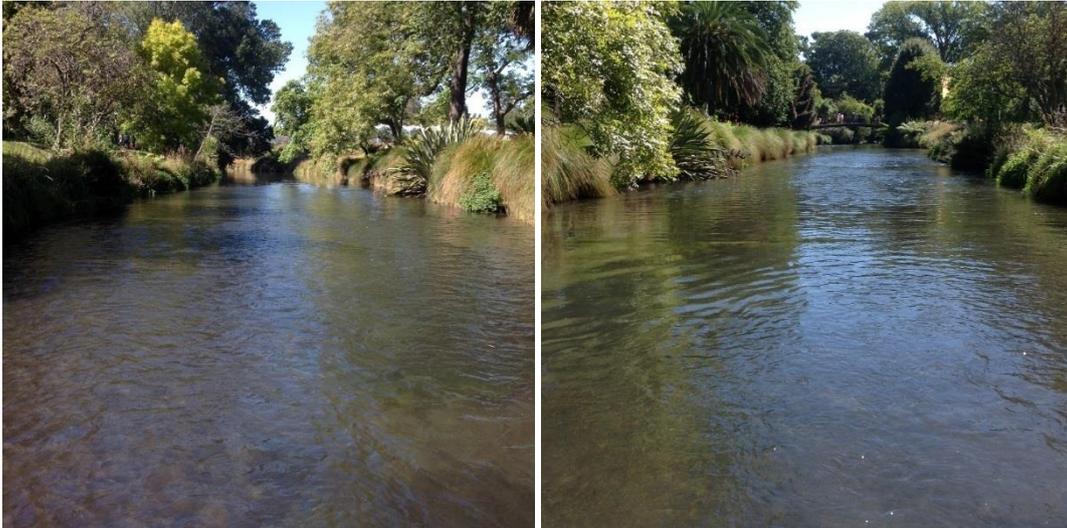
The SI at this site was 2.2, the lowest across all reference and rehabilitation sites. The substrates were dominated by pebbles that were only slightly embedded (embeddedness score of 2), with similar compactness to the other reference sites (score of 2).

Photo 3: Reference Site 3 – Avon River in Hagley Park looking upstream (left) and downstream (right).

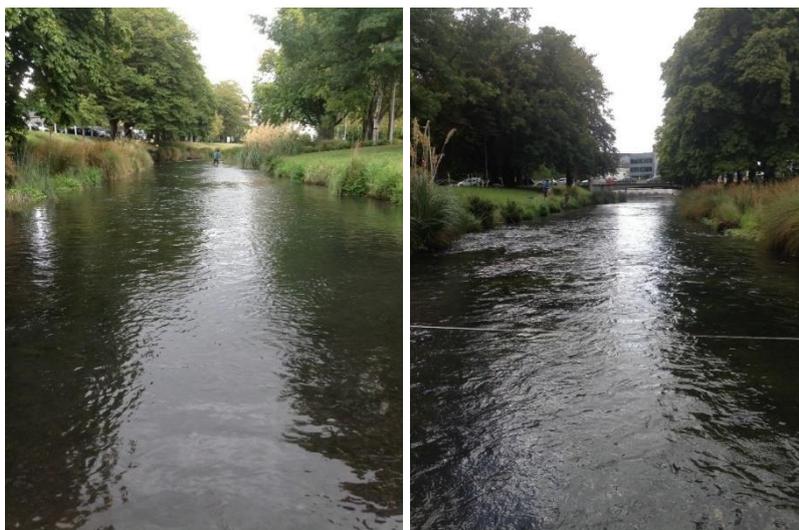
The substrate at this site was dominated by cobbles and pebbles giving an overall SI of 2.8. Substrate composition has remained similar at this site over time. These substrates were only slightly embedded (embeddedness score of 2) and moderate to loosely packed (compactness score of 2).

Photo 4: Rehabilitation Site 1 - Avon River near Durham Street looking upstream (left) and downstream (right).

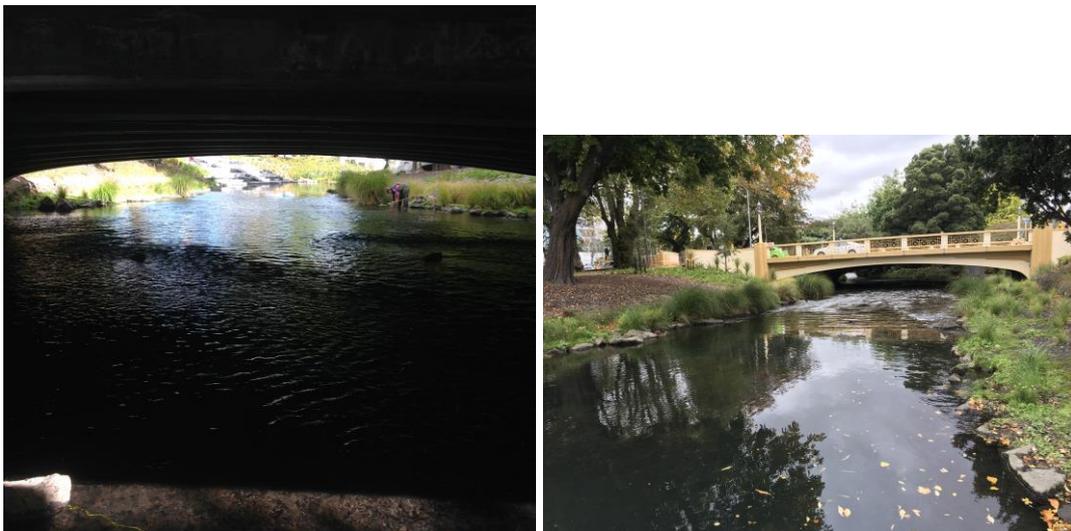
The substrate at this site was dominated by cobbles, with an overall SI of 3.1. This was similar to previous surveys. These substrates were only slightly embedded (embeddedness score of 2) and moderate to loosely packed (compactness score of 2).

Photo 6: Rehabilitation Site 3 - Avon River at Hereford Street looking upstream (left) and downstream under the Hereford Street Bridge (right).

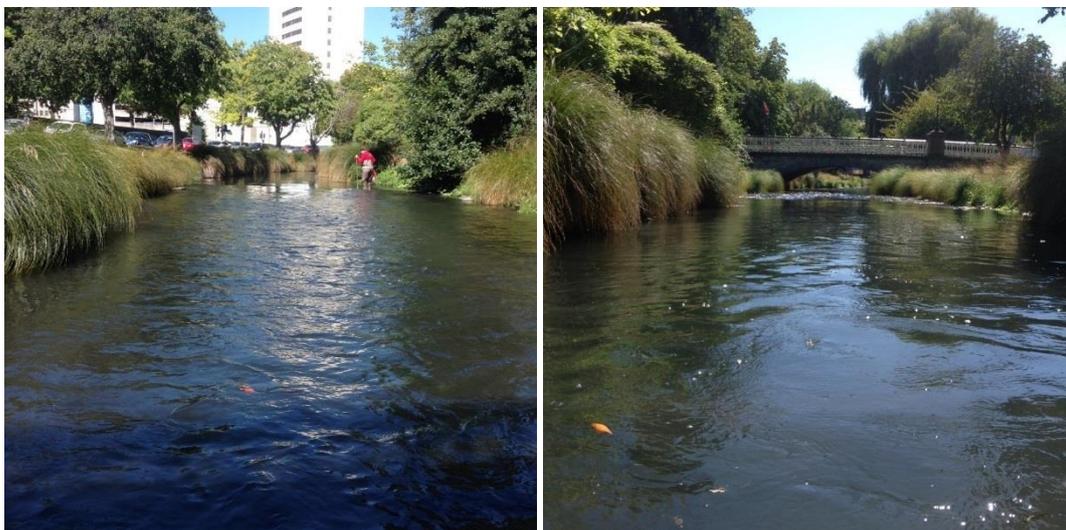
The substrate at this site was dominated by cobbles, with some boulders, with an average SI of 3.5. This was greater than the SI calculated for this site in 2013 and 2014. The substrates were only slightly embedded (embeddedness score of 2) and moderate to loosely packed (compactness score of 2). Sediment depth was greatest in 2017, compared to the previous surveys¹¹.

Photo 7: Rehabilitation Site 4 – Avon River at Victoria Square looking upstream (left) and downstream (right).

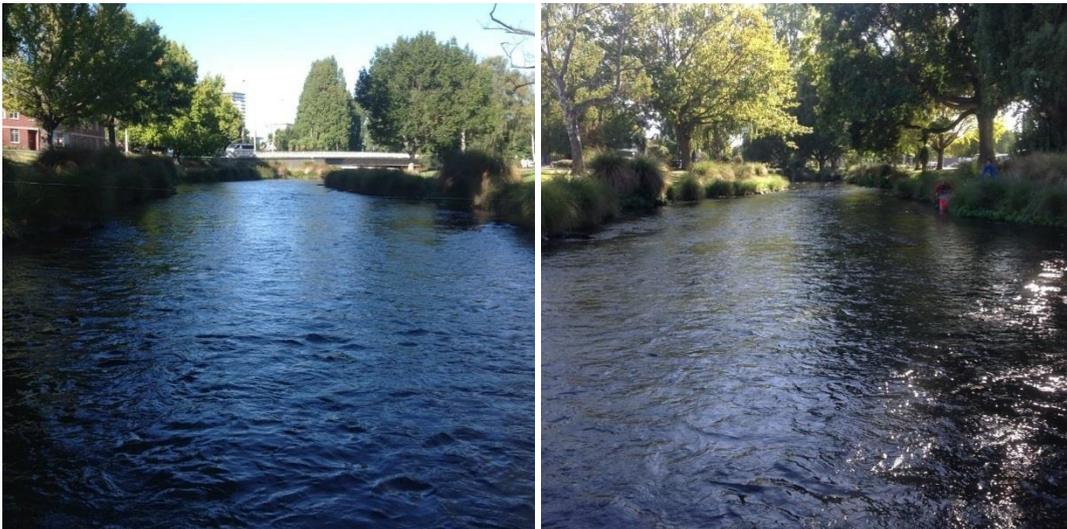
This site had a macrophyte cover of 34%. Macrophytes at this site were largely dominated by large clusters of curly pondweed, with smaller areas of the macroalga *Nitella hookeri* through the mid channel. Macrophyte cover appears to be temporally variable at this site, with high macrophyte cover recorded during the baseline survey, but no macrophytes found in 2014 (Year 1 survey). However, this is almost certainly due to the macrophyte maintenance in the Avon River. Macrophytes were cleared from this site before sampling commenced in 2014, but were cleared after the survey in both 2013 and 2017. Long green, and short and long brown filamentous algae were present at this site. Thin and thick brown algae were also present.

The substrate was dominated by large cobbles and boulders and gave the highest overall SI across all sites of 4.3. The SI calculated for this site in 2017 was markedly greater than that calculated in 2013 (SI of 1.3) but similar to that measured in 2014 (SI of 3.7). The substrates were only slightly embedded (embeddedness score of 1) and moderate to loosely packed (compactness score of 2).

Photo 8: Rehabilitation Site 5 – Avon River at Kilmore Street looking upstream (left) and downstream (right).
