Monitoring of Fish-Friendly Tide Gates, Fish, and Salt Marsh Communities

November 2018

Prepared for:
Christchurch City Council

Instream Consulting Limited
PO Box 28 173
Christchurch 8242

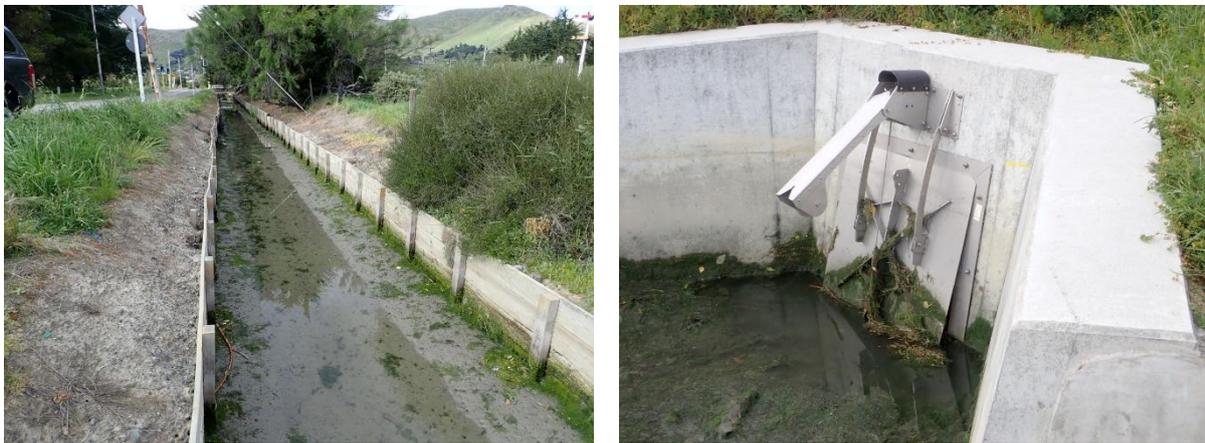
Truscotts Stream Branch is timber-lined, runs alongside Ferrymead Park Drive, and is the smallest of the three waterways studied (Figure 2). Most of the freshwater inflow into Truscotts Stream Branch has been diverted into a series of stormwater ponds to the east, markedly reducing freshwater flows downstream. The FFG at the mouth of Truscotts Stream Branch is a standard design, with a single cantilever arm and weight attached to a single gate that closes on a pipe culvert (Figure 2).

Figure 2: Truscotts Stream Branch (left) and its fish-friendly tide gate (right).

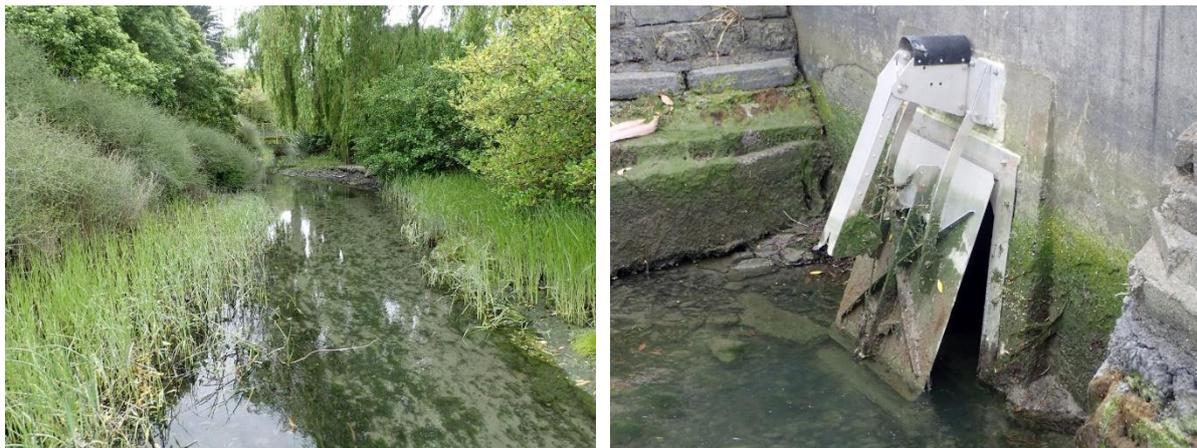
Steamwharf Stream flows through a CCC reserve upstream of the FFG, and it has natural banks that are heavily vegetated with native plants (Figure 3). Freshwater flows in Steamwharf

Stream are sourced from headwater springs. The Steamwharf Stream FFG is of a similar standard design to that at Truscotts Stream Branch (Figure 3).

Figure 3: Steamwharf Stream (left) and its fish-friendly tide gate (right).

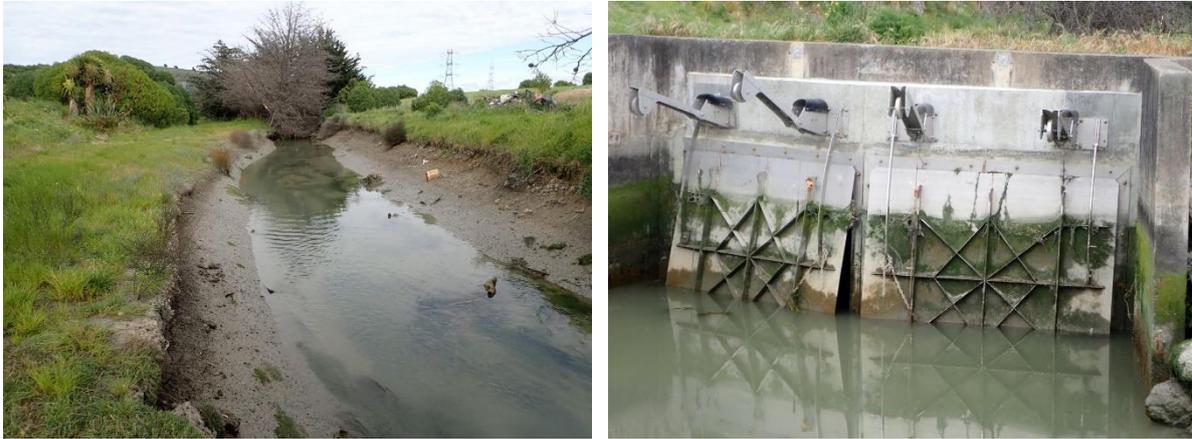
mix of horse paddocks and stormwater detention basins. After leaving the Avoca Salt Marsh, the stream flows through into the estuary via two large rectangular culverts, each with a rectangular FFG with two cantilever arms and counterweights (Figure 4).

Figure 4: Avoca Valley Stream (left) and its fish-friendly tide gates (right).

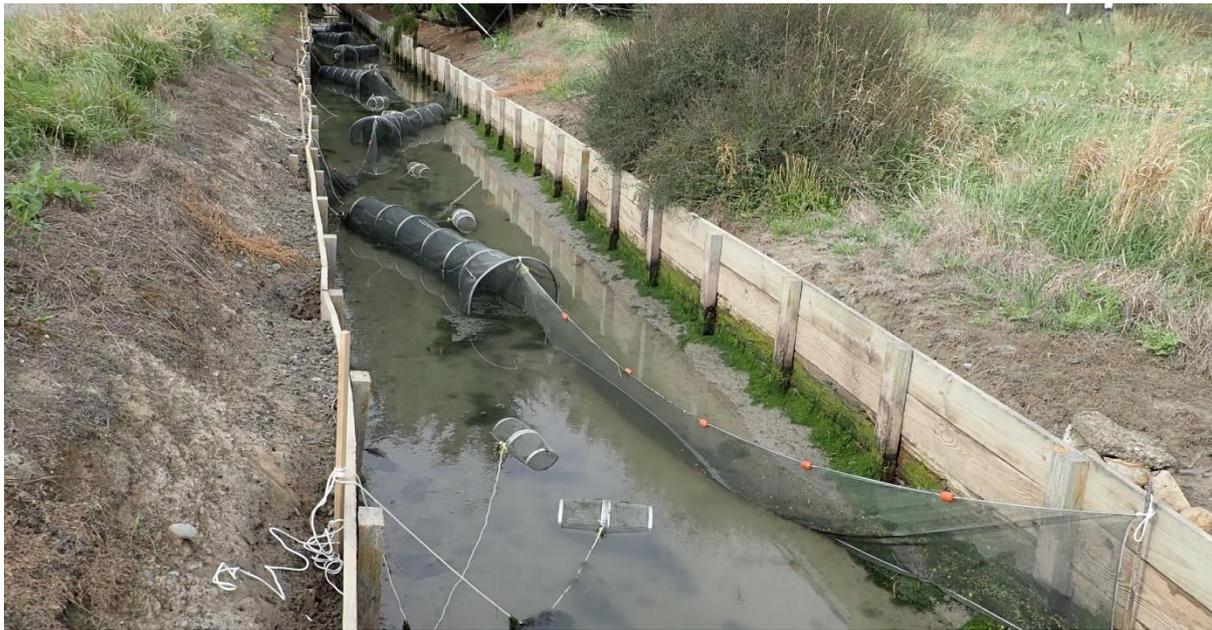
The nets and traps were not baited, so that they passively sampled fish swimming past. Fyke nets were placed densely in a herringbone fashion, with the leader facing downstream on alternating banks (Figure 5). This was done to maximise the likelihood of catching fish swimming upstream past the gates, as well as downstream migrants.

Figure 5: Fyke nets and minnow traps arranged to maximise fish capture rates in Truscotts Stream Branch.

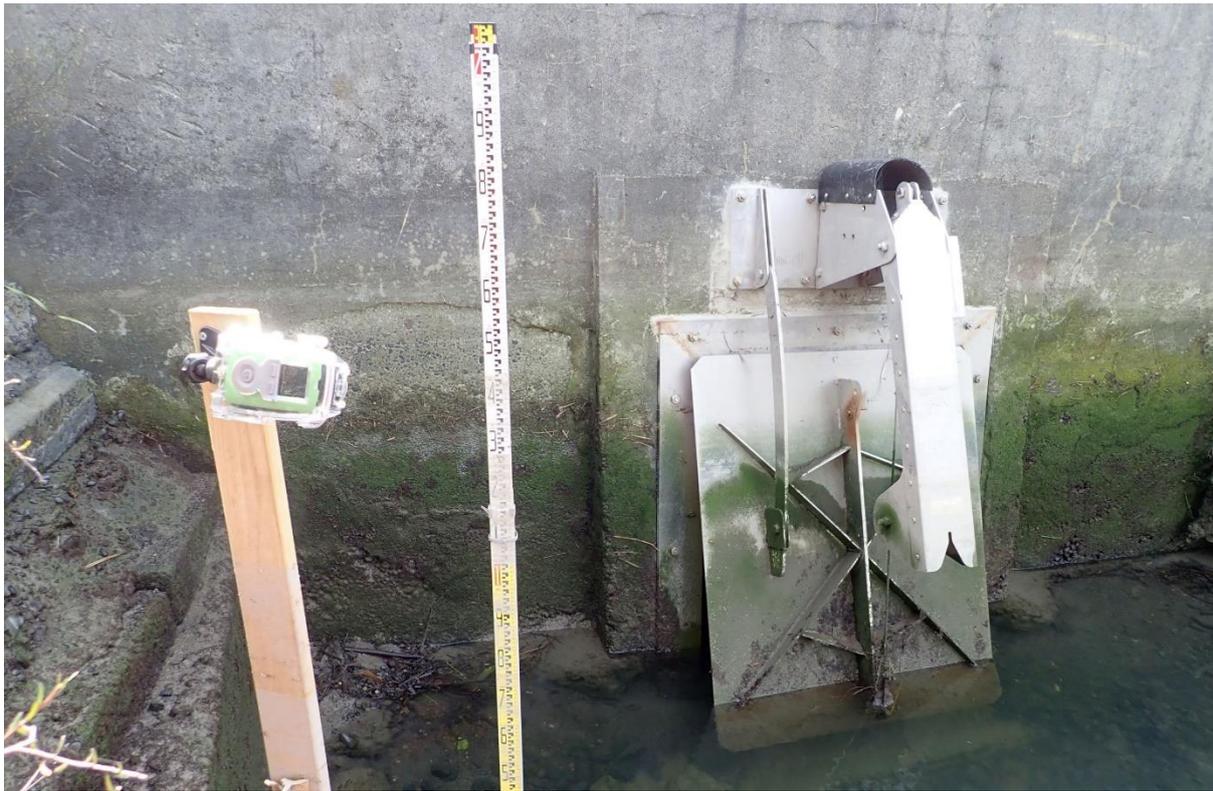
Two different methods were trialled at Steamwharf Stream to monitor FFG opening and water levels. Steamwharf Stream was chosen for the initial trial because inanga spawning occurs upstream and the stream has been the focus of considerable restoration efforts in the past. The first monitoring method involved temporary installation of a weather-proof time-lapse camera to determine gate opening duration, following the general method described by Bocker (2015). A temporary staff gauge was installed beside the FFG, so that the water level could be recorded when each time lapse photograph was taken (Figure 6). The second method involved measuring gate angle with a MPU6050 tri-axial accelerometer, aligned parallel to the gate and mounted to the web of the gate. Accelerometer data were recorded at 5 minute intervals on a standalone data logger. The accelerometer installation and monitoring was undertaken by Altissimo Consulting.

Figure 6: Time-lapse camera and temporary staff gauge setup at Steamwharf Stream.

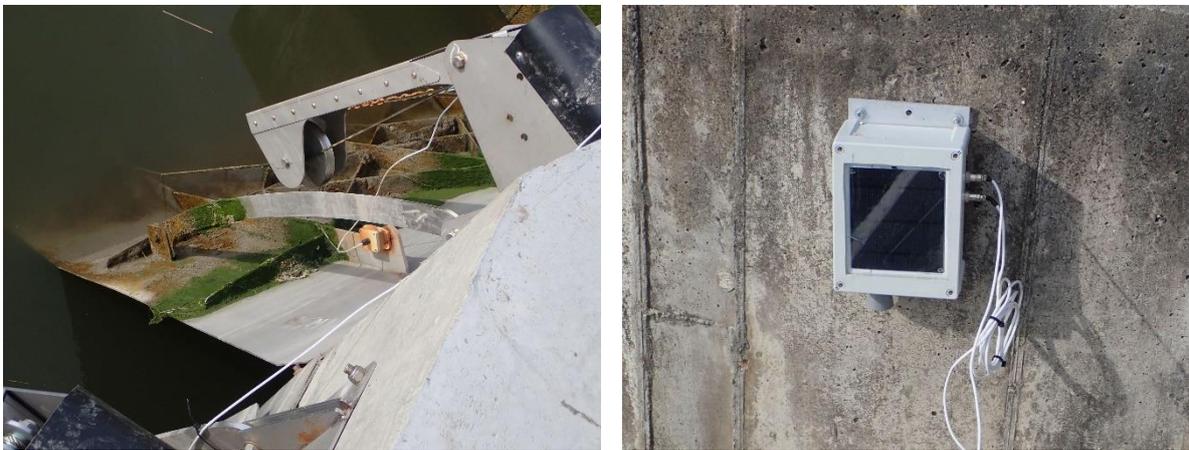
Following the initial trial at Steamwharf Stream, monitoring focussed on Avoca Valley Stream. Altissimo Consulting attached two accelerometers to the Avoca Valley Stream FFGs, with one on each gate (Figure 7). At this site, the accelerometers recorded gate angle every 15 minutes, and data were telemetered. In addition, water levels were monitored at three locations: immediately downstream of the gates, immediately upstream, and approximately 230 m upstream of the gates. Water levels were determined using a Maxbotix MB7389 ultrasonic range finder, referenced to a surveyed location (Figure 7). The relative level (RL) of the water is presented in terms of the Christchurch Drainage Datum. The distance to the surface was averaged over a 10 second period, with samples taken every 15 minutes and telemetered. Anomalous data (caused by floating debris or other obstructions) were removed by Altissimo Consulting in post processing.

Figure 7: Gate monitoring accelerometer (left) and water level recording (right) at Avoca Valley Stream tide gates.

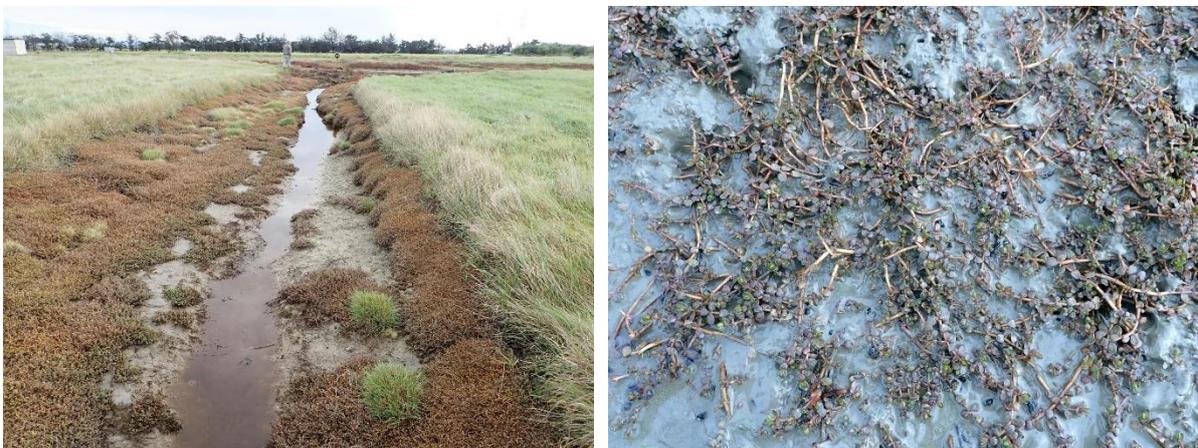
Figure 10: Glasswort lining a tributary drain (left) and threatened New Zealand musk (right)

McCombs (2018) identified a total of 23,853 m² of various vegetation types within an approximately 95,000 m² area of Avoca Salt Marsh (Figure 9). McCombs (2018) noted that plant species composition varied markedly with small changes in topography, reflecting species' tolerance to salinity and inundation frequency. Glasswort (*Sarcocornia quinqueflora*) dominated low-lying areas alongside ponds and watercourses, covering a total area of 15,743 m² (Figure 10), while threatened New Zealand musk (*Thyridia repens*) was widespread in the upper reaches of Butts Valley Waterway, covering an area of 1,557 m². (Figure 10).

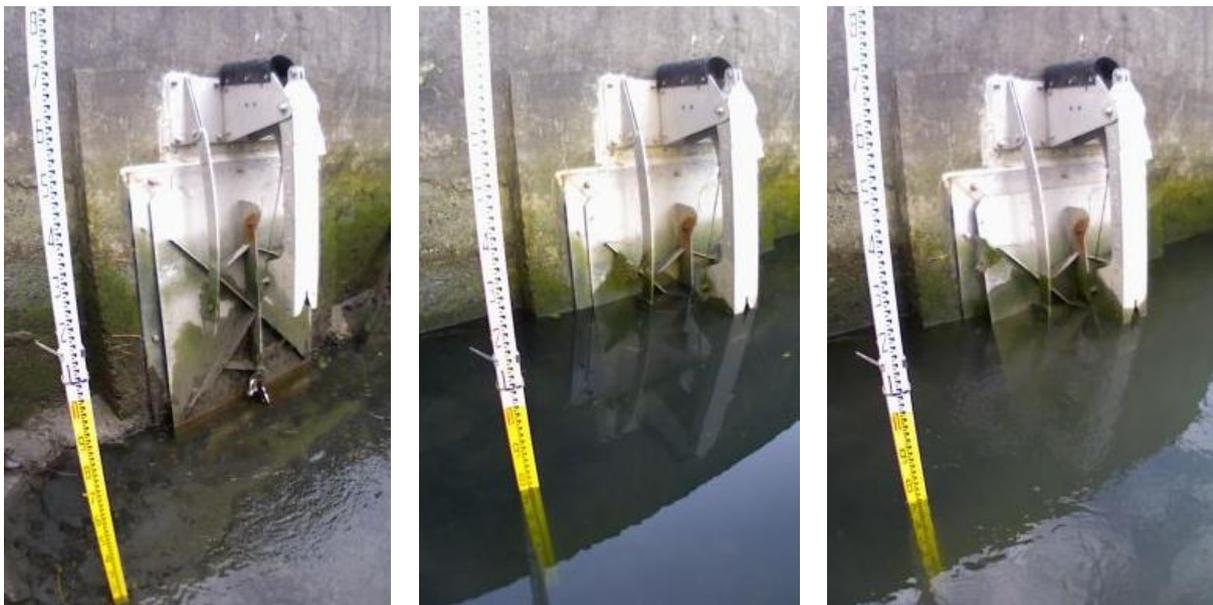
Time-lapse photographs showed that the Steamwharf Stream FFG remained open throughout much of the tidal cycle, only closing at well above mid-tide (Figure 11). Under normal operating conditions with the counterweight engaged, the gate opening at low tide was 450 mm (measured from the bottom of the gate to the culvert face). Disengaging the counterweight resulted in a low tide gate opening width of only 62 mm and the gate closed completely prior to reaching mid-tide (Figure 12).

Figure 12: Steamwharf Stream tide gate with the counterweight temporarily disengaged. The left and middle photographs are on an incoming tide, while the right photograph is on an outgoing tide.

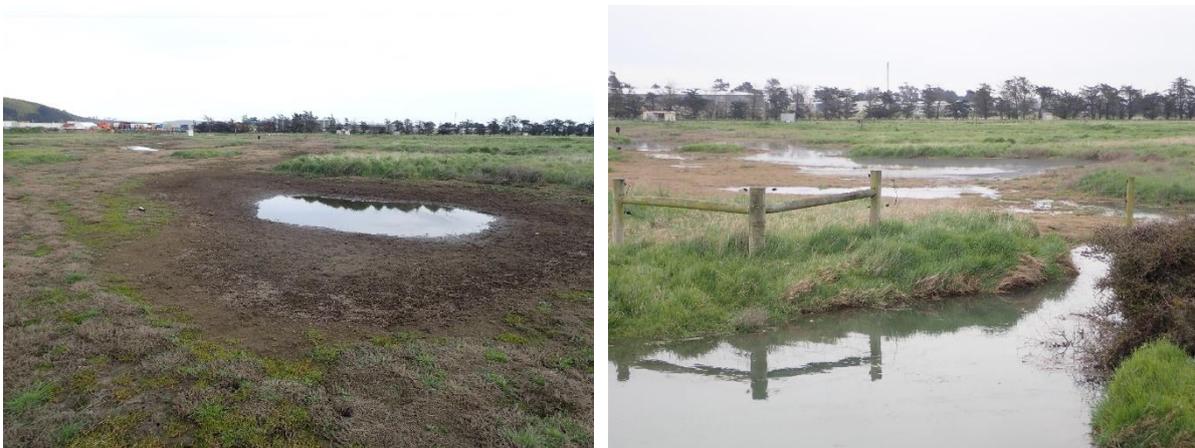
A complex of shallow ponds and salt marsh vegetation at Sites 9 and 19 showed large swings in conductivity when the tide gates were propped open. Observations over several tides revealed that the ponds were intermittently inundated by spring tides that pushed saline water up Avoca Valley Stream and its tributaries (Figure 18). For example, at Site 9 conductivity was 3.6 mS/cm on 28 August 2018 and 26.3 mS/cm five days later, immediately after a spring tide

(Figure 18). The high tide on 2 September 2018 reached an RL of 10.3 m, at which point tidal water was observed to back up a tributary drain and tip into the pond at Site 9. A high tide on 5 September 2018 reached an RL of 9.9 m, which was sufficient to push tidal water up the side drain at Site 11 and into the pond at Site 10, but the tide was of insufficient height to enter the pond at Site 9.

Figure 18: Site 9 on 28 August 2018 (left) and following inundation by a spring tide on 2 September 2018 (right).
