Avon River Precinct Aquatic Ecology

Six-years' post-rehabilitation activities
Prepared for Christchurch City Council

21 July 2020

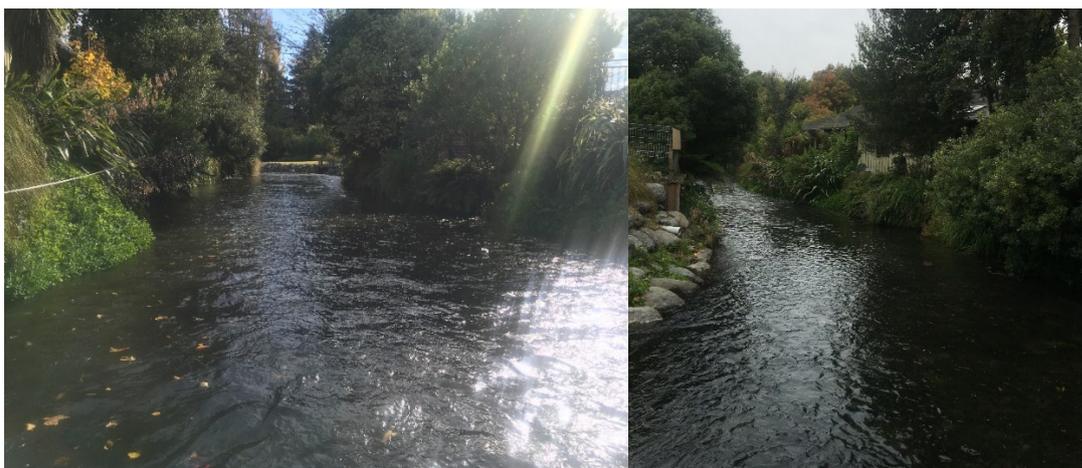
Macrophyte cover was very high, with 90% of the stream bed covered by submerged macrophytes – much higher than what was found in the 2017 survey, though similar to cover in the 2014 survey. Curly pondweed (*Potamogeton crispus*) and common water milfoil (*Myriophyllum propinquum*) were the dominant macrophyte species found. Cover of both organic matter and algae was very low at 0.8% and 3% respectively.

The riverbed substrate was dominated by sand / silt material and pebbles, giving an average SI of 2.7. The substrate was firmly embedded, with an average embeddedness score of 3. Compactness was high, with an average score of 3.5 indicating the substrate was tightly packed.

Photo 1. Reference Site 1 – Avon River downstream of Mona Vale weir, looking upstream (left) and downstream (right).

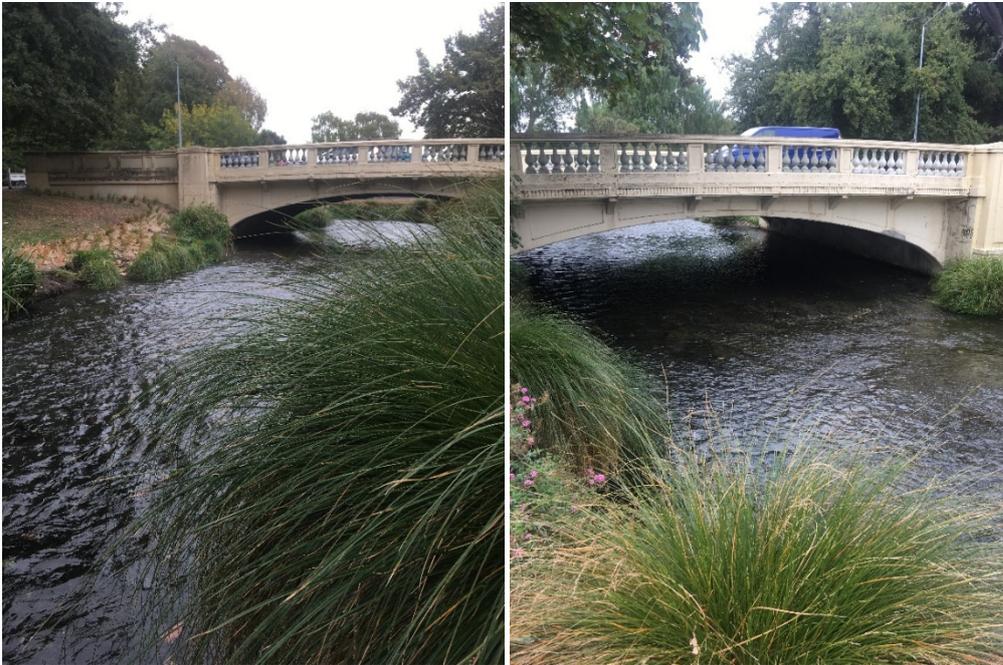
Macrophytes cover was only 8% at the time of surveying, which is relatively low when compared to previous surveys. The dominant macrophyte species found were curly pondweed, common water milfoil and Canadian pondweed (*Elodia canadensis*). Organic matter cover was 7% and algae cover was 11%. Algae found was predominantly thin brown mat algae.

The riverbed substrate was dominated by sand / silt material and pebbles, giving an average SI of 2.4. The substrate was slightly embedded, with an average embeddedness score of 2. Compactness was also moderate, with an average score of 1.8 indicating relatively loose substrate.

Photo 2. Reference Site 2 – Avon River at Carlton Mill Corner, looking upstream (left) and downstream (right).

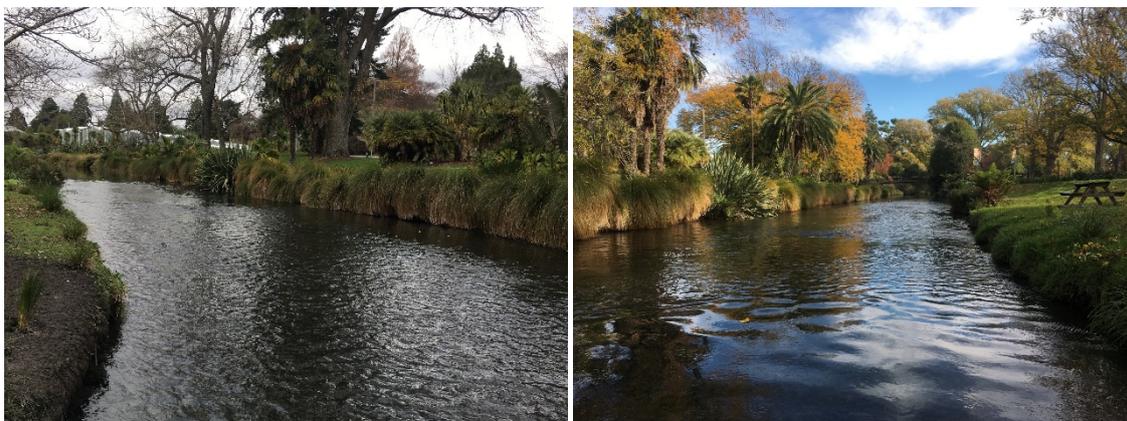
Substrate at Reference Site 3 was predominantly comprised of pebble and small cobbles, with an average SI of 3.2, indicating moderately sized substrate particles. The substrate was slightly embedded, with an average embeddedness score of 2. The substrate was mostly loose with little compaction, with an average compactness score of 2.

Photo 3. Reference Site 3 – Avon River in Hagley Park, looking upstream (left) and downstream (right).

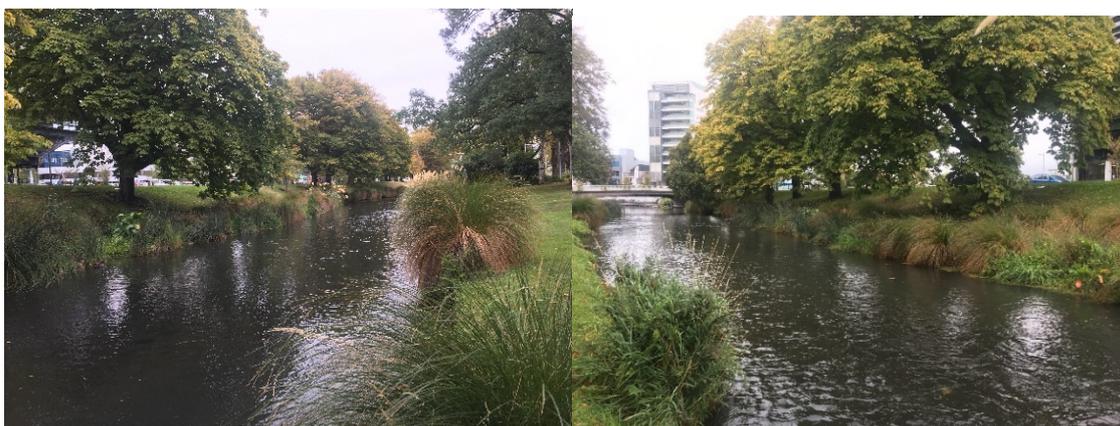
Curly pondweed and common water milfoil were the dominant macrophyte species found at this site, covering, on average, 16% of the riverbed. Organic matter was negligible, with only 0.2% cover, while algae was also very low with only 1% cover – much lower than that found in any previous survey.

The substrate at this site was found to be comprised of small cobble and pebble particles, giving an average SI of 2.8. The substrates were only slightly embedded (average embeddedness score of 2.1), and mostly loose, with little compaction (average of 2.3 compactness).

Photo 4. Rehabilitation Site 1 – Avon River near Durham St, looking upstream (left) and downstream (right).

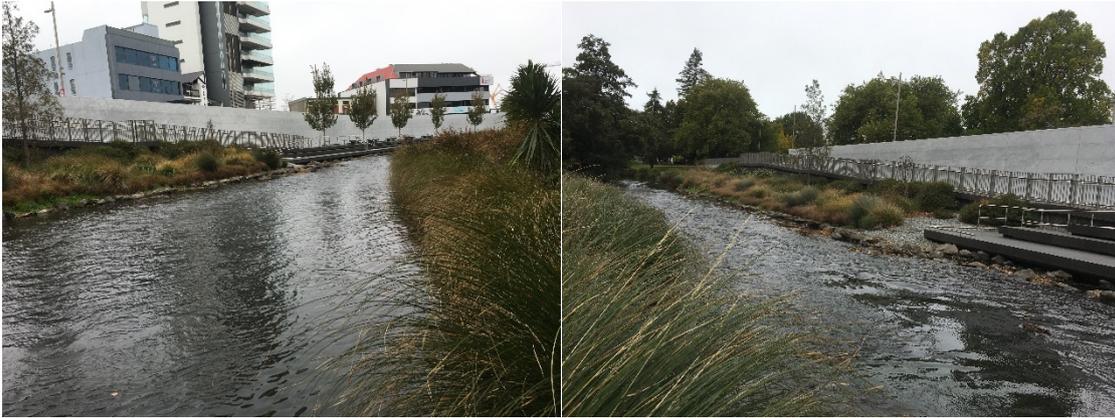
The riverbed substrate was dominated by small cobbles, giving an average SI of 3.3. The substrate was slightly embedded, with an average embeddedness score of 2.3, while compactness was also moderate, with an average score of 2.2, indicating the substrate is mostly loose with little compaction.

Photo 5. Rehabilitation Site 2 – Avon River at Rhododendron Island, looking upstream (left) and downstream (right).

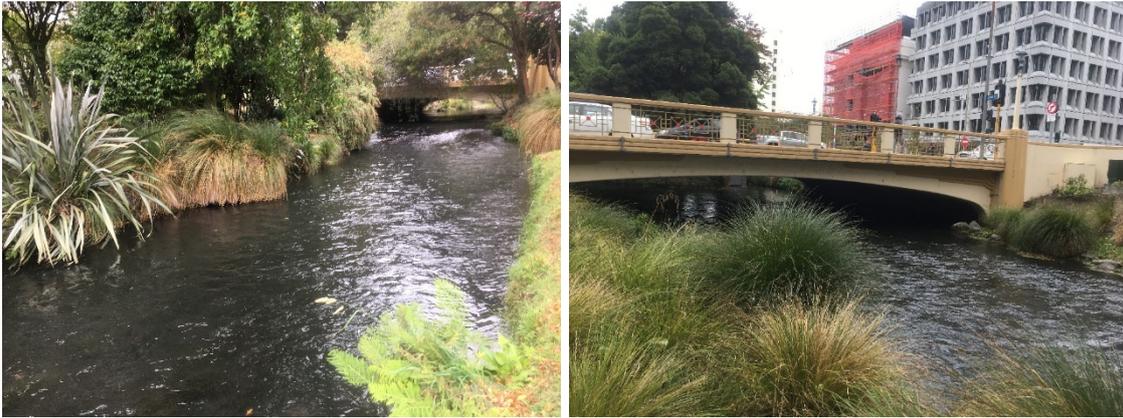
Small cobbles dominated the substrate composition, but large cobbles and boulders were also present, giving an average SI of 3.7. The site received an average embeddedness score of 2.3, indicating that the substrate was slightly embedded, while the riverbed was somewhat loosely packed, with an average compactness score of 2.5.

Photo 6. Rehabilitation Site 3 – Avon River at Hereford St, looking upstream (left) and downstream (right).

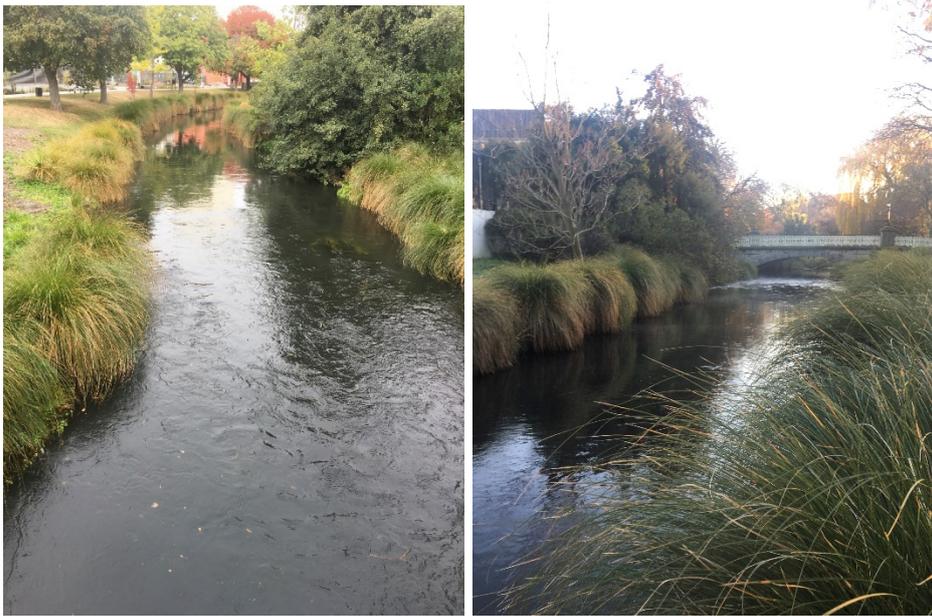
Substrate at Rehabilitation Site 4 was predominantly comprised of large and small cobbles, with an average SI of 4.1, indicating moderate to large-sized substrate particles. The substrate was firmly to heavily embedded, with an average embeddedness score of 3.5. The substrate was moderately to tightly compacted, with an average compactness score of 3.5.

Photo 7. Rehabilitation Site 4 – Avon River at Victoria Square, looking upstream (left) and downstream (right).

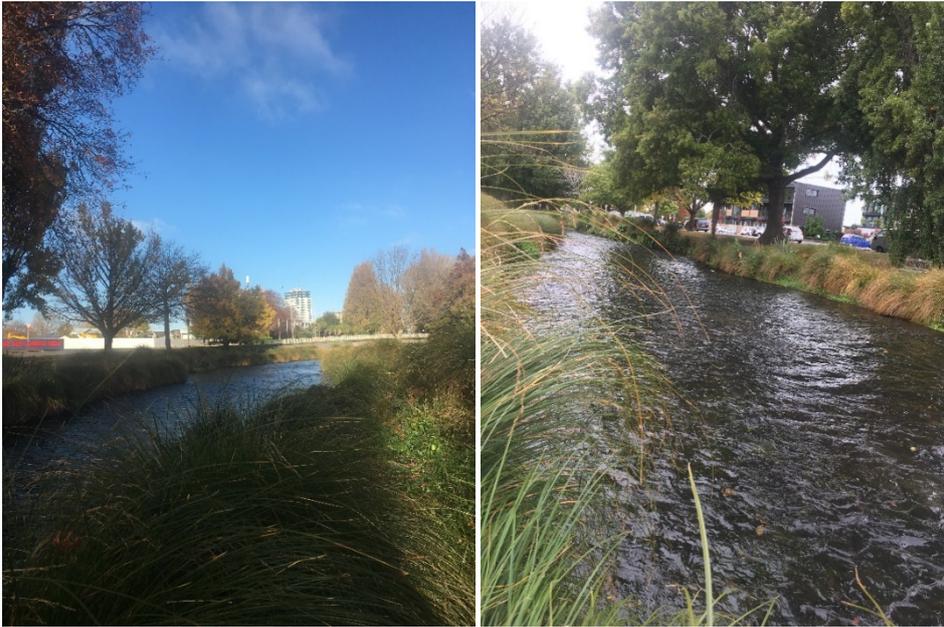
The riverbed composition at Rehabilitation Site 4 was comprised predominantly of pebbles and small cobble, with some large cobbles. The SI at this site was an average of 3.5 indicating moderately sized substrate particles. Substrate was slightly to firmly embedded, with an average embeddedness score of 2.5 and moderately packed, with an average compactness score of 2.7.

Photo 8. Rehabilitation Site 5 – Avon River at Kilmore St, looking upstream (left) and downstream (right).

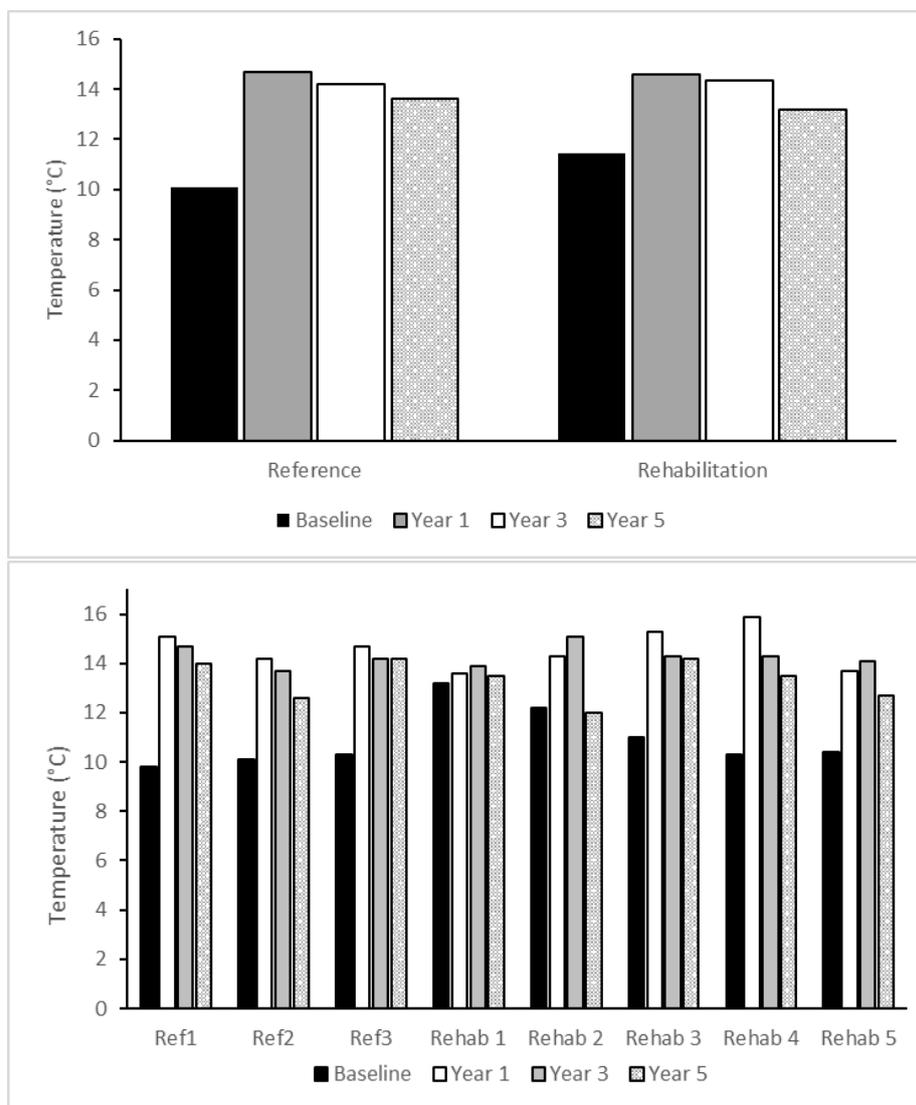
Water temperature varied across sites, with no discernible difference in temperature between reference and rehabilitation sites in this survey (Figure 2). Temperatures recorded in this survey (2020) were relatively similar to those in the previous two post-rehabilitation surveys and warmer than that recorded in the baseline survey. Temperature can fluctuate both daily and seasonally, so it is important to note that water temperature was only measured once at each site on each sampling occasion.

Figure 2. Water temperature (°C) measured at the reference and rehabilitation sites (top) and at each of six transects, at each of the eight Avon River Precinct sites (bottom) for the baseline study (2013, black bars), one-year post-rehabilitation (2014, white bars), three-years post-rehabilitation (2017, grey bars) and six-years post-rehabilitation (this survey – 2020, grey pattern bars).

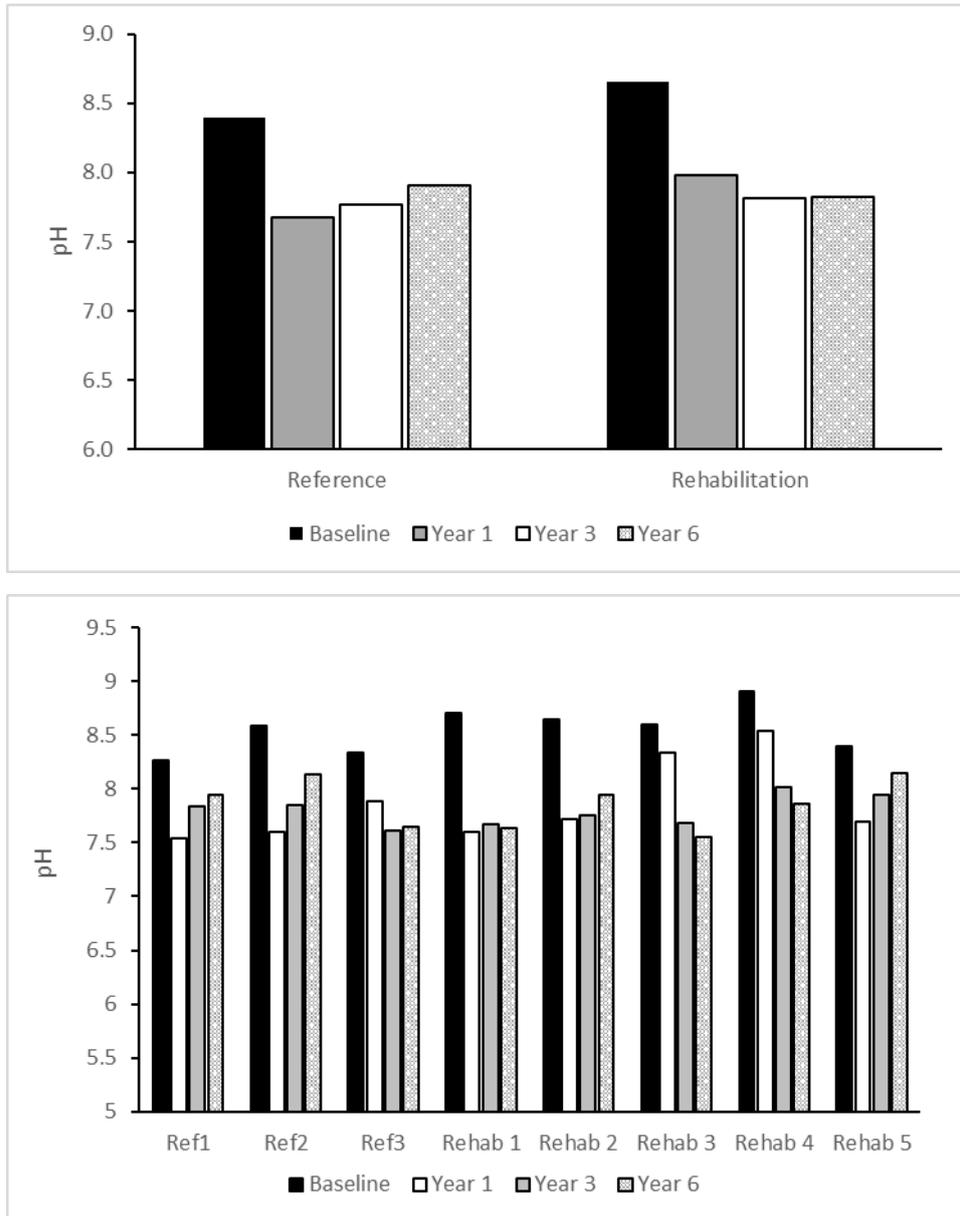
pH recorded in this survey (2020) was similar to that recorded in the prior post-rehabilitation surveys in 2014 and 2017, and lower (more neutral, i.e. closer to a pH of 7) than that recorded in the baseline survey (2013), as shown in Figure 3. There were no discernible differences in pH in any year between reference and rehabilitation sites. Nevertheless, the pH found at all sites in all years was circum-neutral and thus likely to be within a tolerable range for aquatic fauna.

Figure 3. pH measured at the reference and rehabilitation sites (top) and at each of six transects, at each of the eight Avon River Precinct sites (bottom) for the baseline study (2013, black bars), one-year post-rehabilitation (2014, white bars), three-years post-rehabilitation (2017, grey bars) and six-years post-rehabilitation (this survey – 2020, grey pattern bars).

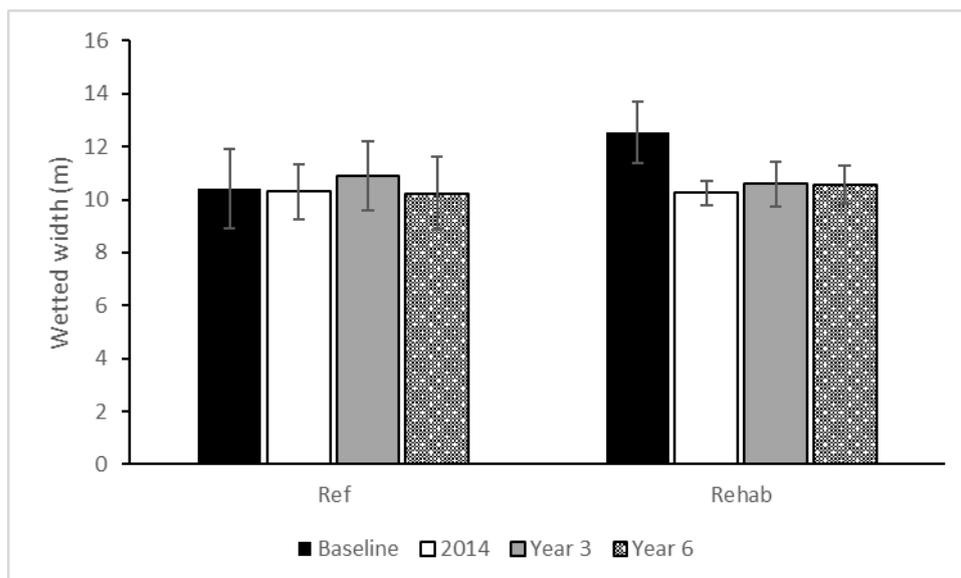
Wetted width measured in this survey (2020) was relatively unchanged compared to previous years, with an average of width of 10.2 m at Reference sites and 10.5 m at Rehabilitation sites (Figure 4). There was no significant difference between years, nor between treatments (i.e. between reference and rehabilitation sites ($F_{3,24} = 10.35$, $P = 0.480$; $F_{1,24} = 2.03$, $P = 0.486$), however, rehabilitation sites are marginally narrower post-rehabilitation activities.

Figure 4. Average ($\pm 1SE$) wetted width (m) measured at the reference and rehabilitation sites for the baseline study (2013, black bars), one-year post-rehabilitation (2014, white bars), three-years post-rehabilitation (2017, grey bars) and six-years post-rehabilitation (this survey – 2020, grey pattern bars).

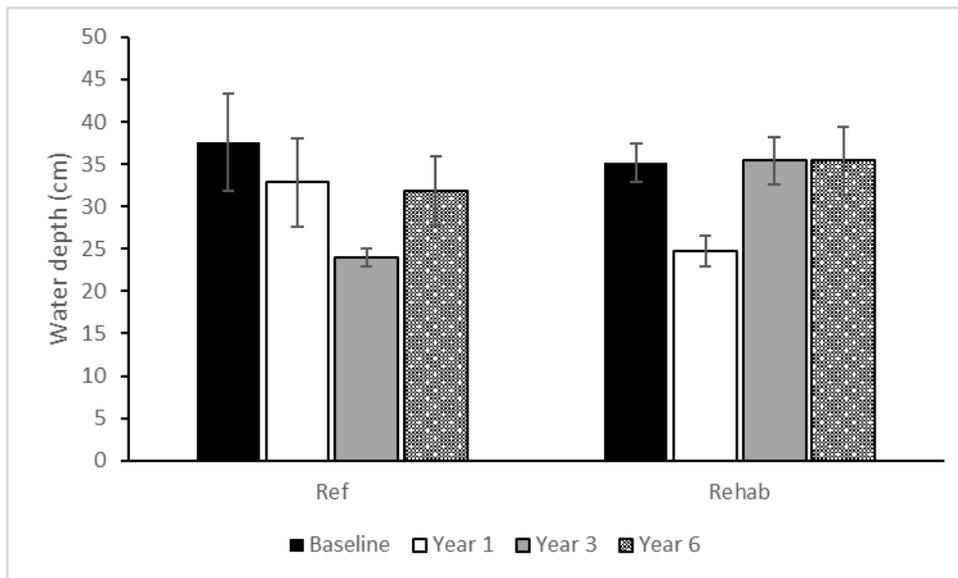
Average water depth was remarkably variable across the sampling occasions, despite what should be relatively similar transect locations used each monitoring period. Average water depths of reference sites and rehabilitation sites were similar in this survey (average depths of 35.4 cm and 31.8 cm deep, respectively) (Figure 5). When all surveys were included in the analysis, there was no significant difference between surveys, nor between reference and rehabilitation sites ($F_{3,24} = 467.8$, $P = 0.078$; $F_{1,24} = 85.2$, $P = 0.248$).

Figure 5. Average (± 1 SE) water depth (cm) measured at the reference and rehabilitation sites for the baseline study (2013, black bars), one-year post-rehabilitation (2014, white bars), three-years post-rehabilitation (2017, grey bars) and six-years post-rehabilitation (this survey – 2020, grey pattern bars).

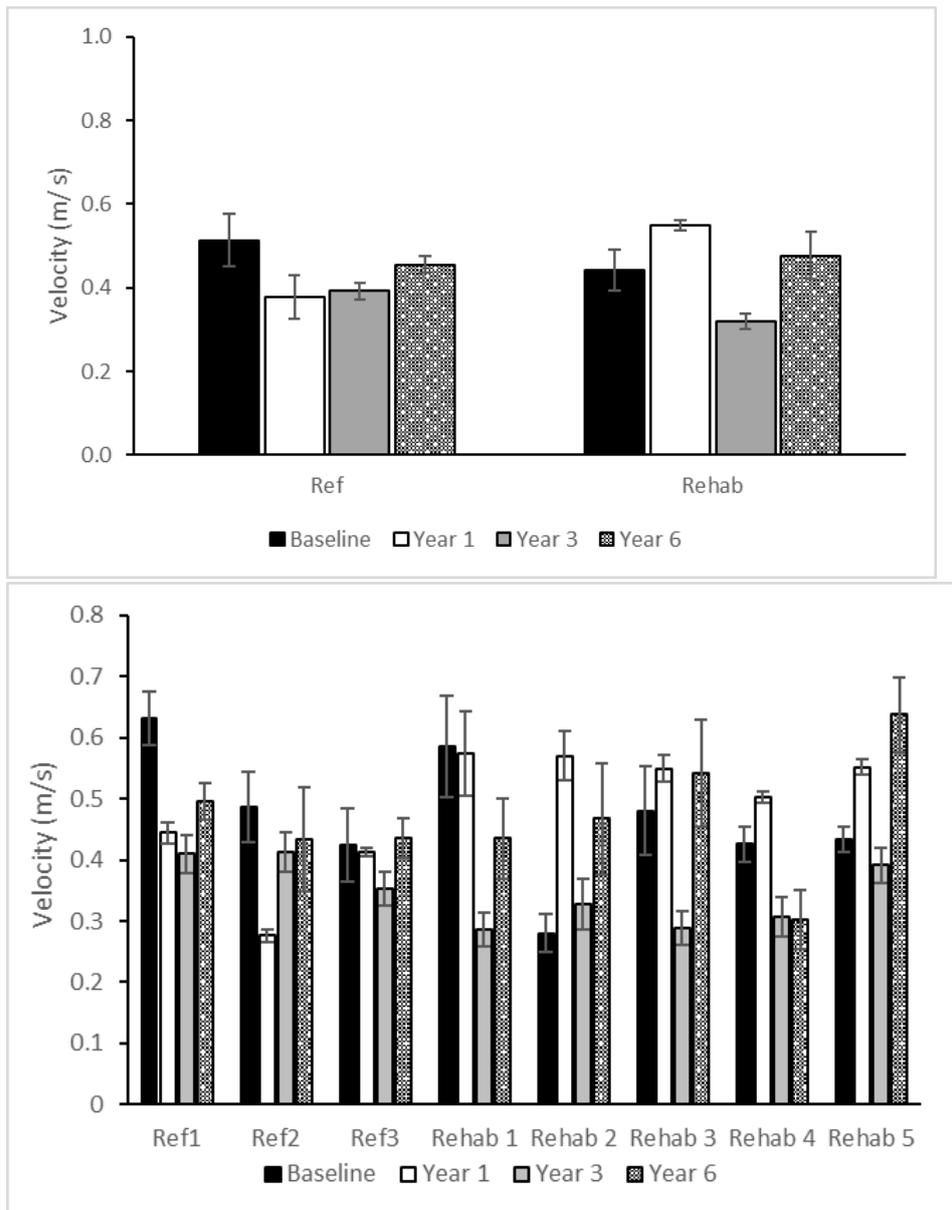
Furthermore, there was a significant interaction between treatment and year ($F_{3,24} = 0.075$, $P < 0.05$). The interaction suggests that rehabilitation sites in 2017 had slower velocity than reference sites in 2013 and rehabilitation sites in 2014. However, it is difficult to differentiate whether this reflects rehabilitation works impacting water velocities or is the result of slightly different sampling locations, preceding seasonal conditions or time of year sampling took place, as no other trends have arisen from the data.

Figure 6. Average ($\pm 1SE$) velocity (m / s) measured at the reference and rehabilitation sites (top) and at each of six transects, at each of the eight Avon River Precinct sites (bottom) for the baseline study (2013, black bars), one-year post-rehabilitation (2014, white bars), three-years post-rehabilitation (2017, grey bars) and six-years post-rehabilitation (this survey – 2020, grey pattern bars).

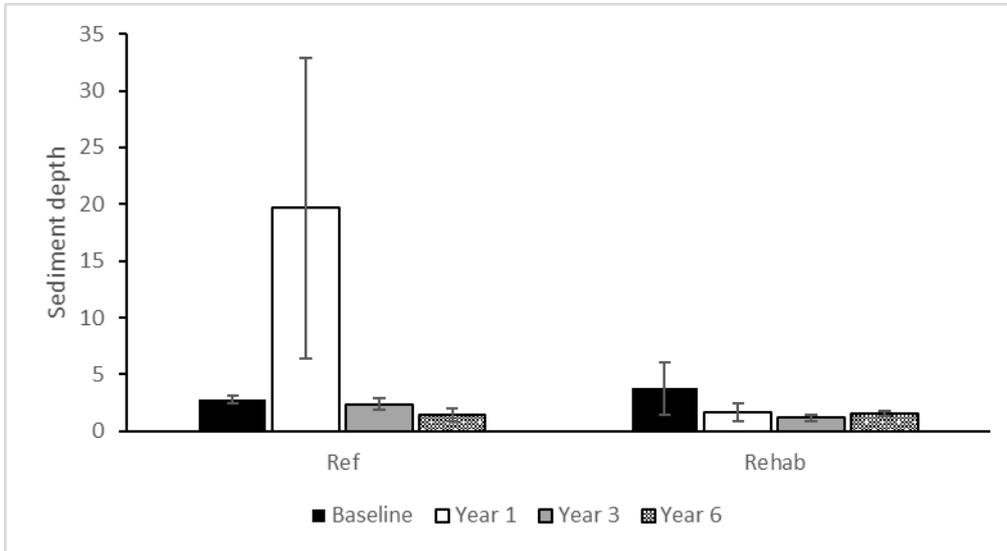
rehabilitation and reference sites in 2014. Sediment depth was greater at reference sites than at rehabilitation sites in 2014. It is probable that differences in measurement methodology have influenced this result⁹.

Figure 7. Average ($\pm 1SE$) sediment depth (cm) measured at the reference and rehabilitation sites for the baseline study (2013, black bars), one-year post-rehabilitation (2014, white bars), three-years post-rehabilitation (2017, grey bars) and six-years post-rehabilitation (this survey – 2020, grey pattern bars).

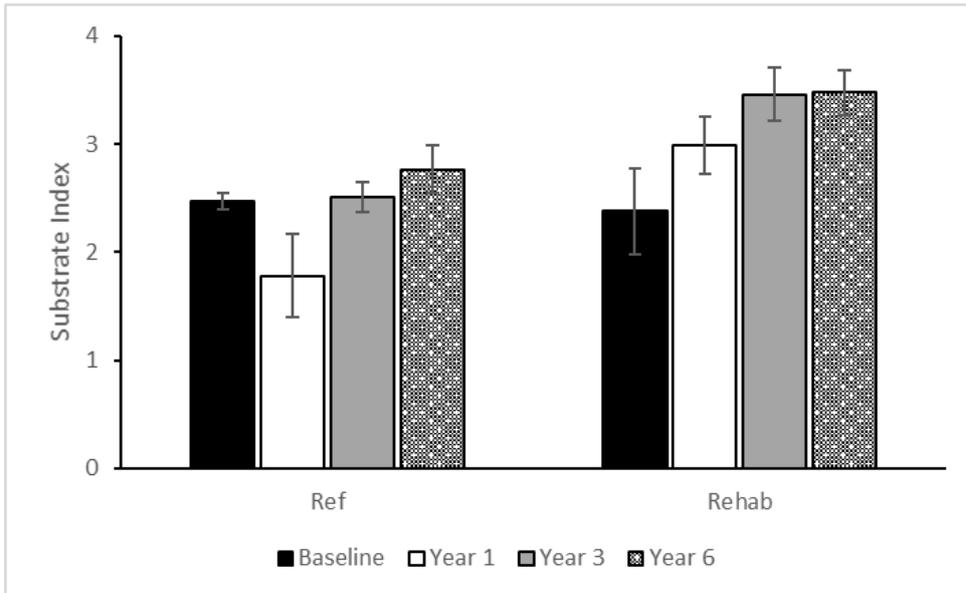
The calculated Substrate Index was significantly greater at rehabilitation sites than at reference sites ($F_{1,24} = 4.72$, $P < 0.01$), indicating that rehabilitation sites had larger-sized substrate particles than that found at reference sites (Figure 8). The average SI at rehabilitation sites was 3.1 and SI at reference sites was 2.4. There was also a significant difference between surveys ($F_{3,24} = 3.31$, $P < 0.05$), and post-hoc Tukey tests showed this difference was due to SI being greater (i.e. substrate was larger) in this survey (2020) compared to the baseline survey (2013). It appears that rehabilitation works has resulted in increased substrate size (i.e. coarser substrates).

Figure 8. Average ($\pm 1SE$) Substrate Index measured at the reference and rehabilitation sites for the baseline study (2013, black bars), one-year post-rehabilitation (2014, white bars), three-years post-rehabilitation (2017, grey bars) and six-years post-rehabilitation (this survey – 2020, grey pattern bars).

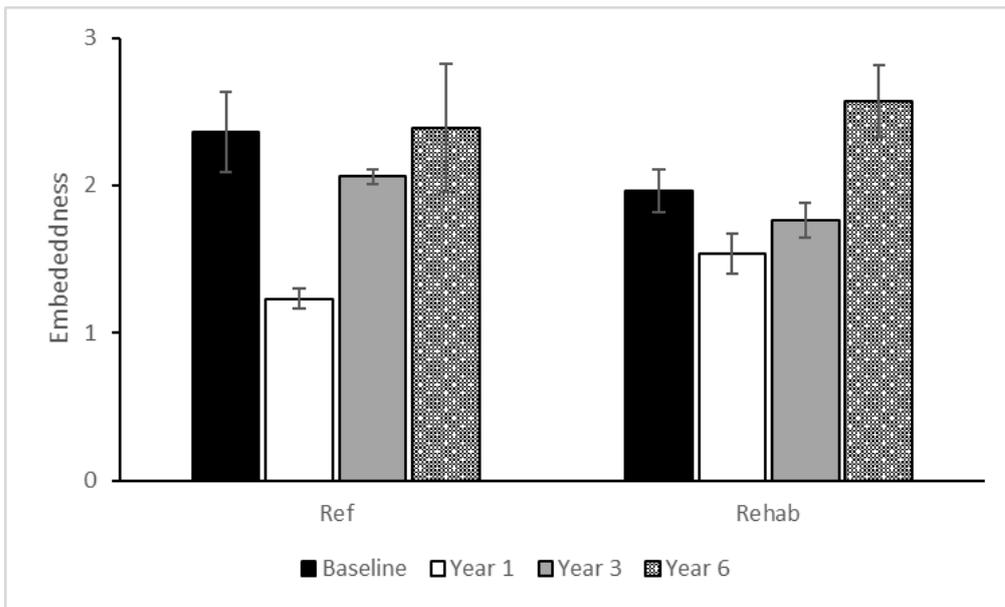
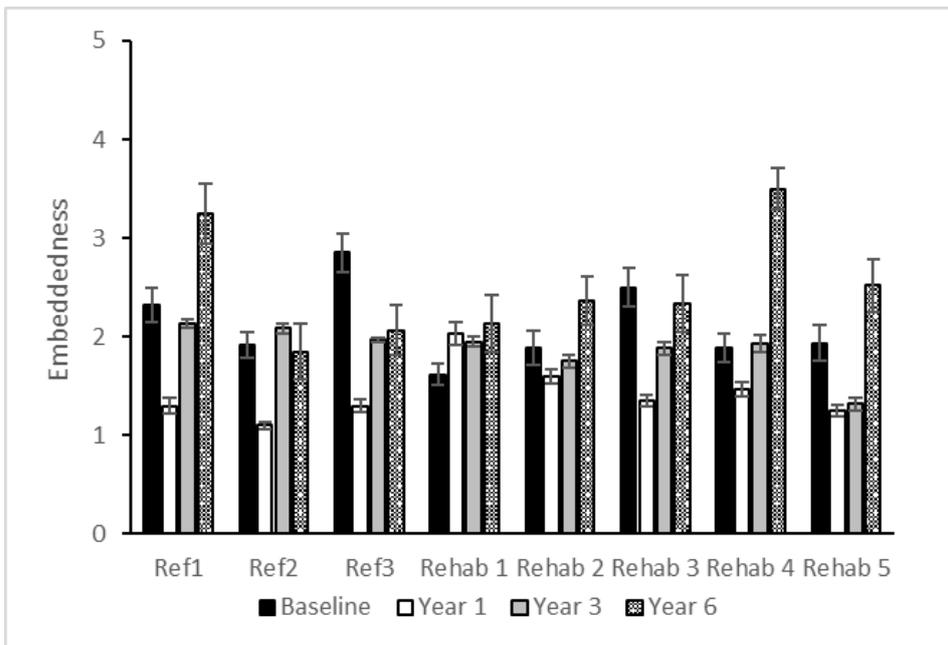
There was no noticeable difference in embeddedness between reference and rehabilitation sites in this survey. When all data were included in the analysis, again there was no significant difference in embeddedness between reference and rehabilitation sites ($F_{1,24} = 0.03$, $P = 0.685$) (Figure 9). There was, however, a significant difference detected in embeddedness between surveys ($F_{3,24} = 4.96$, $P < 0.01$). Pairwise comparisons showed a significant difference between the baseline and 2014 surveys, where embeddedness was lower in 2014. There was also a significant difference in average embeddedness between this survey (2020) and the previous survey (2017) with embeddedness being significantly higher in 2020. Substrates appear to be becoming more embedded at rehabilitation sites with time since the rehabilitation activities.

Figure 9. Average ($\pm 1SE$) embeddedness measured across the reference and rehabilitation sites (top) and at each of six transects, at each of the eight Avon River Precinct sites (bottom) for the baseline study (2013, black bars), one-year post-rehabilitation (2014, white bars), three-years post-rehabilitation (2017, grey bars) and six-years post-rehabilitation (this survey – 2020, grey pattern bars).

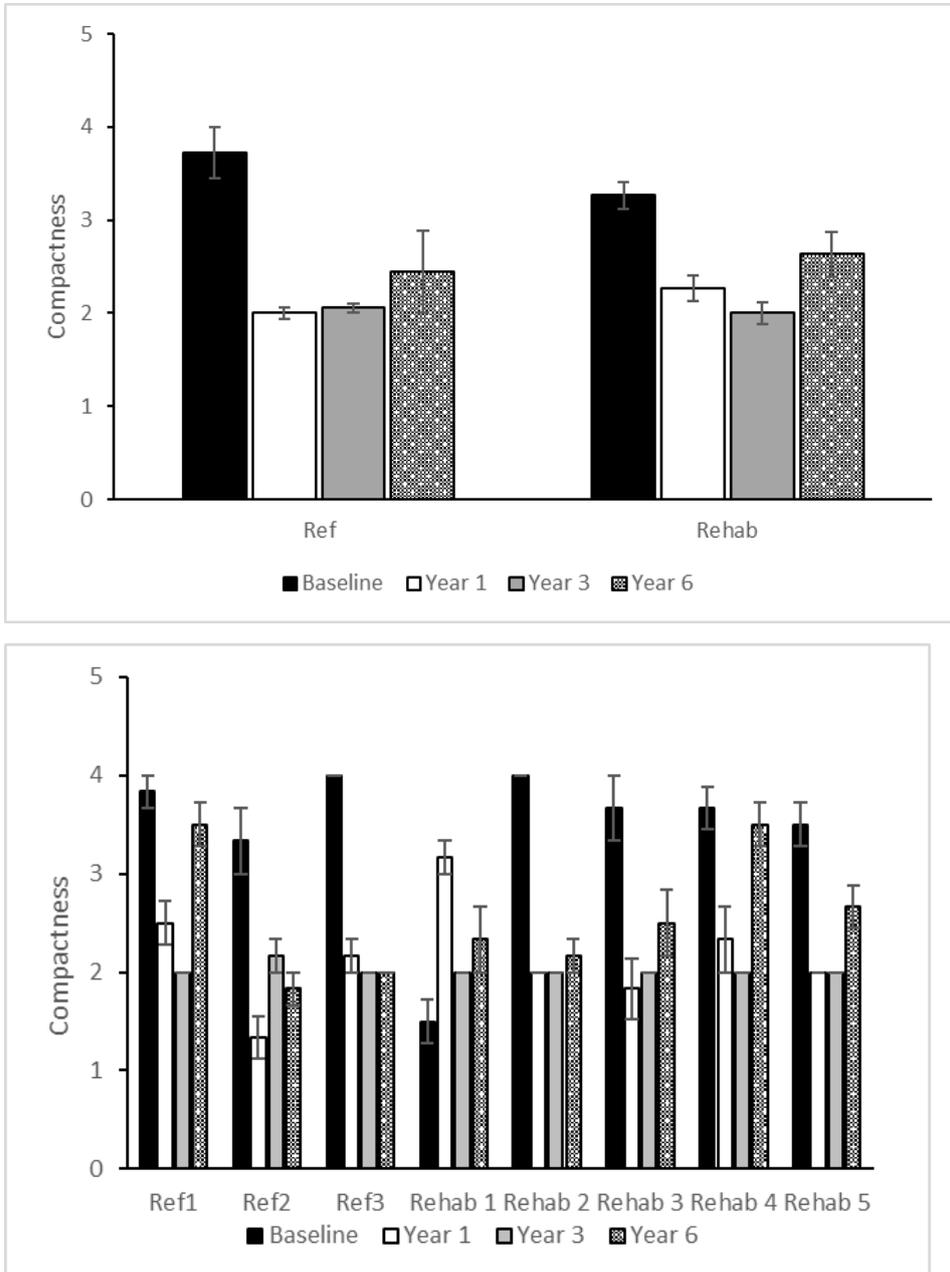
two subsequent surveys. Substrates appear to be becoming more compacted at rehabilitation sites with time since the rehabilitation activities.

Figure 10. Average ($\pm 1SE$) compactness measured across the reference and rehabilitation sites (top) and at each of six transects, at each of the eight Avon River Precinct sites (bottom) for the baseline study (2013, black bars), one-year post-rehabilitation (2014, white bars), three-years post-rehabilitation (2017, grey bars) and six-years post-rehabilitation (this survey – 2020, grey pattern bars).

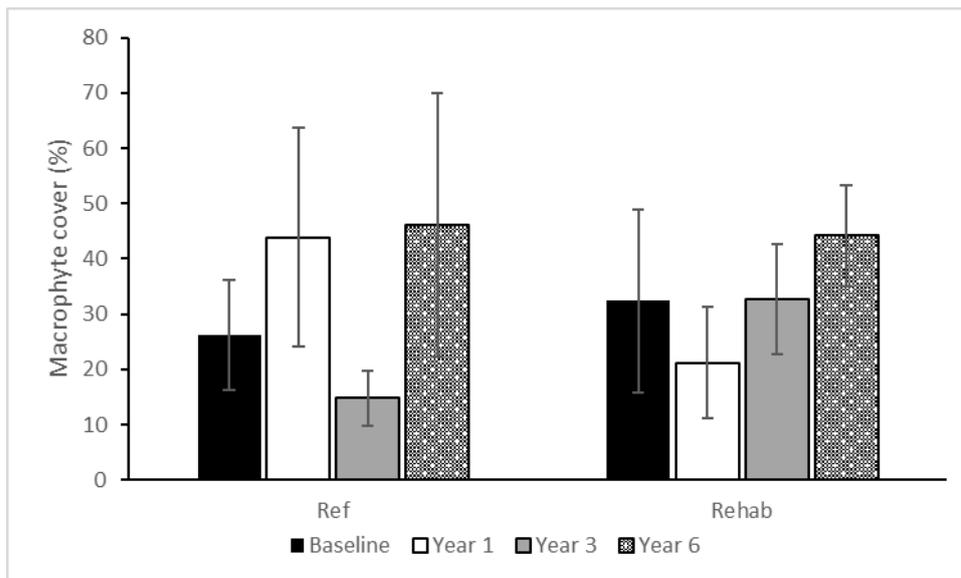
Given that macrophytes are regularly cleared in the Avon River, these results are unsurprising – differences in macrophyte cover resulting from rehabilitation works are likely to be obscured by intermittent changes in macrophyte cover due to clearance.

Figure 11. Average ($\pm 1SE$) macrophyte cover (%) measured at the reference and rehabilitation sites (top) and at each of six transects, at each of the eight Avon River Precinct sites (bottom) for the baseline study (2013, black bars), one-year post-rehabilitation (2014, white bars), three-years post-rehabilitation (2017, grey bars) and six-years post-rehabilitation (this survey – 2020, grey pattern bars).

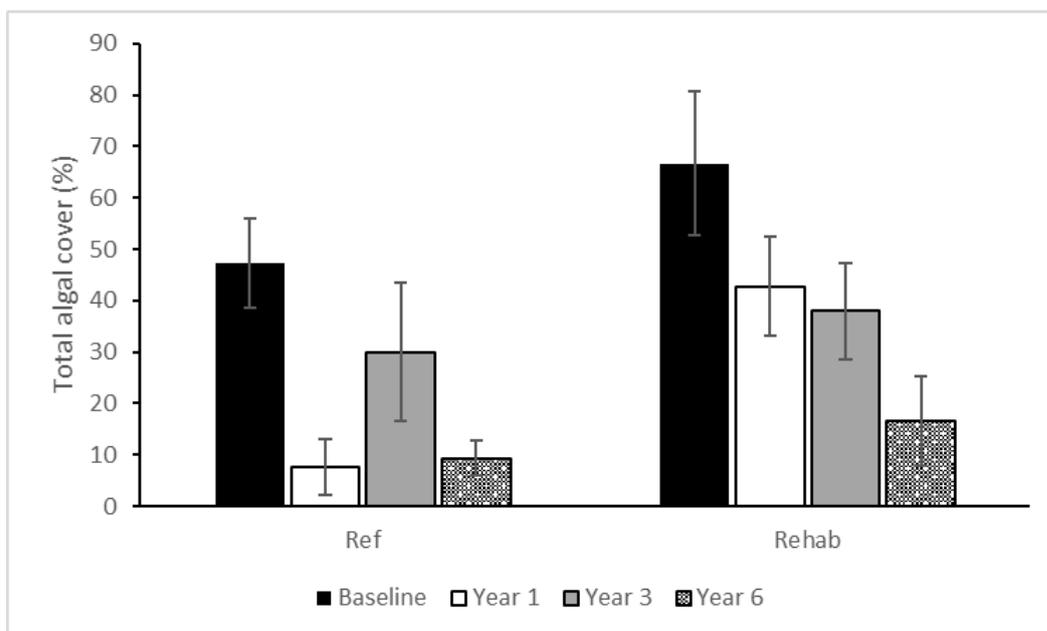
Variability was also observed in algal cover at reference and rehabilitation sites in this survey, where algae was virtually absent at some sites and at up to 40% cover on average at others. When all data were analysed, average algal cover was found to be significantly higher at rehabilitation sites than at reference sites ($F_{1,24} = 280.6, P < 0.05$) (Figure 12). There was also a significant difference amongst years ($F_{3,24} = 1028.3, P < 0.01$). Post-hoc Tukey tests showed algal cover was significantly lower in 2020 than in 2013 (baseline) and 2017 (three-year post-rehabilitation). Additionally, algal cover was higher in 2017 than in 2014.

Figure 12. Average ($\pm 1SE$) algal cover (%) measured at the reference and rehabilitation sites (top) and at each of six transects, at each of the eight Avon River Precinct sites (bottom) for the baseline study (2013, black bars), one-year post-rehabilitation (2014, white bars), three-years post-rehabilitation (2017, grey bars) and six-years post-rehabilitation (this survey – 2020, grey pattern bars).

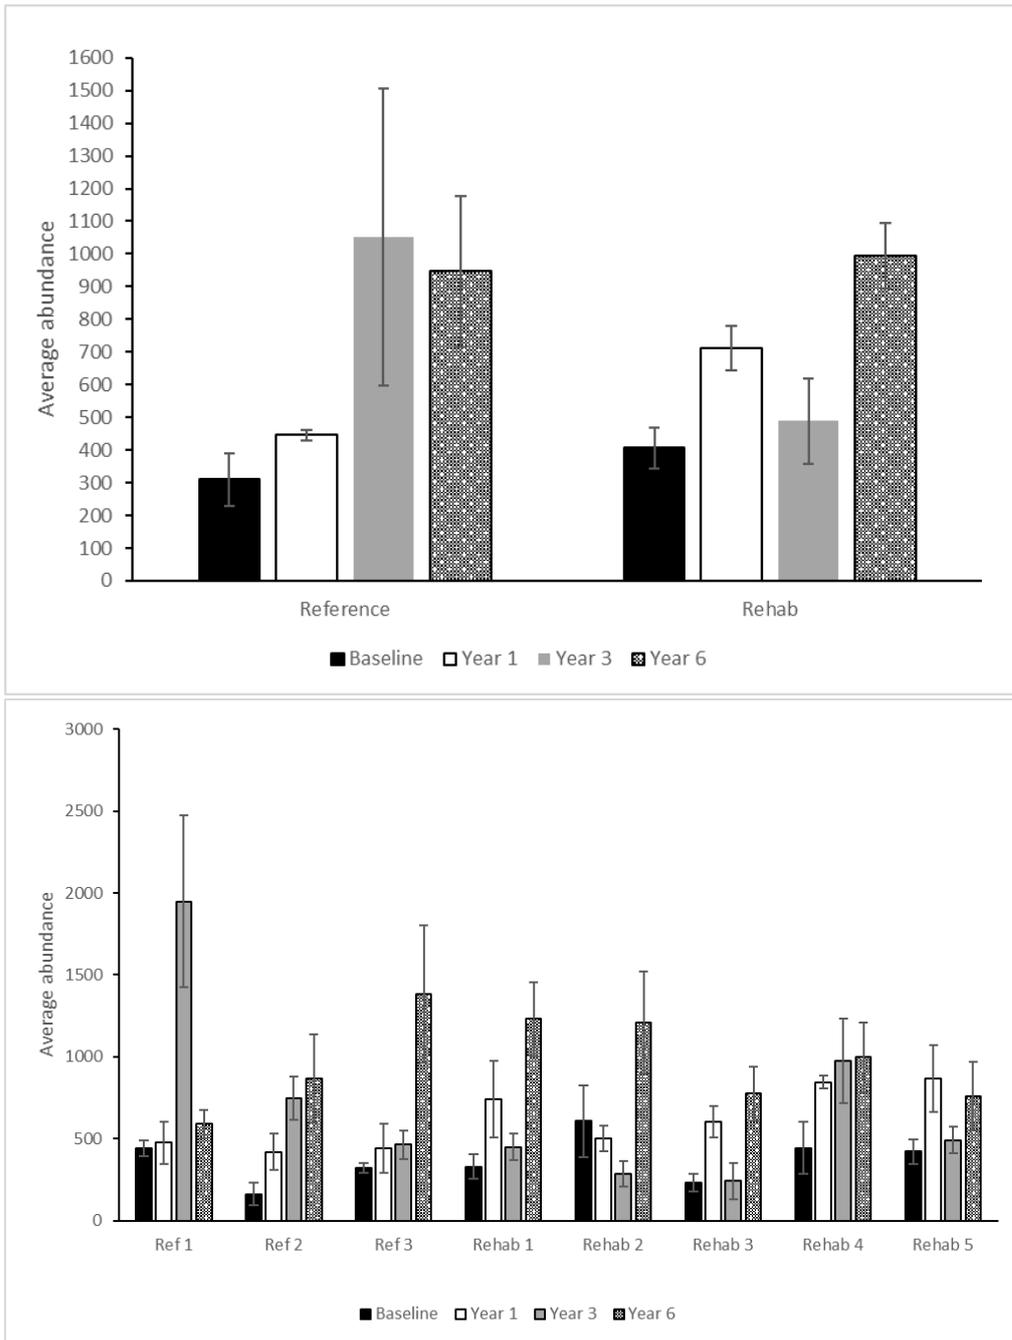
Figure 13. Average ($\pm 1SE$) macroinvertebrate abundance from Surber samples measured across the reference and rehabilitation sites (top) and at each of six transects, at each of the eight Avon River Precinct sites (bottom) for the baseline study (2013, black bars), one-year post-rehabilitation (2014, white bars), three-years post-rehabilitation (2017, grey bars) and six-years post-rehabilitation (this survey – 2020, grey pattern bars).

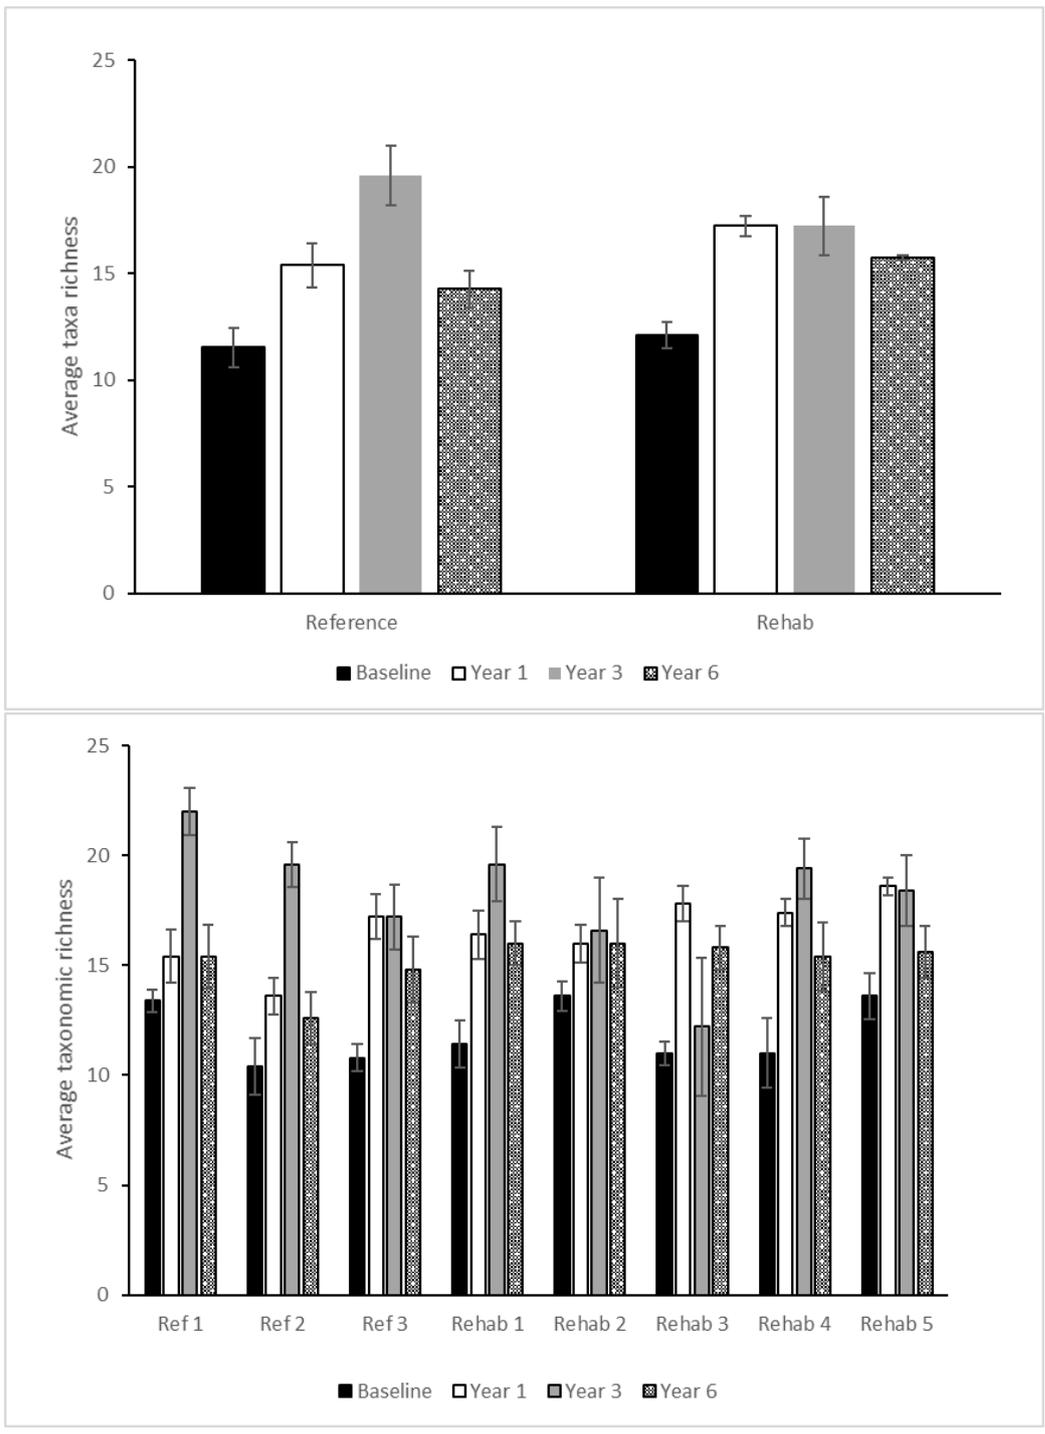
Figure 14. Average ($\pm 1SE$) taxonomic richness from Surber samples measured across the reference and rehabilitation sites (top) and at each of six transects, at each of the eight Avon River Precinct sites (bottom) for the baseline study (2013, black bars), one-year post-rehabilitation (2014, white bars), three-years post-rehabilitation (2017, grey bars) and six-years post-rehabilitation (this survey – 2020, grey pattern bars).

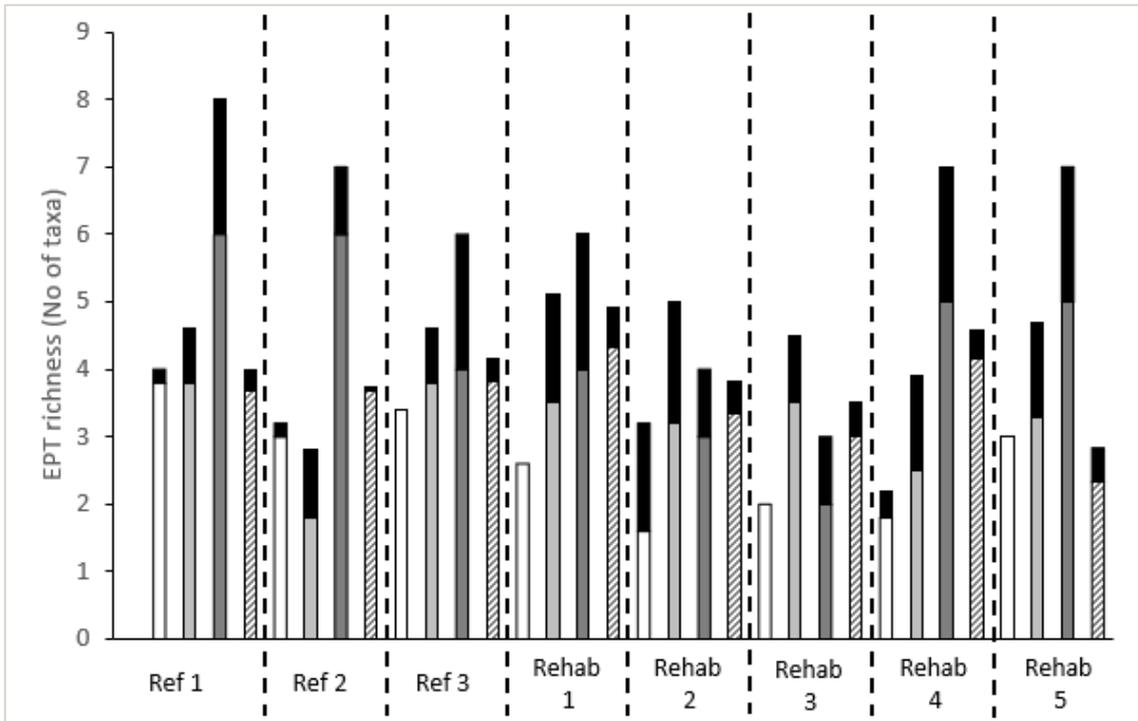
When the pollution tolerant taxa *Oxyethira* and *Paroxythira* were excluded from the analysis, a significant difference in EPT taxa richness was found between rehabilitation and reference sites ($F_{1,24} = 0.209$, $P < 0.05$), where EPT taxa richness was higher at reference sites than at rehabilitation sites. There was also a significant difference in average EPT taxa found among years, though the only significant difference, shown through a post-hoc Tukey test, was between the 2013 and 2017 surveys ($P < 0.01$).

Figure 15. Average EPT richness (light bars) and hydroptilid richness (black bars) collected from Surber samples at all eight sites from for the baseline study (2013, white bars), one-year post-rehabilitation (2014, light grey bars), three-years post-rehabilitation (2017, dark grey bars) and six-years post-rehabilitation (this survey – 2020, grey striped bars). Note, the vertical dotted line is for visual aid to differentiate between sites. SE bars are not shown.
