Avon River Precinct Aquatic Ecology

Six-years' post-rehabilitation activities
Prepared for Christchurch City Council

21 July 2020

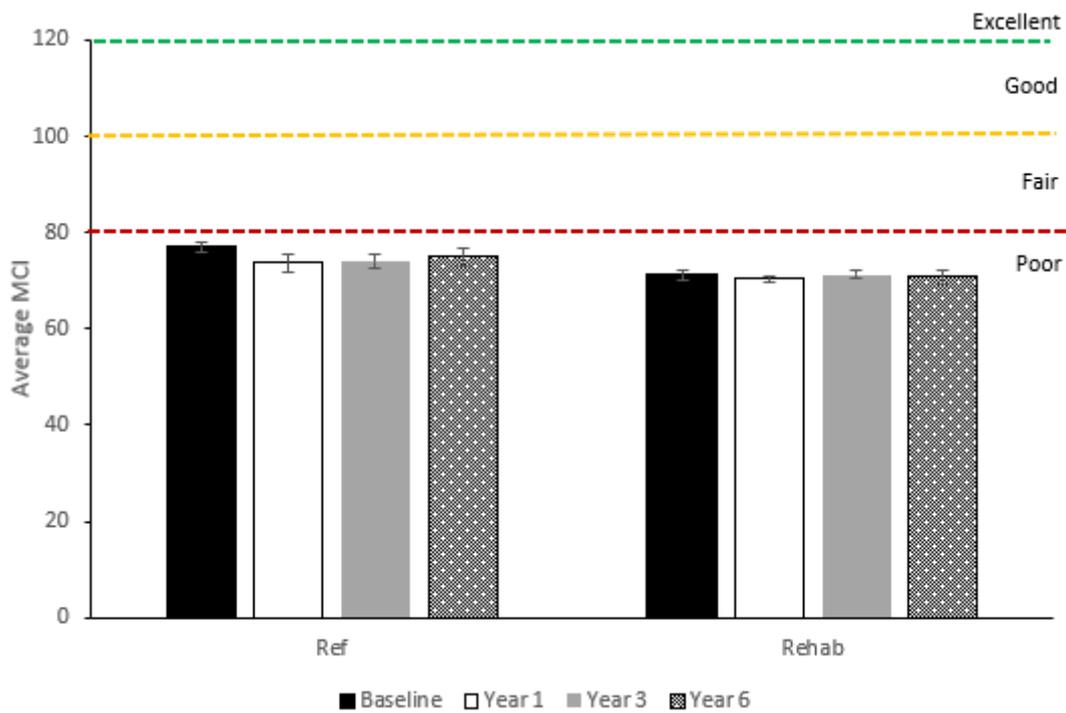
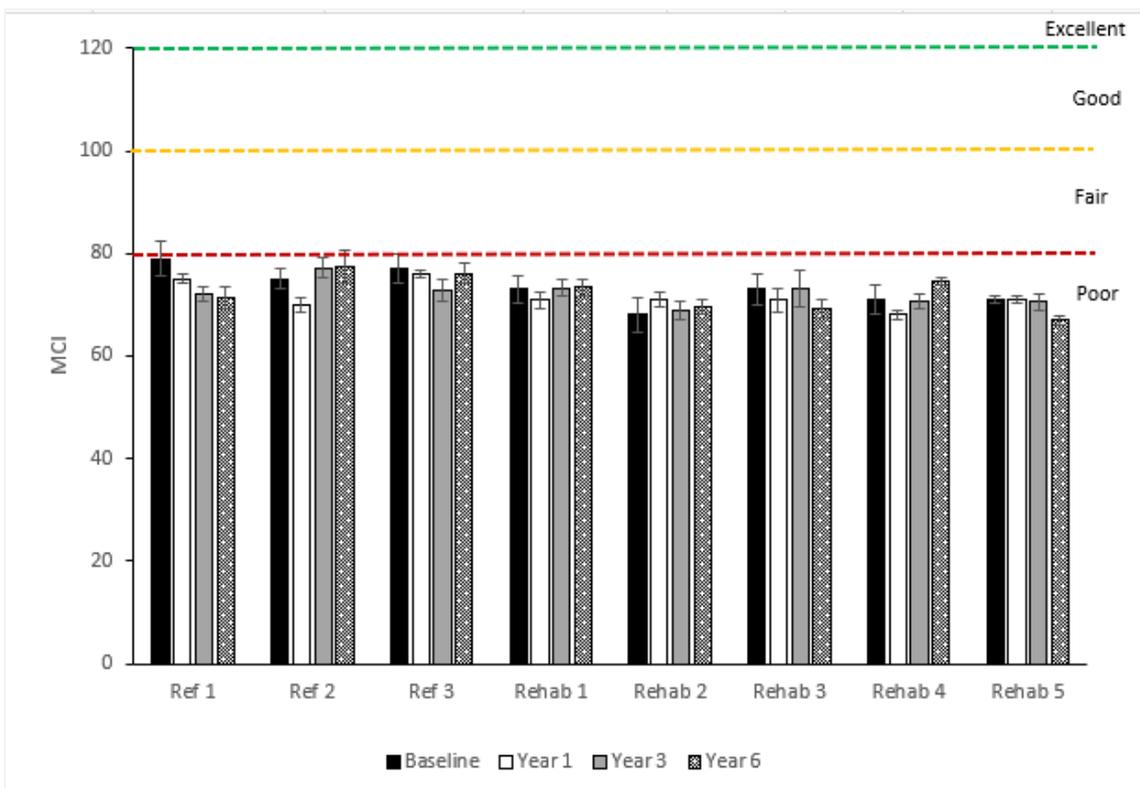
All sites in all years had MCI scores below 80, indicating “poor” stream health with “probable or severe enrichment” (based on the water quality categories of Stark and Maxted 2007). There was no significant difference in MCI score averages over time ($F_{3,24} = 12.44$, $P = 0.565$).

Figure 16. Average ($\pm 1SE$) Macroinvertebrate Community Index (MCI) measured across the reference and rehabilitation sites (top) and at each of six transects, at each of the eight Avon River Precinct sites (bottom) for the baseline study (2013, black bars), one-year post-rehabilitation (2014, white bars), three-years post-rehabilitation (2017, grey bars) and six-years post-rehabilitation (this survey – 2020, grey pattern bars). The dashed lines indicate the water quality categories of Stark and Maxted (2007). See Table 2 for further information.

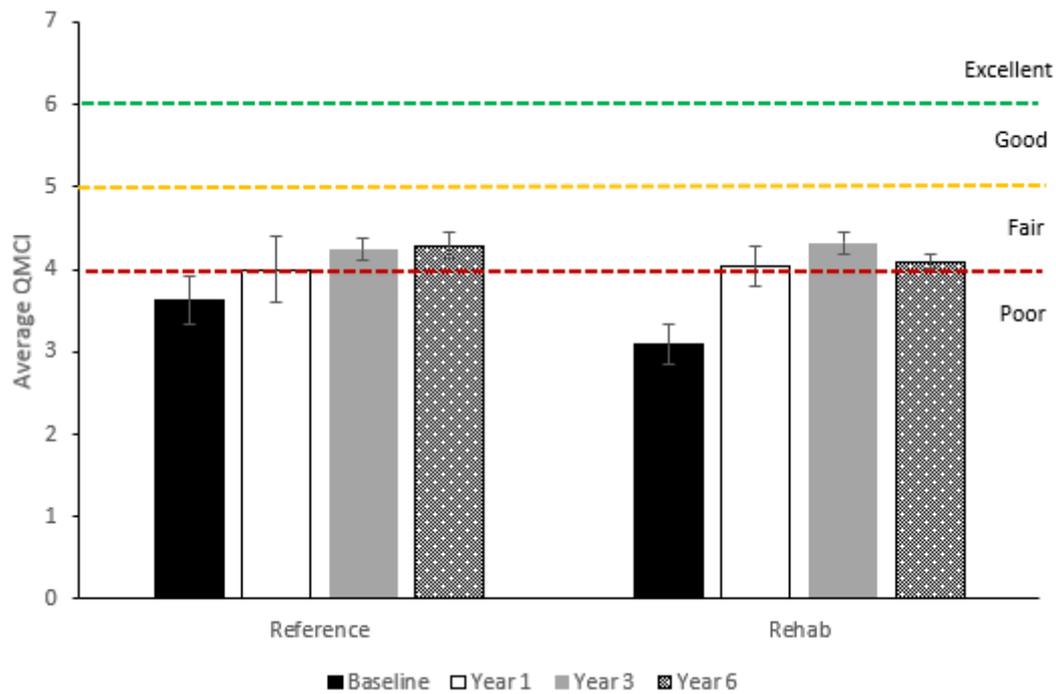
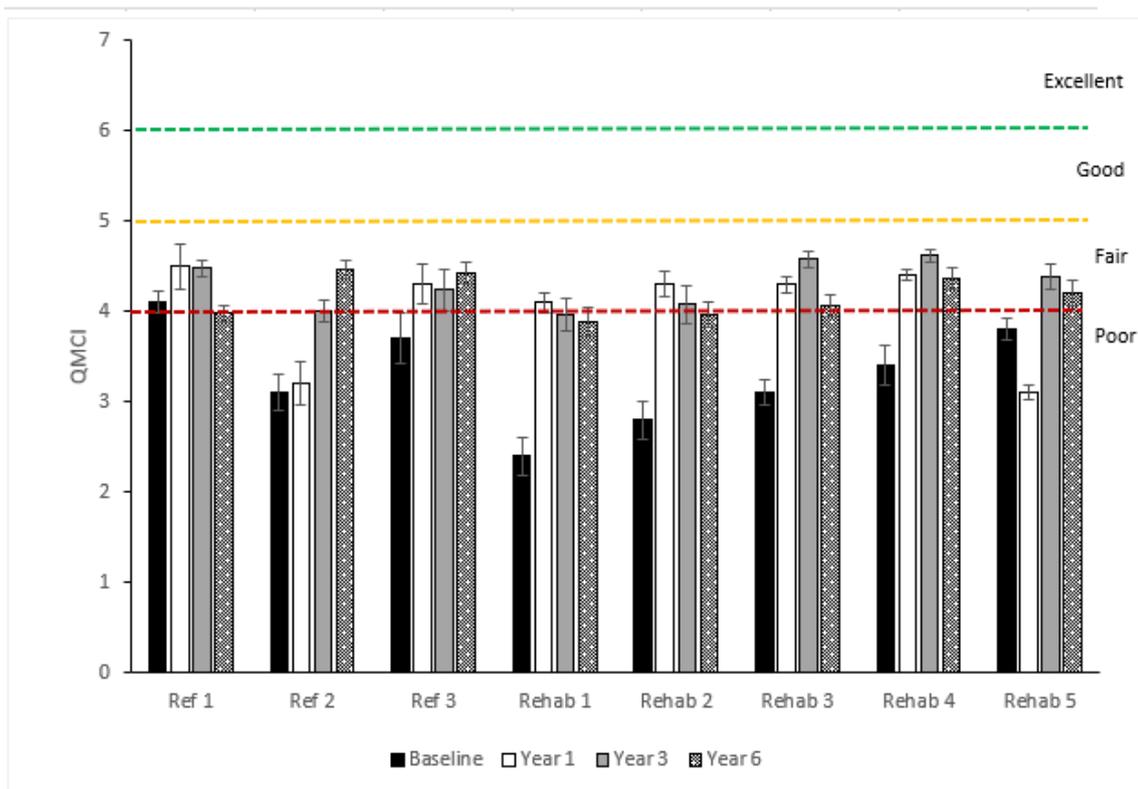
Figure 17. Average ($\pm 1SE$) QMCI measured across the reference and rehabilitation sites (top) and at each of six transects, at each of the eight Avon River Precinct sites (bottom) for the baseline study (2013, black bars), one-year post-rehabilitation (2014, white bars), and three-years post-rehabilitation (2017, grey bars) and six-years post-rehabilitation (this survey – 2020, grey pattern bars). The dashed lines indicate the threshold between water quality categories of Stark and Maxted (2007). See Table 2 for further information.

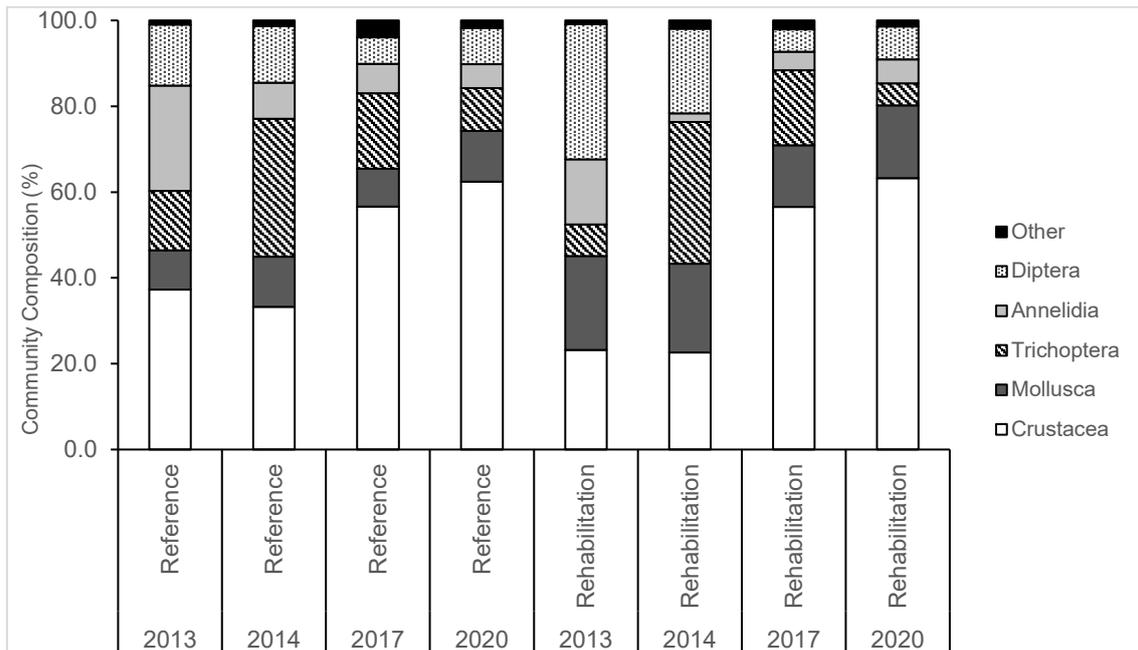
Figure 18. Average macroinvertebrate community composition (%) found at reference and rehabilitation sites across the baseline survey (2013), one-year post-rehabilitation (2014), three-years post-rehabilitation (2017) and six-years post-rehabilitation (2020) surveys.

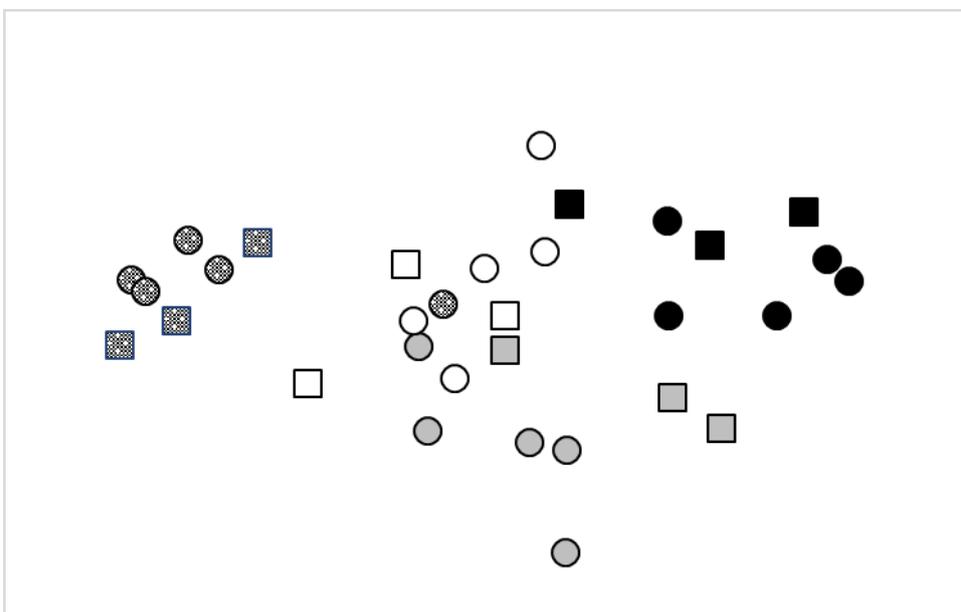
Figure 19. Non-metric multidimensional scaling (NMDS) ordination based on a Bray-Curtis matrix of dissimilarities calculated from macroinvertebrate abundance data collected from the eight sites surveyed in 2013 (baseline survey – black symbols; Boffa Miskell 2014), 2014 (one-year post-rehabilitation – white symbols; Opus 2015), 2017 (three-years post-rehabilitation – grey symbols) and 2020 (six-years post-rehabilitation, grey-pattern symbols; this study). Reference sites are shown as squares; rehabilitation sites are shown as circles. Axes are identically scaled so that sites closest together are more similar in macroinvertebrate composition, than those further apart. The 2-dimensional stress value was 0.18. The significance of differences in community dissimilarity was confirmed using Analysis of Similarities (ANOSIM).

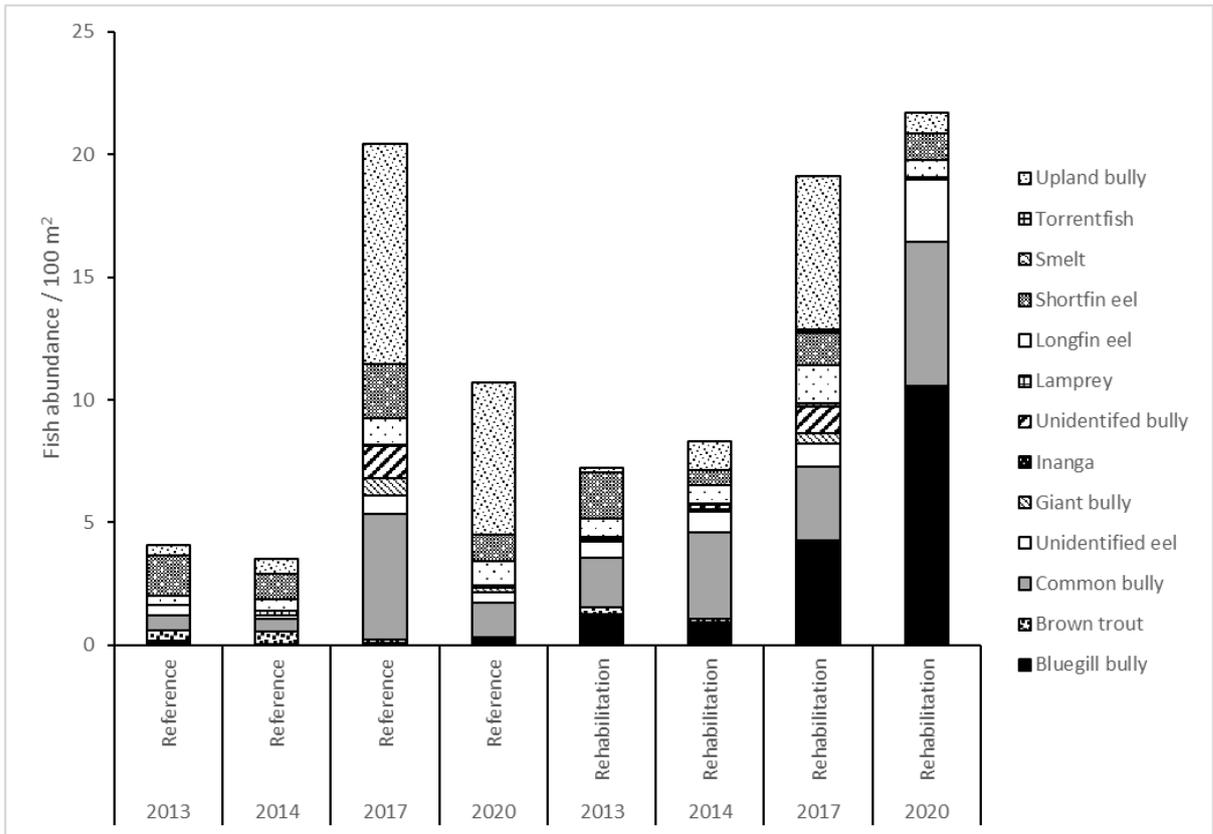
Figure 20. Total abundance of fish, separated by species, found at reference and rehabilitation sites across the baseline survey (2013), one-year post-rehabilitation (2014), three-years post-rehabilitation (2017) and six-years post-rehabilitation (2020) surveys. Numbers are show as catch per unit effort (CPUE): per 100 m² of waterway surveyed using electric fishing.

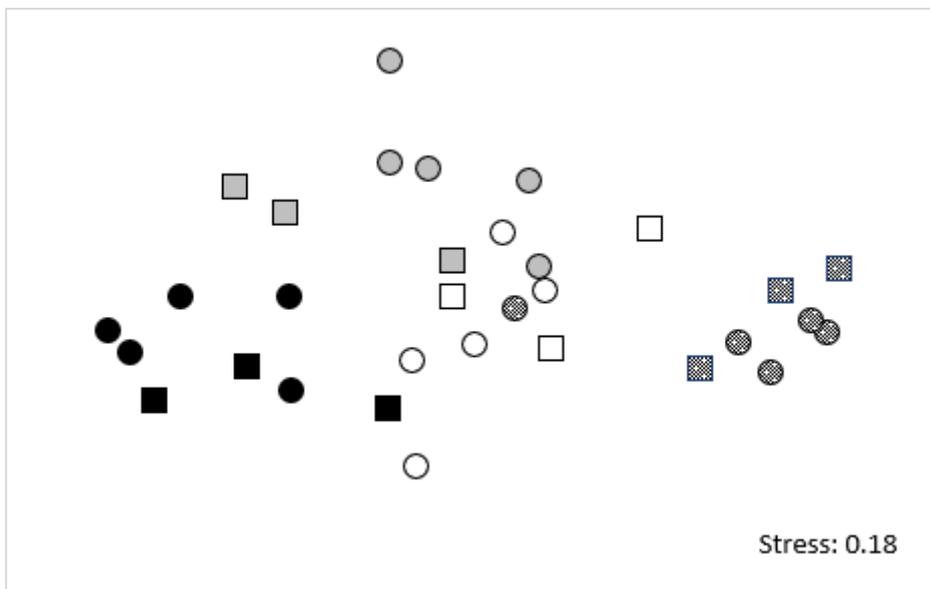
Figure 21. Non-metric multidimensional scaling (NMDS) ordination based on a Bray-Curtis matrix of dissimilarities calculated from fish abundance (CPUE) data collected from the eight sites surveyed in in 2013 (baseline survey – black squares; Boffa Miskell 2014), 2014 (one-year post-rehabilitation – white squares; Opus 2015), 2017 (three-years post-rehabilitation – grey squares) and 2020 (six-years post-rehabilitation, grey-pattern squares; this study). Reference sites are shown as squares; rehabilitation sites are shown as diamonds. Axes are identically scaled so that sites closest together are more similar in macroinvertebrate composition, than those further apart. The significance of differences in community dissimilarity was confirmed using Analysis of Similarities (ANOSIM).
