# River-corridor restoration and whitebait conservation in Steam Wharf Stream, Christchurch

Prepared for  
Christchurch City Council  
July 2020

Report WL20072 for Christchurch City Council  
© Copyright Waterlink Ltd

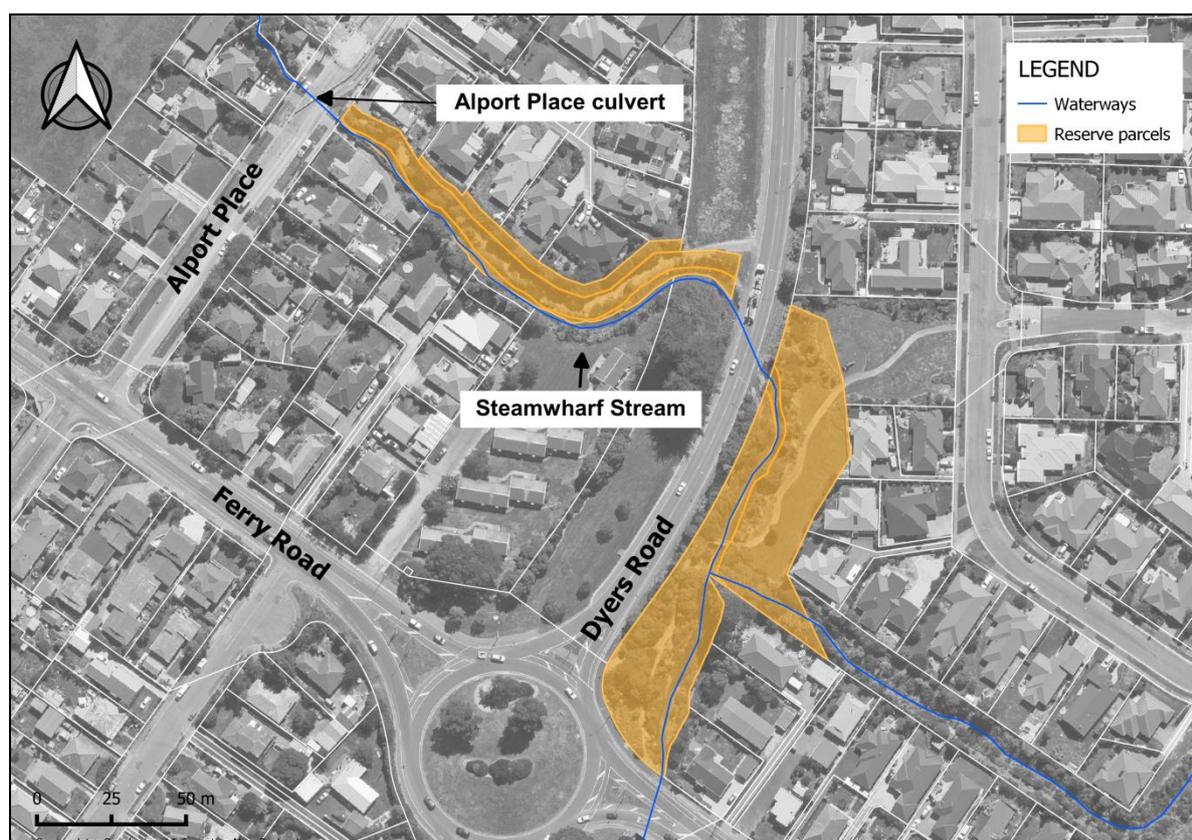
Fig. 1. Overview of the Steamwharf Stream survey area in the lower Heathcote Ōpāwaho catchment.

The Canterbury earthquakes caused widespread changes in Christchurch's natural environments, particularly towards the east of the city in the vicinity of the estuary and waterways (Orchard et al. 2020). In addition to widespread hydrological changes, many waterways were affected by small scale bank collapses, lateral spread and liquefaction (Orchard 2017a; Quigley et al. 2016). These effects were pronounced at Steamwharf Stream in the lower Heathcote Ōpāwaho catchment, where stream bank vegetation has been slow to recover. As part of its wider waterway management work, Christchurch City Council (CCC) has initiated a programme of riparian restoration work at the stream with a focus on the local purpose reserve lands near Dyers Road, and attention to maintenance of the stream bed (Fig. 1).

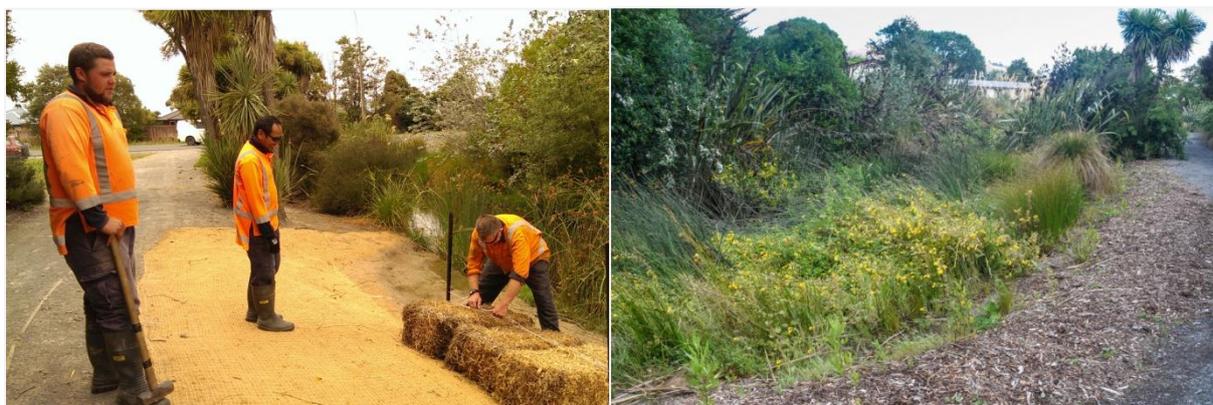
**Fig. 2.** (a) Bank stabilisation restoration work in 2018, which included the installation of straw bales as a mitigation measure to provide temporary spawning habitat. (b) View of the same site in 2020 showing newly established rushes, *Carex* and riparian herbs.

In the current study, these aspects have been investigated in two ways. Firstly, a four month census survey was completed to provide a direct comparison to the 2018 survey results. In addition, a fish survey was completed at the beginning of the spawning season (February) to help assess the status of the Alport Place culvert as a potential migration barrier. Working hypotheses included that the Alport Place culvert was a barrier to migration, but that improved riparian and in-stream habitat conditions downstream would have benefitted the fish population relative to 2018. Therefore, we expected to see a) an abundance of adult fish below the Alport Place culvert at the beginning of the spawning season, b) a lack of adult fish above the culvert, and c) improved egg production in comparison to 2018. We were also hoping that some of the restoration sites may be supporting spawning as they were planted with suitable species with this in mind (Fig. 2).

In February, a single spawning site was recorded in the survey reach at the restoration site shown in Fig. 2. It was a relatively large site (5.1 m<sup>2</sup>) that occupied a terrace feature on the true left. Most of the eggs were laid in monkey musk (*Erythranthe guttata*) that had spread between planted rushes (*Juncus edgariae* and *J. sarophorus*), with kapungawha / lake club rush (*Schoenoplectus tabernaemontani*) also present nearby (Table 4). Total egg numbers were nearly 200, 000 eggs, making this a relatively productive site in comparison to others recorded in the catchment in recent years.

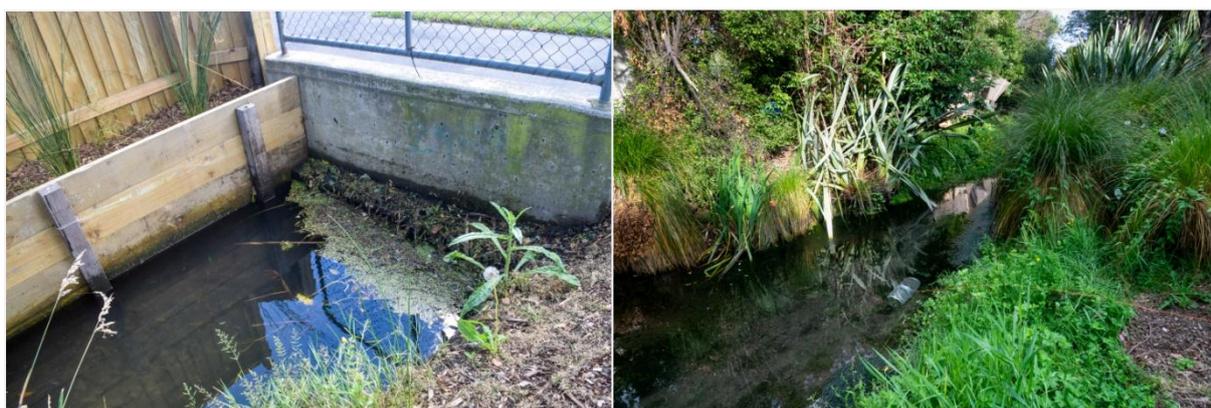
**Fig. 3.** (a) Alport Place box culvert showing the outlet structure which is fully submerged at typical water levels. (b) Steamwharf Stream in the reach below Alport Place at a GMT (minnow trap) sampling point.

For this project, the study area consisted of the reach between Alport Place and Dyers Road for spawning sites surveys based on previous experience (as above). For the fish surveys, the study areas were comparable reaches above and below the Alport Place culvert. This potential fish barrier has recently been investigated by CCC and found to have considerable blockages that likely caused by tree roots (S. Holder, pers. comm.), although flow through the culvert appears relatively unaffected (Fig. 3a). The culvert is a 3 m x 1.5 m concrete box approximately 20 m in length.

Despite the limitations of a single assessment, the combined results of the visual and fish trapping surveys suggest that the Alport Place culvert is presenting a barrier to fish migration. This is consistent with visual observations in 2019 and during other site visits in 2020 in which shoals of īnanga were often seen swimming against the flow at the culvert outlet structure and were not observed upstream (S. Orchard, unpubl. data). Although impacts on the discharge rate are relatively minor at present, the majority of the culvert length appears to be blocked with dense and/or fibrous material. Remediation of the culvert is therefore recommended to allow fish access to the upstream reach of Steamwharf Stream. This has the potential to restore connectivity to around 1 km of adult fish habitat.

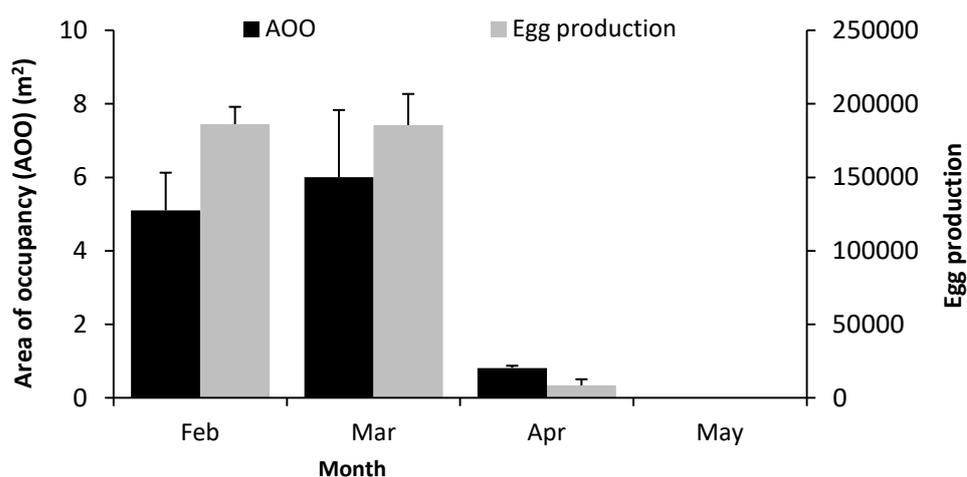
**Fig. 4.** Total area of occupancy and egg production of inanga spawning sites in Steamwharf Stream over four months in 2020.

In March most of the spawning was again located at the above site, with the area of occupancy and egg production being very similar to that recorded the month before (Fig. 4). Additional small sites were found downstream on the true left and a short distance upstream on the true right (sites 1 and 3, respectively, in Table 4).

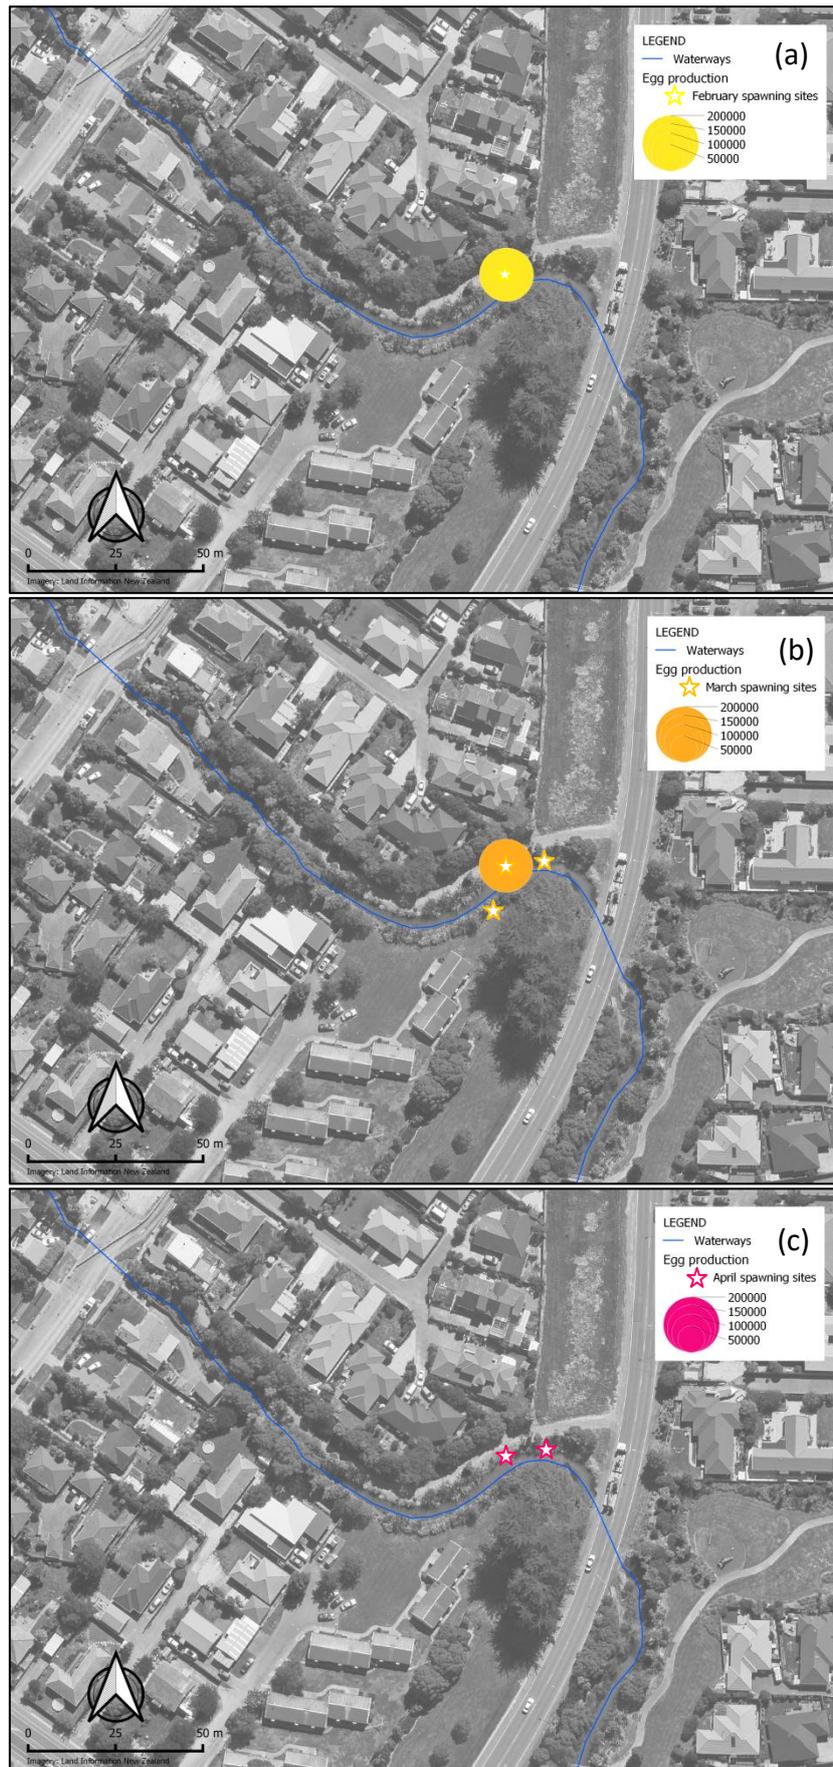
**Fig 5.** Egg production of inanga spawning sites over three months in Steamwharf Stream. a) February, (b) March, (c) April 2020. No spawning was record in a further survey in May.

The location of spawning sites and patterns of egg production is shown in Fig. 5.

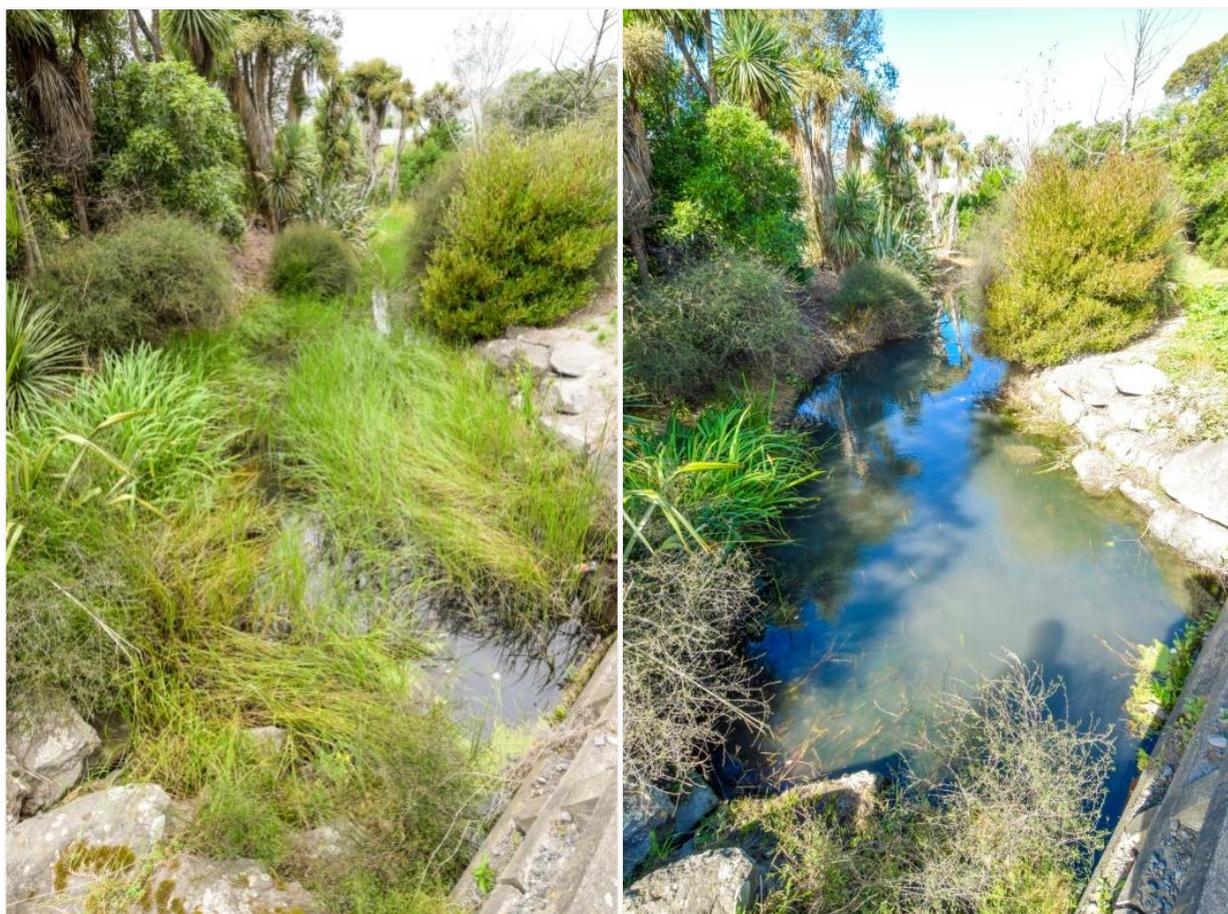
**Fig. 6.** Before (left) and after (right) the clearance of in-stream vegetation in March 2018 looking downstream from Dyers Road. Emergent vegetation beds would naturally cover a considerable percentage of the stream bed in this section of the waterway, and further downstream. The vegetation improves habitat values for fish by providing foraging areas and cover from predators.
