Subject: No.1 Drain Wetpond Hydrological Data Review
Attention: Christchurch City Council
From: Stuart Easton, Gareth Taylor
Date 08/06/2022
Copies to: Peter Christensen, Florian Risse

1 Introduction

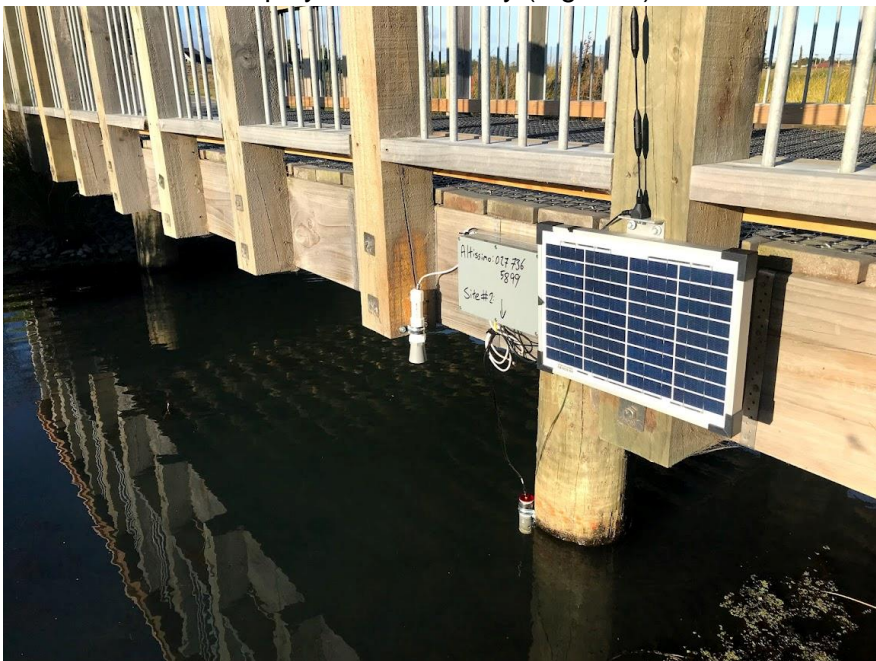
Figure 1. Custom logger system deployed in the pond location.

As part of the project a trial use of custom loggers was utilised to explore if a new cost effective solution could be deployed successfully (Figure 1).

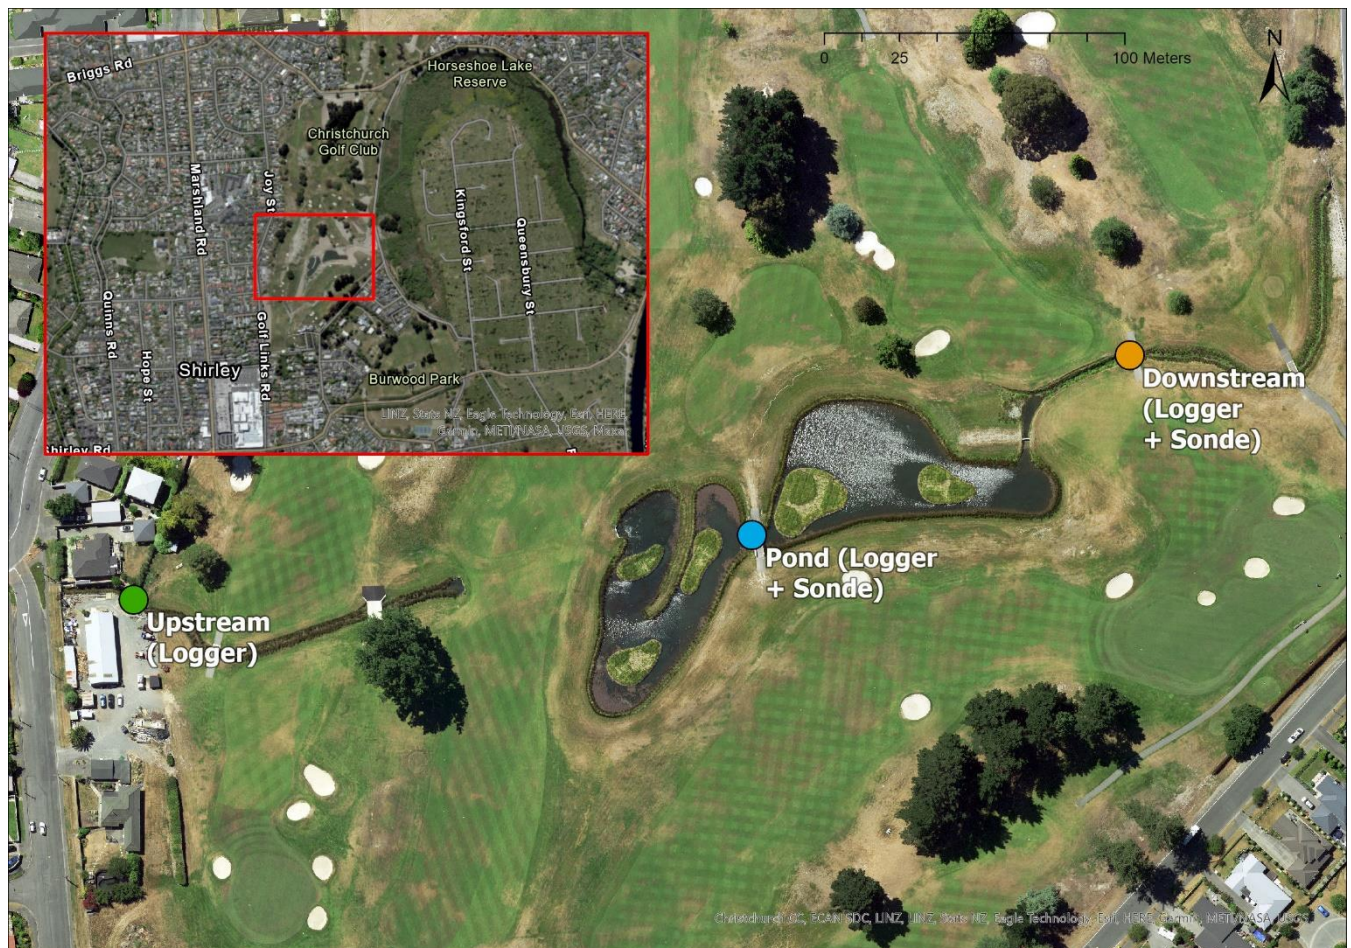
Figure 2. No.1 Wetpond and sensor locations

Data are derived from three custom water level, dissolved oxygen and temperature loggers (**Upstream**, **Pond**, and **Downstream**) which have been developed as an alternative option for cost effective monitoring and were being trailed as part of this project. CCC also installed two water quality Sondes (**Pond** and **Downstream**) operated by CCC over the summer months prior (Table 1). Text colour corresponds to **Figure 2** and the plots included in this memo. Rainfall data are from the NIWA Bromley Ews station¹.

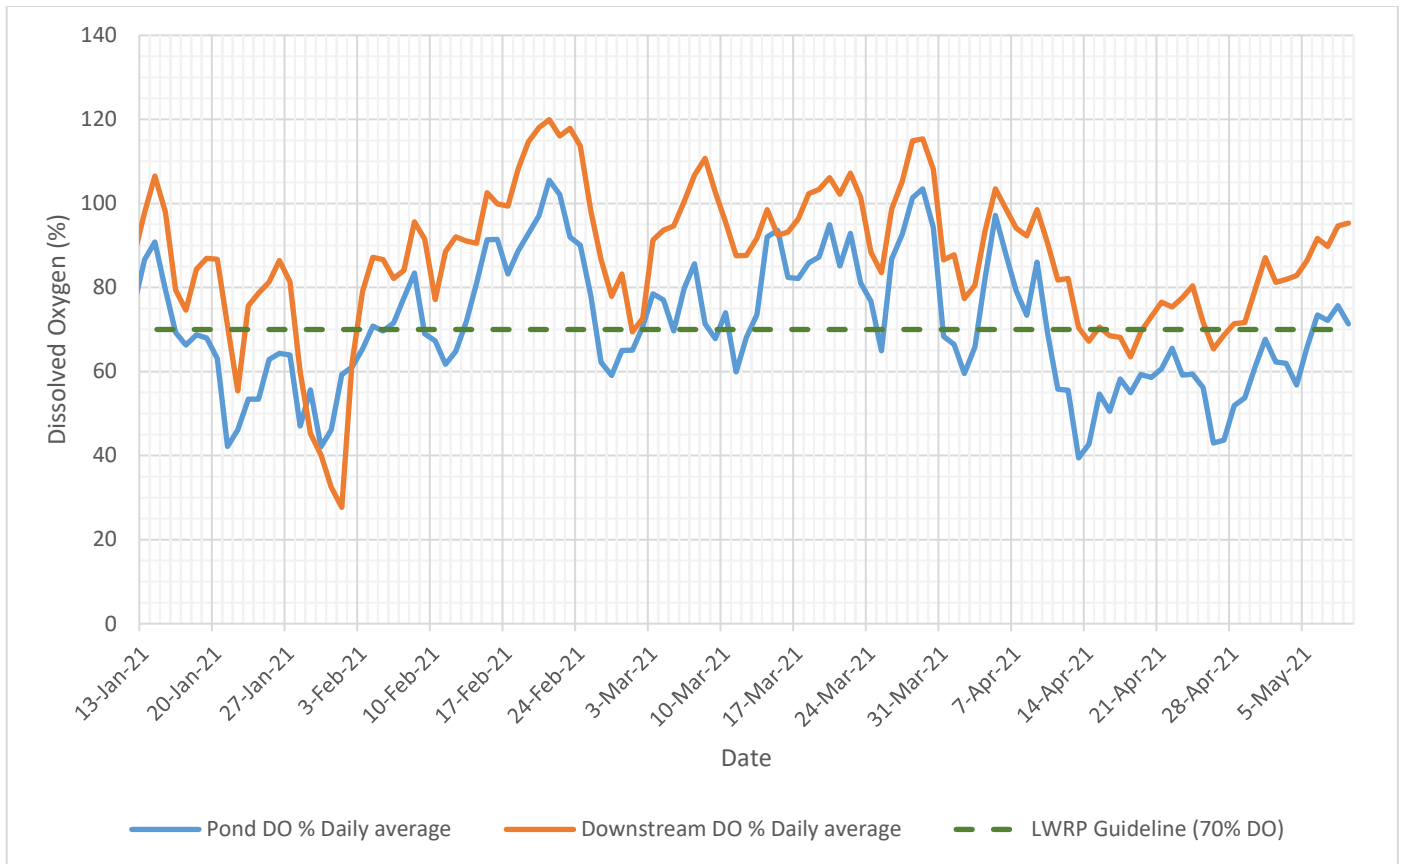
The LWRP dissolved oxygen ecological health indicator for ‘Spring-fed – plains – urban’ streams is $\geq 70\%$ ⁵; to be compared to median levels from one calendar year of monitoring. For the four months of available sonde data, the median DO level was 70.6% at the Pond, and 85.2% at the Downstream site, indicating satisfactory DO levels. Further monitoring over winter and spring is necessary to determine if the guideline will be met across the full calendar year. The LWRP Freshwater Outcomes and daily average DO levels are plotted in Figure 9.

Figure 9 Daily average DO % saturation and LWRP Freshwater Outcomes
