Charlesworth Drain Water and Sediment Quality, and Īnanga Spawning

July 2025

Prepared for:
Christchurch City Council

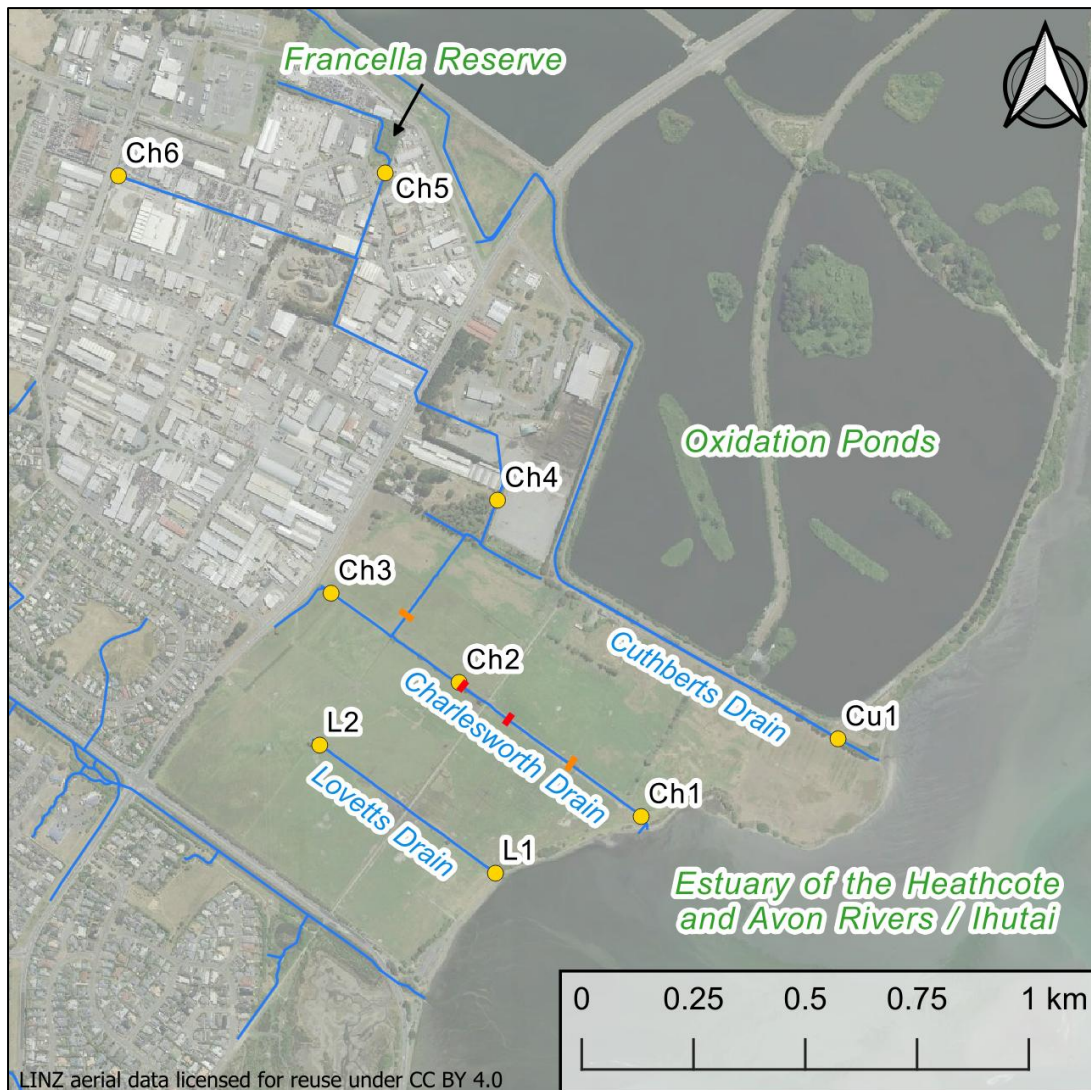
Figure 1: Location of water quality and sediment sampling sites. Section of Charlesworth Drain sampled for inanga eggs occurred between the orange markers while the intertidal salt wedge occurred between the red markers.

Table 1: Sampling locations.

Code	Waterway	Location	Easting	Northing
L1	Lovetts Drain	Near mouth	1576204	5178246
L2	Lovetts Drain	Mid-paddocks	1575811	5178532
Ch1	Charlesworth Drain	Near mouth	1576530	5178373
Ch2	Charlesworth Drain	Mid-paddocks	1576123	5178673
Ch3	Charlesworth Drain Branch No. 1	Downstream of Dyers Road ¹	1575836	5178872
Ch4	Charlesworth Drain	Immediately upstream of paddocks	1576209	5179080
Ch5	Francella Reserve Pond	Francella Reserve	1575957	5179813
Ch6	Charlesworth Drain	Downstream of Maces Road	1575361	5179806
Cu1	Cuthberts Drain	Near mouth	1576970	5178546

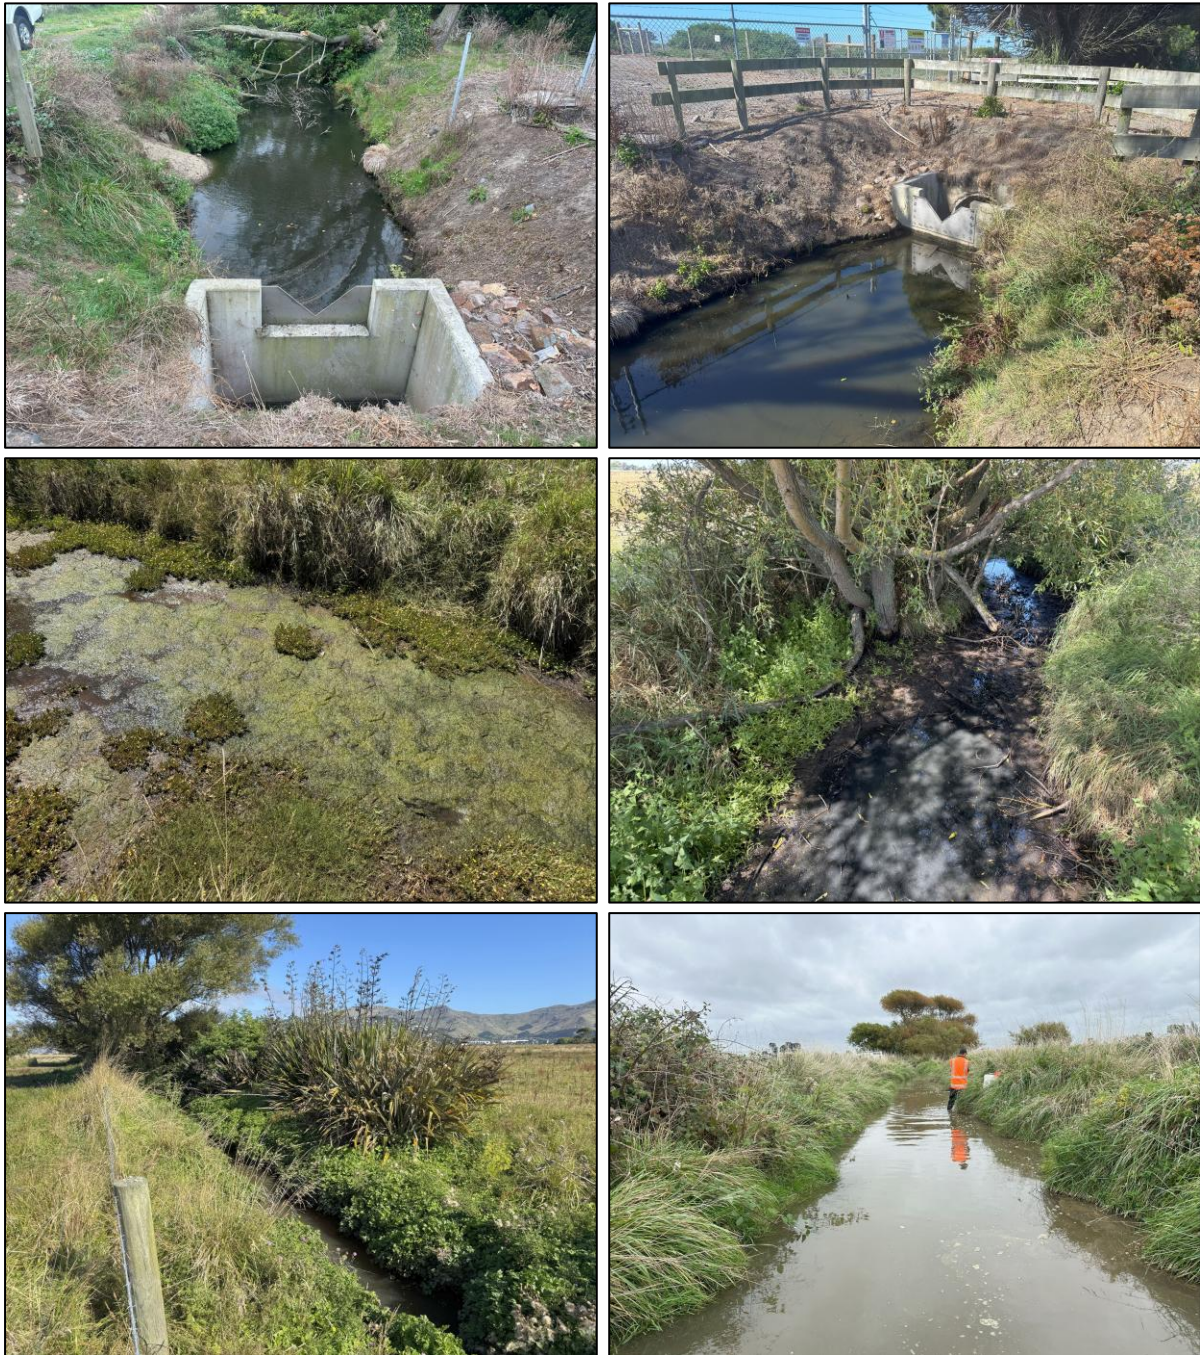
Figure 2: Weir preventing tidal ingress at Cuthberts Drain (top), a lack of freshwater inputs at Lovetts Drain (middle), and the suitable inanga spawning survey reach at Charlesworth Drain (bottom).

Inanga spawning surveys were conducted along Charlesworth Drain to identify the extent of suitable spawning habitat and egg production in the Linwood Paddocks. Cuthberts Drain and Lovetts Drain were also visited but were excluded from future monitoring due to there being no freshwater inputs into Lovetts Drain (evident at low tide) and a large weir structure near the downstream extent of Cuthberts Drain, which prevents fish passage, as well as any tidal ingress, thus inhibiting any spawning potential (Figure 2).

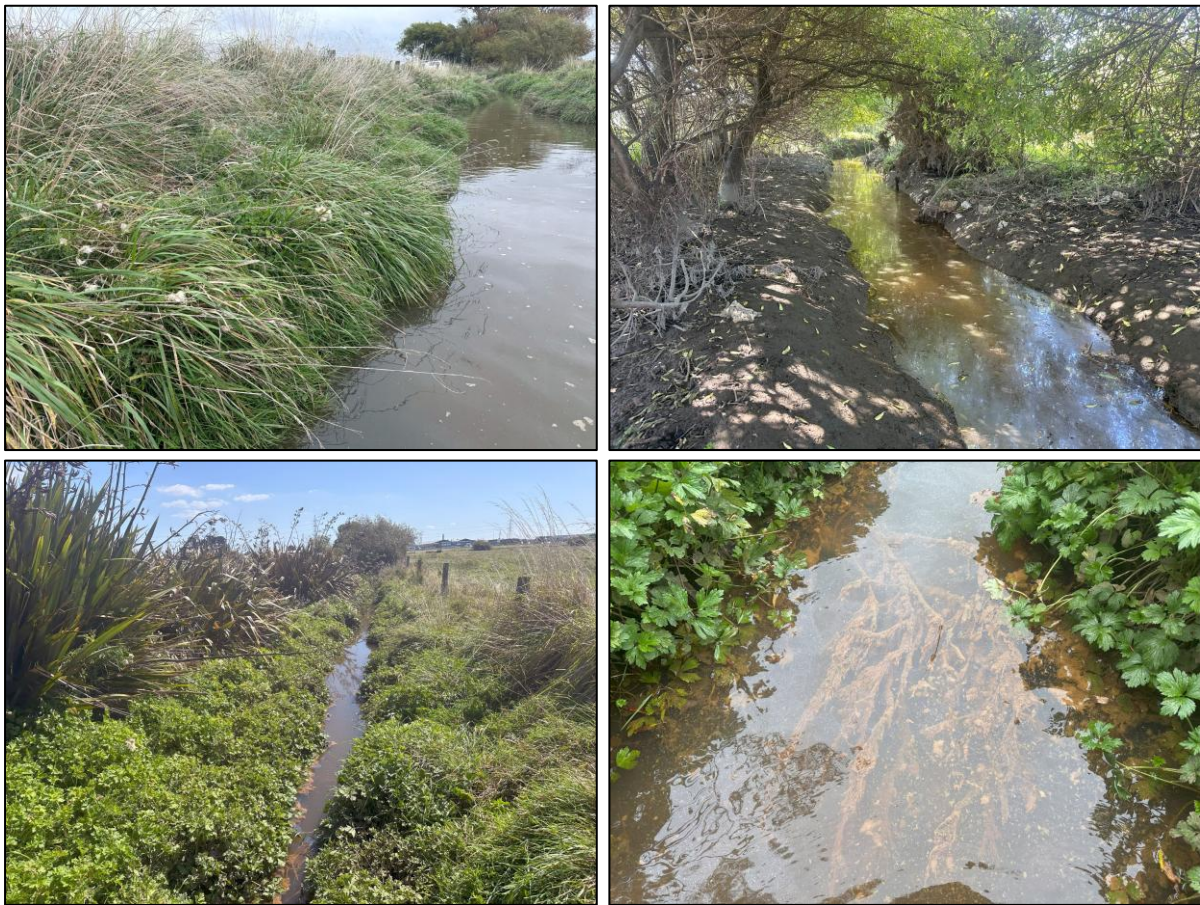
No Īnanga eggs, nor any adult Īnanga, were observed in Charlesworth Drain during any sampling period despite extensive searching. Despite the absence of observed Īnanga spawning, Charlesworth Drain contained extensive areas of suitable spawning habitat, particularly in the lower sections of the survey area downstream of the main farm road. These lower areas were dominated by long grasses, while the upper sections featured buttercup with scattered flaxes. However, suitable habitat was limited immediately upstream of the farm road culvert, where groundcover was often sparse due to shading from willows (Figure 9). Areas dominated by buttercup and grasses offered high-quality spawning conditions, with dense stems and root mats that retained moisture well. In contrast, sections shaded by willows lacked adequate ground vegetation, making them unsuitable for Īnanga spawning.

Figure 9: Riparian conditions within Īnanga spawning range, including dense grasses downstream of road (top left), absence of spawning vegetation under willows immediately upstream of farm road (top right), and dense bushels of buttercup (*Ranunculus* sp.) (bottom). Note sedimentation and suspended orange iron floc in water column.

Additional ecological constraints are also apparent. The drain appears highly degraded, with substantial sedimentation, visible hydrocarbons, and accumulations of iron floc. These conditions suggest poor habitat quality for adult Īnanga. Moreover, a high abundance of slugs and their eggs was observed (Figure 10), indicating that egg predation by slugs may be a further factor limiting successful spawning.

- Remove dense willow canopy along the intertidal salt-wedge zone of Charlesworth Drain to promote groundcover vegetation and support īnanga spawning habitat.
- Assess and, if necessary, modify the downstream tidal gates at the mouths of Charlesworth Drain and Lovetts Drain to improve fish passage and connectivity between the estuary and upstream habitat.
- Undertake fish surveys to confirm whether īnanga or other migratory species are using Charlesworth Drain.
- Avoid mowing of known or potential īnanga spawning areas (especially lower Charlesworth Drain and Linwood Canal) prior to and during the spawning season (January to May).
- Undertake further water quality monitoring to better understand trends in key parameters (e.g., ammoniacal-N, BOD, E. coli, copper, and zinc).

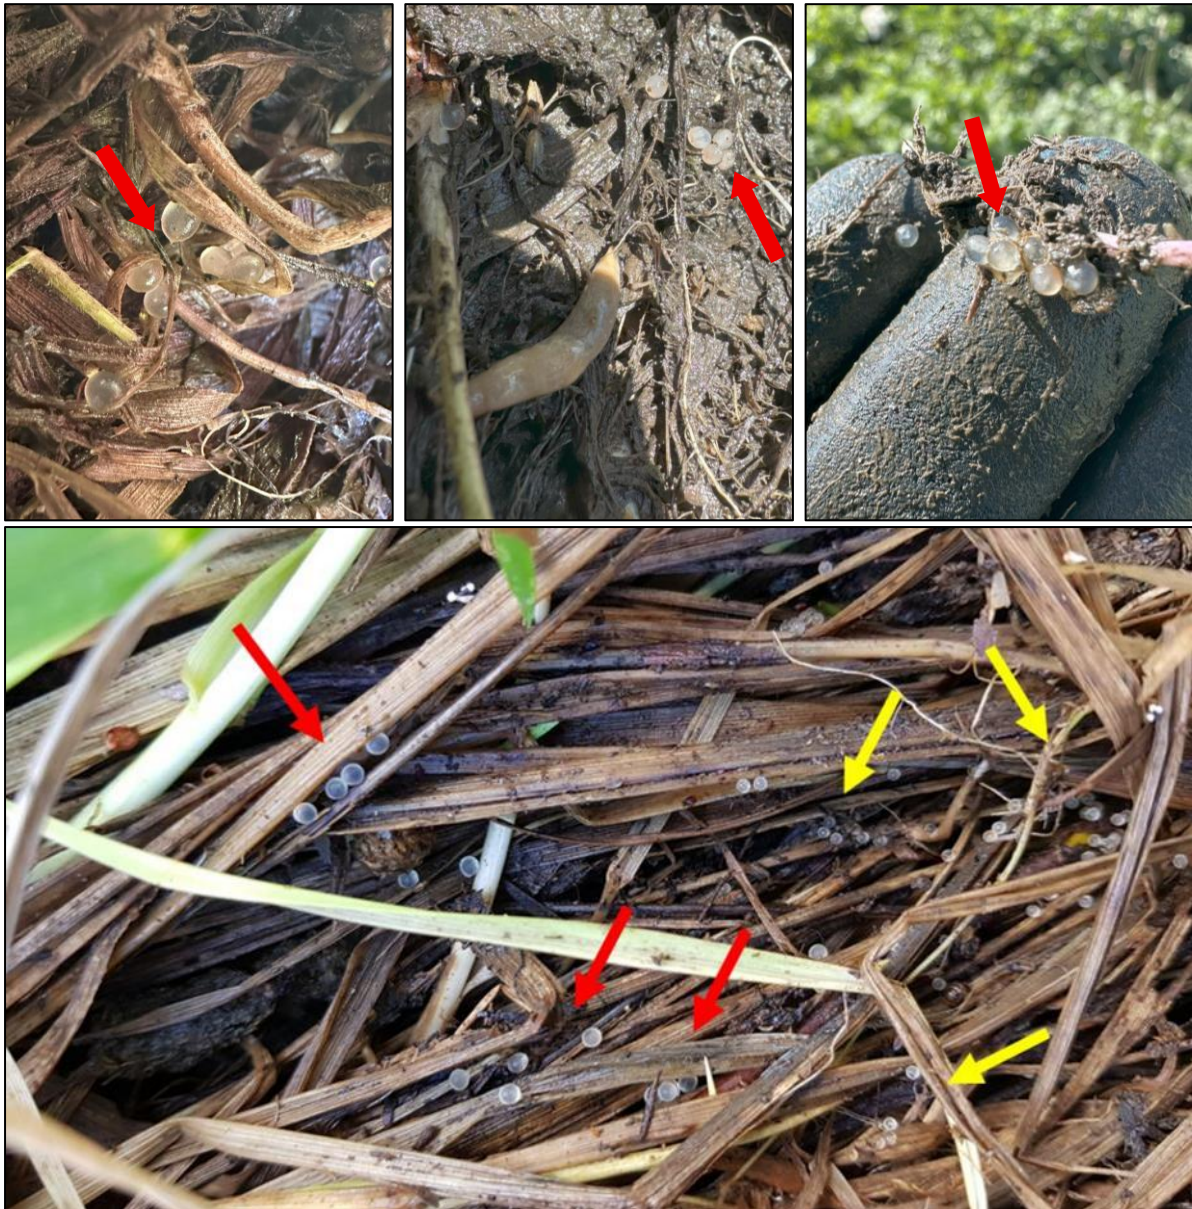
Figure 10: Slug eggs observed in Charlesworth Drain (top) and example of comparison between īnanga and slug eggs (bottom) from Jung (2022). Red arrows indicate slug eggs and yellow arrows indicate īnanga eggs. Slug eggs are typically larger (≥ 2 mm) than īnanga eggs (0.8 to 1.2 mm) and often oval and opaque.

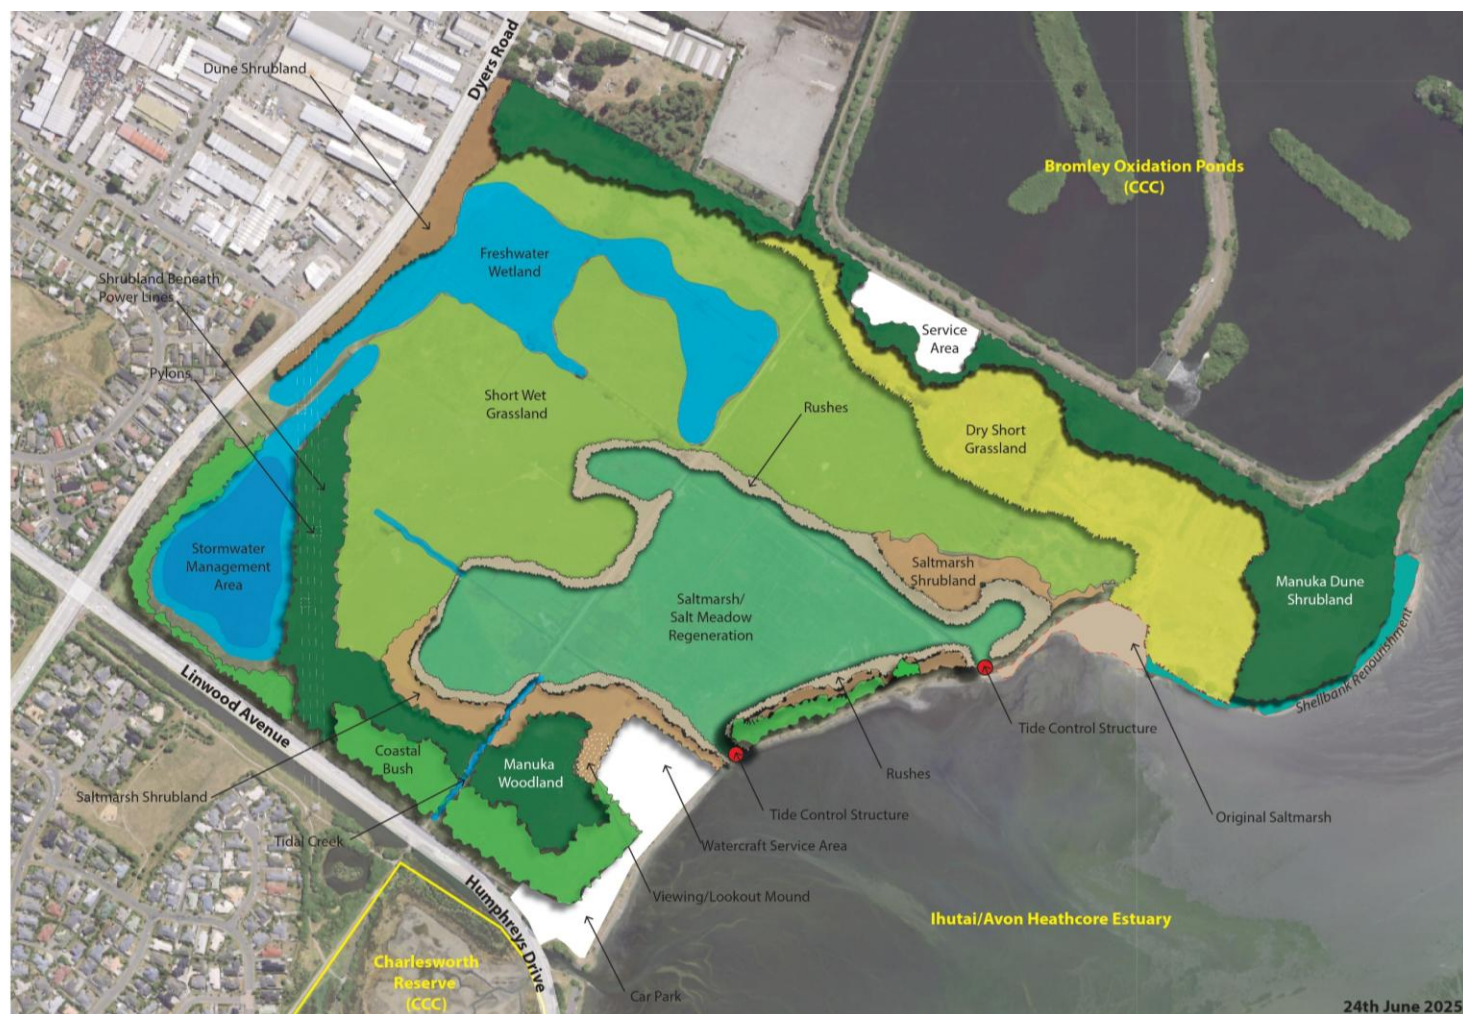
APPENDIX 1: LINWOOD PADDOCKS CONCEPT PLAN

Provided by Christchurch City Council, October 2025.
