Dudley Creek Flood Remediation:

ECOLOGICAL CONDITION OF LOWER DUDLEY CREEK

EOS Ecology Report No: BEC01-15015-01 | June 2015
Prepared for: BECA
Prepared by: EOS Ecology
Shelley McMurtrie & Alex James

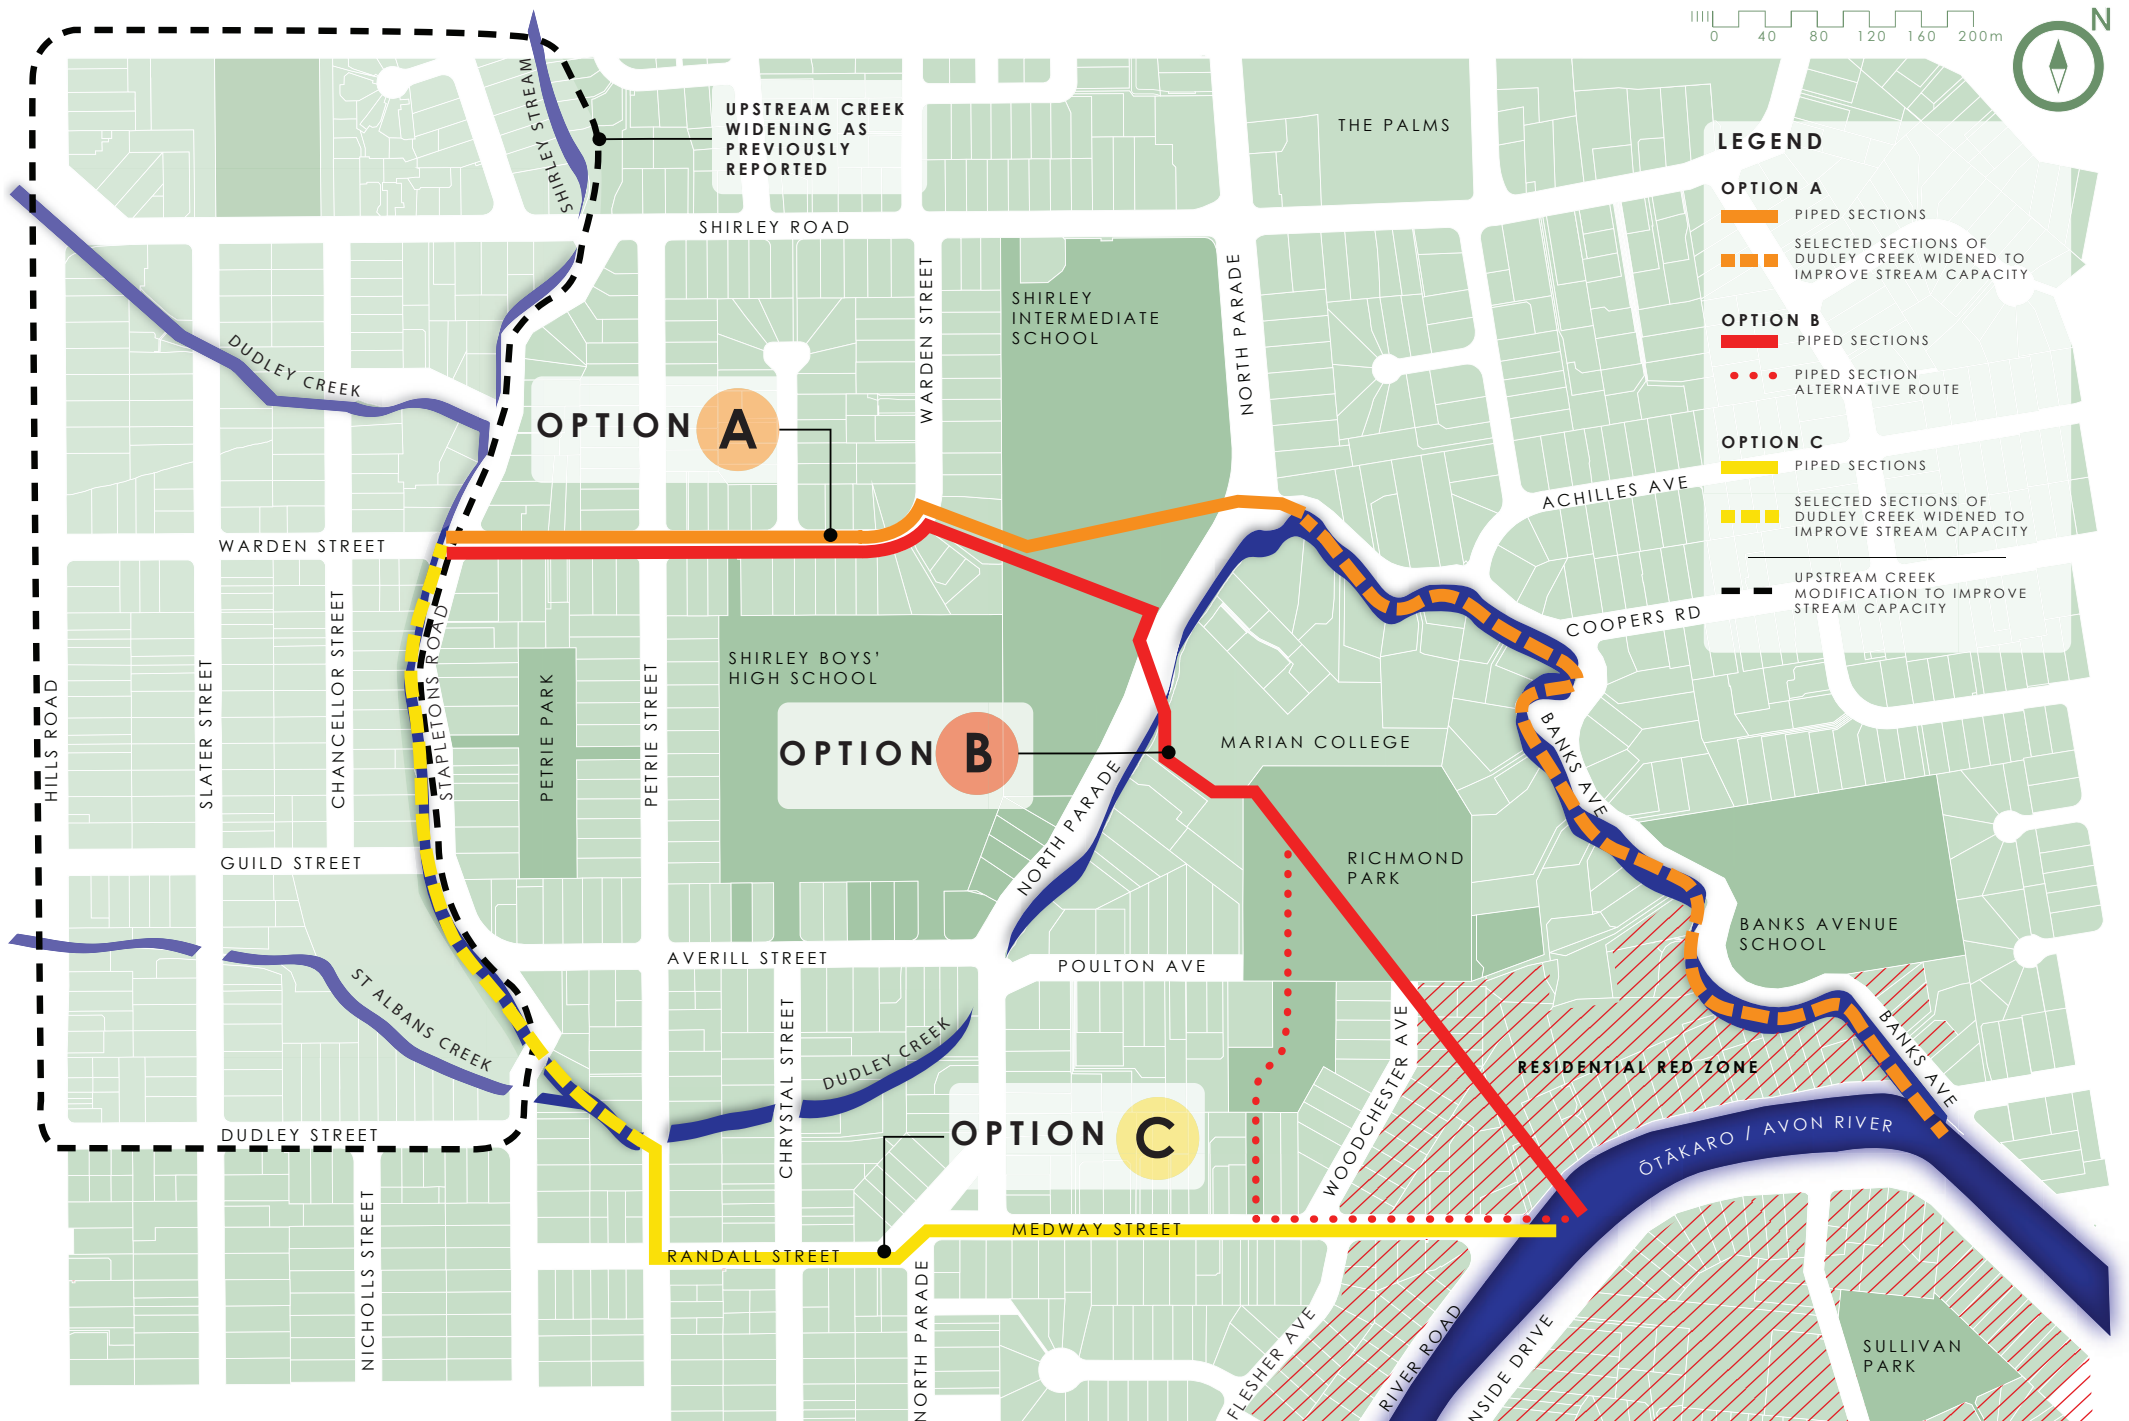
FIGURE 1 ►
Options proposed to
alleviate flooding in the upper Dudley
Creek catchment. Map created by the
project team on the 3 June 2015.

This report relates to those downstream options being investigated further (as shown in Figure 1 and herewith referred to as the Dudley Creek downstream flood remediation options), to ascertain the most suitable solution that encompasses flood remediation as well as a range of other issues, such as cost, longevity, future-proofing, and ability to meet the CCC's other five values (ecology, landscape, recreation, heritage, culture – as specified in CCC, 2003a, b). The options being considered include a piped diversion at Warden Street combined with channel widening along Banks Avenue (Option A in Figure 1), a piped diversion at Warden Street that discharges directly to the Avon River (with two possible outfall locations, Option B in Figure 1), and channel widening along Stapletons Road prior to a piped diversion at Petrie Street that discharges into the Avon River (Option C in Figure 1).

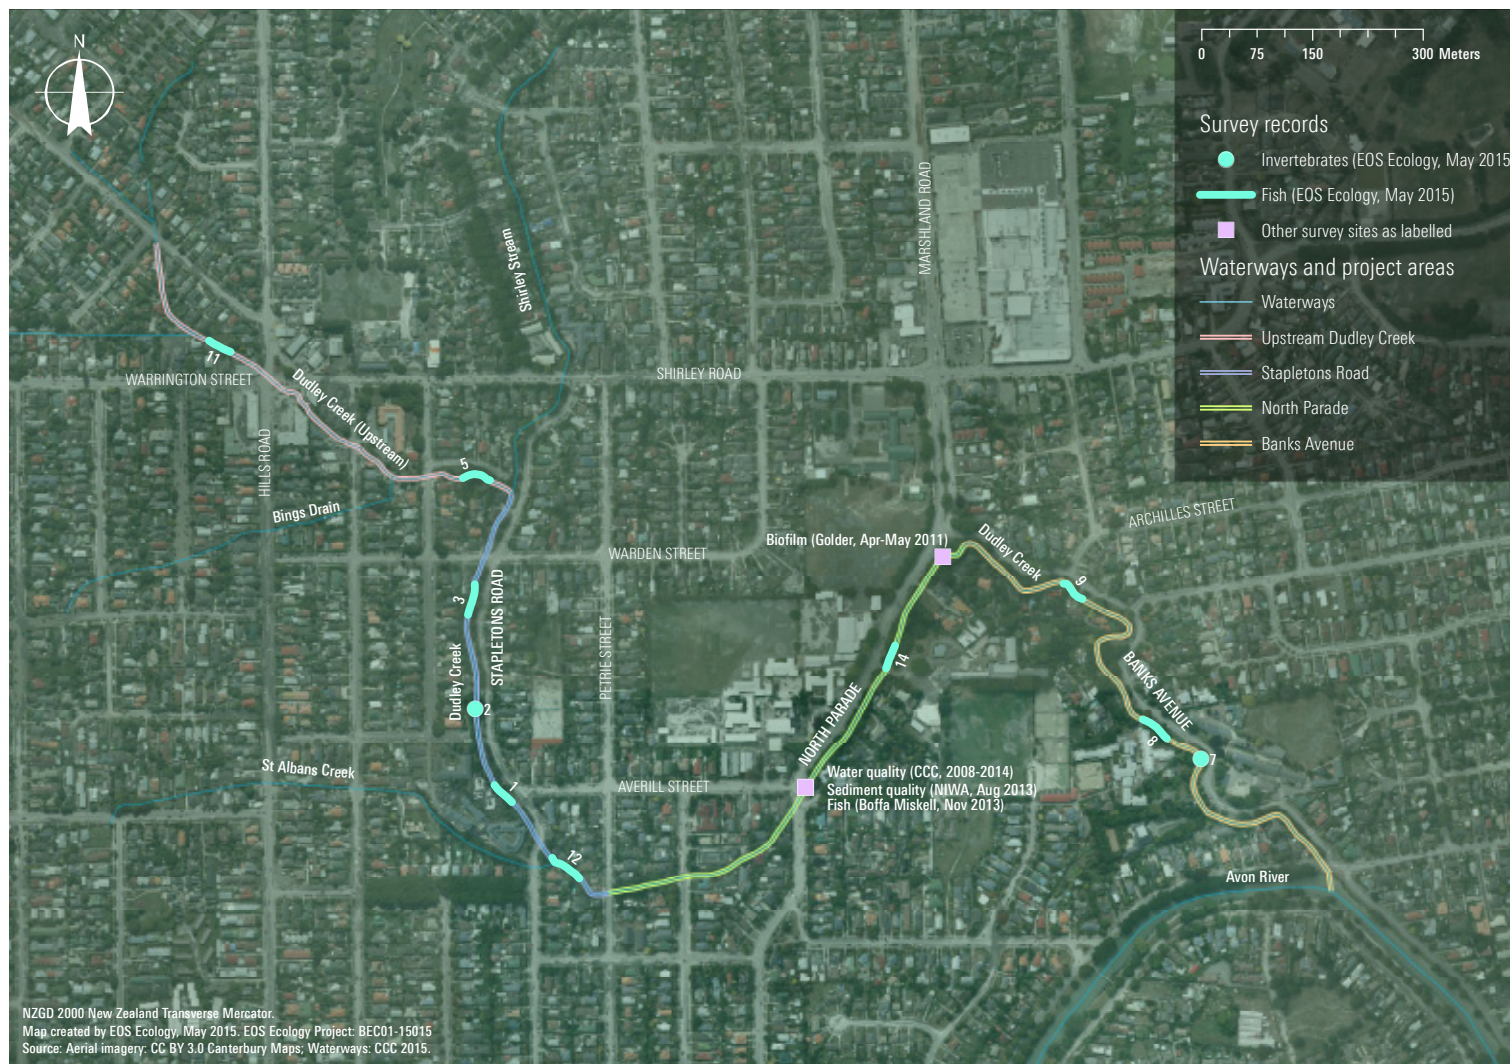
FIGURE 2
Map showing the location where ecological data (either fish or invertebrates) and water/sediment quality data was obtained for Dudley Creek. EOS Ecology sites were sampled in May 2015, the remaining data was provided by Christchurch City Council, with the dates of sampling as specified on the map. The three project sections for the downstream reach (i.e., Banks Avenue, North Parade, Stapletons Road) are also indicated. Site photographs are provided in Appendix 1.

Due to the dearth of information on fish and invertebrates, surveys were undertaken along Dudley Creek between the Avon River and Shirley Stream confluences, including two aquatic invertebrate sites and six fish sites (Figure 2). As fish are migratory, an additional two sites were also fished in Dudley Creek outside of the immediate project area, upstream of the Shirley Stream confluence (Figure 2).

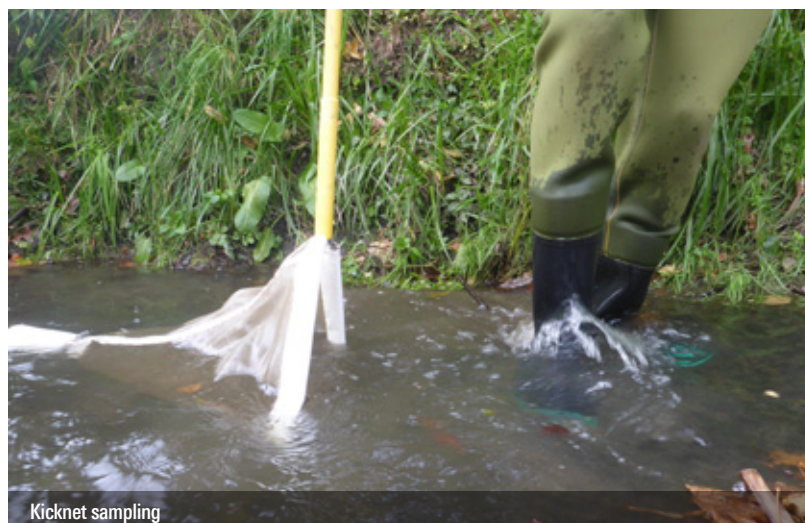
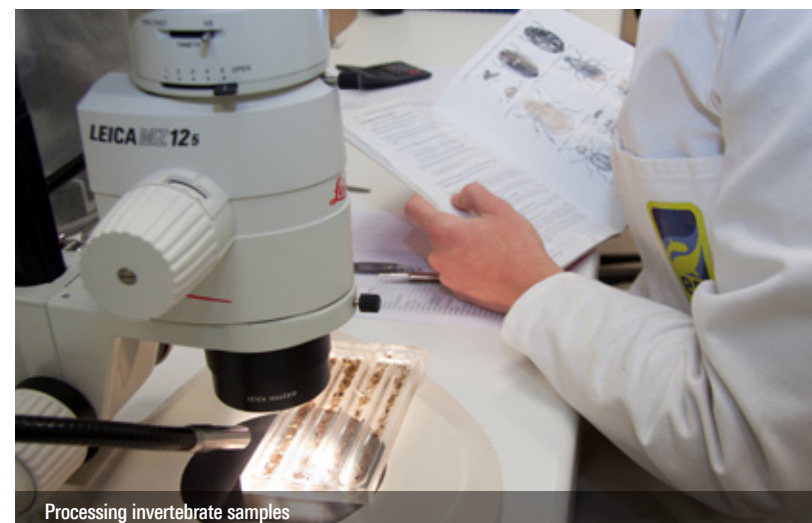
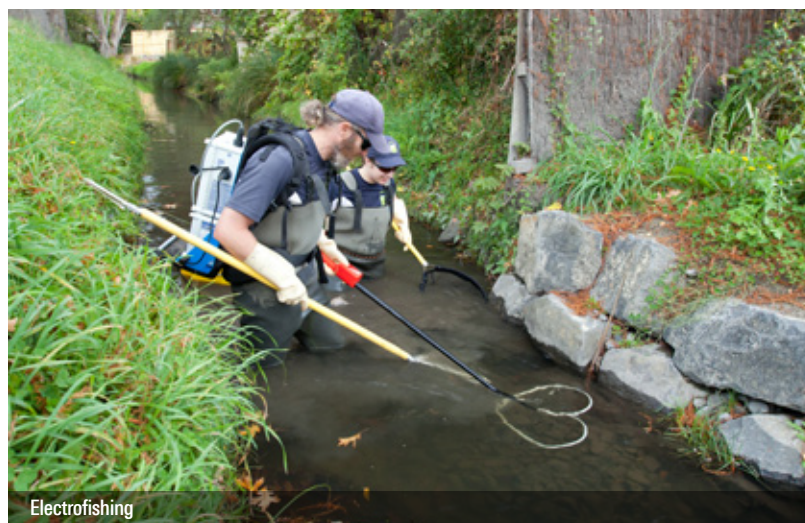
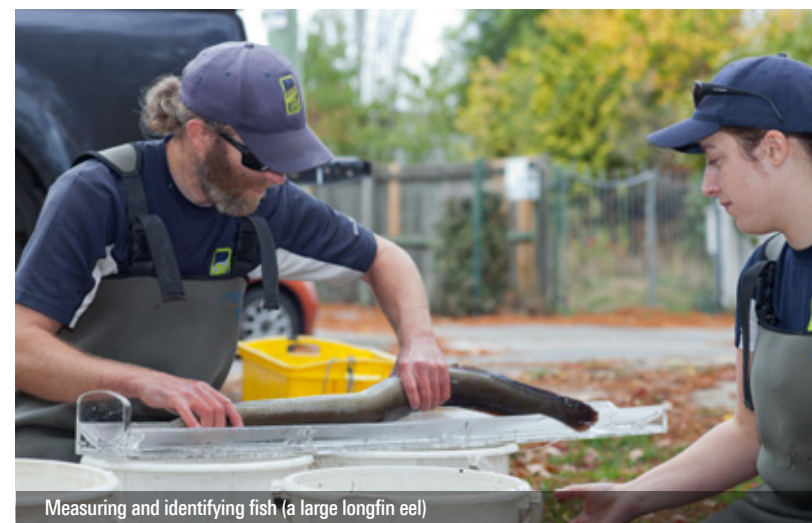
FIGURE 3
Photographs of ecological
sampling methods used in
May 2015 to assess the health
of Dudley Creek between the
confluence with the Avon River
and the confluence with Shirley
Stream.

Kicknet sampling

Processing invertebrate samples

Electrofishing

Measuring and identifying fish (a large longfin eel)

Fish surveys were undertaken via a 'single pass electrofishing' method using a backpack operated Kainga EFM 300 electrofishing machine (Figure 3). Electrofishing passed as low amperage electric current through the water temporarily stuns the fish, allowing them to be caught in a handheld stop net or net. The captured fish are placed in buckets of water and are identified and measured (Figure 3) before returning them live to the stream. Fish data was then summarised by catch per unit effort (CPUE). CPUE refers to the number of fish captured per unit of effort expended, which in this case was the area of stream that was electrofished. One of the key attributes recorded at each fishing site was the amount of fish cover provided by substrate (cobble, rocks, logs), aquatic plants, undercut banks and overhanging vegetation.

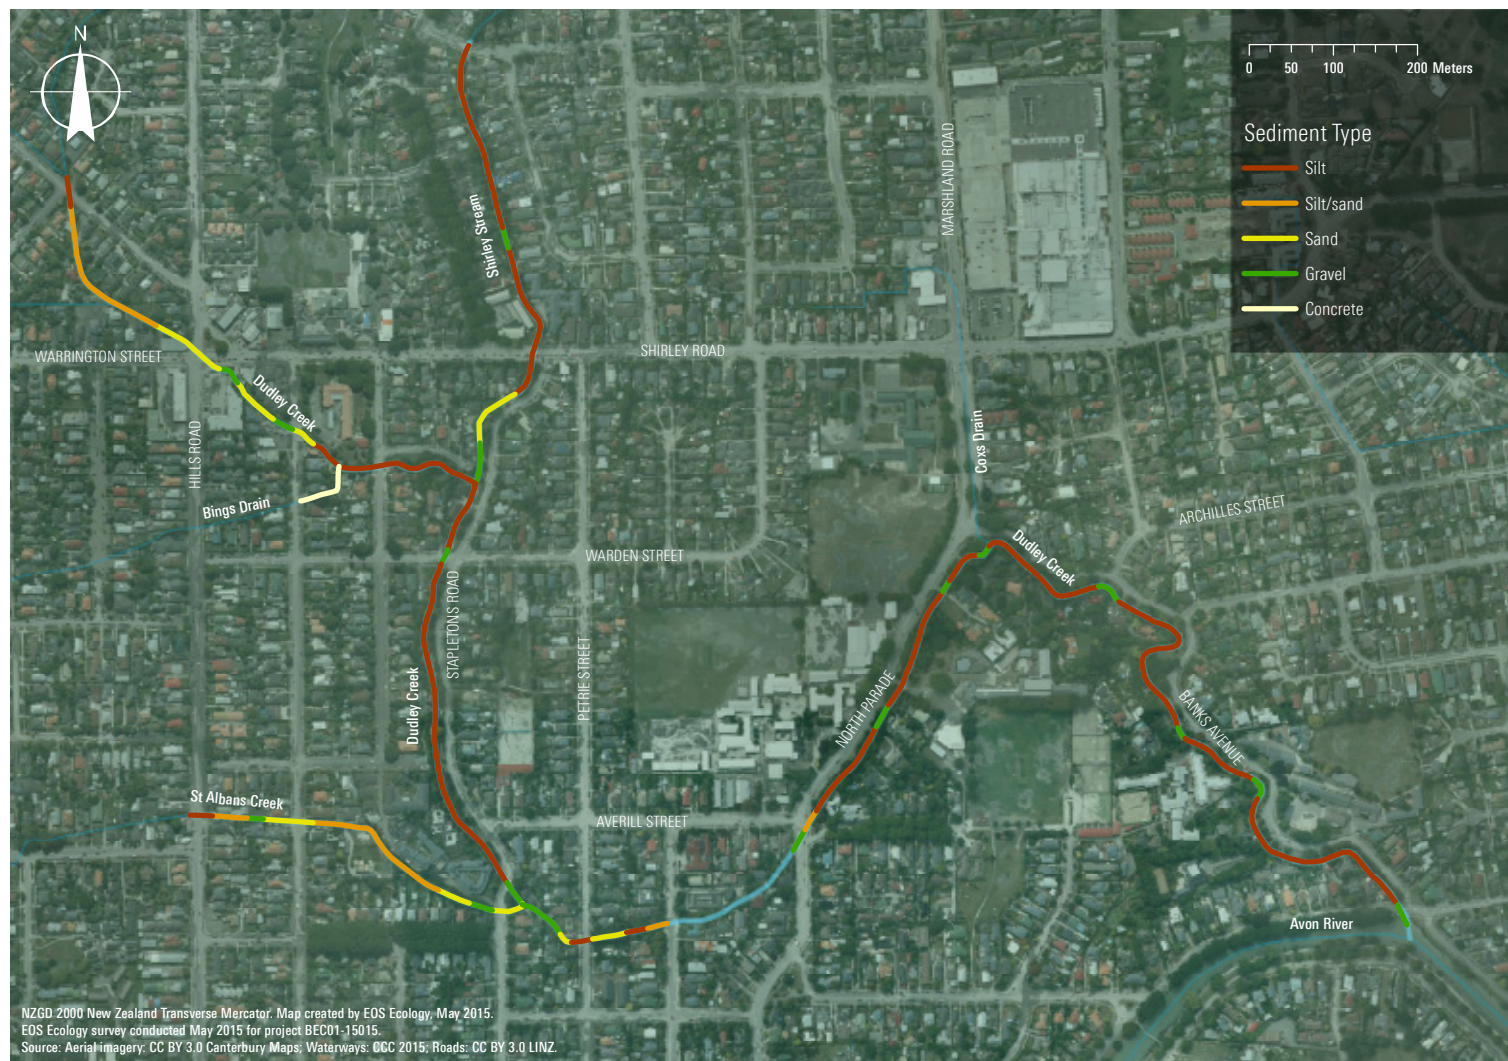
Dudley Creek is a slow flowing, flat gradient stream. The majority of the stream had a silt or sand substrate (Figure 4, 5), which is of poor habitat value. There were some areas of larger rocks overlying this fine substrate providing improved habitat conditions in those locations (Figure 5). Small patches of coarser substrate (gravel and cobbles) were present where the gradient of the stream is steeper (Figure 4, 5), and these were regarded as the better areas of instream habitat. In slow flowing sections with greater numbers of large-leaved exotic deciduous trees, the substrate was covered with a thick layer of leaf litter. In slow flowing sections this litter would likely remain for some time and could result in low oxygen levels in the stream as they break down, reducing the ability of aquatic biota to survive. The lower reaches of Dudley Creek (from the Avon River confluence upstream to near the Banks Avenue-North Parade intersection) is also tidal. In this section the flow reverses (i.e., flowing upstream) during high tide in the Avon River, and there is a tidal fluctuation level of around 0.5 m.

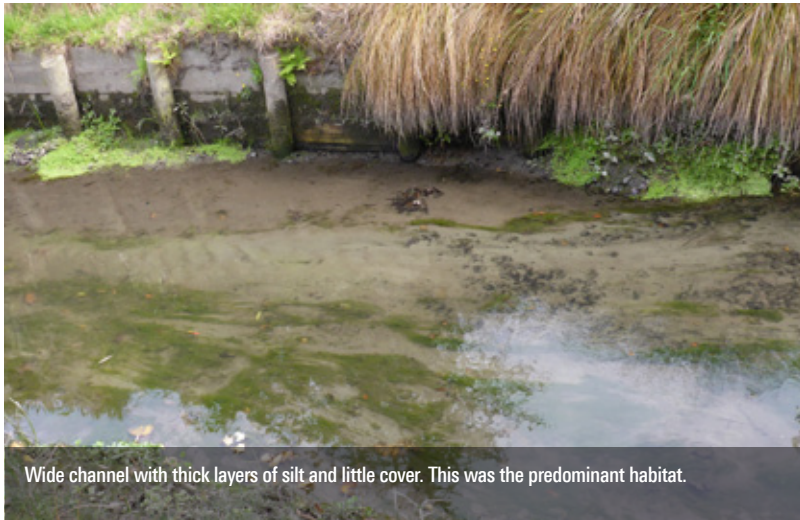
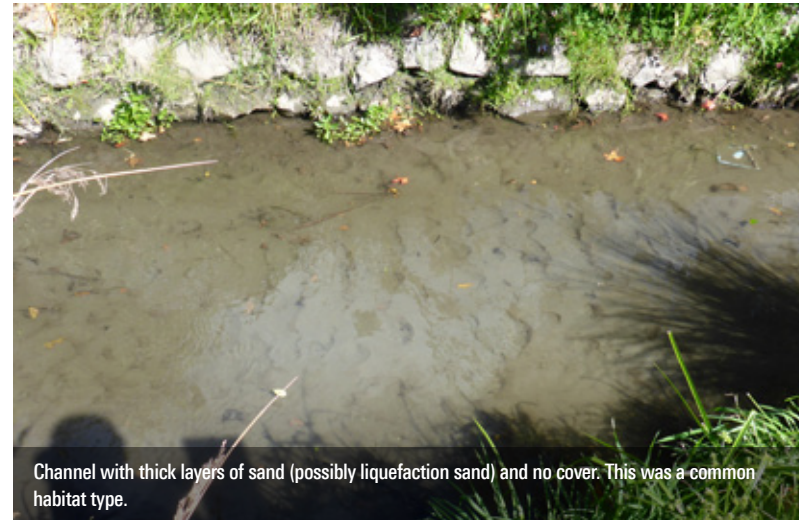
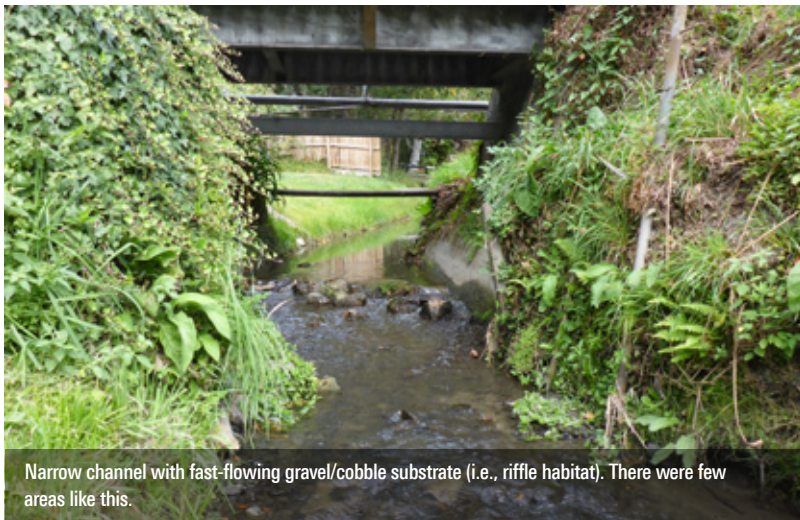
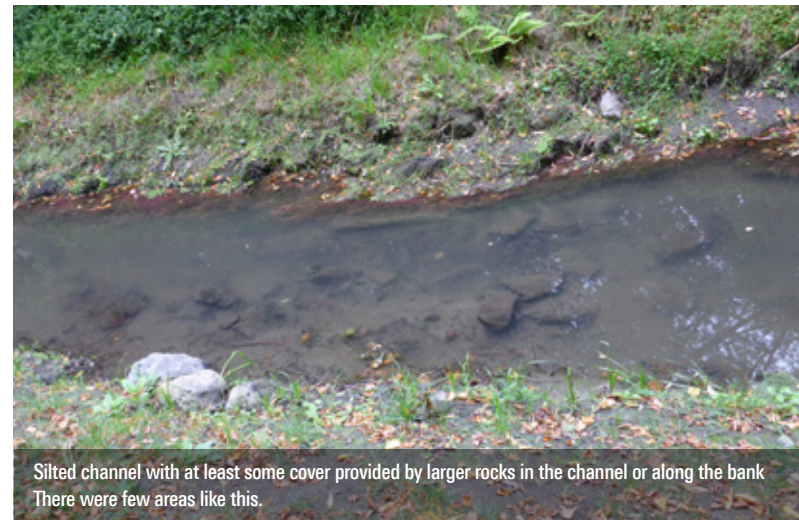
FIGURE 5
Photographs of the different substrate types found along Dudley Creek between the Avon River and Shirley Stream confluences.

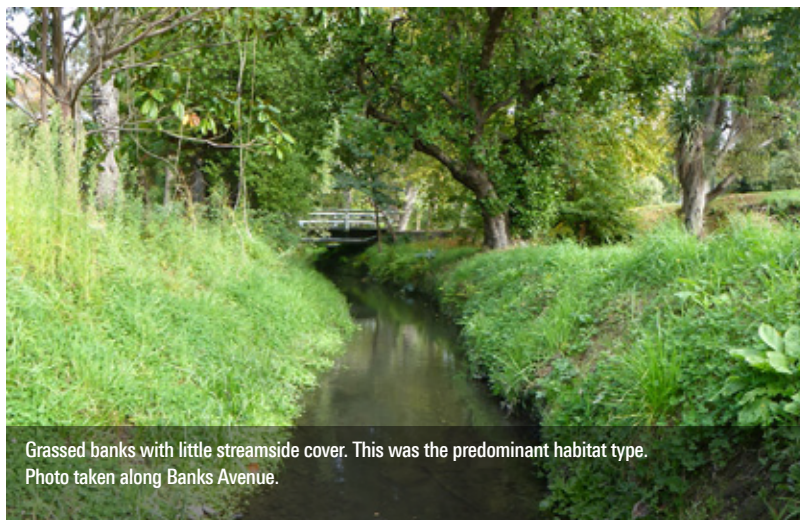
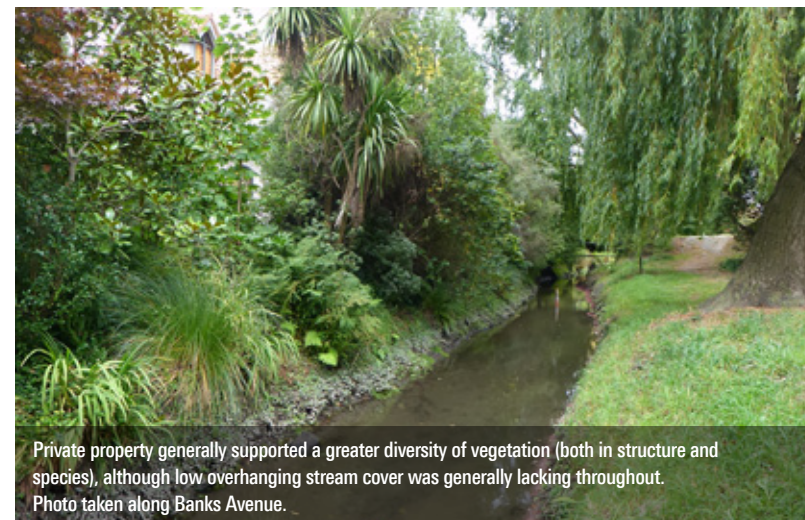
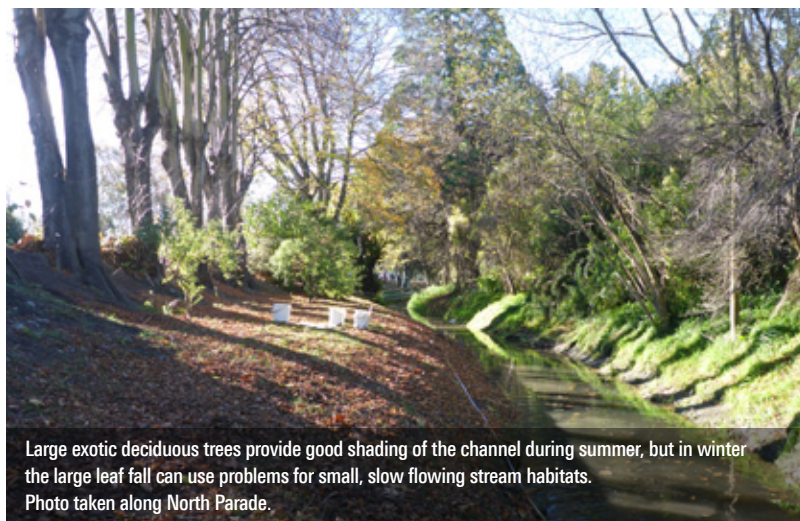
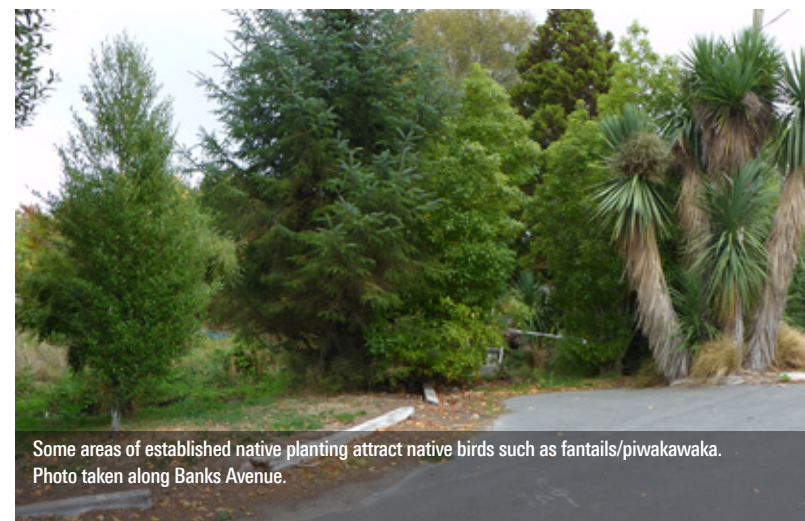
FIGURE 6
Photographs of the different riparian vegetation types found along Dudley Creek between the Avon River and Shirley Stream confluences.

The predominant understory vegetation along the true-left side (i.e. the road reserve side) of the stream along Banks Avenue, North Parade and Stapletons Road, was mainly mown grass (Figure 6), with small patches of recently planted native grasses along the stream edge (i.e., *Carex*). Plants on the true-right (which is predominantly private land) had a greater variety and distribution of species, including native and exotic plants. There were few areas where larger grass species (such as *Carex secta*) and flax/harakeke large enough to provide some vegetative overhang along the stream. A number of plant pest species were also identified growing along the stream banks, including male and female ferns, ivy, tradescantia, and old mans beard (vigorous growth along the

true-right side of Dudley Creek along Stapletons Road). The stream banks themselves were made up of a mixture of natural earth, rock walls, iron and timber retaining walls.

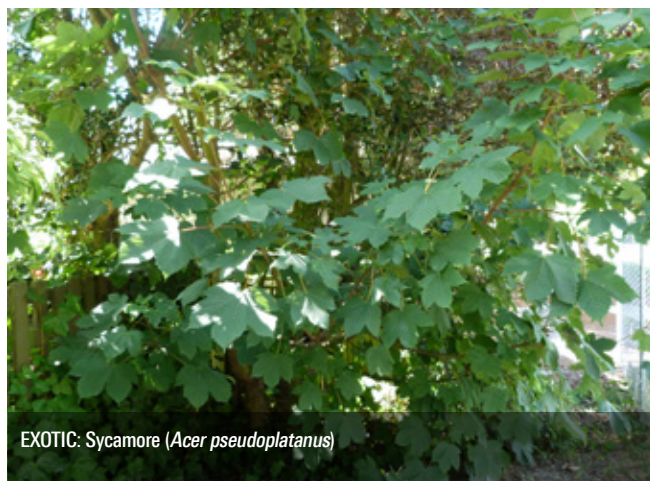
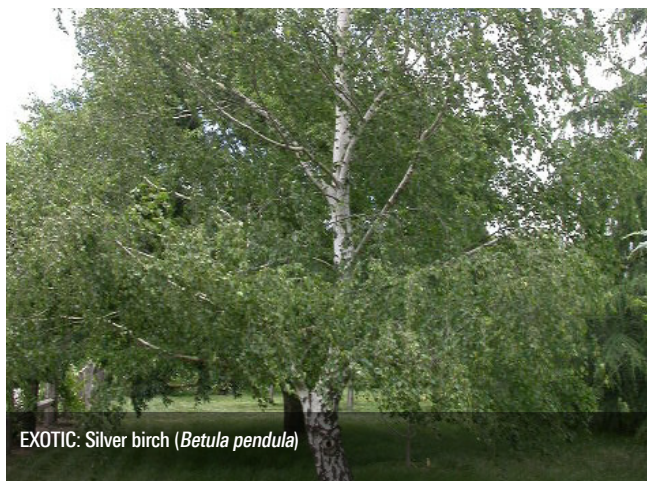
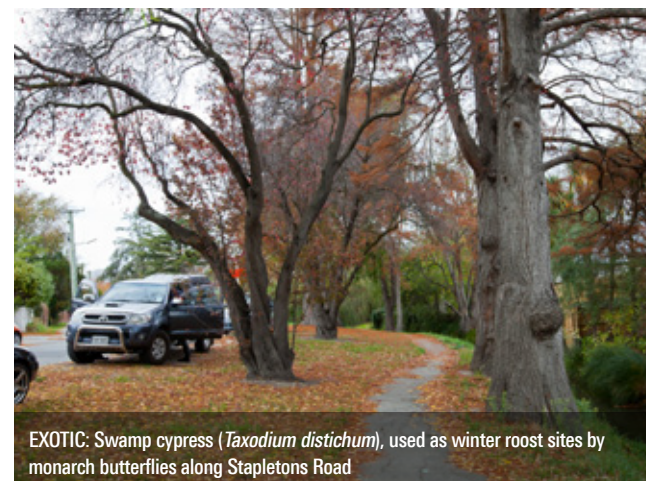
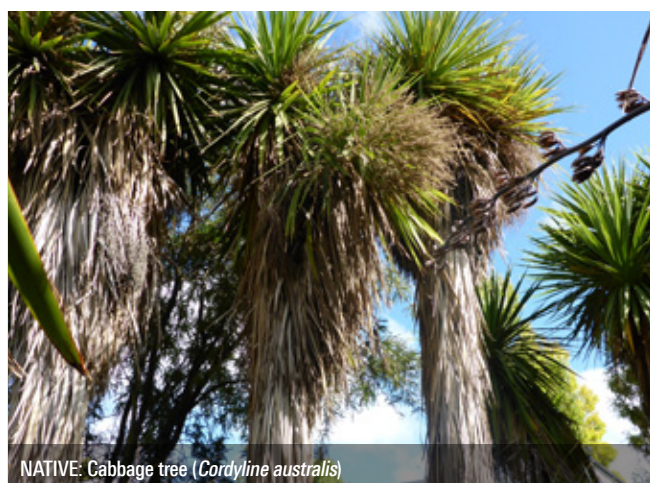
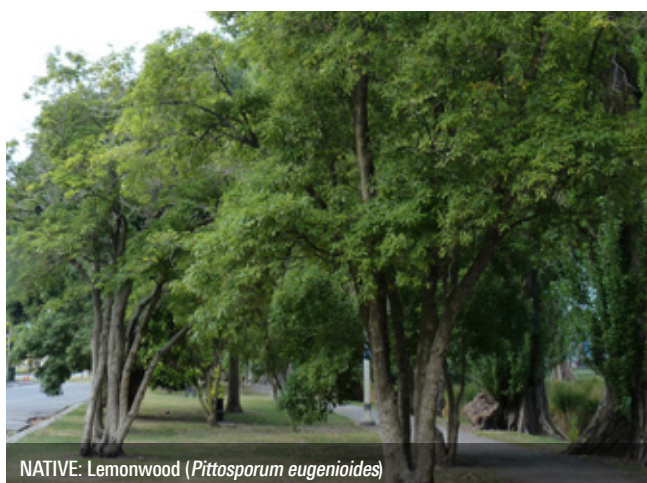
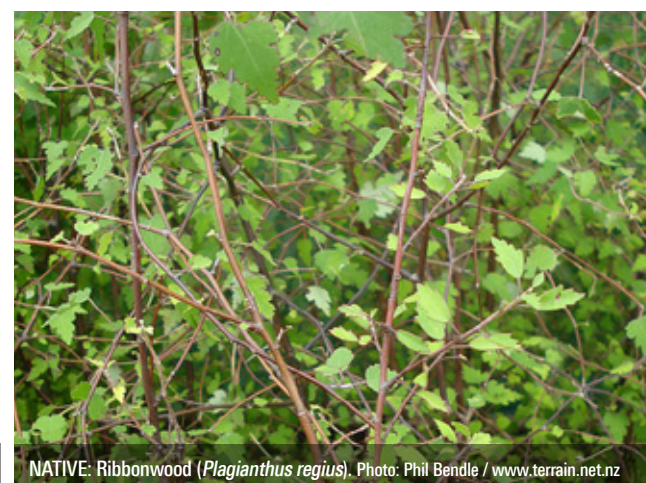
FIGURE 7 The most common exotic and native mature trees found along Dudley Creek in the Banks Avenue and Stapletons Road sections (sections shown in Figure 2).

Based on the classification of Howell (2008) sycamore and silver birch are regarded as environmental weeds in New Zealand (as it relates to their status on land managed by the Department of Conservation). Ecan's Regional Pest Management Strategy (RPMS) (Maw, 2011) aims to remove sycamore (along with a range of other species) in 'high-value environmental areas' within the Canterbury region, due to their ability to readily invade natural systems. Waterways within cities usually represent more natural systems within an otherwise heavily modified landscape. As such, the choice of plant and tree species within riparian zones should give consideration to the effect they have on riparian ecosystems and stream functioning, in addition to any aesthetic function. For this reason tree species such as sycamore and silver birch were identified as biosecurity risk species for the riparian zone along the Avon River by McMurtrie *et al.* (2013), due to their prolific viable seed/fruit production, invasive habitat, and thus greater maintenance requirements. Silver birch are also now recognised as a significant allergen source, and have been linked to a range of allergic reactions in some people.

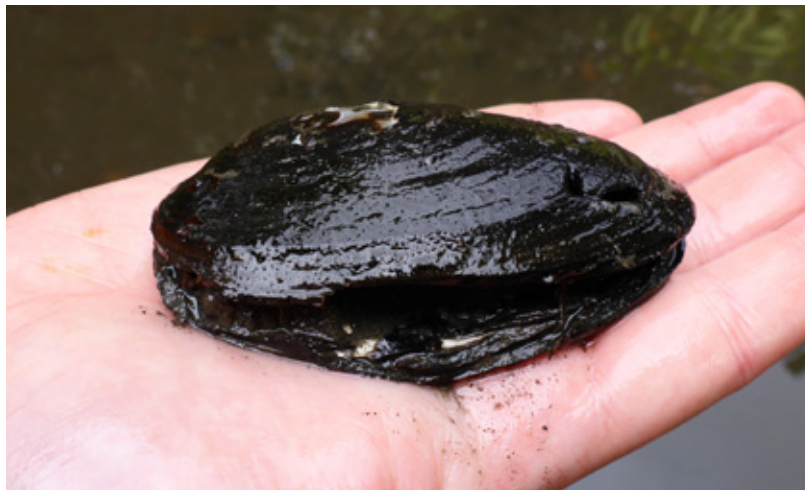
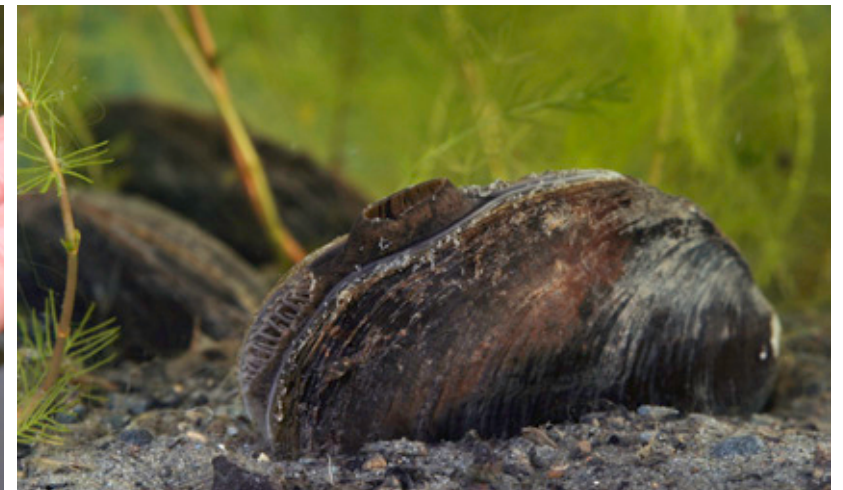
FIGURE 9
Empty freshwater mussel/kakahi shells (left) were found in Dudley Creek along Banks Avenue. No live specimens (right) were found although a specific search for them was not undertaken.

Of particular note was the discovery of empty freshwater mussel/kakahi (*Echyridella menziesi*) shells observed in Dudley Creek within the Banks Avenue Section (adjacent to Achilles Street) (Figure 9), indicating they are either present in the catchment or were at least present in the past. *E. menziesi* have a threat classification of “at risk – declining” (Grainger *et al.* 2014). They are our largest freshwater bivalve, growing up to around 10 cm in length, and are useful in regulating water quality due to their filter feeding behaviour. Freshwater mussels/kakahi are declining globally due to pollution, habitat alteration, and sedimentation.

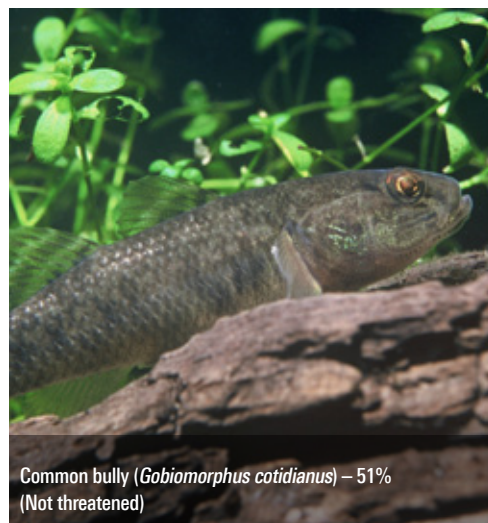
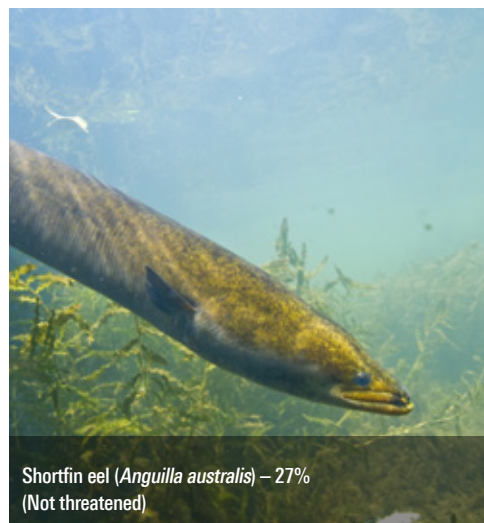
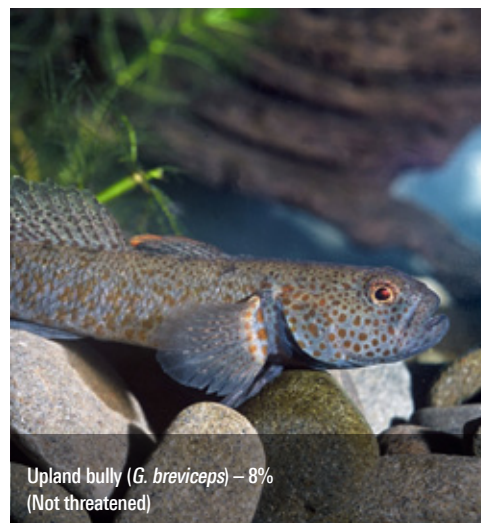
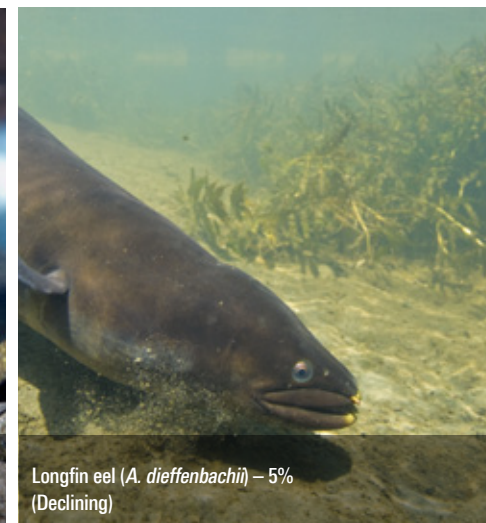
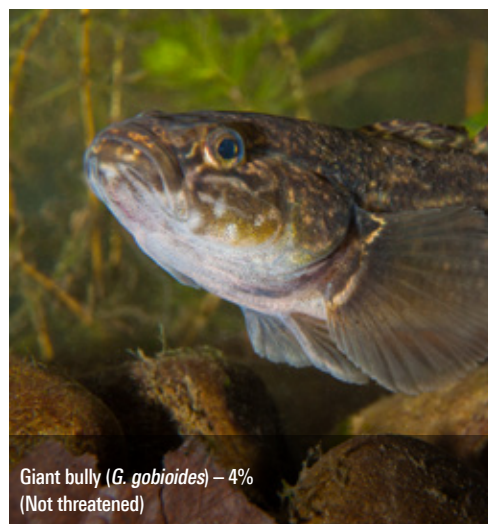
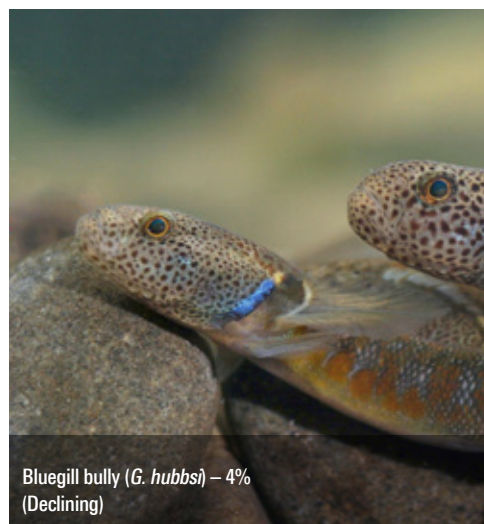
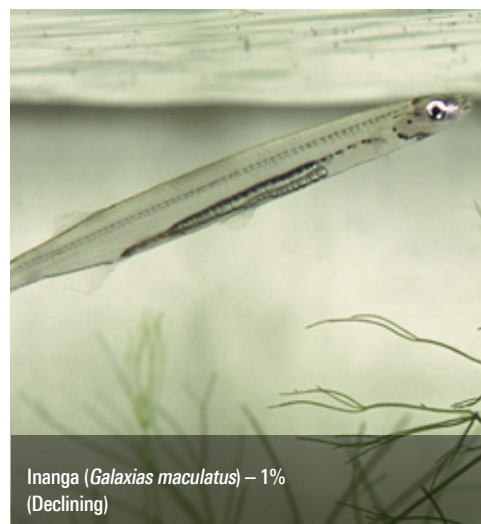
FIGURE 1
Photographs of the fish species found along Dudley Creek during the recent electrofishing surveys by EOS Ecology. The percentage contribution to the total catch is shown for each species (based data from eight EOS Ecology sites surveyed in May 2015 and one CCC site surveyed in November 2013, as shown in Figure 2). The threat classifications of Goodman *et al.* (2014) are also provided.

Seven species (Figure 10) and 282 individuals were captured during the May 2015 electrofishing surveys of Dudley Creek (sites are shown in Figure 2), which included four additional species to those previously recorded in recent CCC data (i.e., Blakely, 2014). Common bully and shortfin eel were the most common and widely distributed species; accounting for half (common bully) and a quarter (shortfin eel) of all fish captured (Figure 10), and found in all four surveyed sections of Dudley Creek (Table 3). Both are widely distributed throughout New Zealand, and both are known to be tolerant of a range of habitat conditions. Shortfin eels are especially known for their tolerance of soft sediment (sometimes referred to as 'mud eels'), which they will often burrow into in streams with little cover. Upland bullies were generally associated with sites that had a coarse substrate (i.e., gravel, cobbles, or rocks).

Three species were found in Dudley Creek that have a threat classification of 'at risk - declining': bluegill bully, inanga, and longfin eel (Figure 10, Table 3). The diminutive bluegill bully is the smallest of the bully species and are found in limited areas in Christchurch's waterways. They prefer a cobble streambed and moderate to swift water velocities, and so were only found in a single riffle section along Banks Avenue (the upstream fish site in the Banks Avenue section) (Figure 11, Table 3).

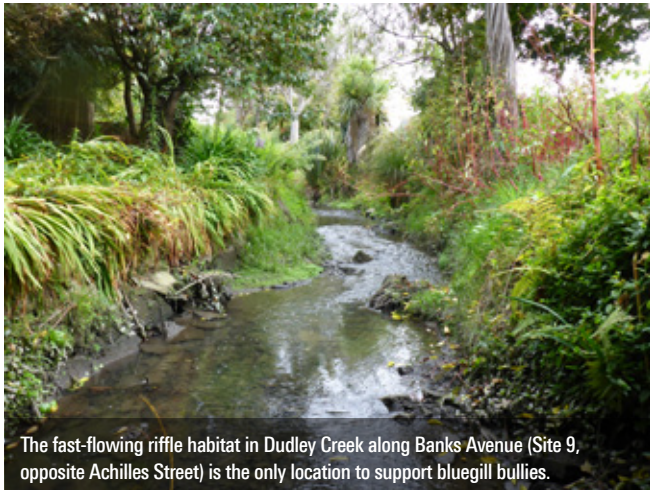
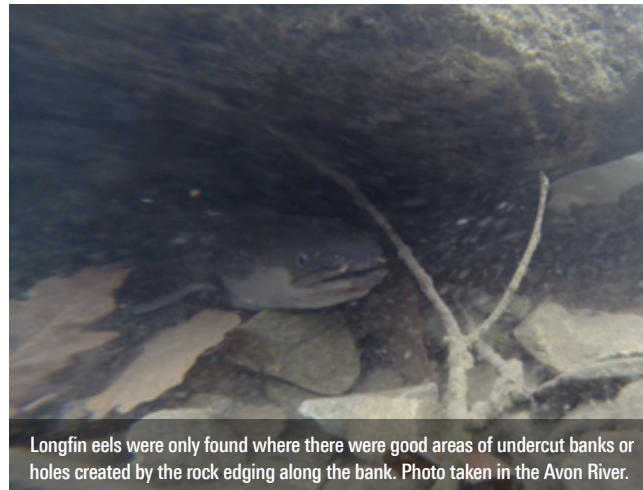
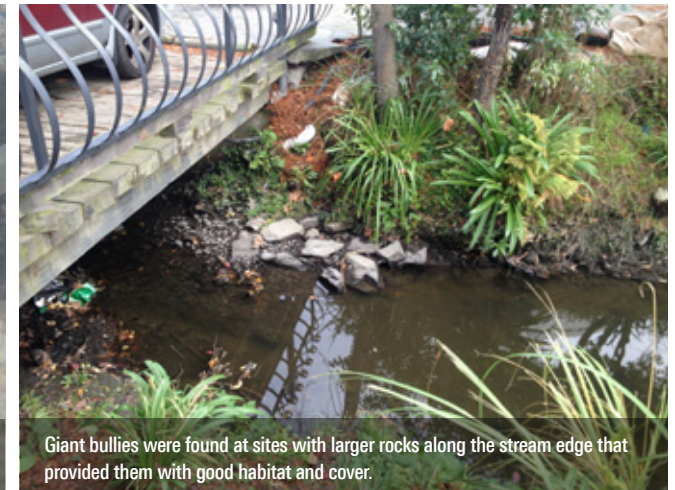
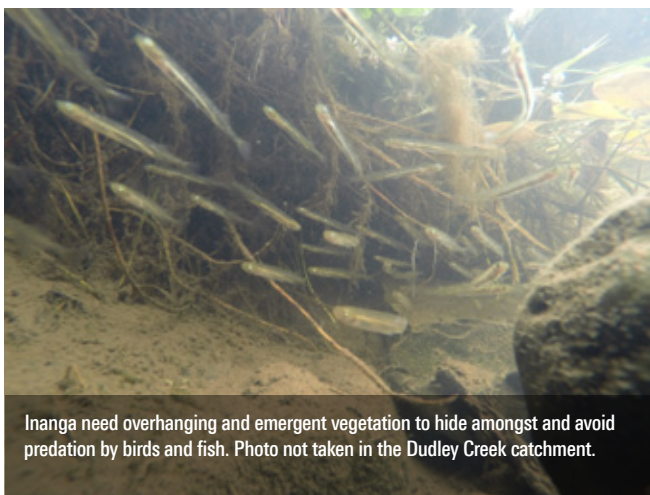
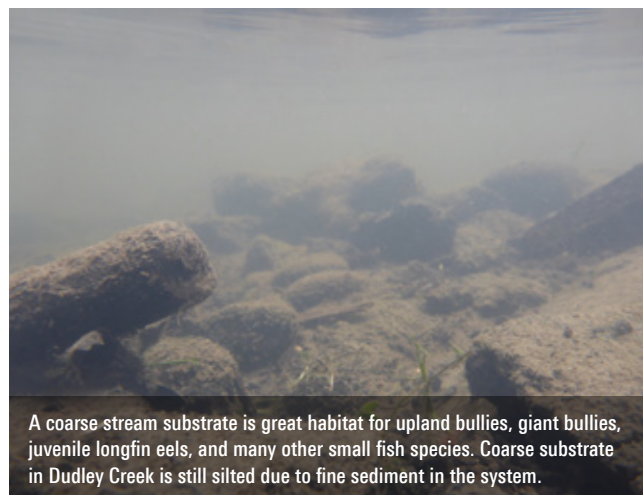
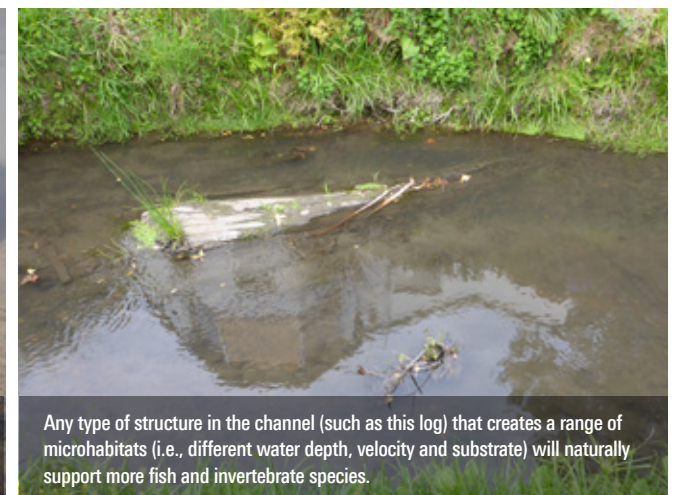
FIGURE 11 Photographs of key habitat types associated with different fish species

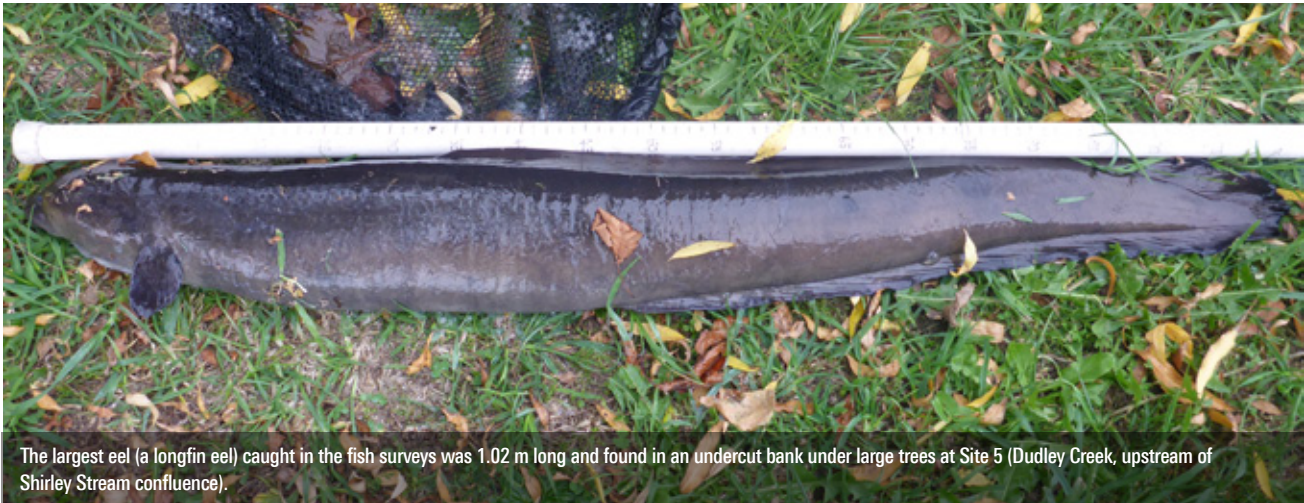
The largest eel (a longfin eel) caught in the fish surveys was 1.02 m long and found in an undercut bank under large trees at Site 5 (Dudley Creek, upstream of Shirley Stream confluence).

FIGURE 12 Particularly large eels caught or observed in Dudley Creek.

Longfin eel were only found at the two upstream sections, where cover for large longfin eels (in for the form or large rock walls with deep crevices, or undercut banks) was sufficient for them. The size range of longfin eels indicated a reasonable age population structure, and included a particularly large specimen just over 1 m long (Table 4, Figure 12). As eels are so slow growing, the larger specimen could be over 60 years old. Both longfin and shortfin eels migrate to sea after

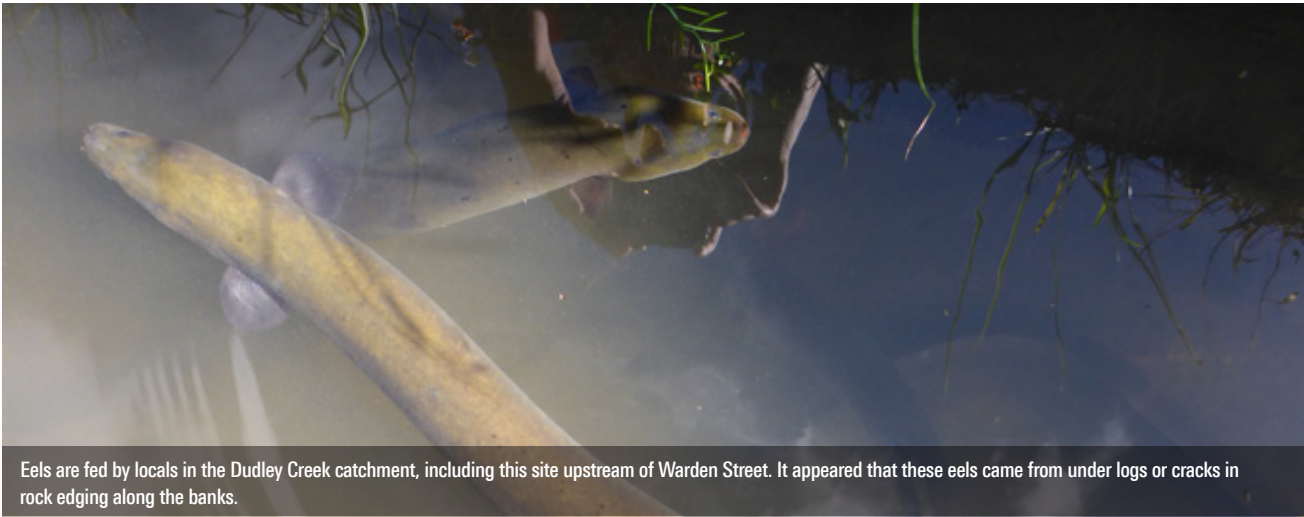
Eels are fed by locals in the Dudley Creek catchment, including this site upstream of Warden Street. It appeared that these eels came from under logs or cracks in rock edging along the banks.

There are a number of locations along Dudley Creek where eels (including both shortfin eels and longfin eels) are fed by adjacent landowners (Figure 12). Provided there is sufficient cover for these fish, they will tend to remain in the general area where they are regularly fed. For a small stream like Dudley Creek with a limited invertebrate fauna, the regular feeding of eels would help to maintain a larger number of eels than might be found there naturally. Provided these large fish are fed meat and not bread (which is not a nutritious food item) the feeding of eels should not cause any water quality issues that is sometimes associated with the large numbers of mallard ducks that can be attracted to an area via regular feeding with bread.

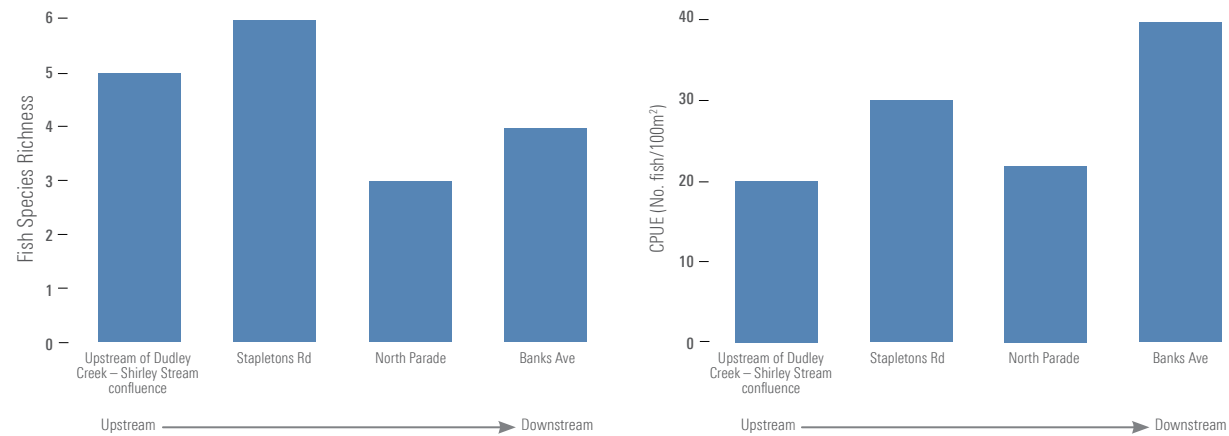
FIGURE 13 Fish species richness and catch per unit effort (CPUE) for four sections of Dudley Creek based on an electrofishing survey by EOS Ecology in May 2015.

Fish species richness was higher further upstream with the surveyed sections upstream of Petrie St having 5–6 fish species and those downstream having 3–4 fish species (Table 3; Figure 13). The catch per unit effort (CPUE) was greatest in the Banks Avenue section (at around 40 fish per 100 m² of area fished). This was driven by the large number of fish found at the riffle site (Site 9). The upstream-most section (upstream of the Shirley Stream confluence) and the North Parade Section had the lowest CPUE, being around half that of the other sections (Figure 13). Fish cover (i.e., larger rock substratum, woody debris, overhanging vegetation, undercut banks) played an important role in the abundance of fish, with sites having higher total fish cover tending to have a greater CPUE (Figure 14). In a highly modified stream like Dudley Creek, it is vital to ensure there is sufficient cover available to support all the fish species found in this catchment.
