Dudley Creek Flood Remediation:

ECOLOGICAL CONDITION OF LOWER DUDLEY CREEK

EOS Ecology Report No: BEC01-15015-01 | June 2015
Prepared for: BECA
Prepared by: EOS Ecology
Shelley McMurtrie & Alex James

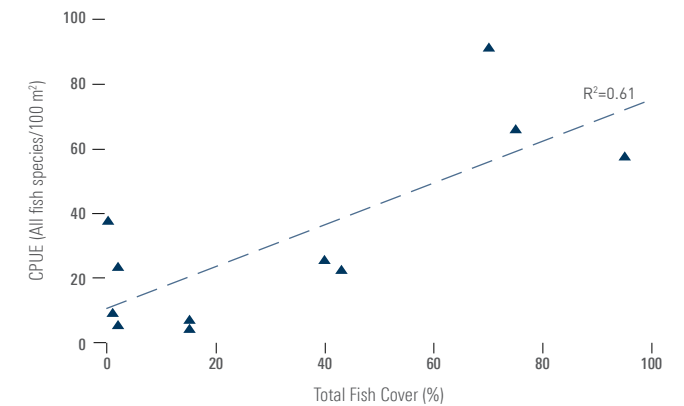
FIGURE 14 The relationship of catch per unit effort (CPUE) with total fish cover based on electrofishing surveys by EOS Ecology in May 2015. Greater fish cover was positively correlated with a greater density of fish.

Fish species richness was higher further upstream with the surveyed sections upstream of Petrie St having 5–6 fish species and those downstream having 3–4 fish species (Table 3; Figure 13). The catch per unit effort (CPUE) was greatest in the Banks Avenue section (at around 40 fish per 100 m² of area fished). This was driven by the large number of fish found at the riffle site (Site 9). The upstream-most section (upstream of the Shirley Stream confluence) and the North Parade Section had the lowest CPUE, being around half that of the other sections (Figure 13). Fish cover (i.e., larger rock substratum, woody debris, overhanging vegetation, undercut banks) played an important role in the abundance of fish, with sites having higher total fish cover tending to have a greater CPUE (Figure 14). In a highly modified stream like Dudley Creek, it is vital to ensure there is sufficient cover available to support all the fish species found in this catchment.

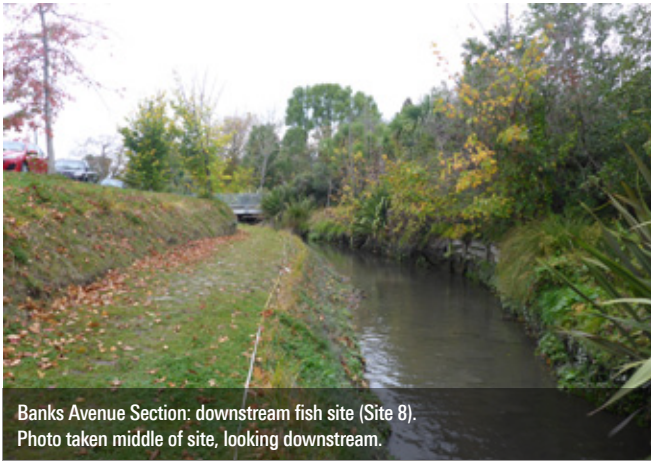
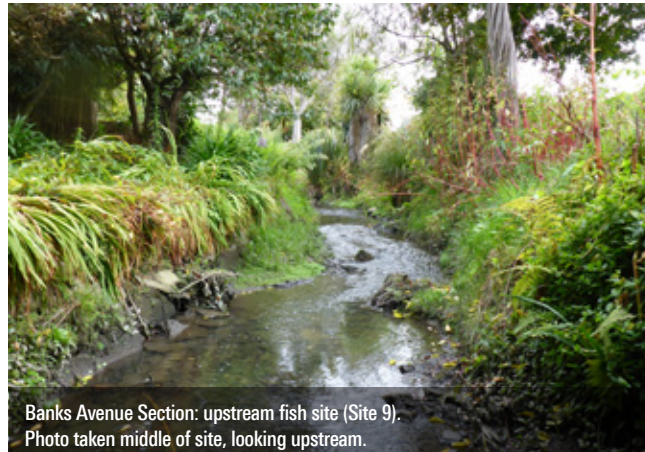
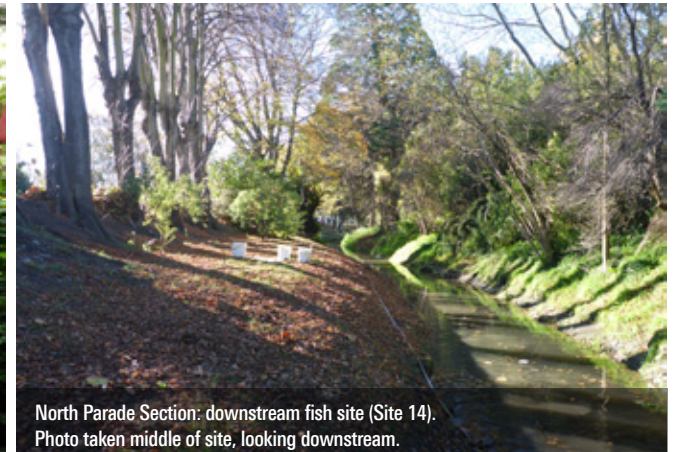
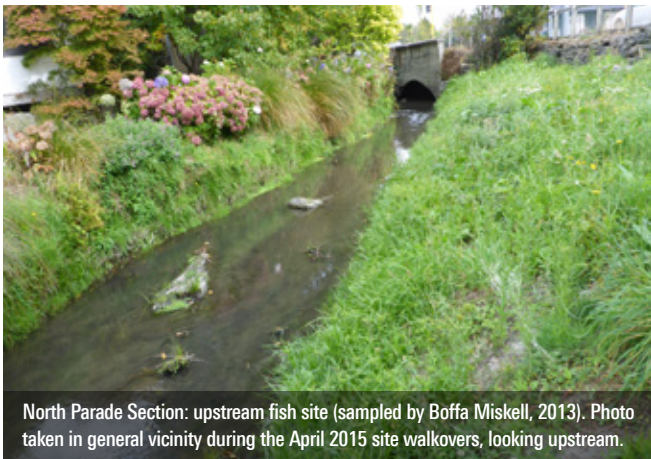
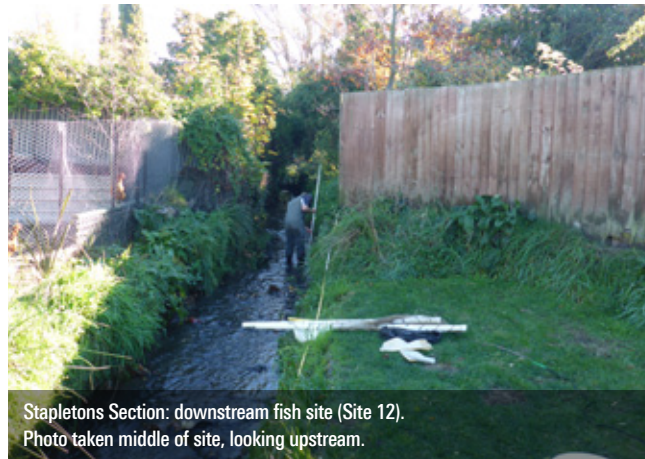
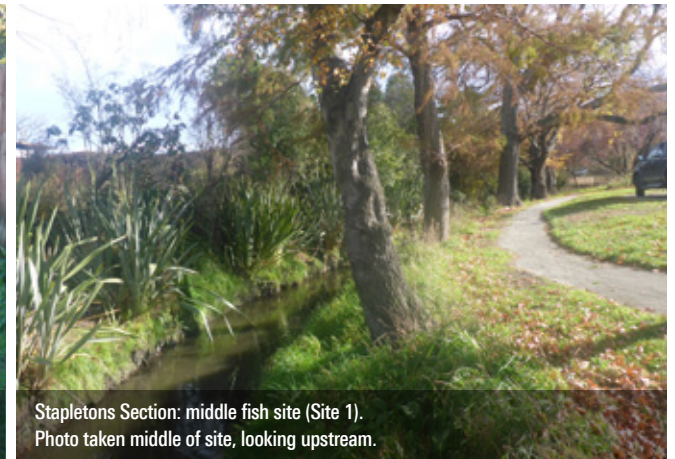
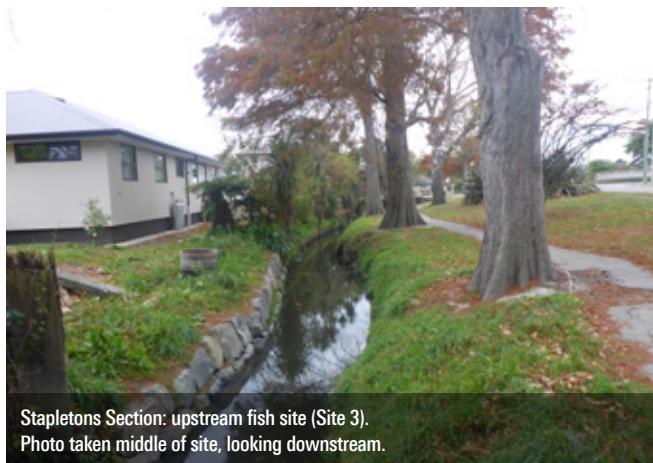
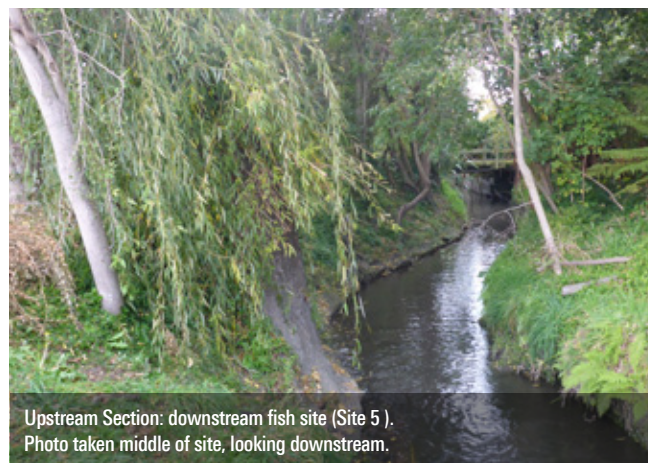
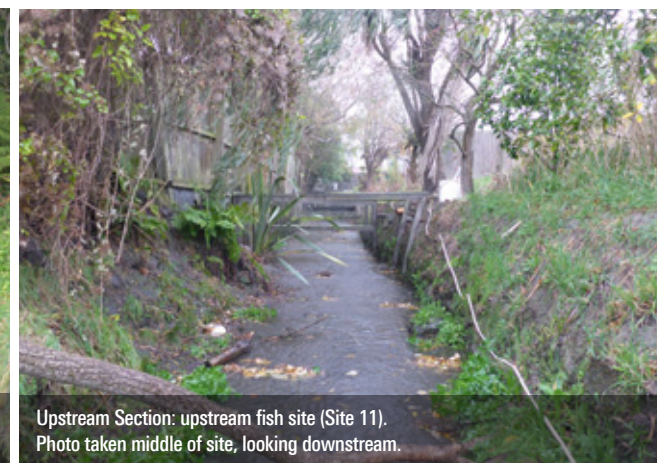
7.1 APPENDIX 1: FISH SAMPLING SITE PHOTOGRAPHS

Site photographs of fish sites along Dudley Creek between the confluence with the Avon River and the confluence with Shirley Stream. Photographs were taken at the time of the May 2015 ecological surveys, unless otherwise stated.

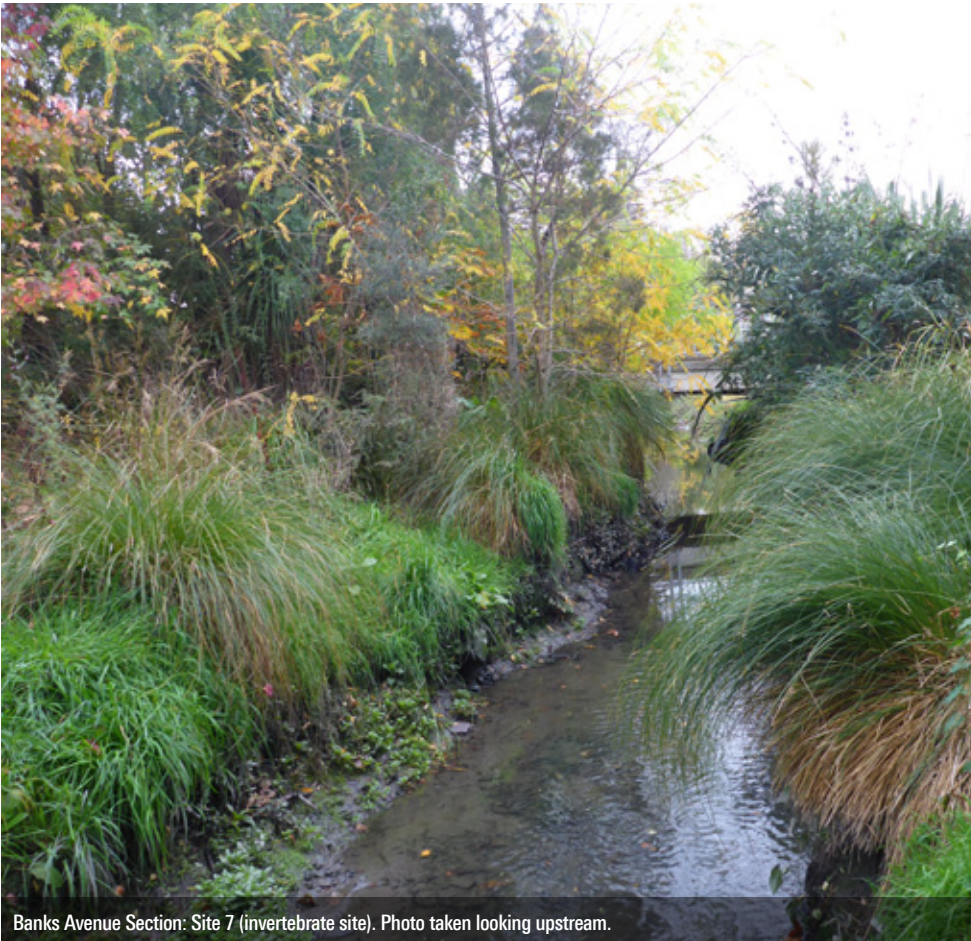
Banks Avenue Section: Site 7 (invertebrate site). Photo taken looking upstream.

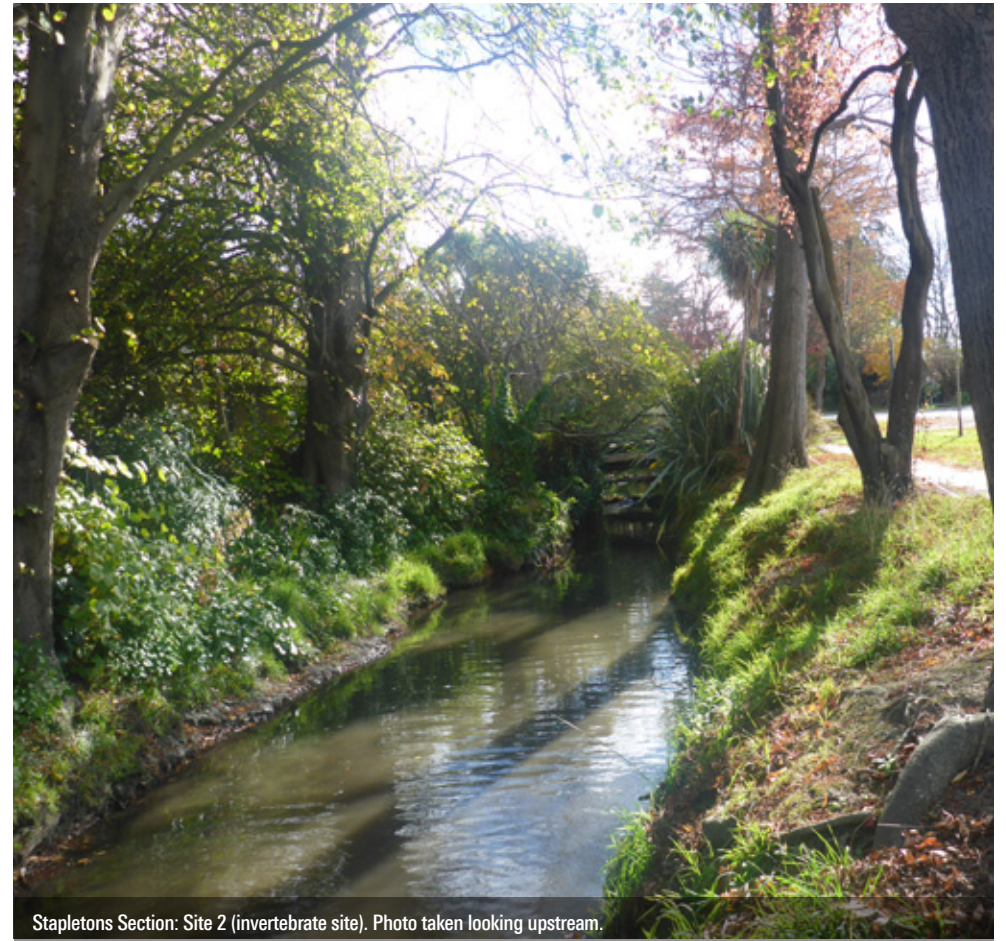
Stapletons Section: Site 2 (invertebrate site). Photo taken looking upstream.
