Smacks Creek Riverbank Reserve

Ecological restoration guidelines

May 2023

Christchurch
City Council

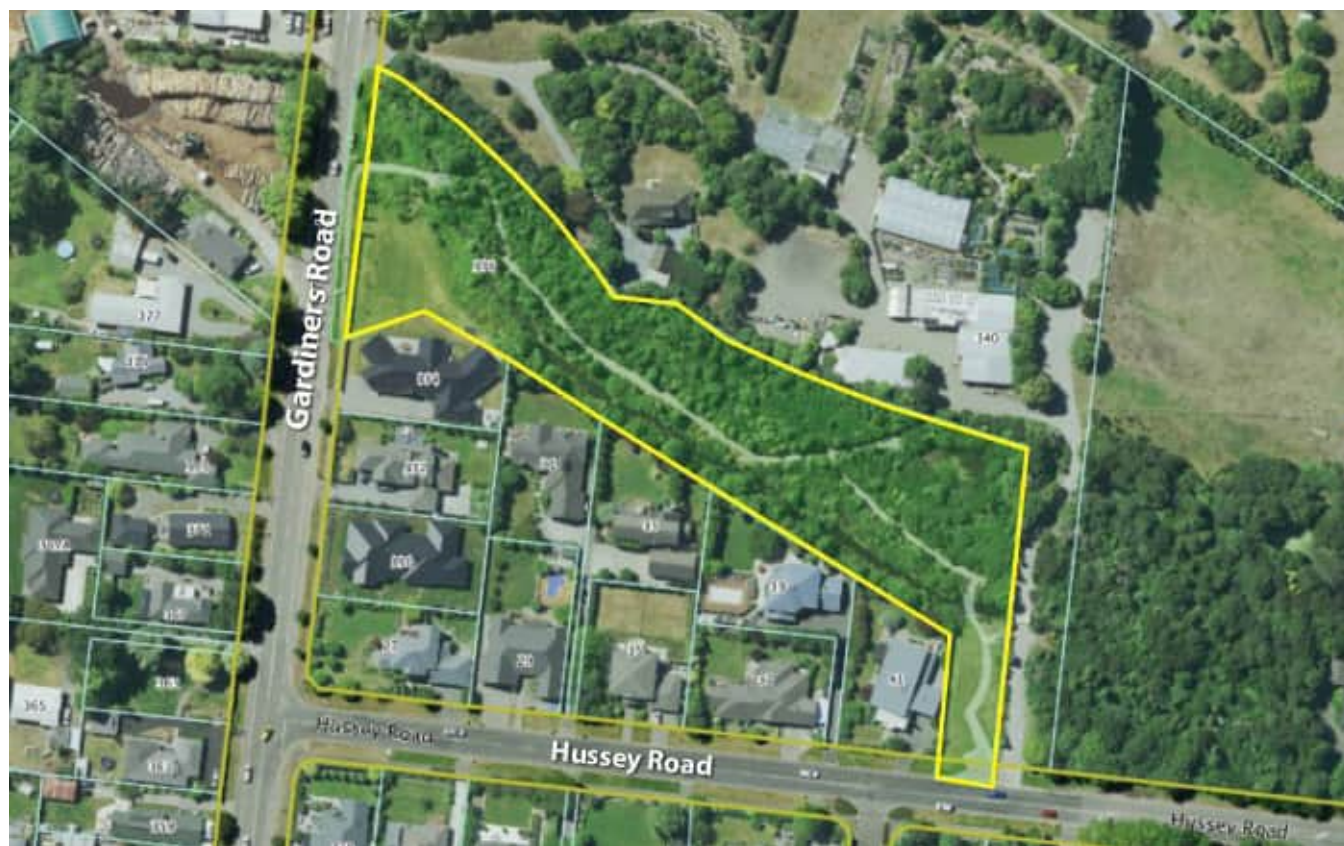
Figure 1: Smacks Creek Riverbank Reserve

Smacks Creek Riverbank Reserve (Figure 1) is just over one hectare in area, and is accessible from Hussey and Gardiners Roads (Figure 1). The reserve borders residential properties to the south, and Redwood Aquatics to the north, and Smacks Creek – a tributary of the Pūharakekenui-Styx River – flows along the southern edge of the reserve. Because of this connection with the Pūharakekenui-Styx River, any planning and development of the Smacks Creek Riverbank Reserve must also support Christchurch City Council (Council)’s adopted ‘Styx Vision 2000 – 2040’ planning document.

A development proposal for Smacks Creek Riverbank Reserve (Figure 1) was consulted on in 2004, and was approved for implementation that same year⁷. Note that in this document, the reserve is called “Smacks Creek Esplanade Reserve”.

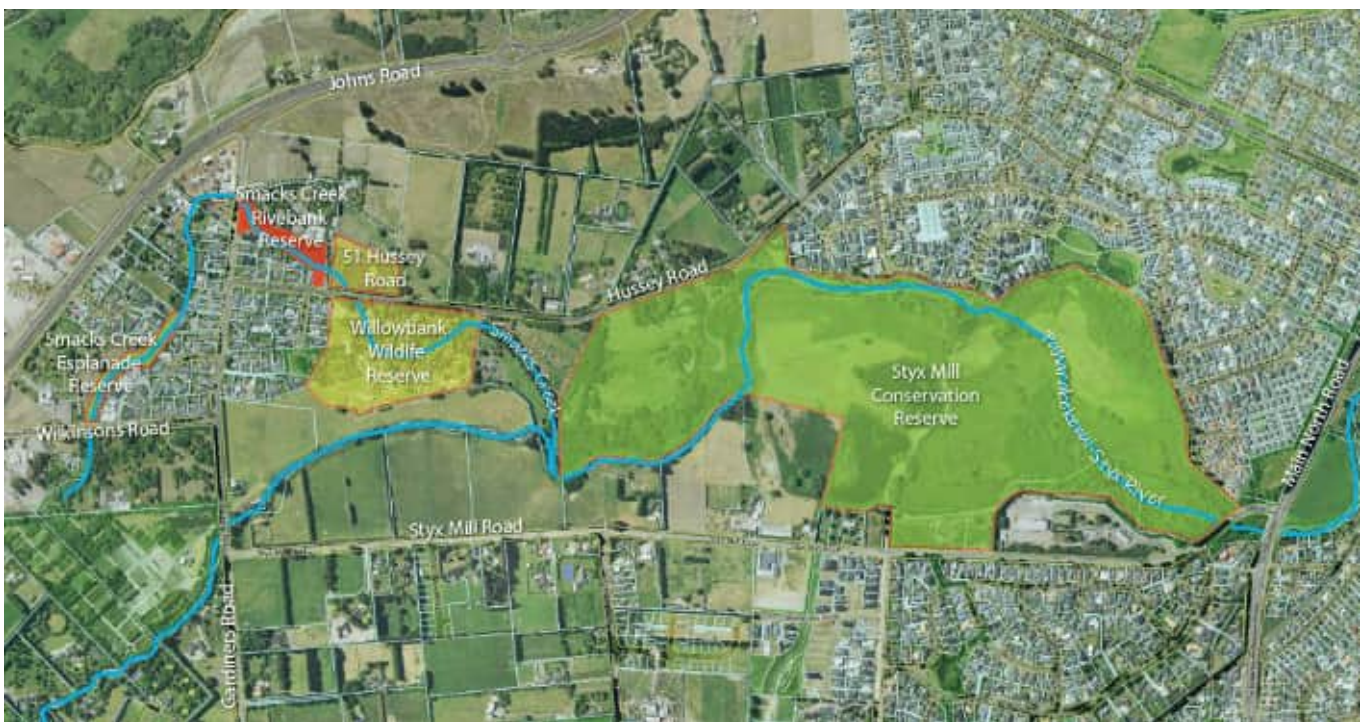
Figure 2: Nearby or adjacent natural areas to Smacks Creek Riverbank Reserve.

Although comparatively small, Smacks Creek Riverbank Reserve also has ecological value associated with its connectivity or proximity with to other nearby natural areas (Figure 2):

- Smacks Creek is a headwater tributary of the Pūharakekenui-Styx River, and therefore has a role to play in protecting the freshwater values of a wider river ecosystem.
- Another restored section of Smacks Creek - Smacks Creek Esplanade Reserve – is approximately 200 m south-west and is accessible from Wilkinsons Road. This reserve contains significant riparian restoration plantings that are being impacted by pest plants and garden-origin/ornamental plants, however we plan to carry out a full waterway restoration project through this section in 2024.

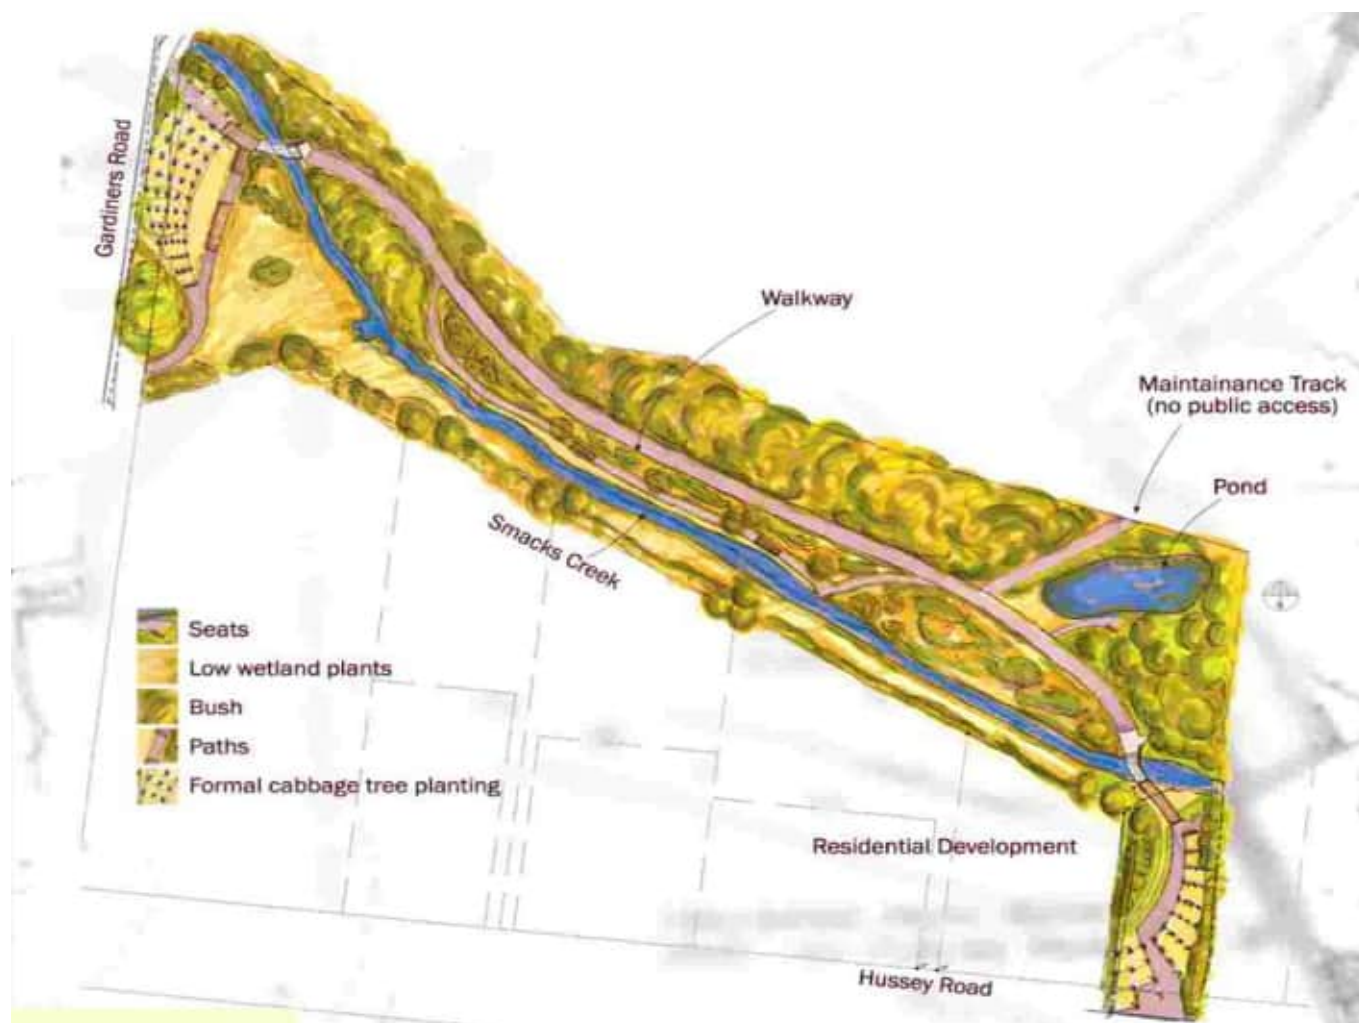
Figure 3: Landscape development plan for Smacks Creek Riverbank Reserve from the development proposal (2004).

The objectives of the development plan included:

- That the wilderness nature of the area be maintained to act as a contrast to the adjacent urban areas.
- That the ecological values associated with Smacks Creek and the reserve continue to be protected and enhanced.
- That any built structures complement and enhance the wilderness nature of the reserve through appropriate location and design.
- That by working with the natural processes of decay and regeneration ongoing maintenance costs are kept to a minimum.
- To provide opportunities for people to gain, and appreciate, a ‘wilderness experience’.

Plant eco-sourced native plant species: The 2004 development plan shows a formal cabbage tree (*Cordyline australis*) planting at both entrances to the reserve (Refer Figure 3). However we know that cabbage tree leaves can become a nuisance when they litter the ground, and can cause the public to complain, especially when next to a path and residential property. To reduce maintenance costs, native shrub and ground cover planting shall be established at the Hussey Road entrance, and native ground cover plants will replace the grass berms at the Gardiners Road entrance. This will eliminate the need for regular mowing, and establish the reserve as a fully grass-free park.

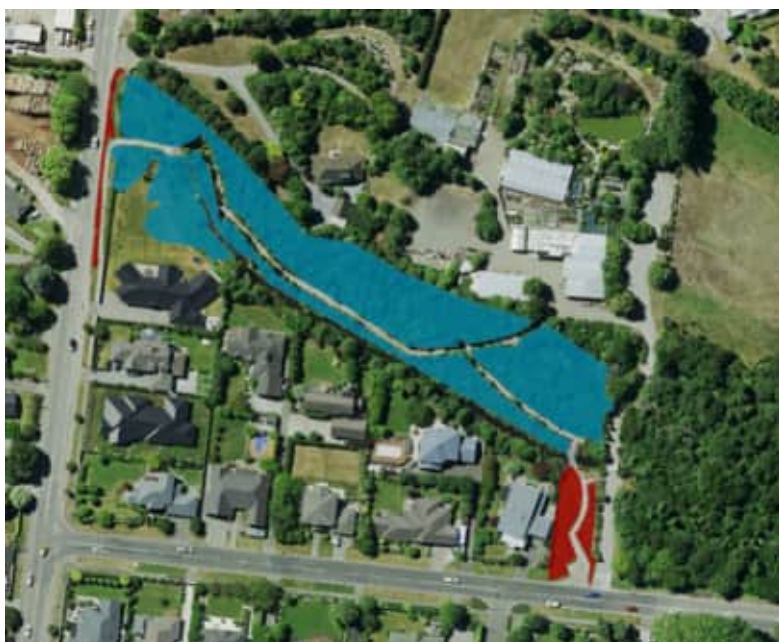
Figure 4: Map showing management areas – the blue are the 'natural areas' and the red are 'turf'. Obtained from the Community Parks Maintenance Contract Map.

Currently only reactive maintenance occurs within the reserve. Contractors mow the lawns and grass berms (shown in red in Figure 4), and prune vegetation off the tracks but do not maintain the natural areas (shown in blue in Figure 4). Recently, staff from the Styx Living Laboratory Trust have been carrying out woody weed control within the forest and fen wetland areas of the reserve.

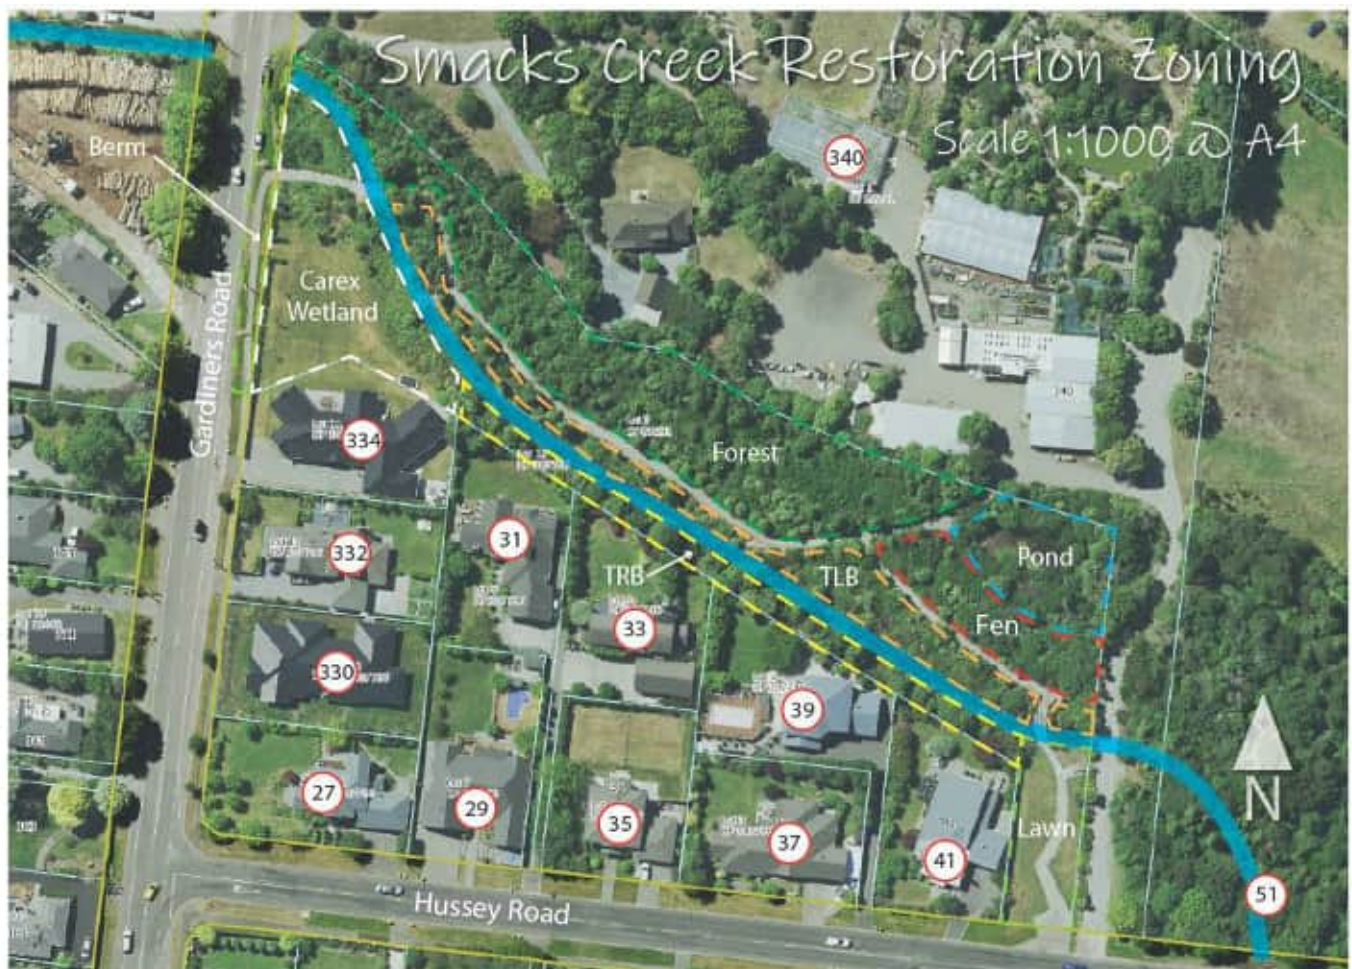
Figure 5: Restoration zoning within Smacks Creek Riverbank Reserve.

For the purpose of this plan, we have separated the reserve into seven distinct restoration zones that require specific actions for habitat restoration. These zones are shown in Figure 5 (below), and include:

- The freshwater aquatic environment
- Riparian margins along the true left bank (TLB) and true right banks (TRB) of Smacks Creek
- Native forest
- A constructed pond at the eastern end of the reserve
- The *Carex secta* wetland at the Gardiners Road entrance
- The fen wetland
- Reserve entrance areas (currently grass berms and lawns)

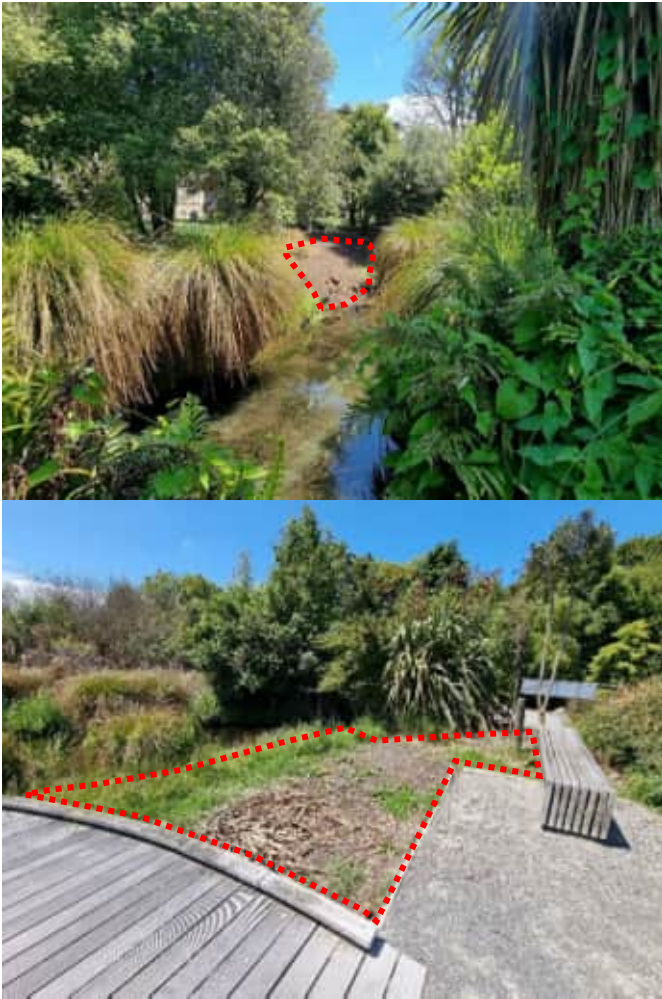
Figure 6: Areas along riverbanks that require infill planting.

Infill planting: Where areas within the riparian strip have been cleared (E.g. Figure 6, top), these areas shall be in-filled with large grade riparian plants that will be quick to establish and fill any voids. This will not only bolster habitat, but will also reduce maintenance effort by eliminating open grassy areas.

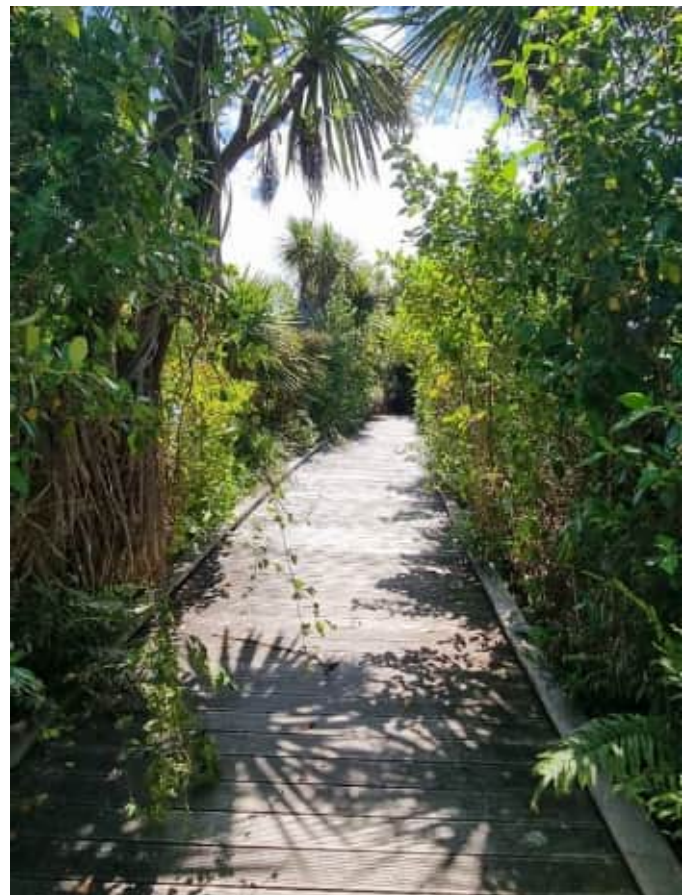
Figure 7: Overhanging branches and blackberry along paths and boardwalks.

Vegetation maintenance along path: More regular maintenance of the track edges is intended to be carried to ensure people can easily move along the path unimpeded by overhanging branches or vines - including blackberry (e.g. see Figure 7). Any pruning shall be carried out in such a way that a high degree of natural character is maintained and does not look artificially pruned or hedged. Branches will only need to be pruned to just above head height, above which a canopy will be allowed to form across the path. Note that as the forest continues to mature, less of this type of maintenance is likely to be needed.

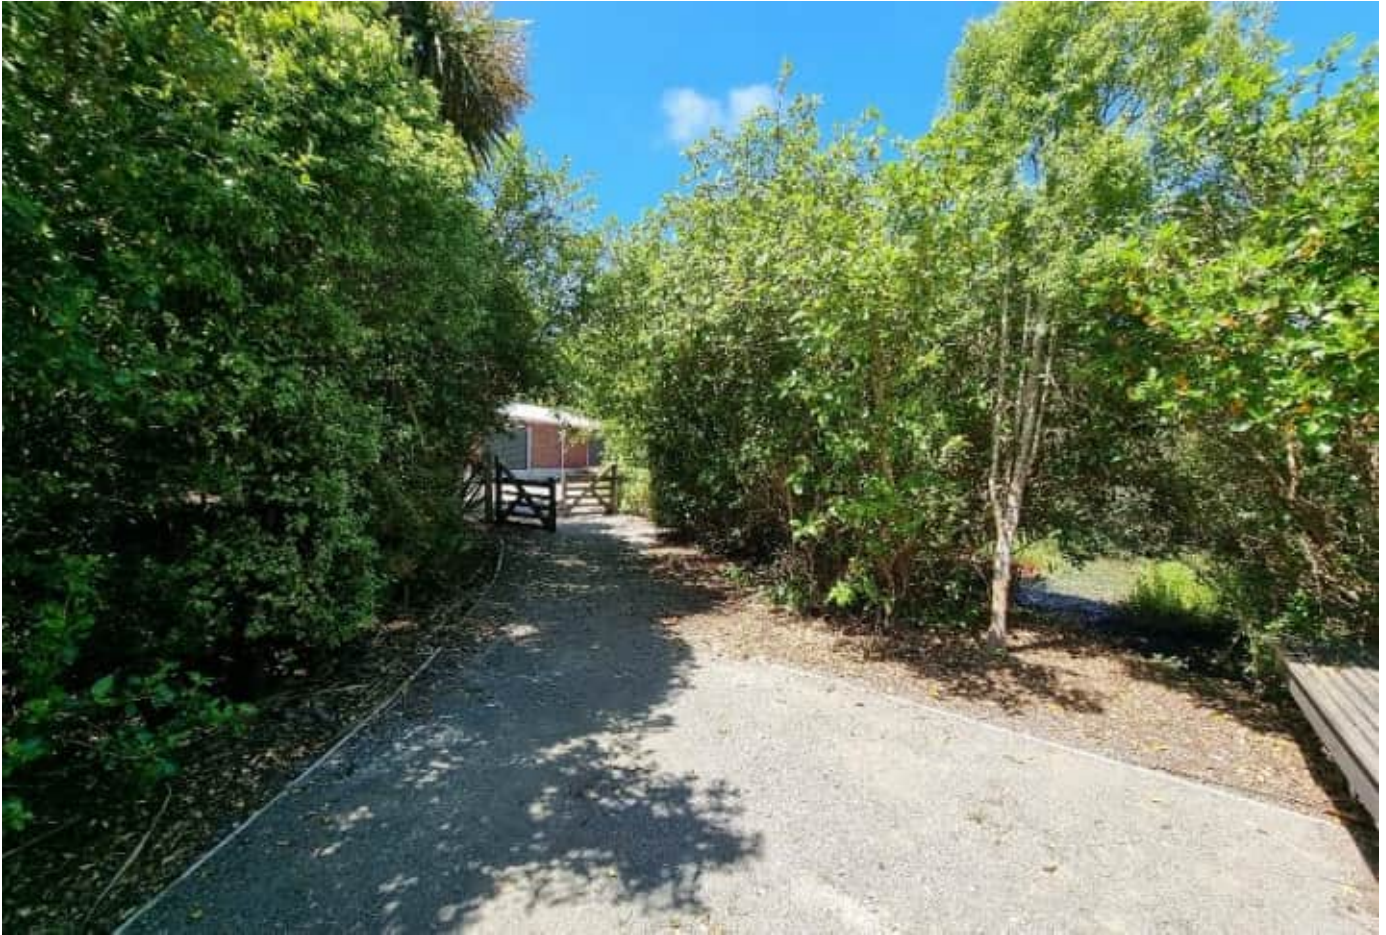
Figure 8: Redundant track and gate to Redwood Aquatics to be removed and planted as native forest

Remove Access to Redwood Aquatics: A short section of track that branches off the main track historically provided access from Redwood Aquatics (Figure 8). Following discussion with Redwood Aquatics, it has been determined that this gate and track is no longer needed. Therefore the gate shall be secured and the section of path removed and planted as native forest. The area with a seat that overlooks the pond will remain, although the path that connects it to the main path will be narrowed by extending the planting. This will reinforce the main pathway.

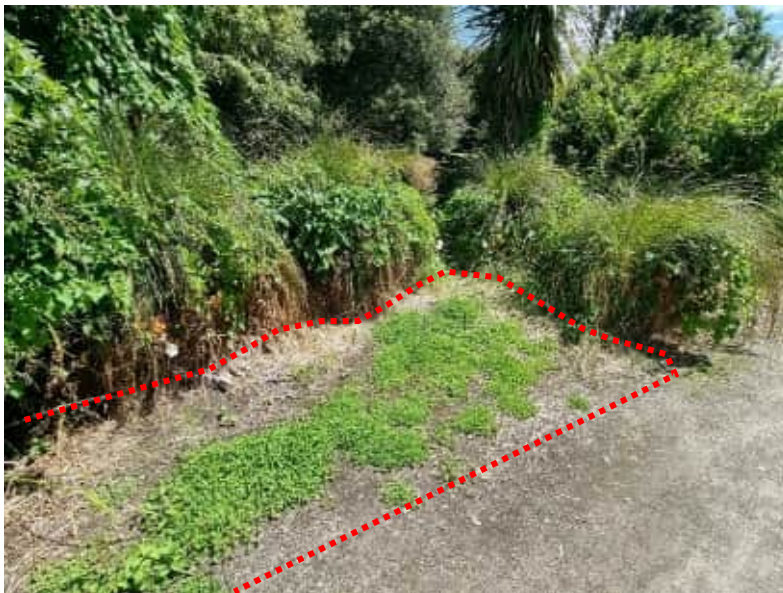
Figure 9: Cleared areas along path to be planted with native forest edge or understorey species

Infill planting: In a number of locations along the main track where plantings have either failed or have been cleared by contractors, these areas will be re-planted with native forest understorey species to remove unsightly gaps and reduce ongoing maintenance costs.

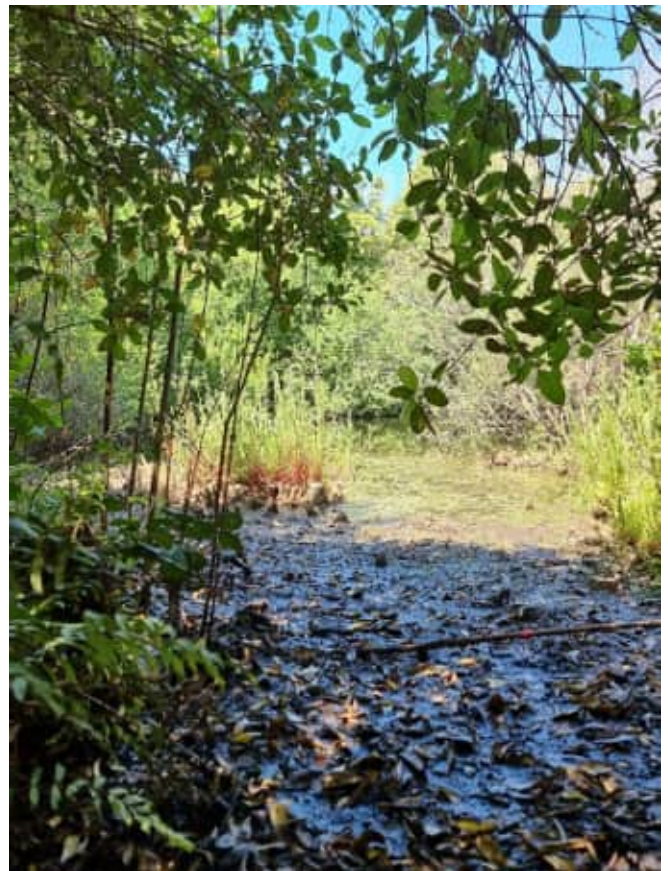
Figure 10: Constructed pond to be restored

A pond (Figure 10) near the maintenance gate to Redwood Aquatics, was created by previous owners prior to the area becoming a public reserve. The previous owners also stocked the pond with goldfish and carp, and Council staff have sighted a red-eared slider turtle in the pond recently (2023) also. There are a number of key actions – outlined below – that can be taken to improve the quality of the pond and manage it as a valuable wetland habitat. After these actions are completed, monitoring of the pond's condition will be important to assess its ecological value. At this stage, there will not be any modification to the physical profile of the pond itself, as this may affect the water level in Smacks Creek and/or introduce invasive species in to the creek. The pond is also defined as a wetland under the National Policy Statement (NPS) on Freshwater.

Removal of weeds: The removal of deciduous exotic trees should improve the condition of the pond, by reducing leaf fall. Other pest plants within and around the pond shall also be removed.

Establish riparian planting: Appropriate eco-sourced native plants will be established to replace any pest plants around the perimeter of the pond.

Aquatic pest control: A survey for exotic/invasive fauna in the pond will be carried out including taking water samples to detect eDNA, and removing any undesirable species that are found. Monitoring regularly will be important for directing the future restoration of the pond. Pest animals are discussed later in this document.

Develop viewing area: Enhance the space around the existing seating area to create a space for quiet contemplation with good views to the restored pond area.

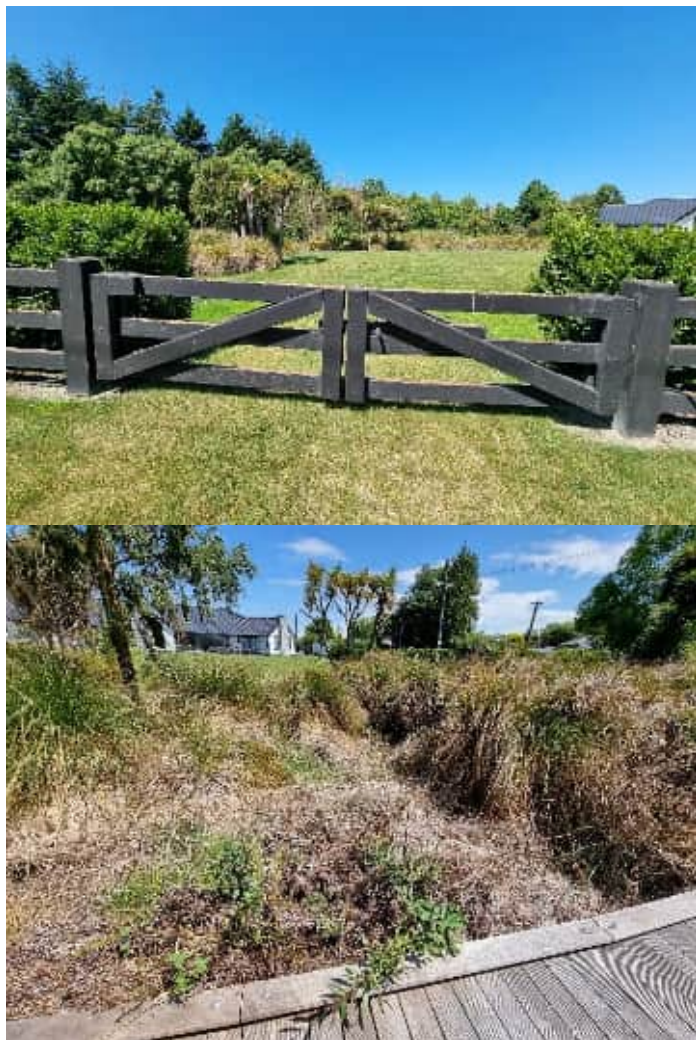
An area of approximately 470 m² of significant indigenous wetland vegetation at the Gardiners Road reserve frontage has been removed and sewn as lawn (Figure 11, top). We intend to restore this important area of wetland as a matter of priority.

Figure 11: Images showing the current state of the previous wetland. The top image was taken from the footpath parallel to Gardiners Road and shows the flat lawn area. The bottom image is taken from the boardwalk within the reserve, looking towards the lawn area.

Re-establish *Carex secta* wetland: Current fill material in lawn area shall be removed to reinstate original profiles, and any contaminated soils (if any) disposed of appropriately. The area (approximately 470 m²) will be planted with eco-sourced plant species that are appropriate for this habitat type (refer Appendix 2).

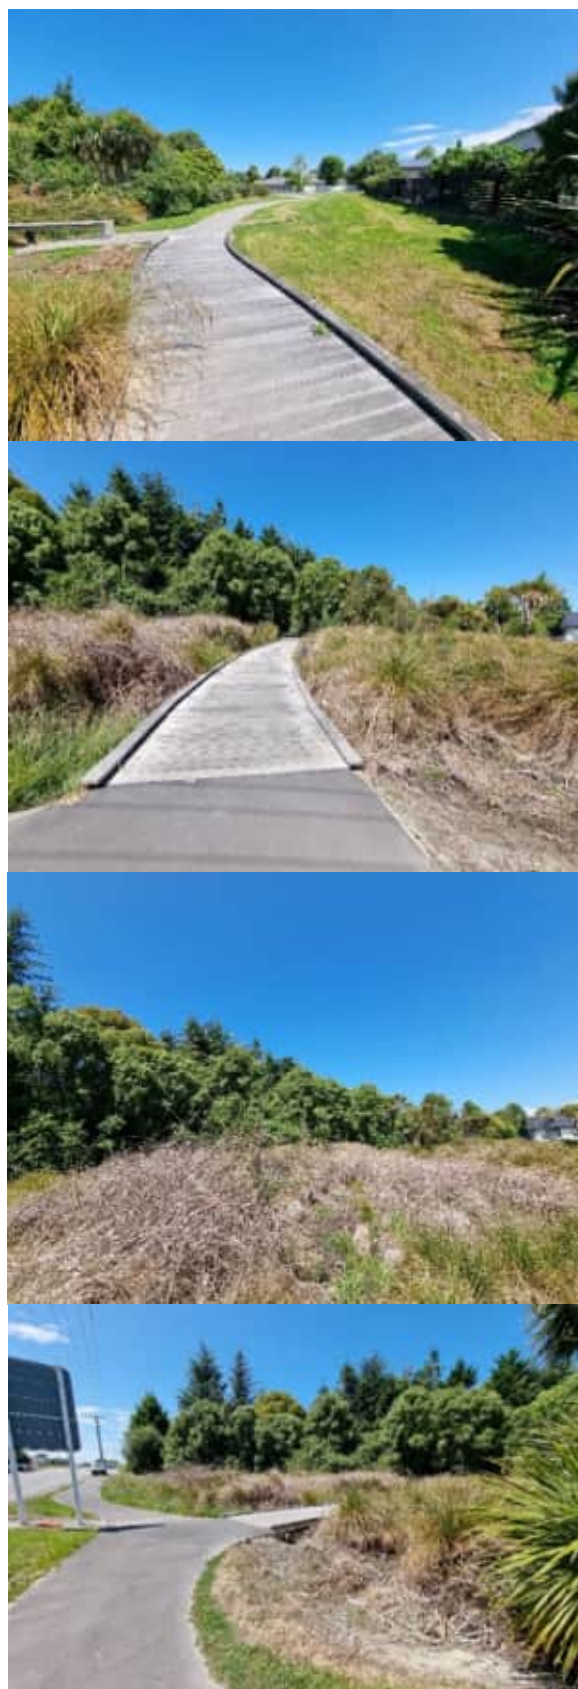
The areas at each entrance of the reserve (Figure 12) require enhancement to ensure they are tidy, align with the objective to achieve the aspirations of the approved landscape development plan, reduce maintenance costs, reduce mowing-related CO2 emissions, and create a more ‘wilderness feel’ to the reserve.

The Hussey Road entrance is currently maintained lawn, with a swale along the western side. The grass requires scheduled mowing to upkeep amenity standards.

The Gardiners Road entrance is currently untidy. There has been weed control in this area, but there is still rank grass, crack willow, grey willow and dead blackberry. There is also narrow strip of rural roadside berm lawn alongside Gardiners Rd.

Figure 12: Areas requiring maintenance and infill planting around the two entrances to the reserve: Hussey Road (top) and Gardiners Road (bottom three images).

Removal of weeds: Weeds shall be removed to prepare for native plantings.

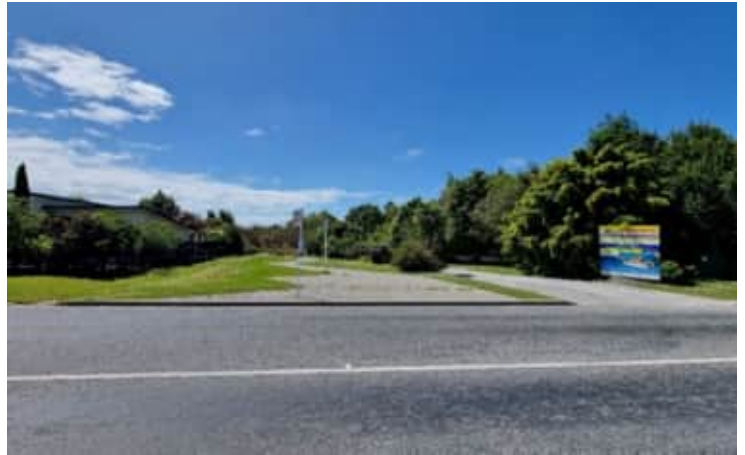
Figure 10: Entrance to the reserve from Hussey Road, with the driveway to Redwood Aquatics on the far right.

Currently there are no interpretation or informational signs within the reserve. There is an obvious need for signs at each entry point to indicate the entrances and increase interest in public use of the reserve. The Hussey Road entrance is particularly inconspicuous, with the only existing signs being used to indicate a bus stop along the road and the shared bike and walking track (Figure 10). The drafting of these entrance signs is currently sitting with the Parks Unit's Visitor Experience Team to be completed pending funding.
