memorandum

RE Living Earth Odour Monitoring: 1st November to 30th November 2025 Summary

1.0 Background

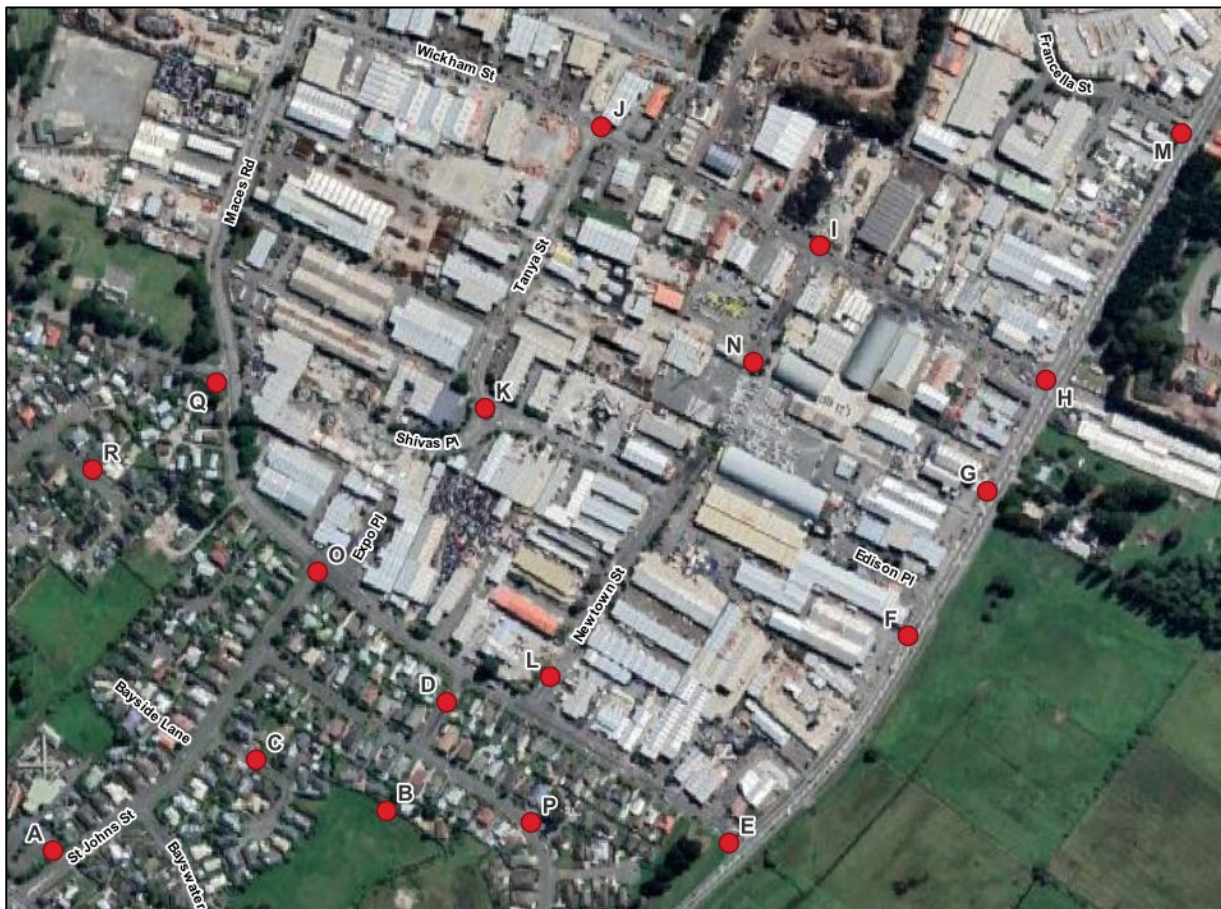
Figure 1: Odour Observation Locations

Sites H and M are immediately downwind of the site, located along Dyers Road with sites G and F. Sites I, J, K, and N are located in the heavy industrial zone. Sites A, C, B, D, P, and R are located in the residential zone around Bayswater Reserve. Sites E, L, O, and Q are located roughly along the residential-industrial boundary. In assessments, Sites E, O, D and Q are in the residential zone, while Site L is in the general industrial zone.

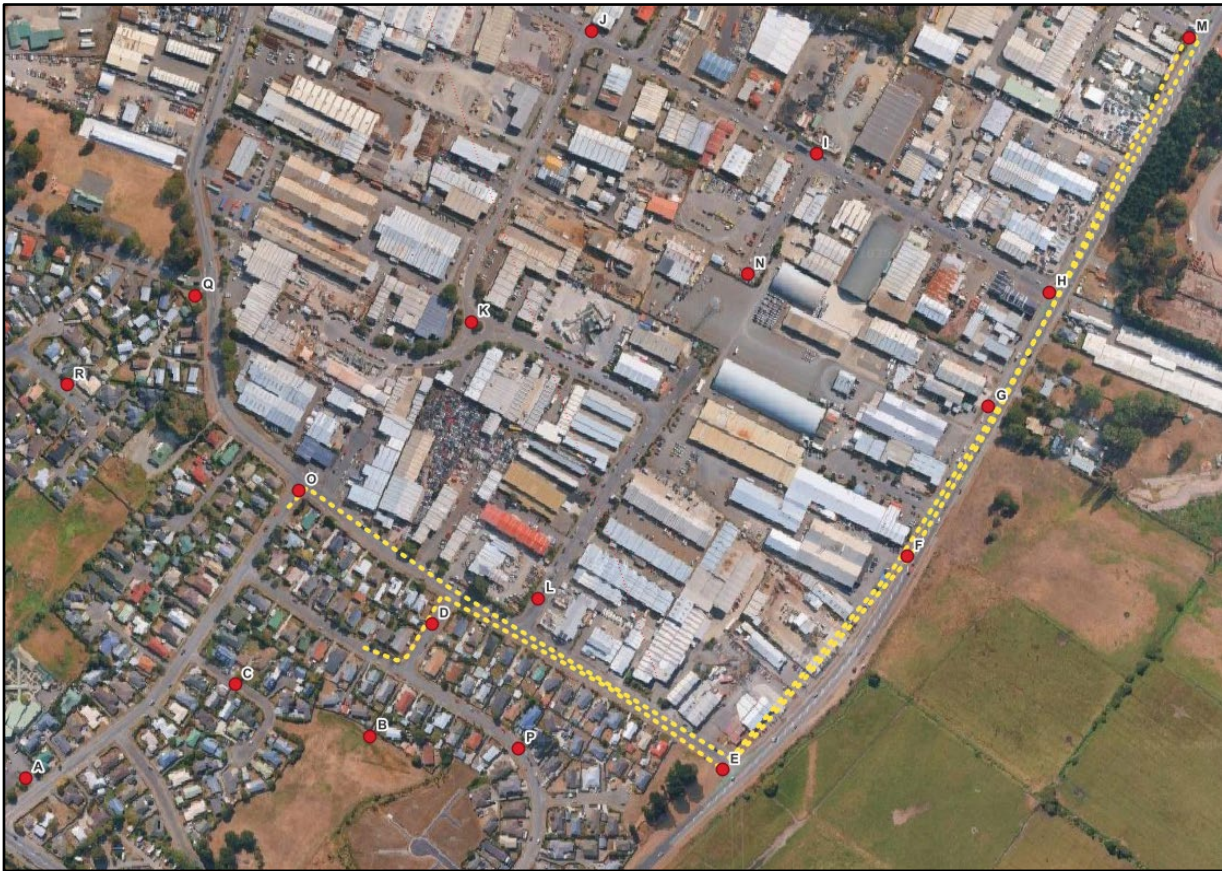
Figure 2: 5th November 2025 - Odour Scout Route

██████████ were the PDP odour scouts. The scouts were present for approximately 1 hour. The scouts started near Site D, and then walked along the boundary of the industrial area towards Site M, before returning to Site D. North-easterly winds were forecast. The objective was to undertake odour monitoring in the area downwind of the LE Site. The odour scout route (yellow dots) and key scouting locations are shown in **Figure 2**.

Weak (2) compost odour was detected in the residential area, at sites O and Q, and in the industrial area near sites G and H. Distinct (3) compost odour was also detected between sites G and H.

The compost odour in the residential area was not determined to be offensive or objectionable, due to the highly intermittent nature of the odour. The compost odour detected in the industrial area was not determined to be offensive or objectionable.

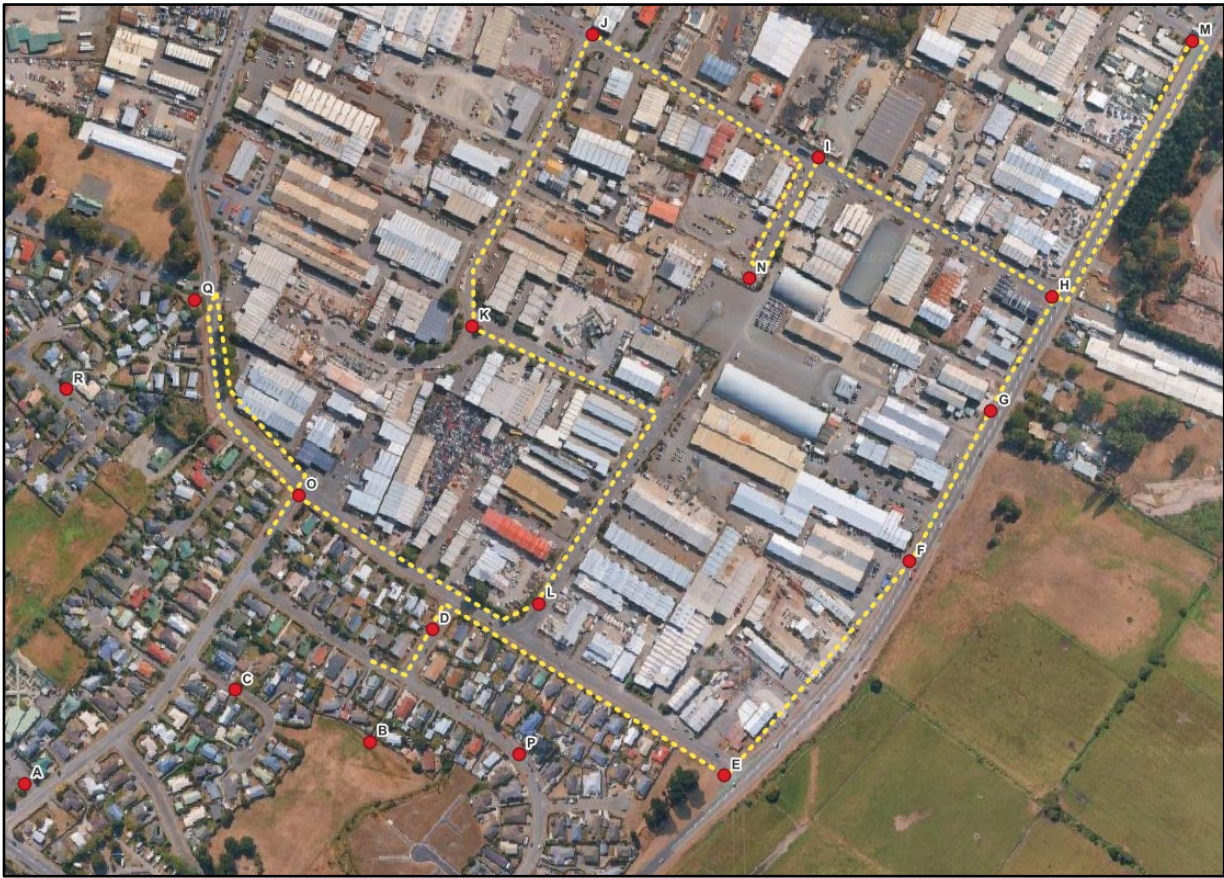
Figure 3: 11th November 2025 - Odour Scout Route

██████████ were the PDP odour scouts. The scouts were present for approximately 1 hour. The scouts started near Site D, and then walked along the boundary of the industrial area towards Site M, before walking through the industrial area and finishing near Site O. North-easterly winds were forecast. The objective was to undertake odour monitoring in the area downwind of the LE Site. The odour scout route (yellow dots) and key scouting locations are shown in **Figure 3**.

Distinct (3) compost odour was also detected between sites G and M in the industrial area. No compost odour was detected in the residential area.

The compost odour in the industrial area was determined to be neither offensive nor objectionable.

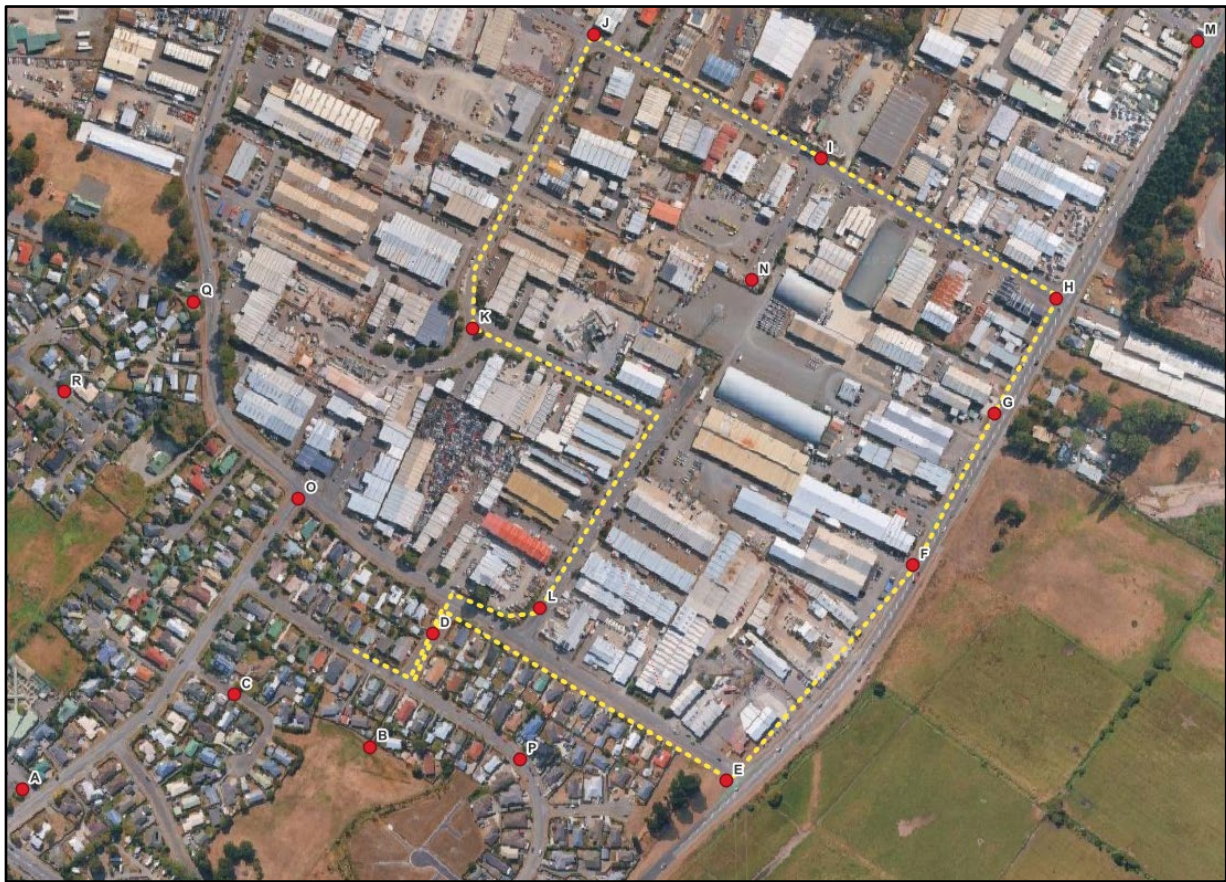
Figure 4: 12th November 2025 - Odour Scout Route

██████████ were the PDP odour scouts. The scouts were present for approximately two and a half hours. The scouts started near Site D, and then walked along the boundary of the industrial area towards Site M, before walking through the industrial area and then returning to Site D. Following this, the scouts split up and conducted separated FIDOL assessments at Site L and Site H, before driving to the LE site, and conducting a site walkover along with a FIDOL assessment at the site boundary. North-easterly winds were forecast. The objective was to undertake odour monitoring in the area downwind of the LE Site. The odour scout route (yellow dots) and key scouting locations are shown in **Figure 4**.

Weak (2) compost odour was also detected near along Maces Road in the residential area. Due to the intermittent nature of the compost odour, it was determined to be neither offensive nor objectionable.

The odour was tracked from the residential area to the industrial area where distinct (3) compost odour was detected. The scouts also visited the LE site and took observations, noting that the odour was only detectable at the site boundary when material was being moved from the building into waiting trucks. This accounts for the intermittent nature of the odours observed offsite.

The compost odour in the industrial area was determined to be neither offensive nor objectionable.

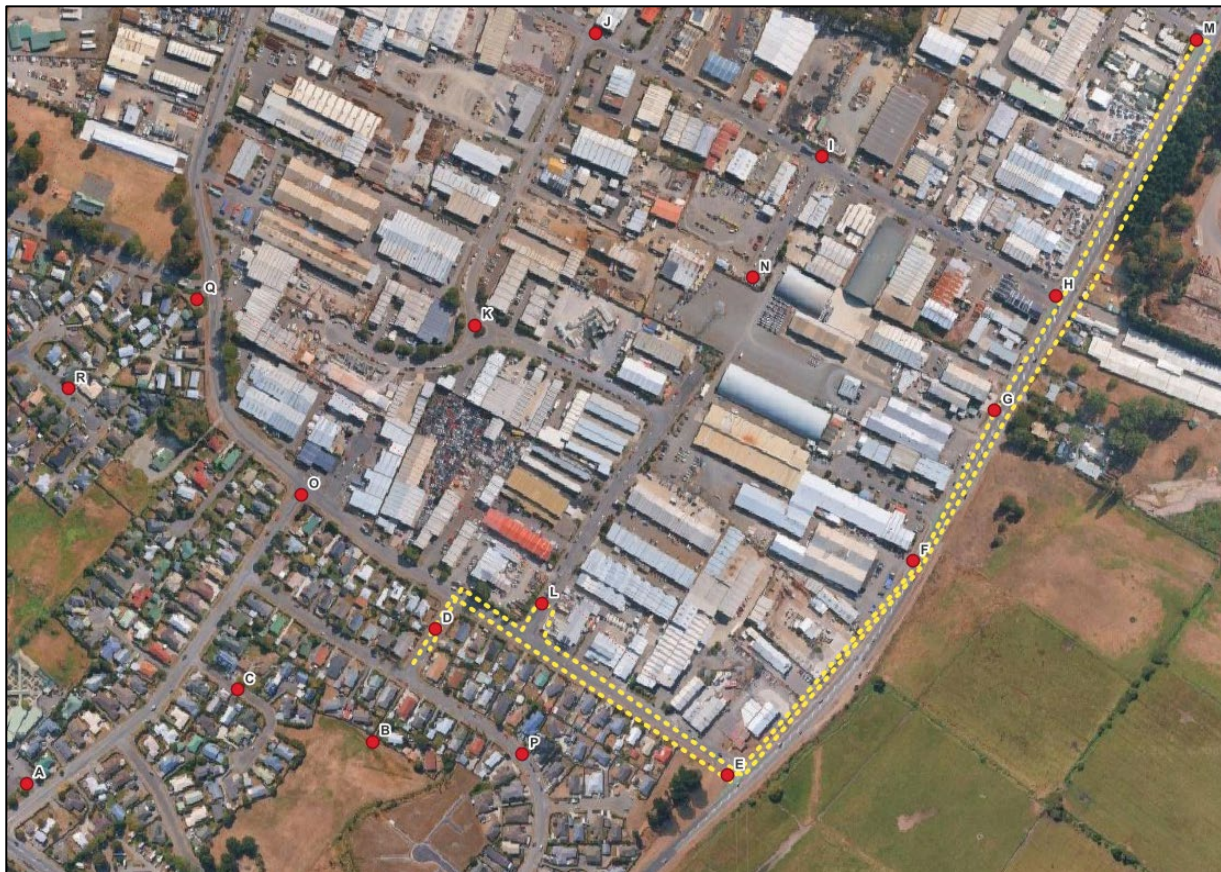
Figure 5: 12th November 2025 - Odour Scout Route

██████ was the PDP odour scout. The scout was present for approximately 45 minutes. The scout started near Site D, and then walked along the boundary of the industrial area towards Site M, before walking through the industrial area and then returning to Site D. North-easterly winds were forecast. The objective was to undertake odour monitoring in the area downwind of the LE Site. The odour scout route (yellow dots) and key scouting locations are shown in **Figure 5**.

Weak (2) compost odour was detected in the industrial area, near Mr Boats. No compost odour was detected in the residential area.

The compost odour in the industrial area was determined to be neither offensive nor objectionable.

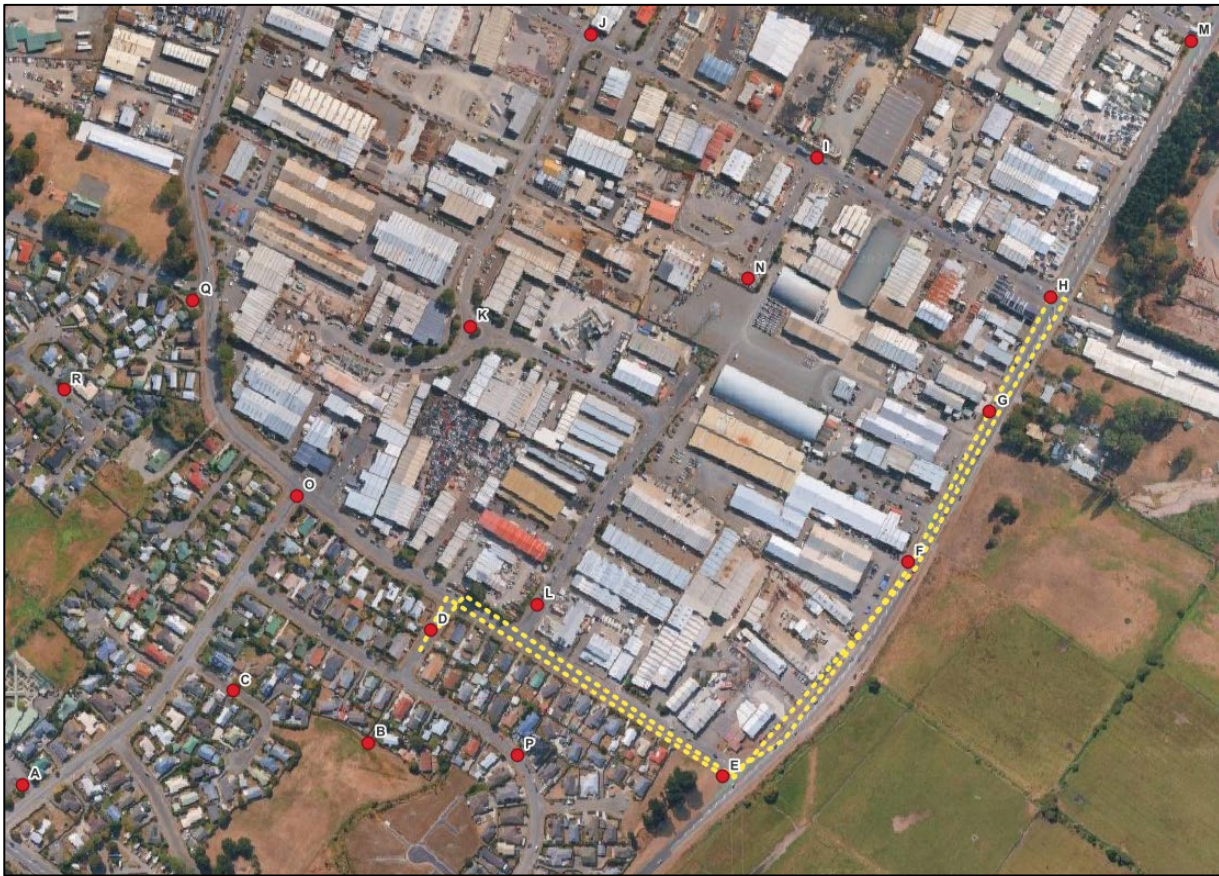
Figure 6: 26th November 2025 - Odour Scout Route

██████████ were the PDP odour scouts. The scouts were present for approximately 45 minutes. The scouts started near Site D, and then walked along the boundary of the industrial area towards Site H, before returning to Site D. North-easterly winds were forecast. The objective was to undertake odour monitoring in the area downwind of the LE Site. The odour scout route (yellow dots) and key scouting locations are shown in **Figure 6**.

No compost odour was detected in either the industrial or residential area. Distinct (3) asphalt odour was detected along Maces Road, from Site D to E, due to recently laid chipseal, while distinct (3) burning plastic odour was detected along Dyers Road near Site G, due to the plastic welding at Dakins Group.
