# Land Drainage Recovery Programme

## Cashmere Worsleys flood storage basin – project update

### May 2019

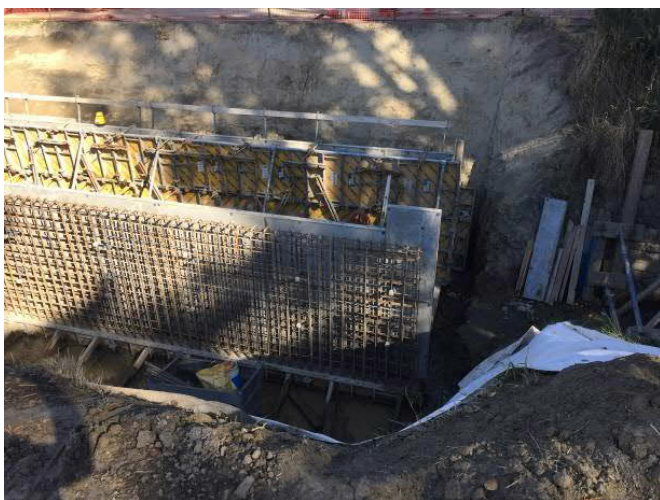
Reinforcement for the concrete walls being prepared

The construction of the control structure involves excavation in the existing Cashmere Valley Drain to allow a U-shaped concrete structure to be installed. This will house 2 bottom hinged gates that will be remotely operated once commissioned. Some images of general construction progress are shown below.

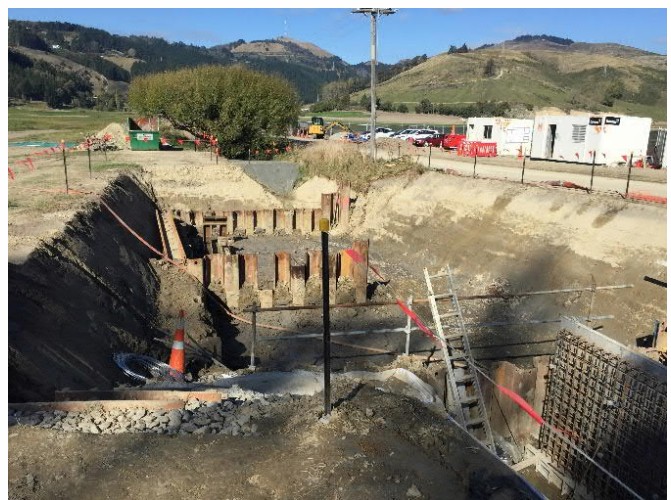
Sheet piles in area of main structure

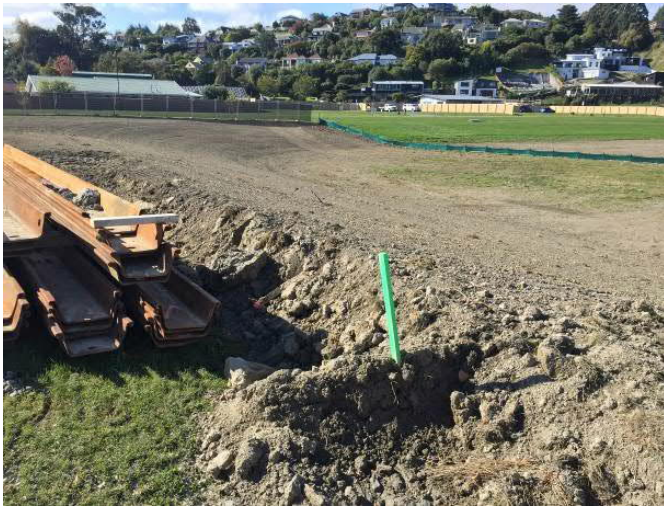
Completed earthworks adjacent to Cashmere Valley Drain

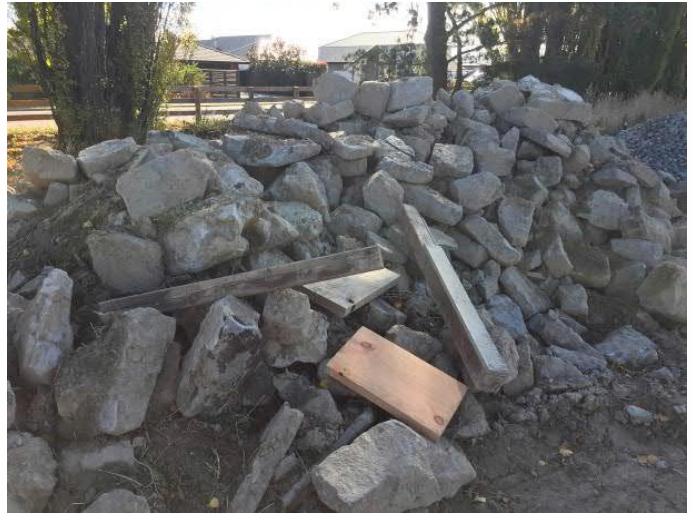
Stone from collapsed section of drain stockpiled for re-use

The works also require dismantling some sections of the heritage stone lined drain, parts of which had previously collapsed. We are working with Heritage New Zealand and our archaeologists to ensure that the works leave the local heritage in a better state than before.

The stones have been removed and stored and the wall will be reconstructed to tie in with the remaining intact stone lining and the new structure. Below are some images showing how the drain looks and diagrams showing how it will be reconstructed.

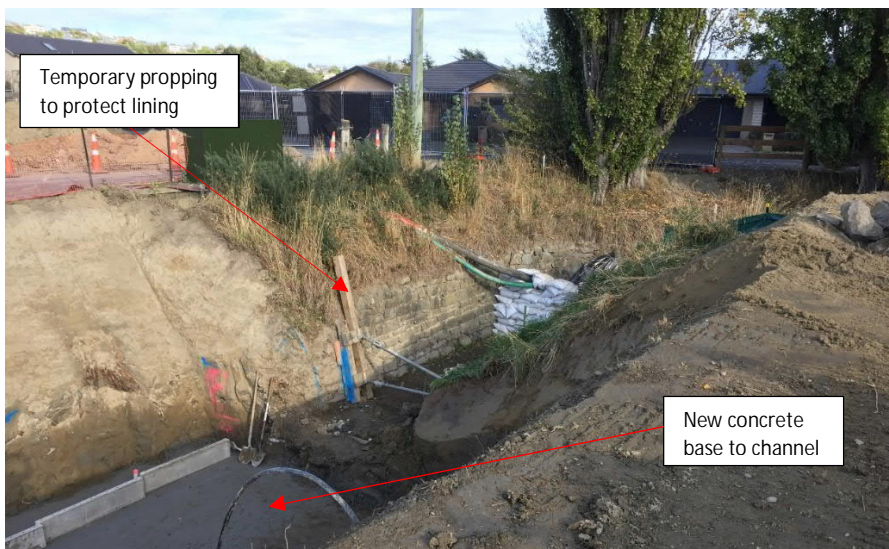
Interface between intact stone lining and area of drain being reconstructed

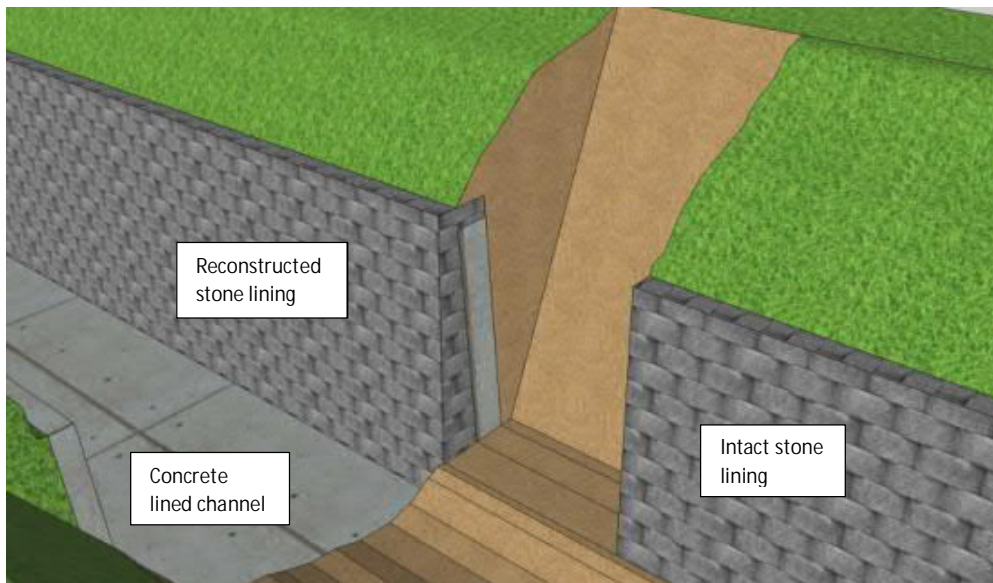
Shows connection between intact stone lining and reconstructed channel
