7 November 2016

INFILTRATION TESTING RESULTS FOR AKAROA TREATED WASTEWATER DISPOSAL VIA IRRIGATION – ROBINSONS BAY AND POMPEYS PILLAR

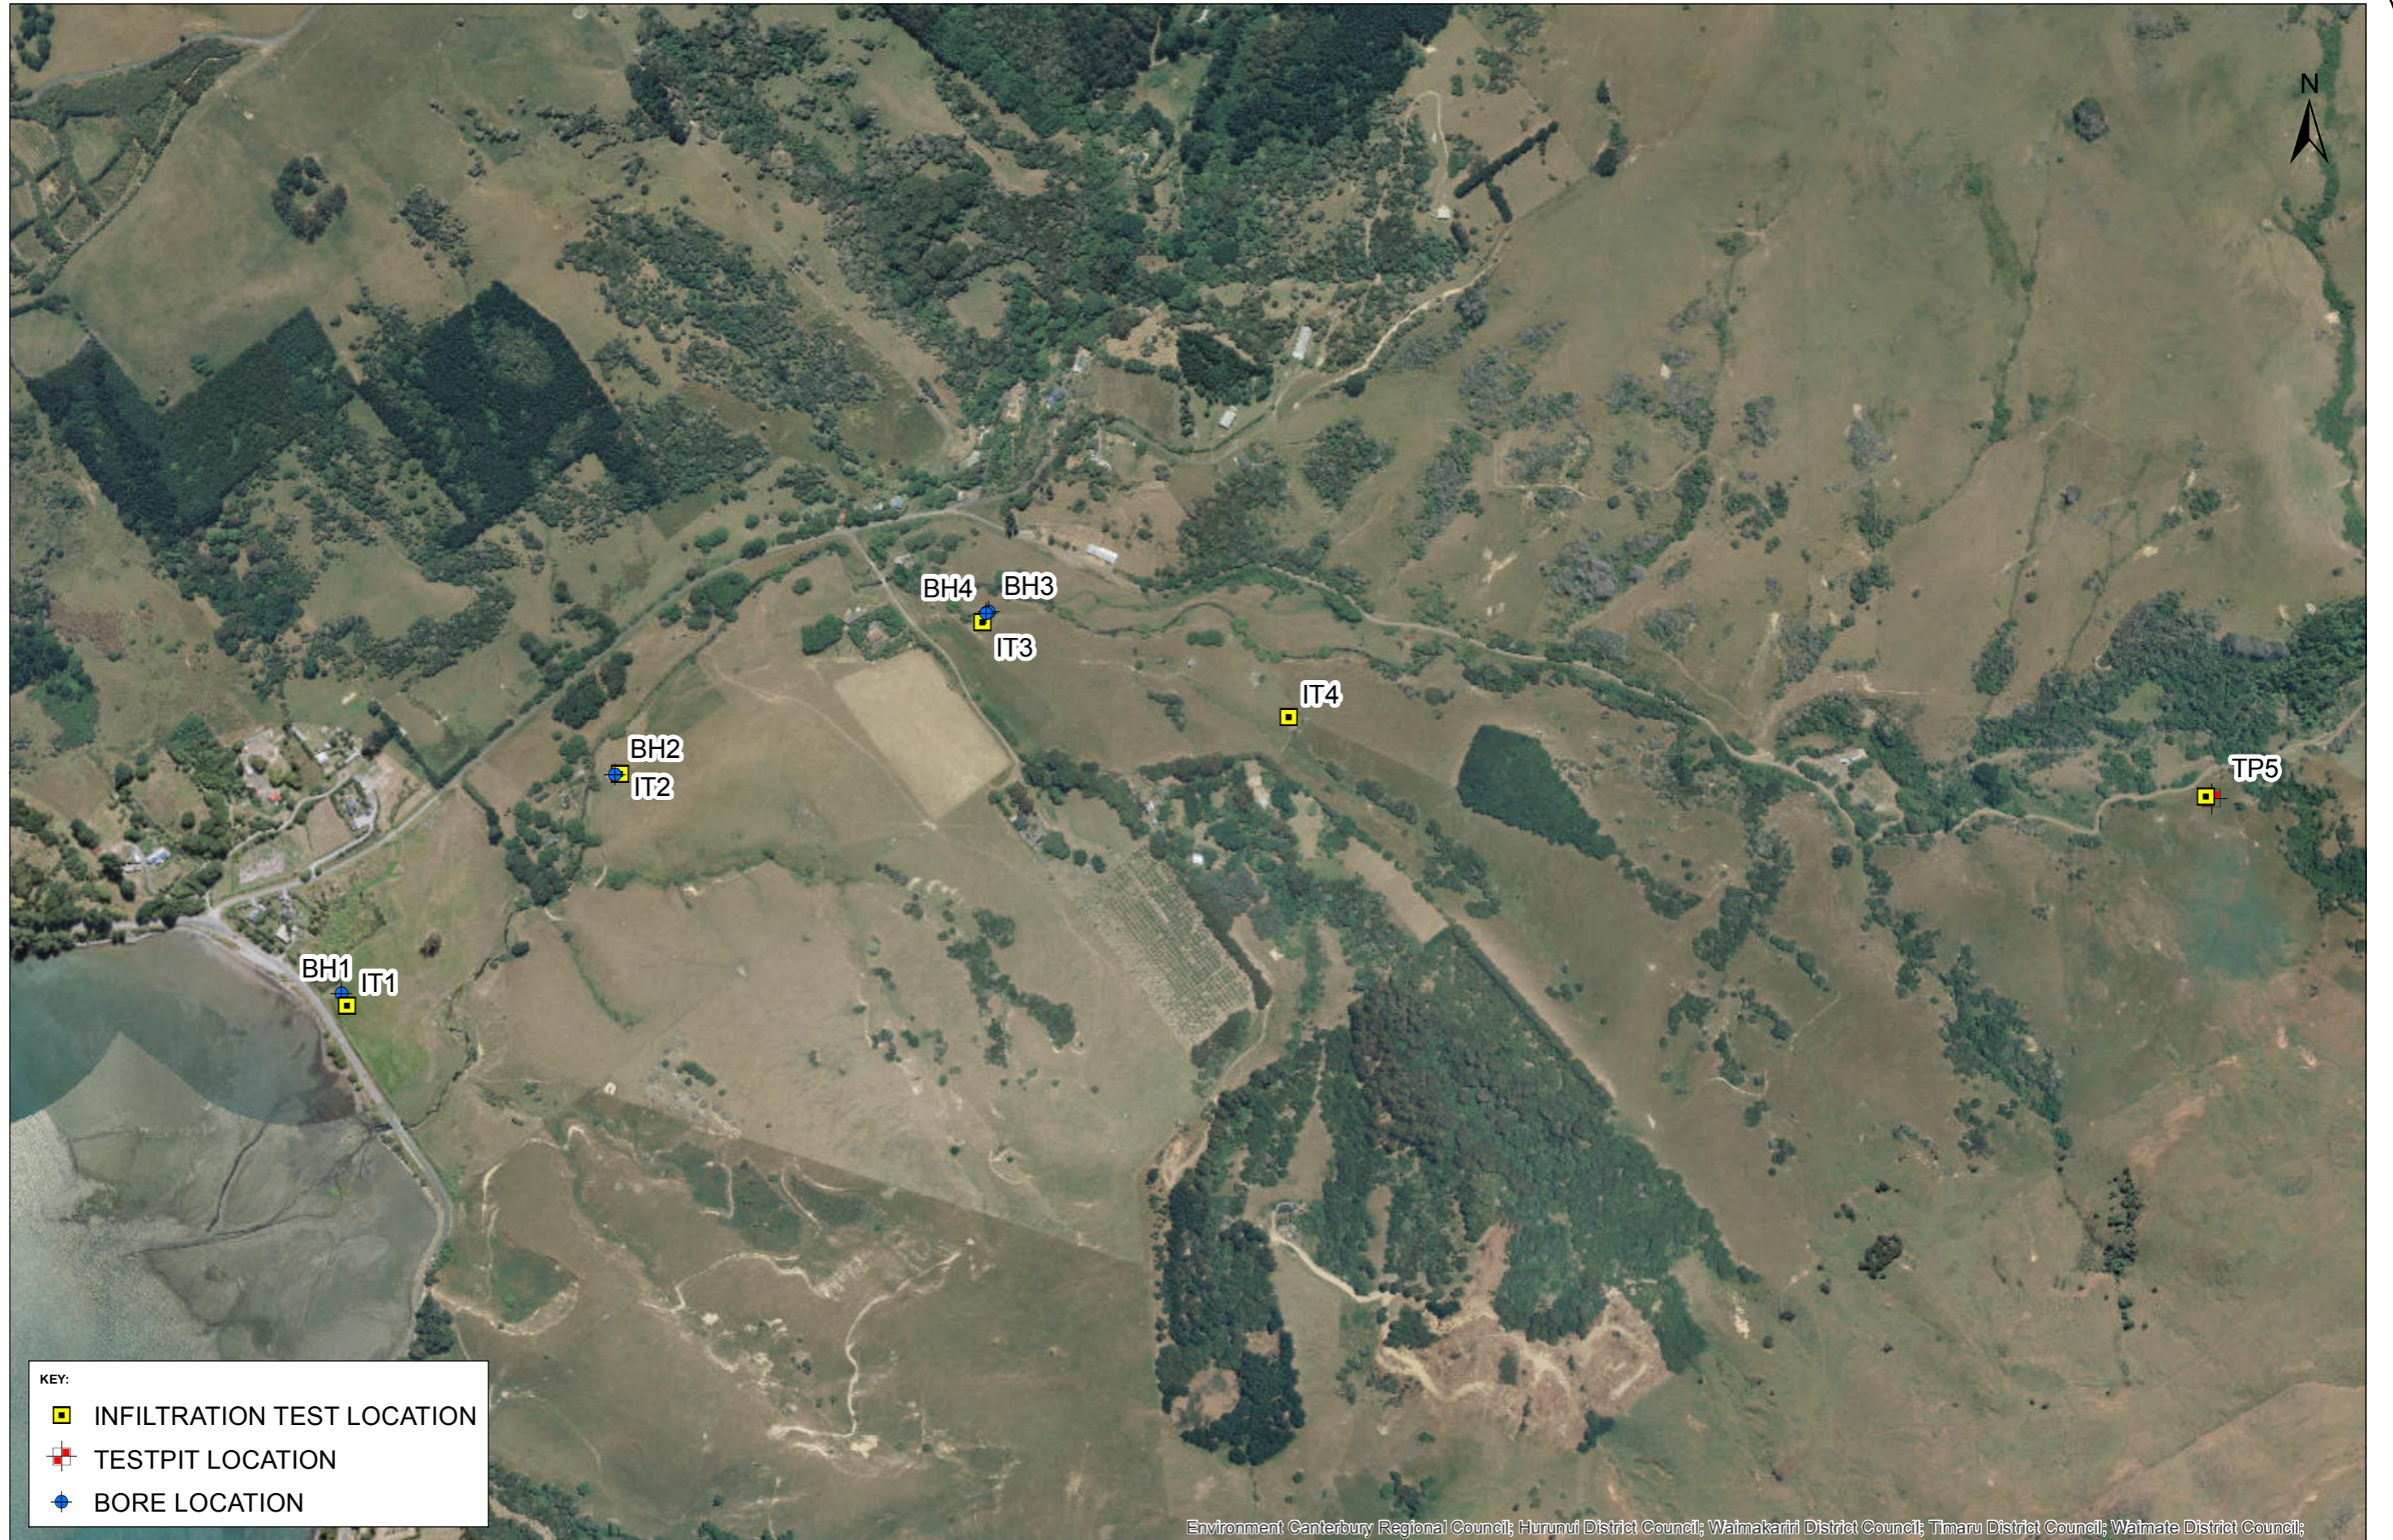
FIGURE 2A: ROBINSONS BAY INFILTRATION TEST AND BORE LOCATIONS

- INFILTRATION TEST LOCATION
- ⊕ TESTPIT LOCATION
- ◆ BORE LOCATION

Infiltration tests were carried out at the locations shown in Figure 2A and 2C, Appendix A. The monitoring bore locations are also shown in Figure 2A and 2B, Appendix A. The installation of these bores can be seen in Photographs 15 – 19 (Appendix B). Sixteen infiltration tests were carried out using a double ring infiltrometer for a target minimum period of 90 minutes. Two infiltration tests, one in the surface soils and one in the lower permeable sub-surface soils, Photographs 1 – 15 (Appendix B), were carried out at eight locations (IT1 – 5 and IT8 - 10) to determine a representative infiltration rate for Robinsons Bay and Pompeys Pillar areas, respectively.

Table 2 summarises the data of the surface and sub-surface infiltration tests including location, depth and soil type. Figure 2A and 2C, Appendix A shows the locations of the infiltration tests carried out. Photographs of the infiltration tests (IT) and test pit (TP) materials are included in Photographs, Appendix B.

Sixteen infiltration tests were carried out at the locations shown in Figure 2A and 2C, Appendix A. To enable a comparative analysis of the land, the tests were carried out within low (alluvial) (IT1 – IT3), intermediate (loess colluvium) (IT 4 and IT5), and high (loess) (IT8 – IT10) areas. Over the week that infiltration testing was carried out, 37 mm of rain was recorded at the Akaroa electronic weather station (EWS) (36593) (Cliflo, 2016). This is not expected to have influenced the stabilised infiltration testing results.

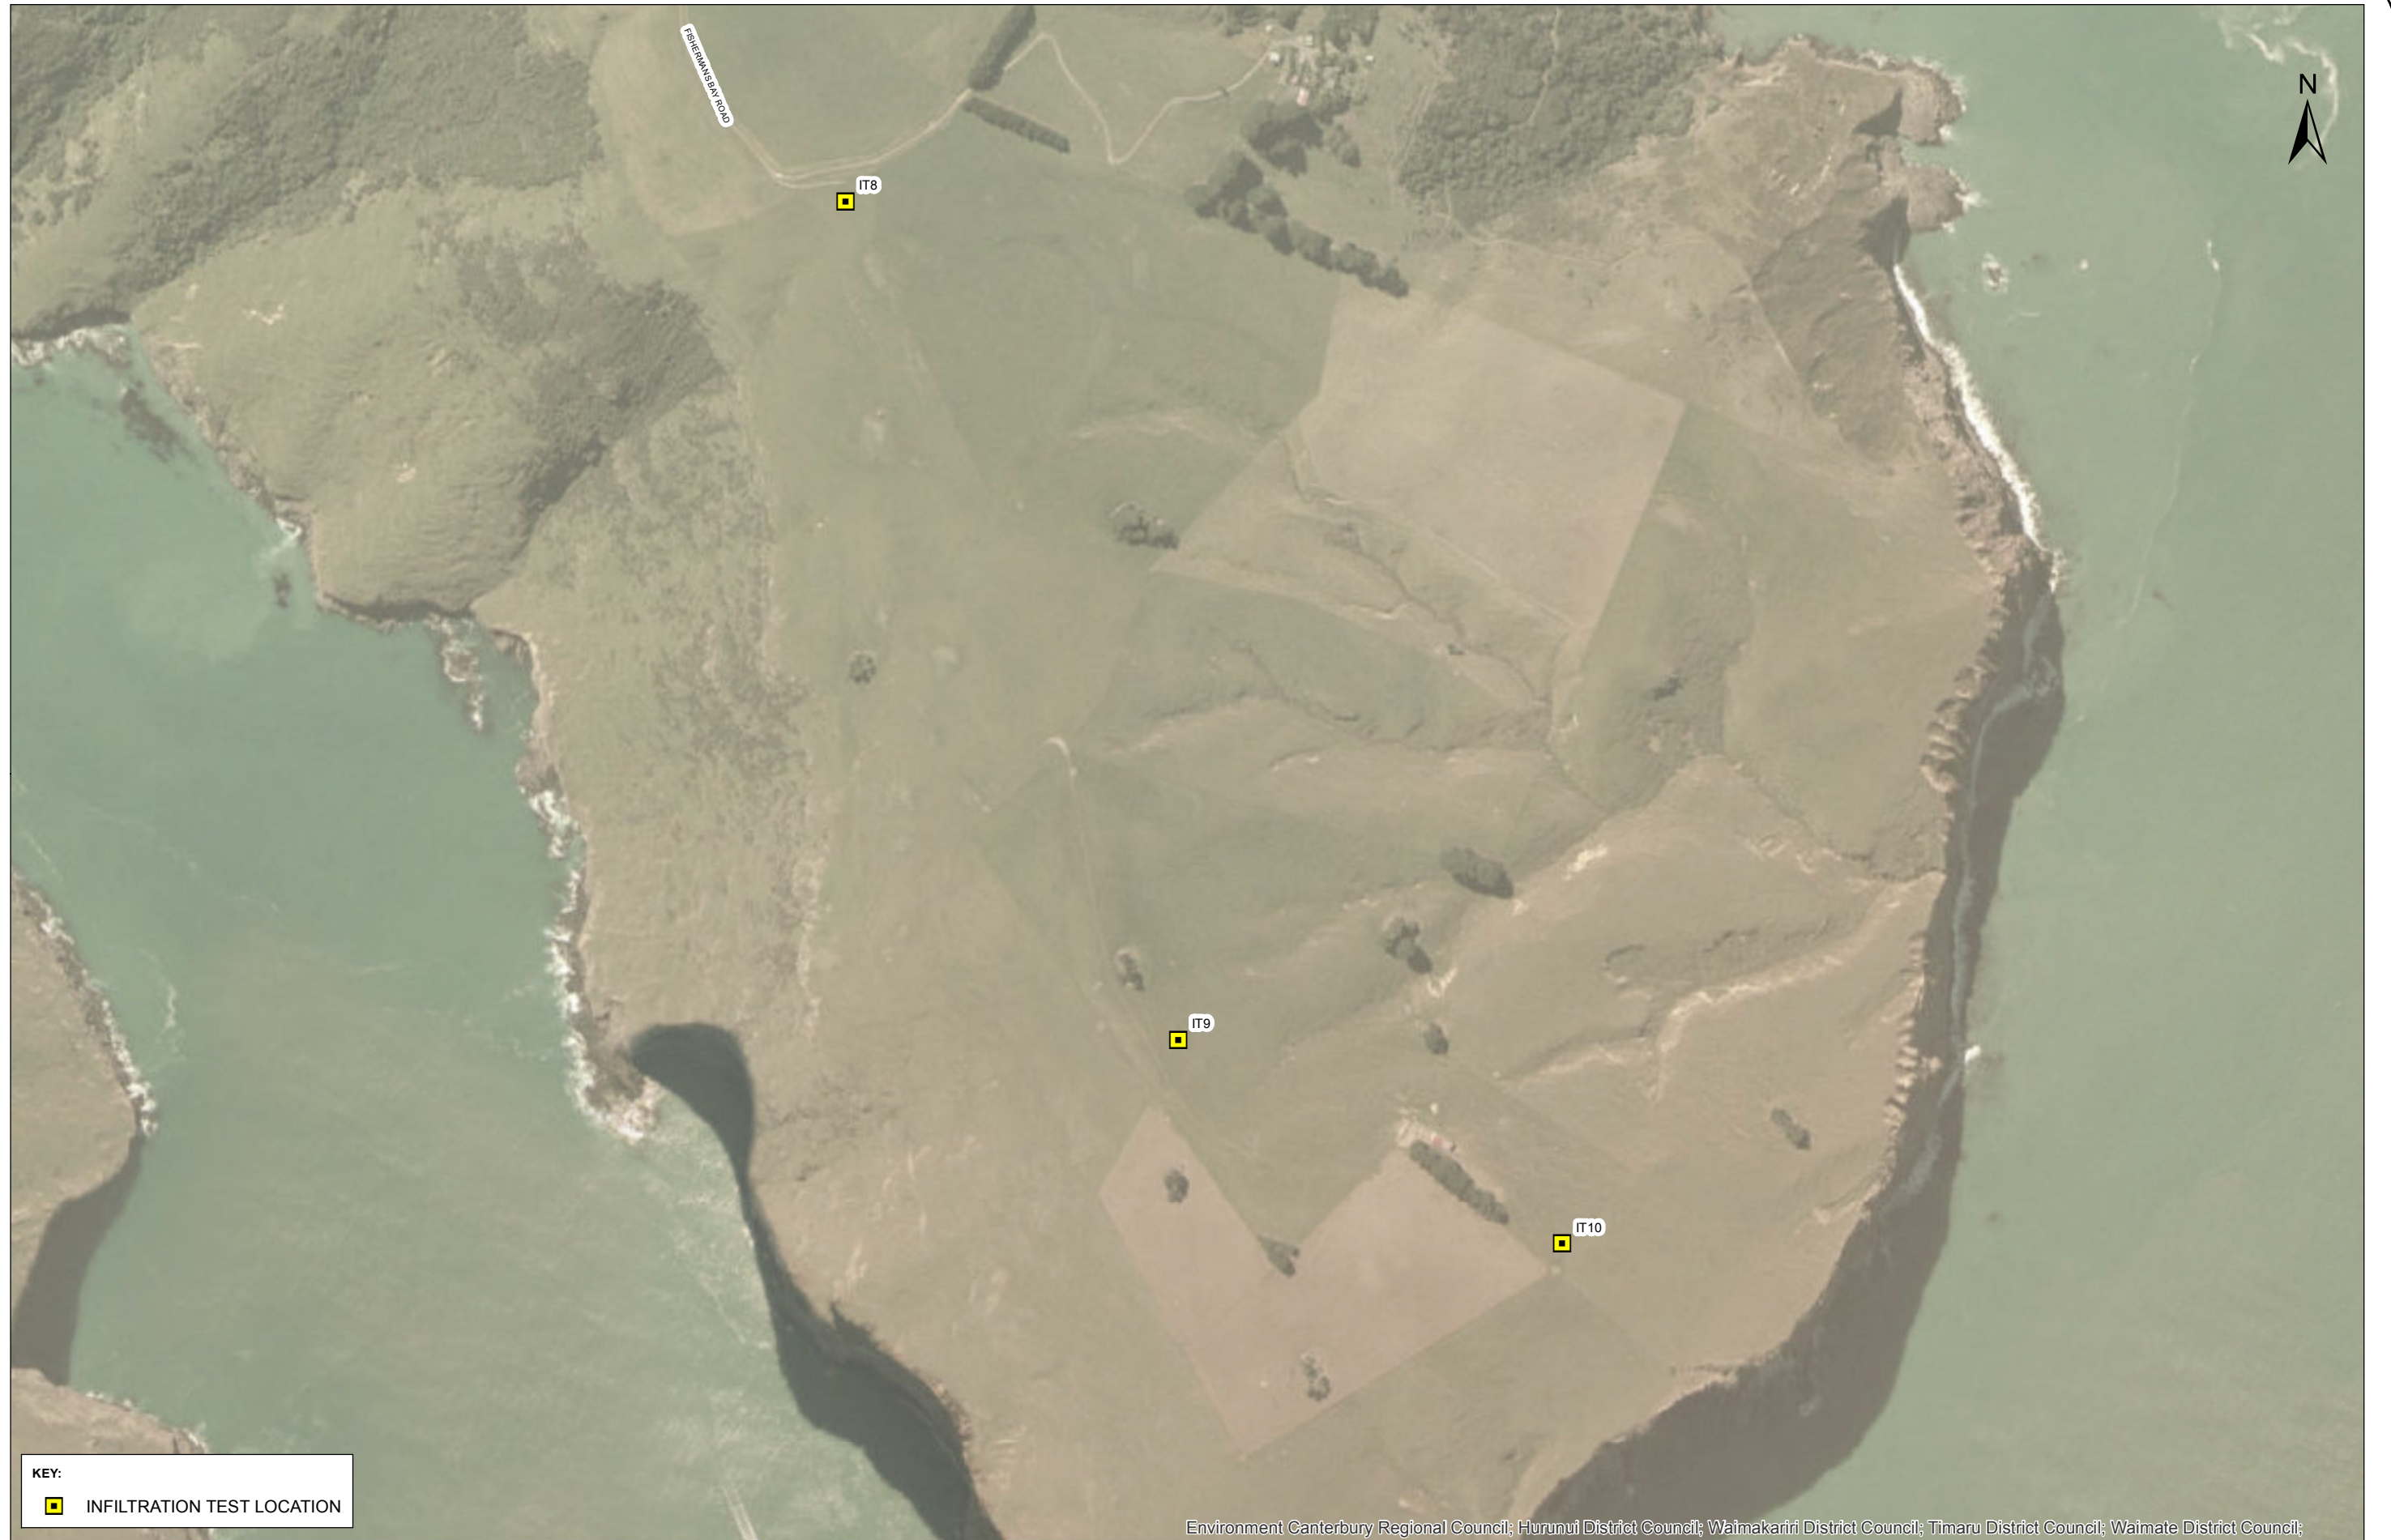
FIGURE 2C: POMPEYS PILLAR INFILTRATION TEST LOCATIONS

KEY:
■ INFILTRATION TEST LOCATION

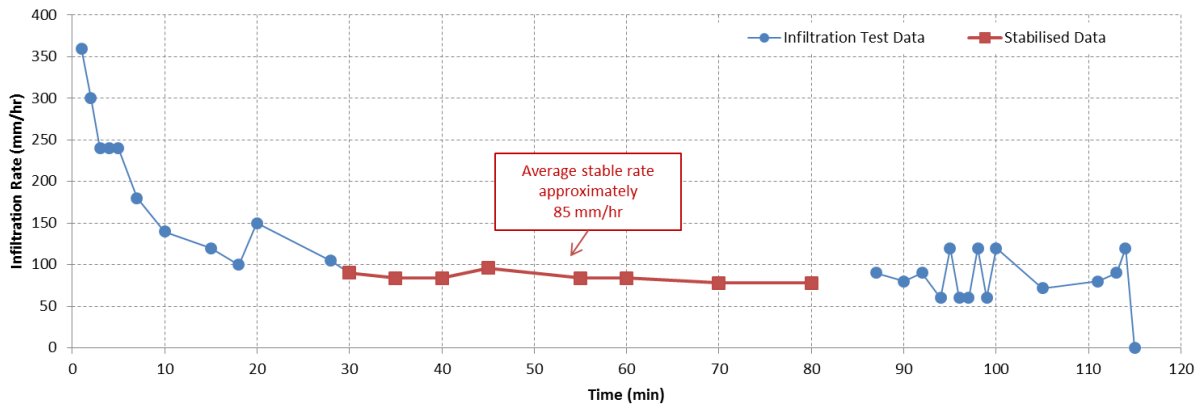
Figure 3: Infiltration Rate during Test IT1:surface.

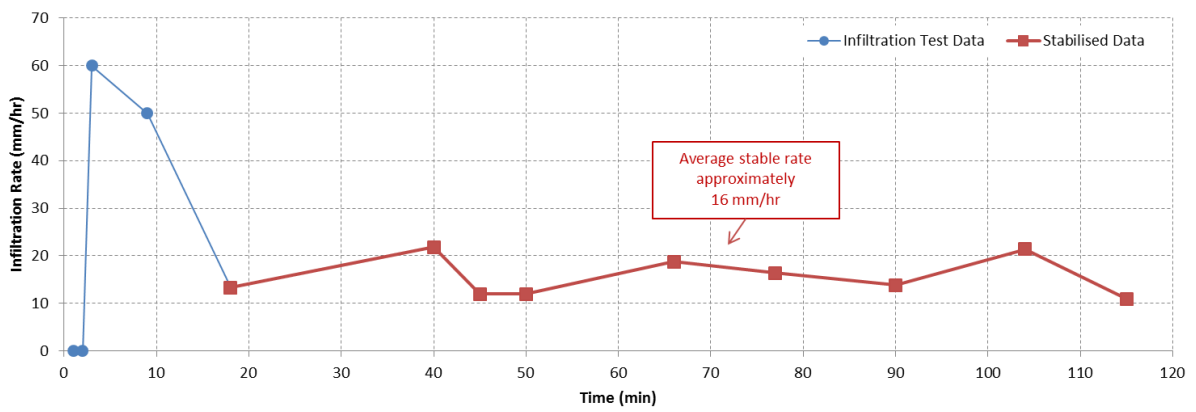
Figure 13: Infiltration Rate during Test IT8:surface.

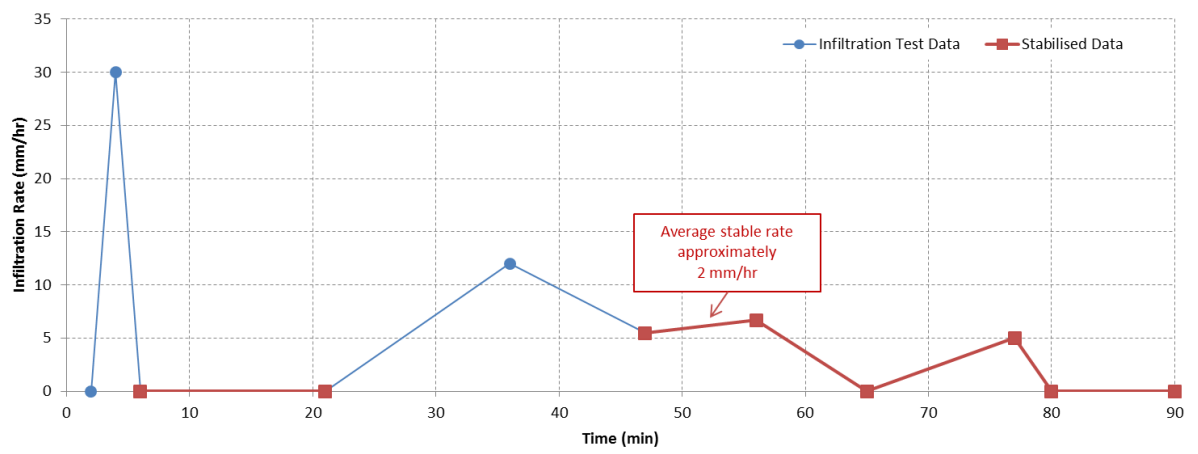
Figure 16: Infiltration Rate during Test IT9:sub-surface.

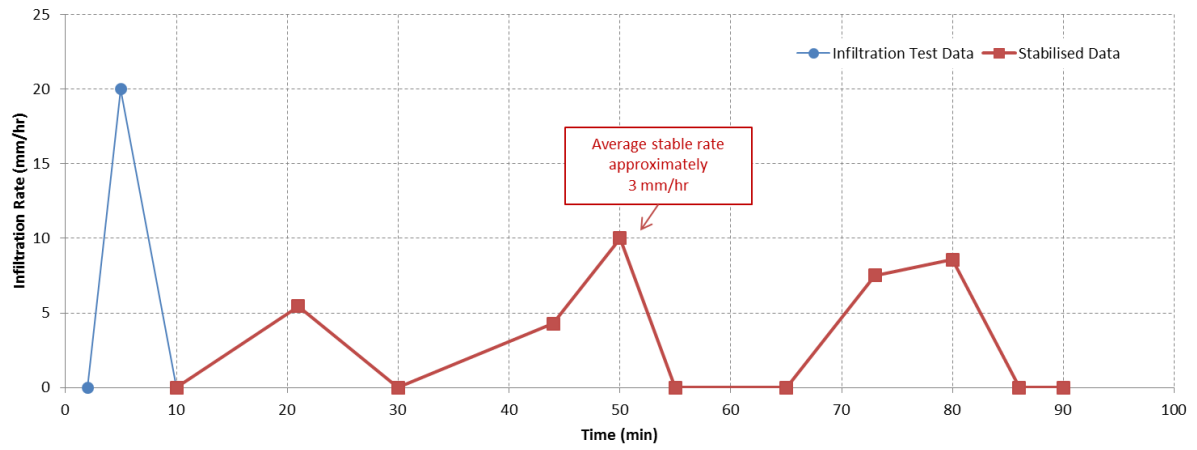
Figure 18: Infiltration Rate during Test IT10:sub-surface.

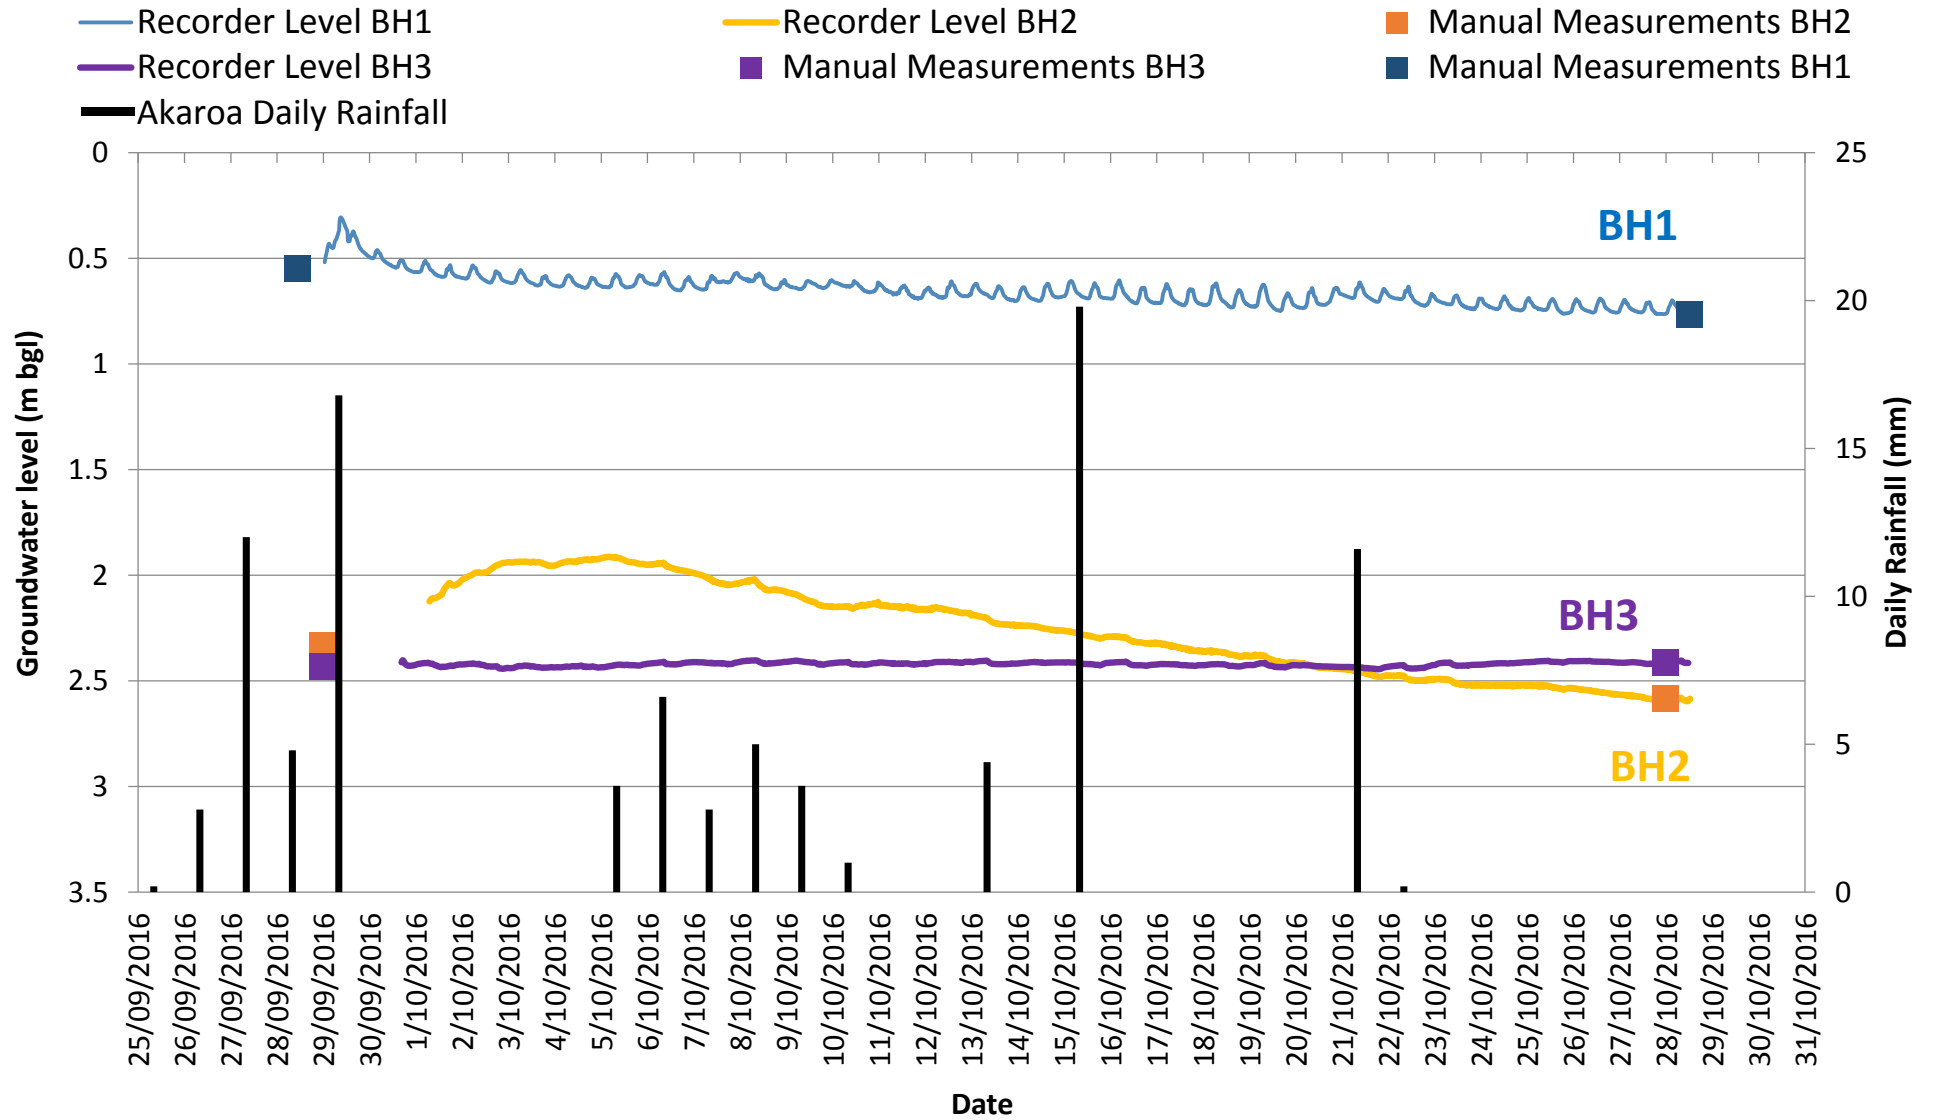
Figure 19 : Groundwater levels Robinsons Bay (Bore 1 – 3)

The results show that for BH1 the depth to groundwater varied from about 0.3 m bgl to approximately 0.6 m bgl. The groundwater level appeared to respond to the rainfall between 26 to 29 September but did not respond to other rainfall events. It should be noted that the rainfall data is from the Akaroa EWS (36593) and it is possible that the daily rainfall at the locations of the boreholes differed from that at the weather station.

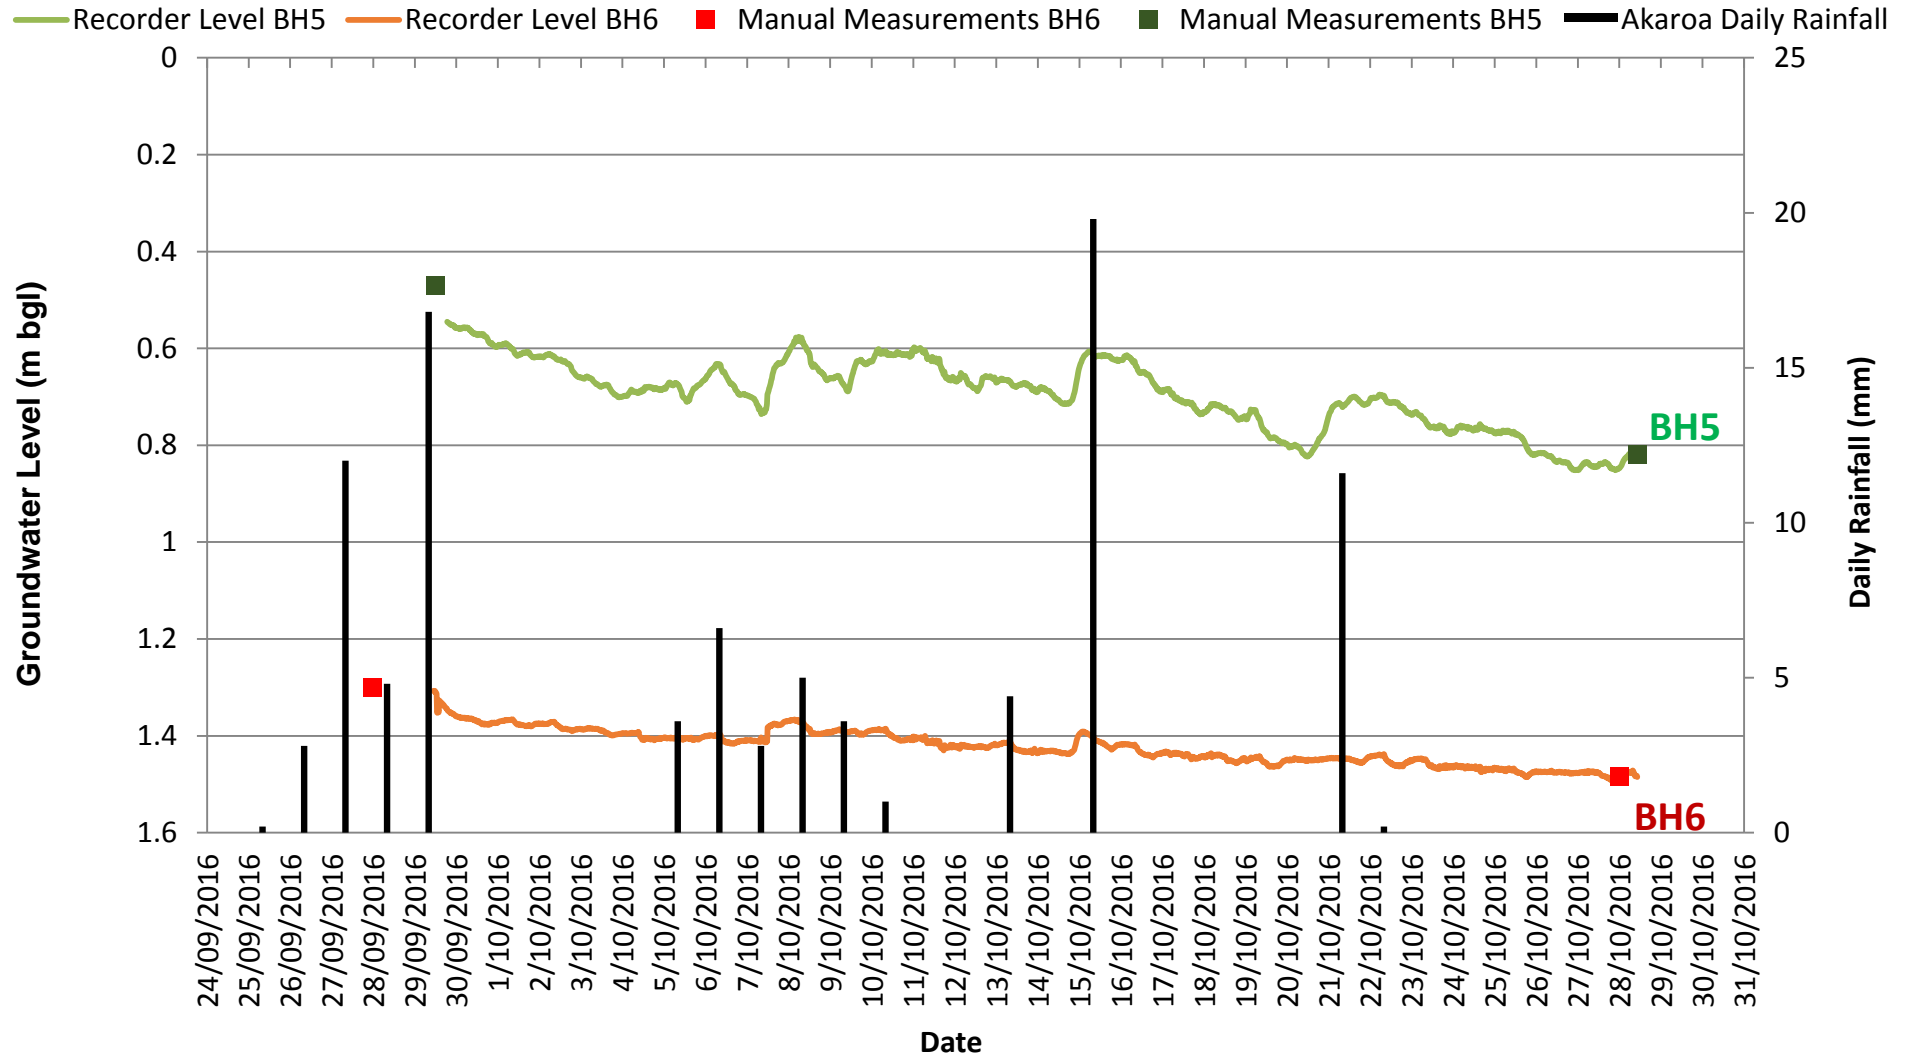
Figure 20 : Groundwater levels Robinsons Bay (Bore 5 – 6)

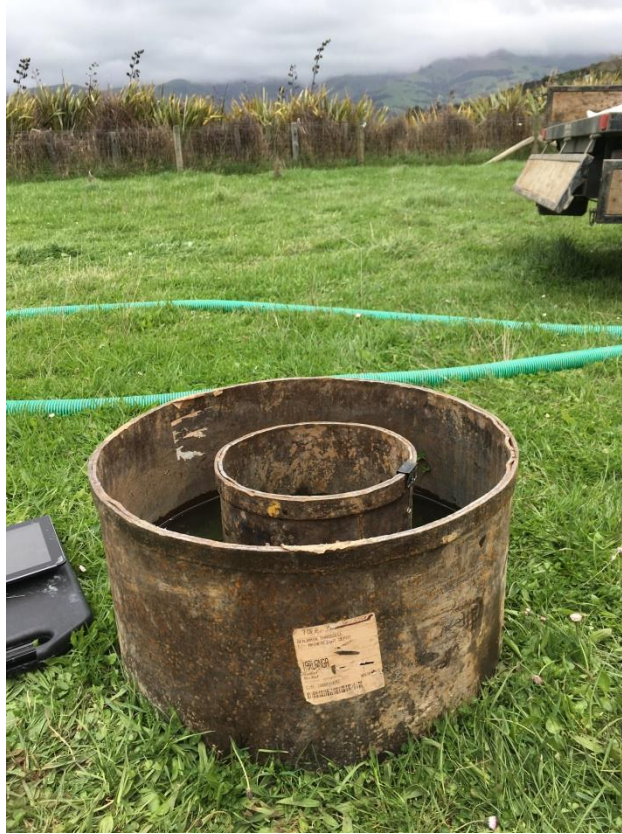
Photograph 1: Infiltration Test IT1 surface infiltration test within Robinsons Bay (Site 1).

IT1 was carried out within a flat section and close to the coast. The soils encountered during the IT1 sub-surface infiltration test were consistent with the Barry Soil description. The topsoil at this site was dispersed with the subsurface layer, and there was root penetration throughout the topsoil layer with continuation into the yellow brown friable subsoil.

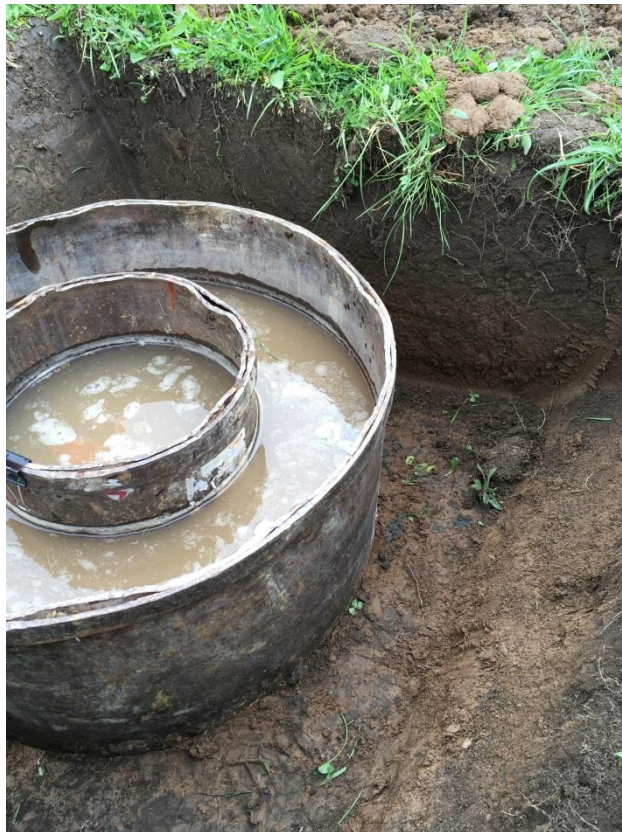
Photograph 2: Infiltration Test IT1 sub-surface infiltration test within Robinsons Bay (Site 1).

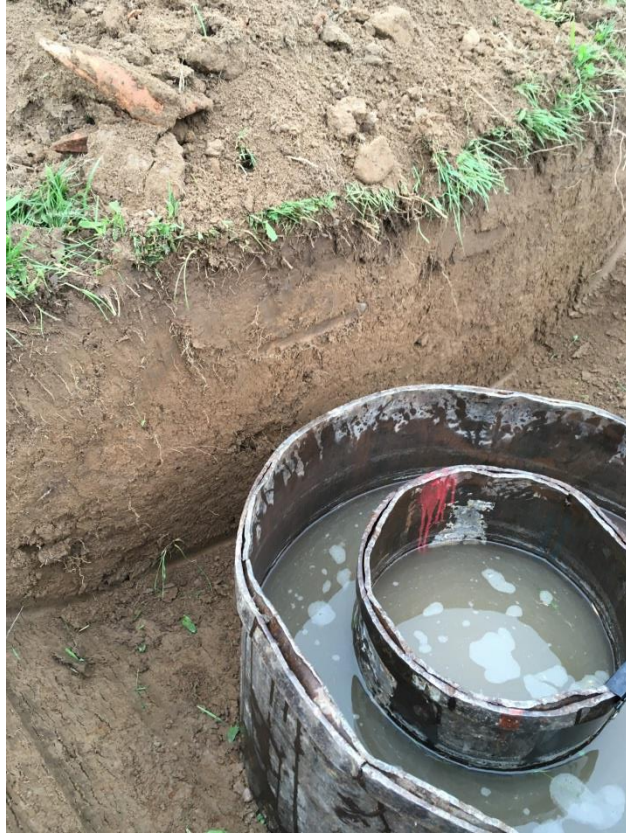
Photograph 3: Infiltration Test IT2 sub-surface infiltration test within Robinsons Bay (Site 2), surface test IT2 not shown..

IT2 was also carried out within a flat section, further up Robinsons Bay Valley, approximately 30 m from the stream. The soils encountered in IT2 sub-surface infiltration test were consistent with the Barry Soil description. It is evident in the Photograph 2 (Appendix B) that there was a pale olive grey layer beneath the topsoil, and underlying this was yellow brown lightly mottled orange friable materials. Despite the shallow depth of topsoil, there was good root penetration in this excavation. It was observed in the bore hole installation that gravels were encountered at 1.5 m below ground level (bgl).

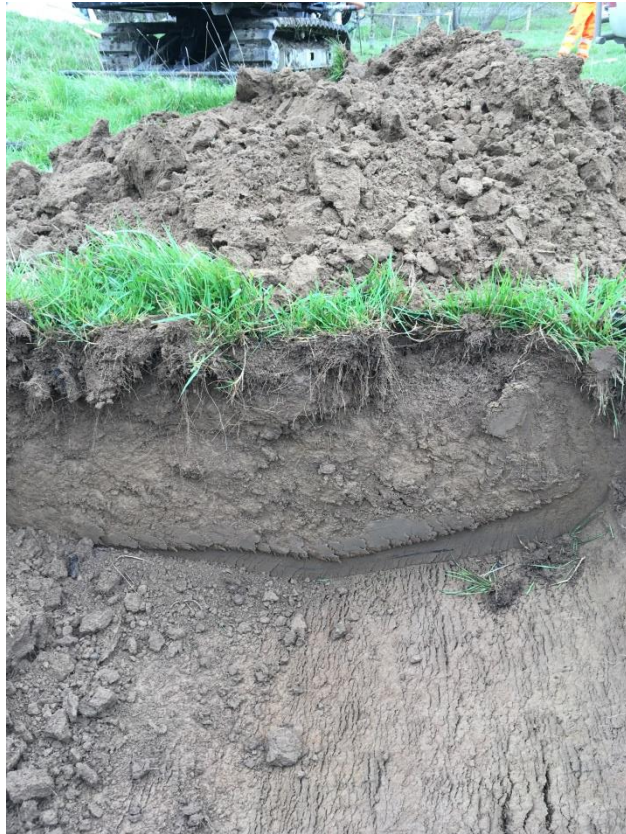
Photograph 4: IT3 sub-surface pit within Robinsons Bay (Site 3), surface test IT3 not shown.

IT3 was within flat land, with a good depth of topsoil and root penetration continuing through the subsoil. The materials encountered in the sub-surface infiltration test were consistent with the Barry Soil description. This site was approximately 40 m from the stream, and again gravels were encountered at 1.5 m bgl.

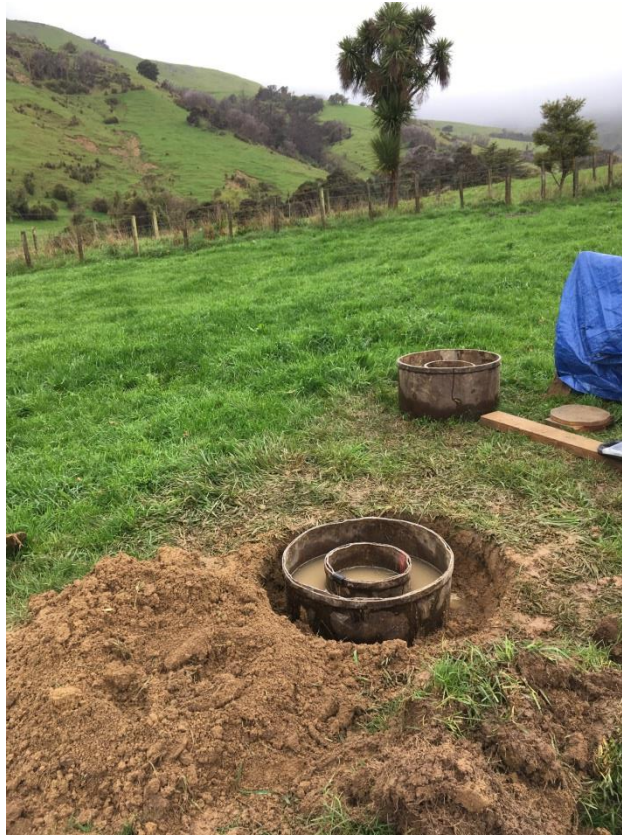
Photograph 5: Infiltration Test IT4 surface and subsurface within Robinsons Bay (Site 4).

IT4 was situated on a gentle slope. It appeared that the materials in the excavation for the sub-surface infiltration test more closely matched Takahe Soils, rather than Barry Soil. There was no pale olive grey beneath the topsoil, underlying the topsoil was yellow brown nutty friable material. There was root penetration throughout the topsoil layer with some continuation into the yellow brown friable subsoil.

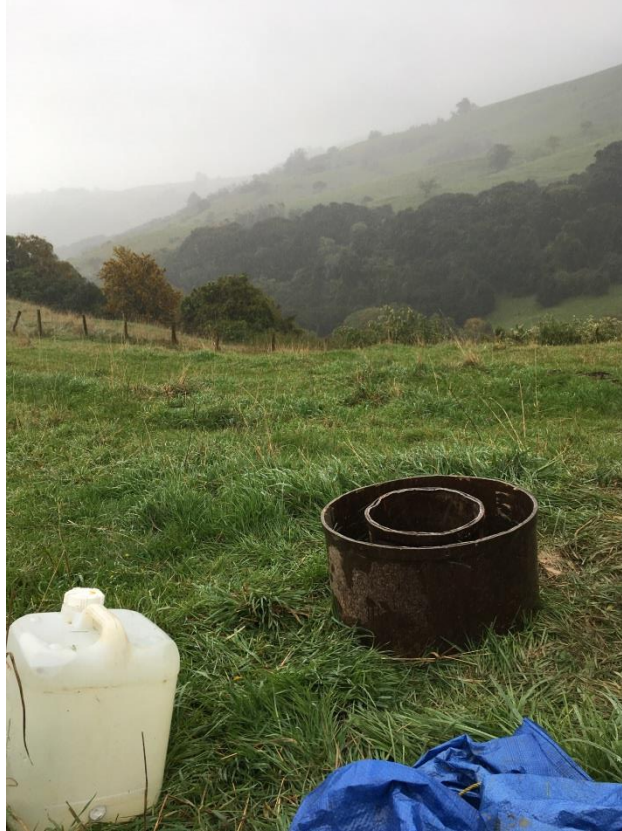
Photograph 7: Infiltration Test IT5 surface within Robinsons Bay (Site 5).

IT5 were carried out upon a reasonably steep slope, and further up the hill were scattered rocky outcrops. The infiltration testing was carried out in a gently sloping section of this relatively steep land parcel. The soils encountered during the excavation for the sub-surface infiltration test were consistent with the Takahe Soil description.

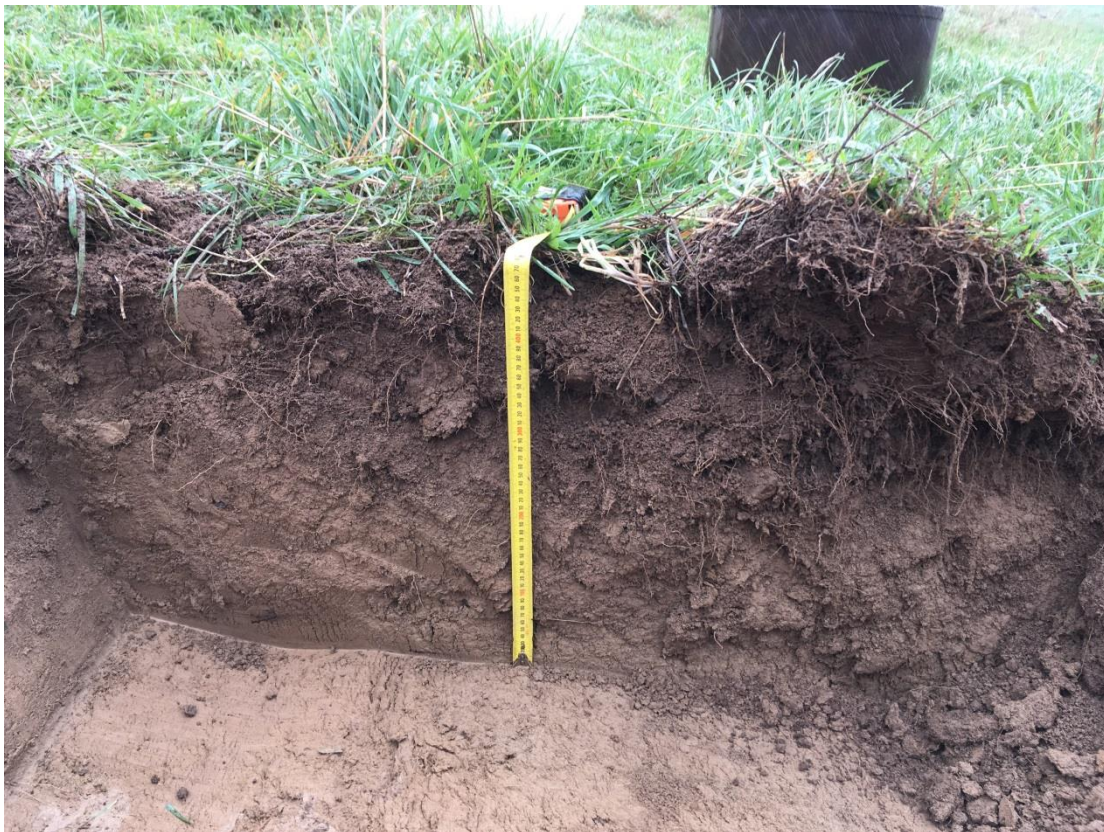
Photograph 8: Infiltration Test IT5 sub-surface pit within Robinsons Bay (Site 5).

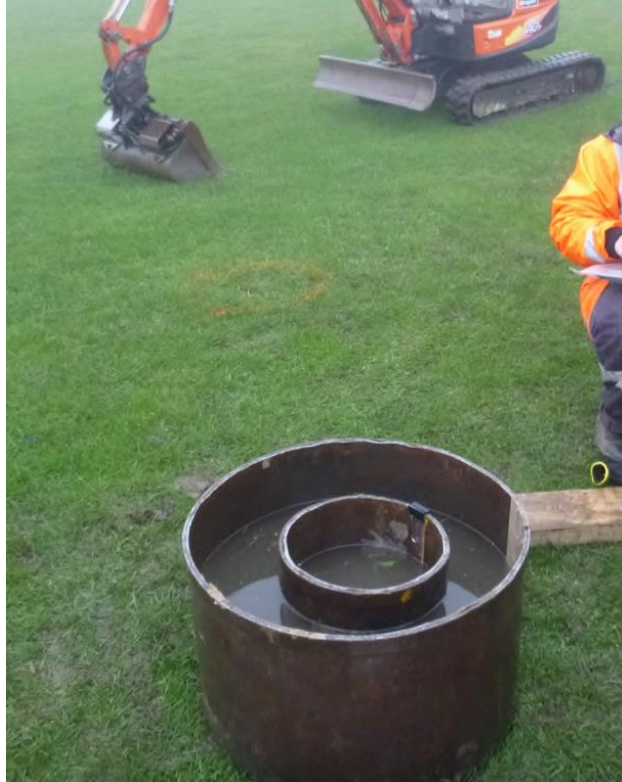
Photograph 9: Infiltration Test IT8 surface test within Pompeys Pillar (Site 8).

IT8 was carried out on a relatively steep section of Pompeys Pillar. There was a very good depth of topsoil with root penetration continuing through the underlying soil. The materials encountered in the sub-surface infiltration test were consistent with Takahe Soils description.

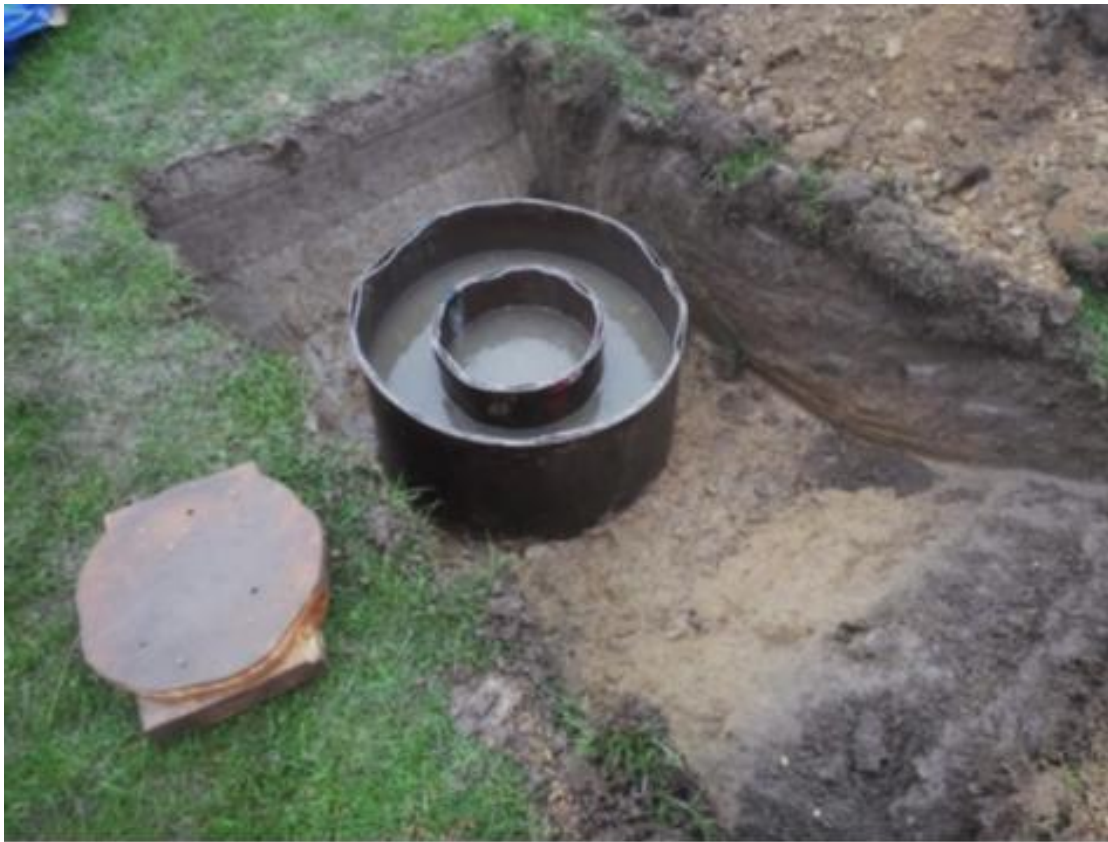
Photograph 10: Infiltration Test IT8 sub-surface test within Pompeys Pillar (Site 8).

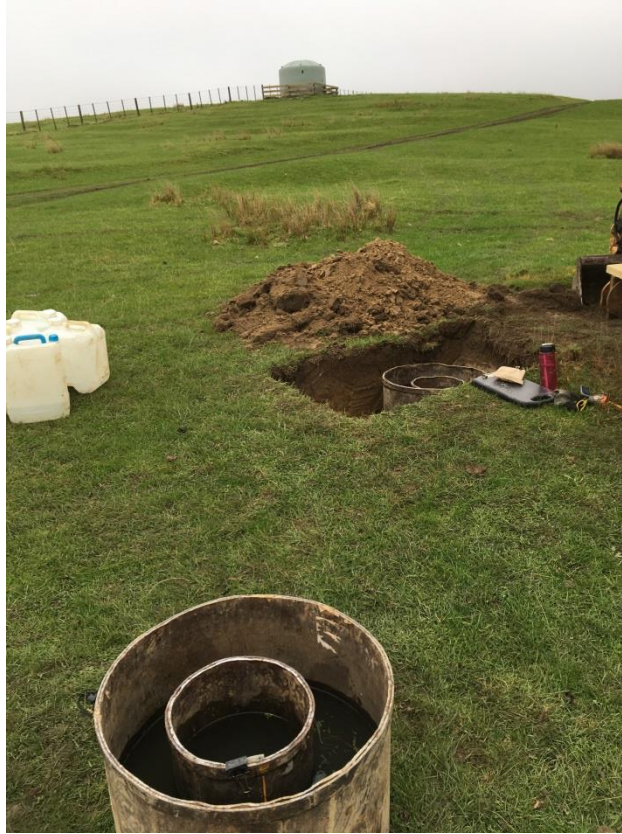
Photograph 11: Infiltration Test IT9 surface and sub-surface test within Pompeys Pillar (Site 9).

IT9 was situated on a very gently sloping section, further up the hill were scattered rocky outcrops. It appeared that the materials in the sub-surface infiltration test more closely matched Takahe Soils. Similarly to observations in IT8, there was a good depth of topsoil, and underlying this was yellow brown mottled orange silty sand. There was some good root penetration throughout the topsoil layer with some continuation into this yellow brown mottled orange friable subsoil.

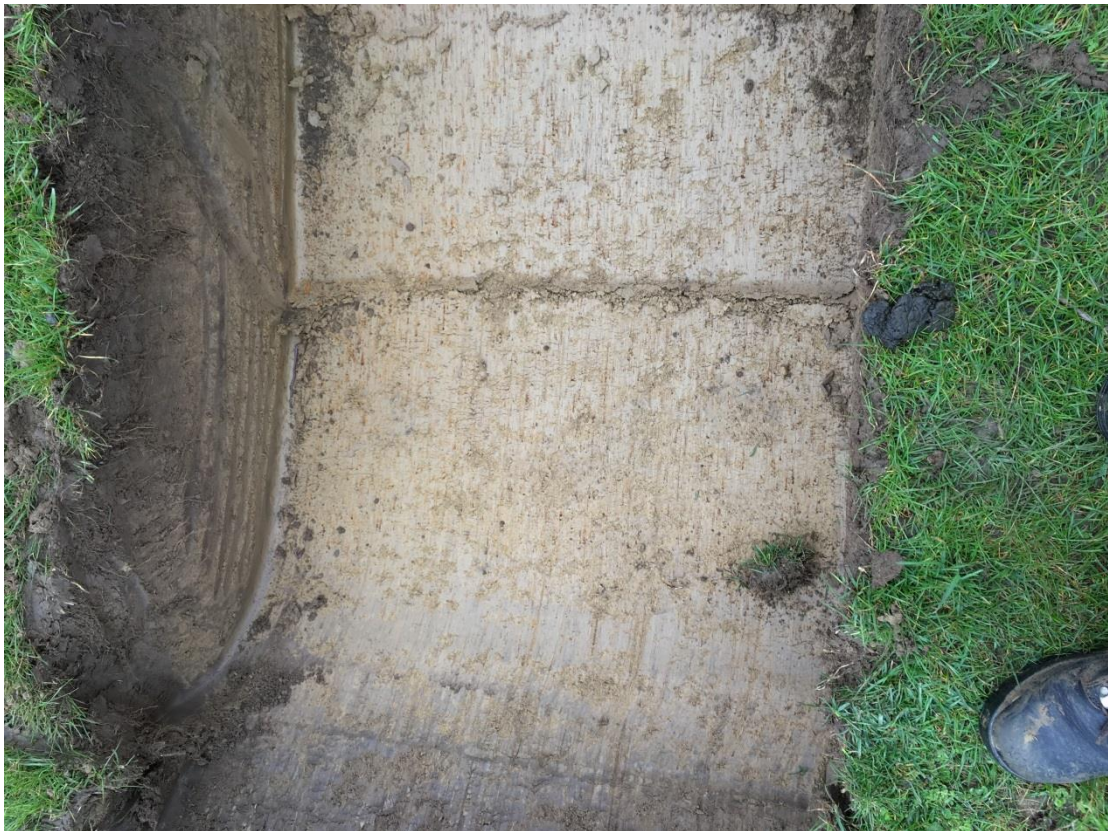
Photograph 12: Infiltration Test IT9 sub-surface test pit within Pompeys Pillar (Site 9).
