7 November 2016

INFILTRATION TESTING RESULTS FOR AKAROA TREATED WASTEWATER DISPOSAL VIA IRRIGATION – ROBINSONS BAY AND POMPEYS PILLAR

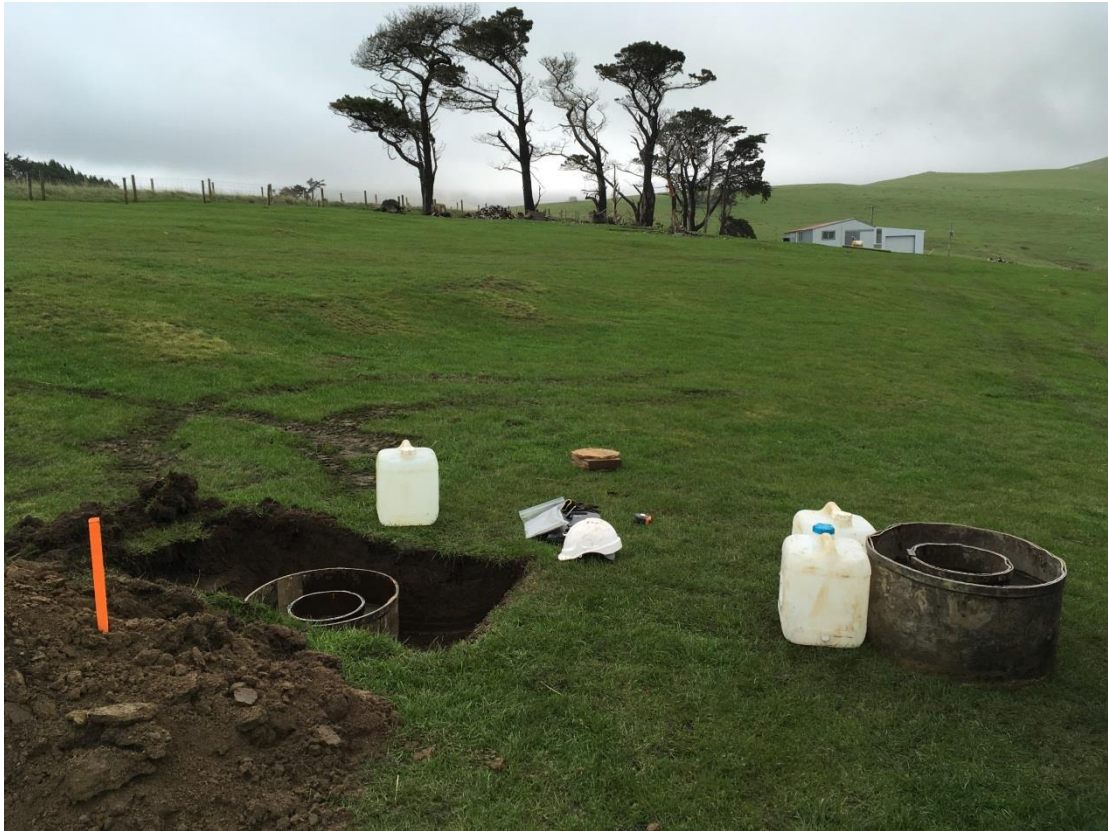
Photograph 13: Infiltration Test IT10 surface and sub-surface tests within Pompeys Pillar (Site 10).

IT10 was carried out within a flat area close to the shearing sheds. The soils encountered in the sub-surface infiltration test were consistent with the Takahe Soil description. There was less topsoil than IT8 and IT9, however there was good root penetration throughout the topsoil layer with some continuation into the subsoil.

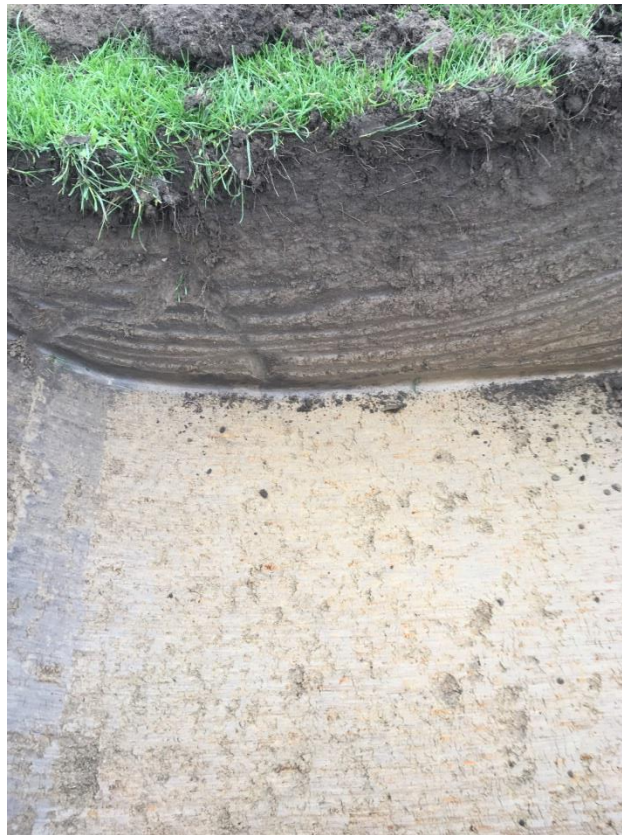
Photograph 14: IT10 sub-surface pit within Pompeys Pillar (Site 10).

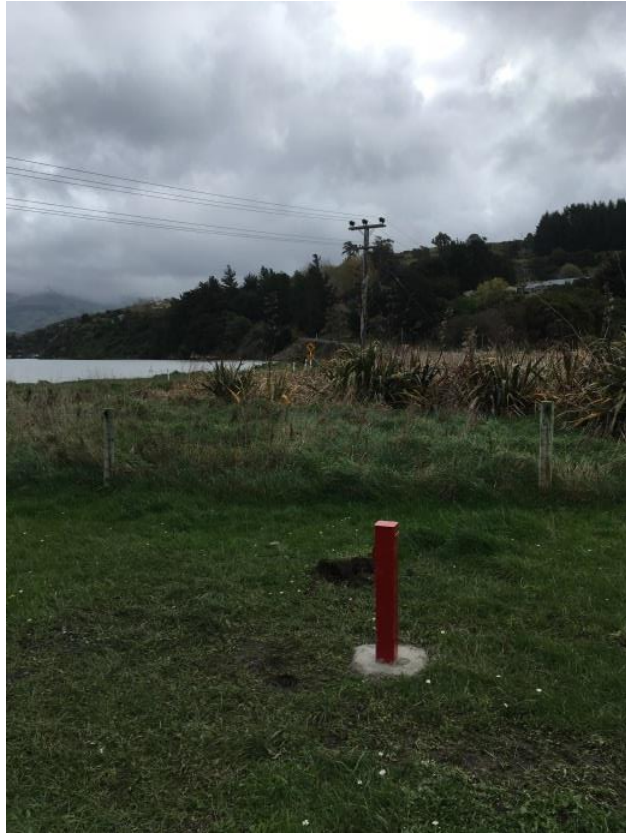
Photograph 15: BH1, Robinsons Bay (Site 1).

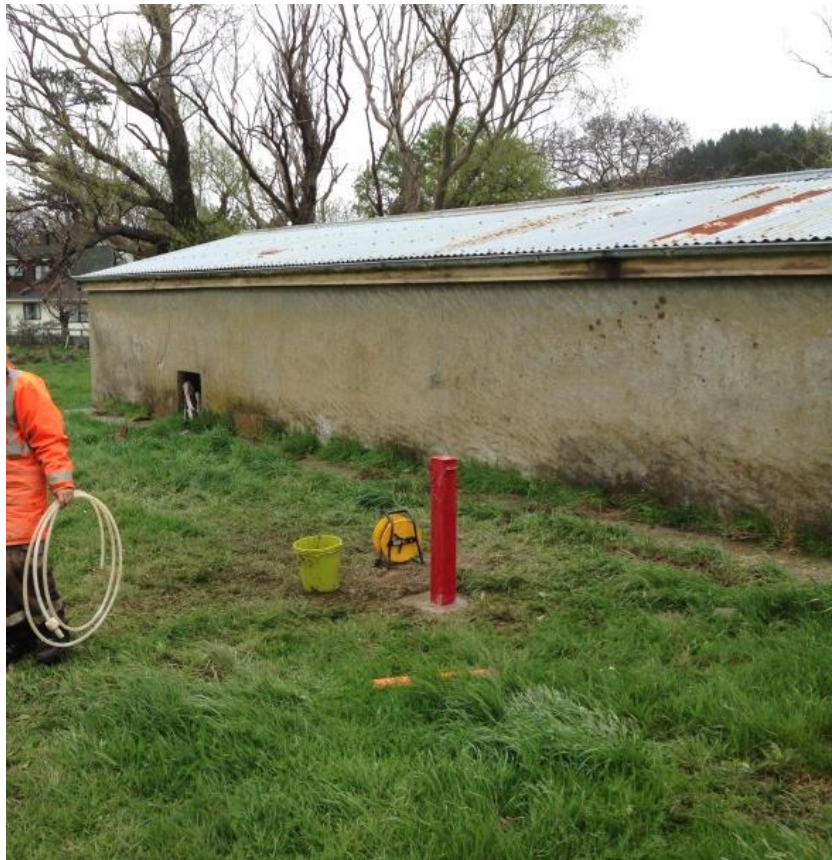
Photograph 16: BH2, Robinsons Bay (Site 2).

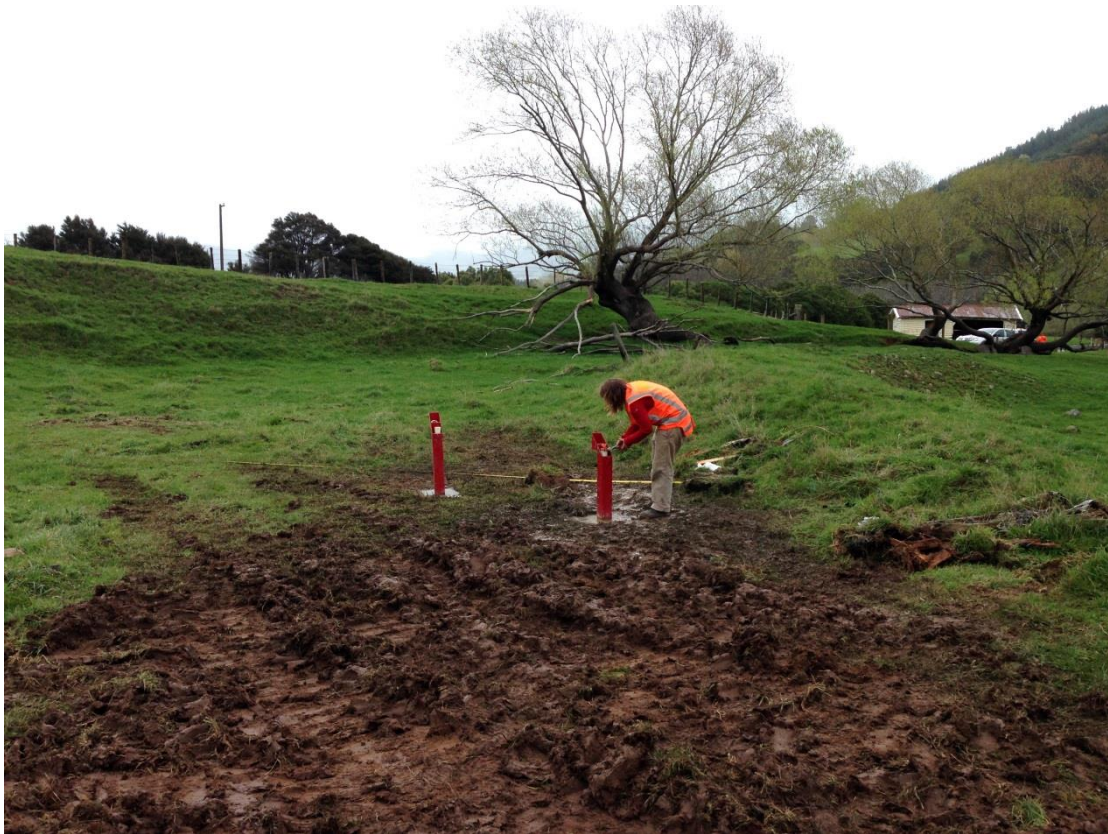
Photograph 17: BH3 (right) and BH4 (left), Robinsons Bay (Site 3).

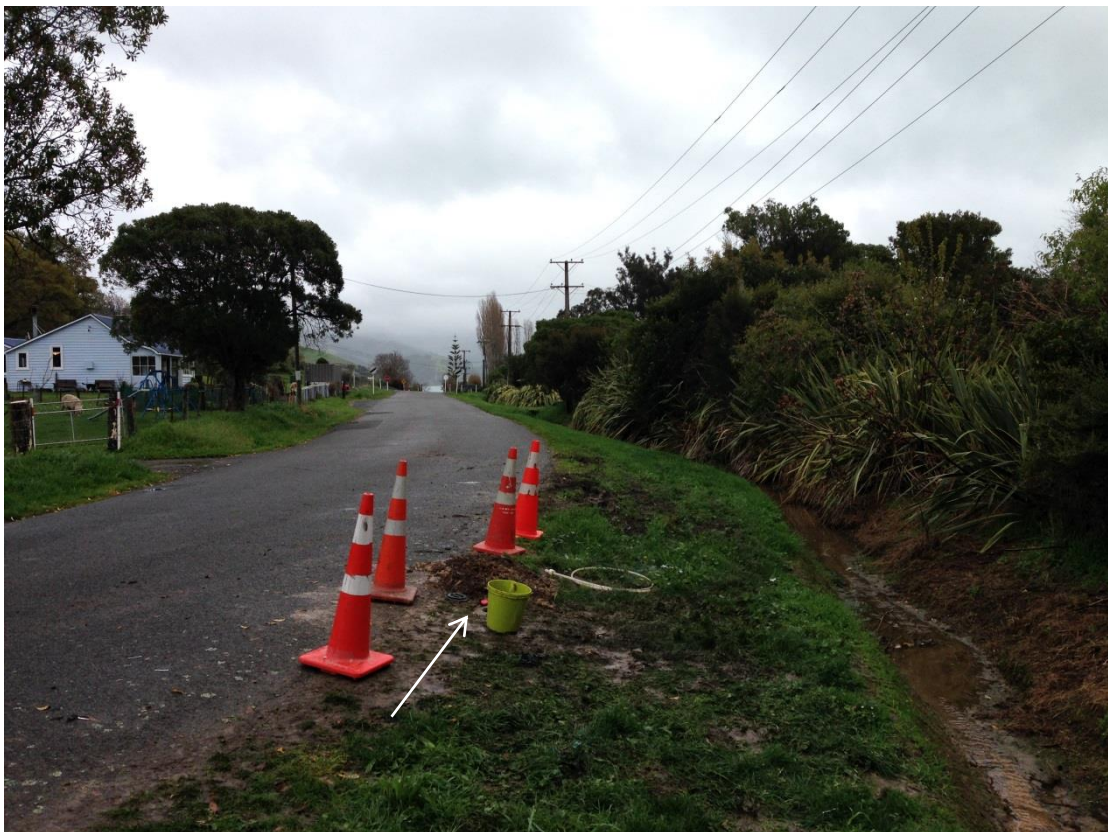
Photograph 18: BH5, Takamatua Valley Road (revised Site 6).

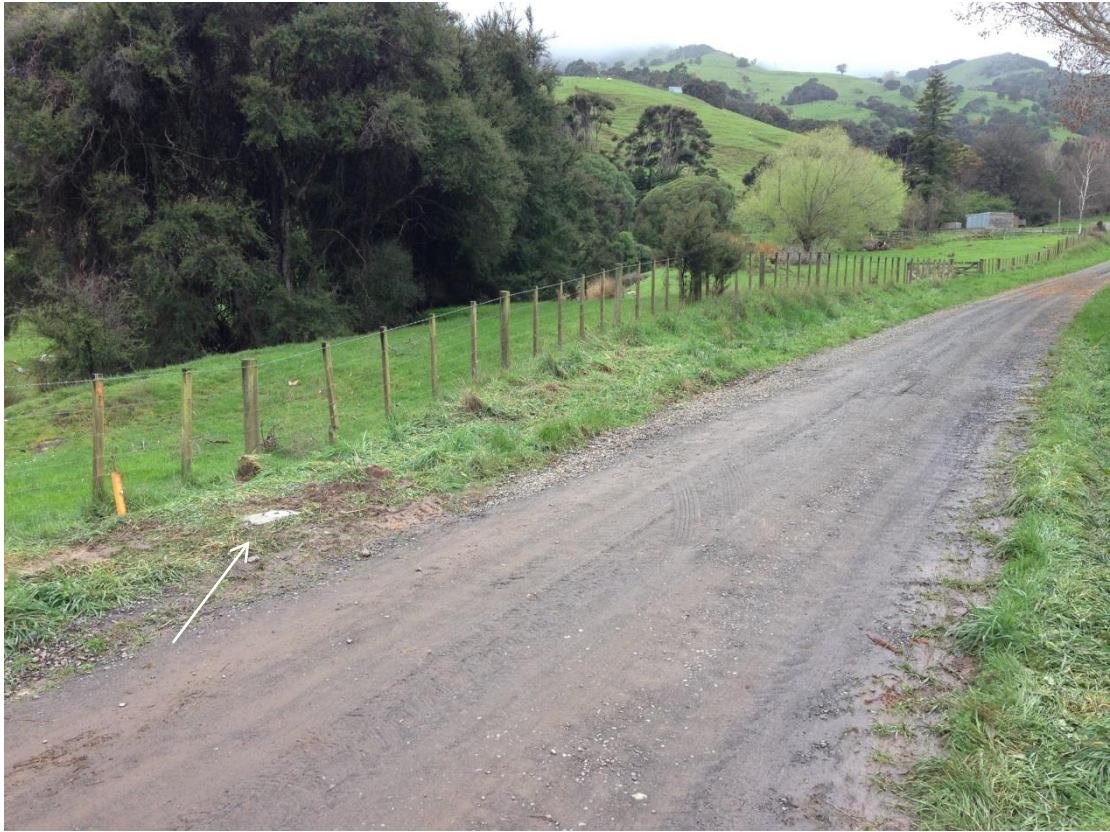
Photograph 19: BH6, Old Le Bons Track (Site 7).
