A lysimeter experiment and field trial to determine options for the beneficial reuse of wastewater from Duvauchelle and Akaroa, Banks Peninsula (November 2014 – June 2017)

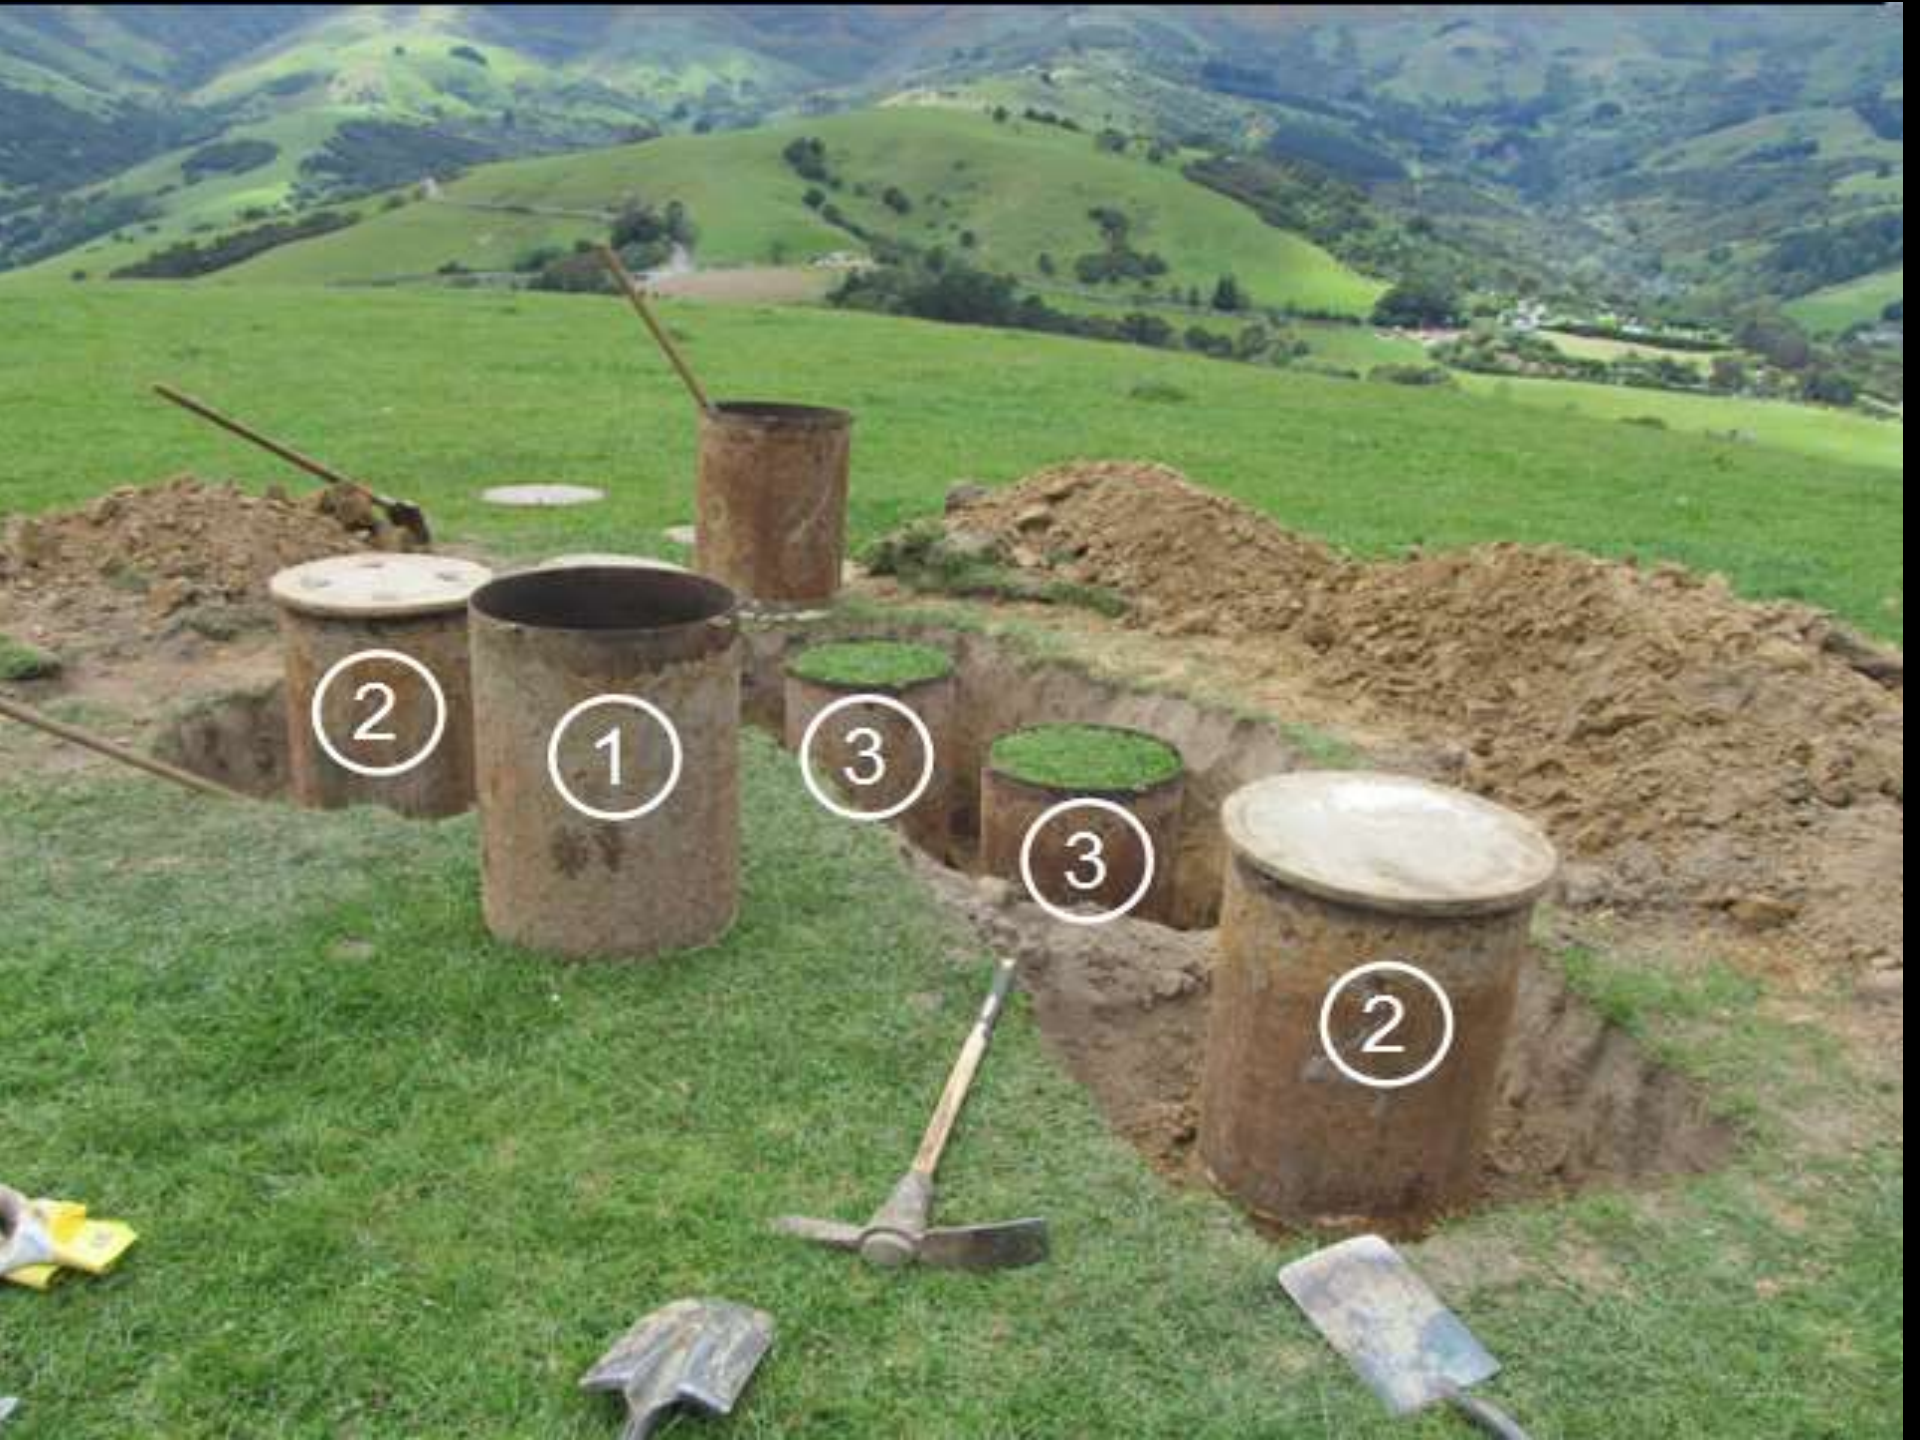
An aerial photograph of a large, irregularly shaped reservoir with turquoise water. The surrounding landscape is a mix of green fields and brownish, eroded soil. Two red stars are placed on the image to indicate soil sampling locations. One star is at the northern end of the reservoir, and the other is on the eastern shore, south of the reservoir's main body.

Barry soil (silt loam) ★

★ Pawson silt loam

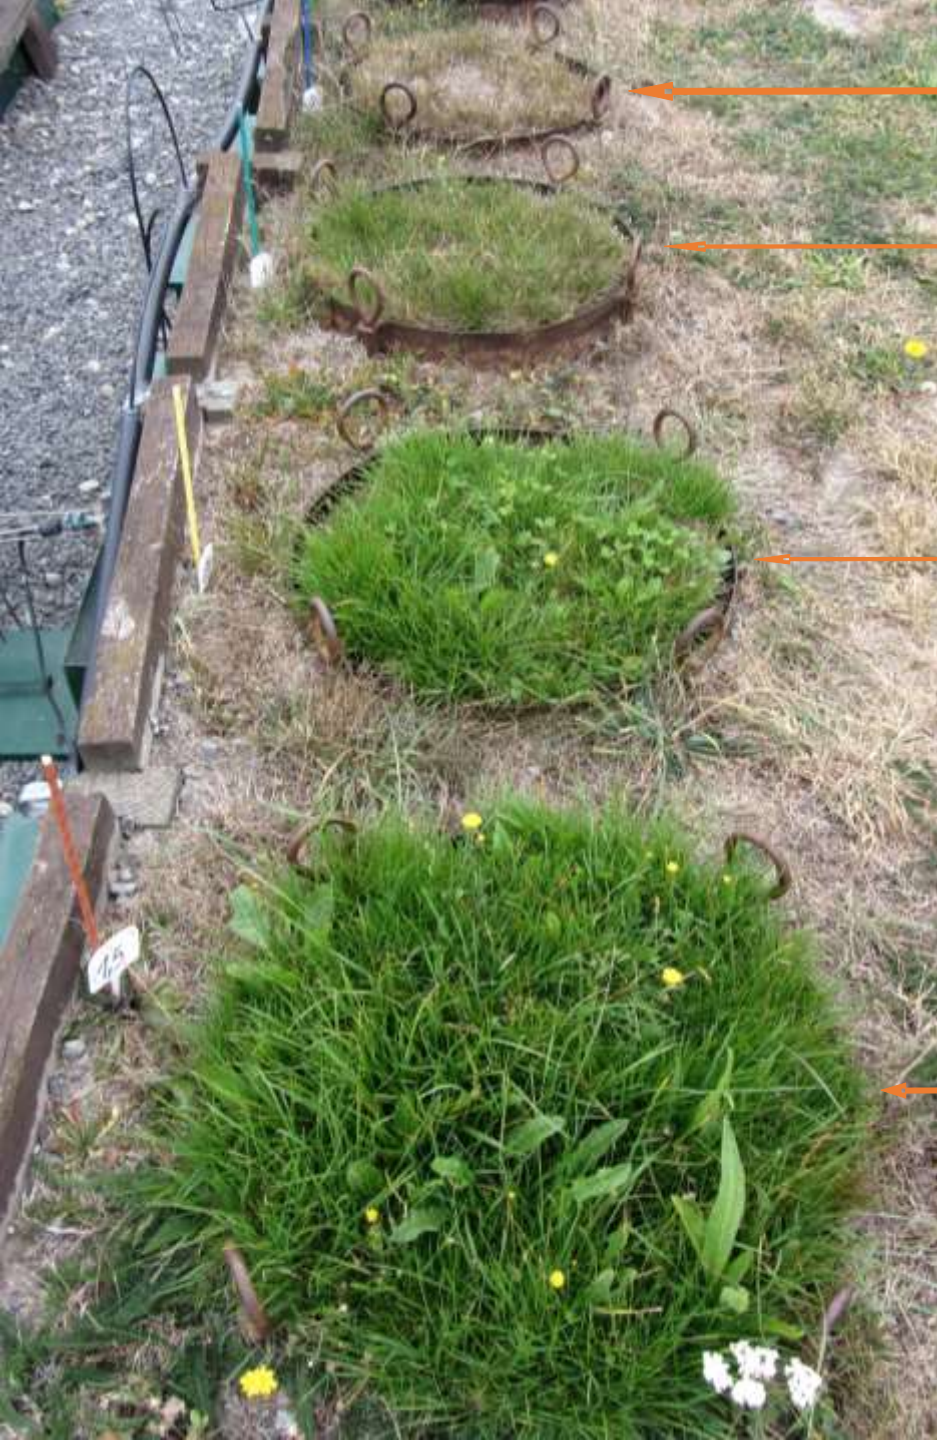
Control (no irrigation)

440 mm/yr

825 mm/yr

1650 mm/yr

Wastewater accelerates pasture growth

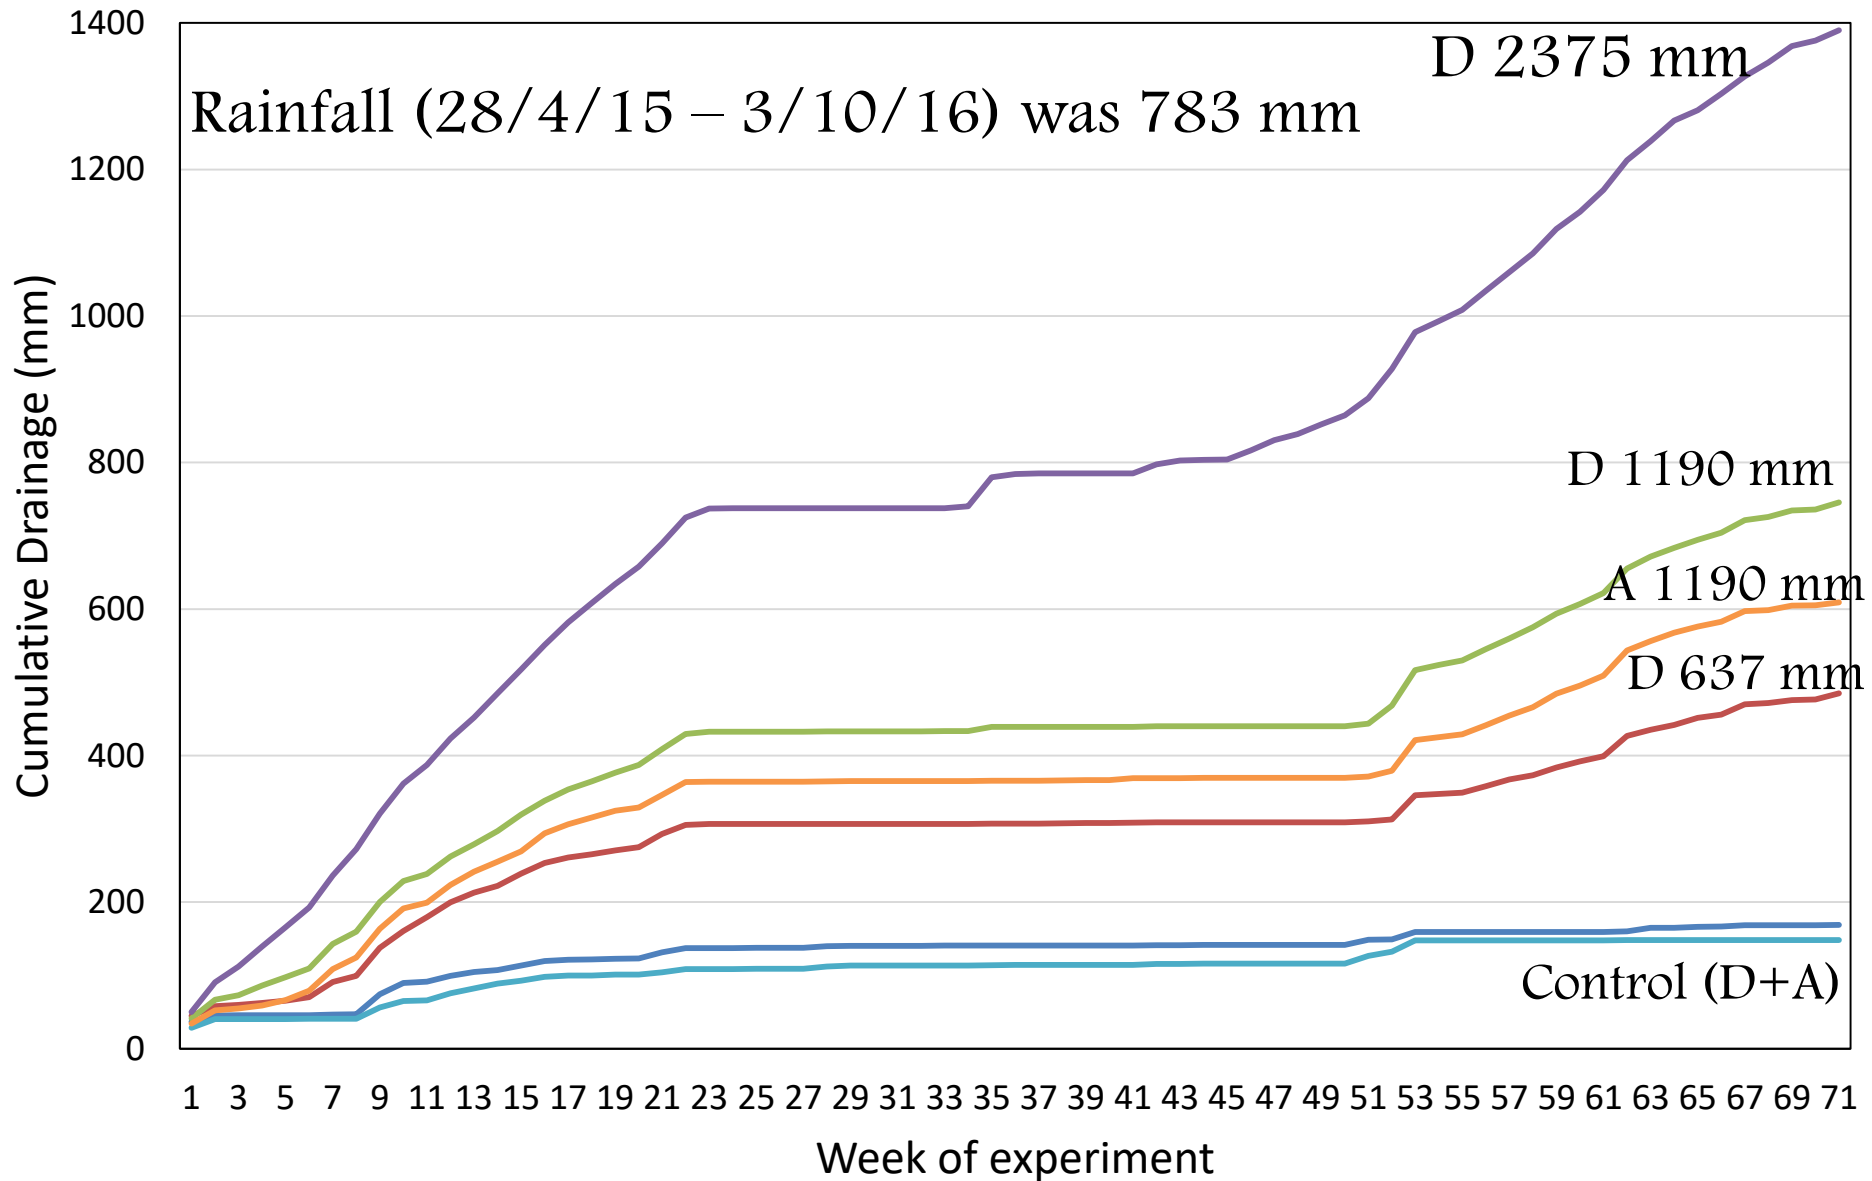
All soils drained freely with no ponding

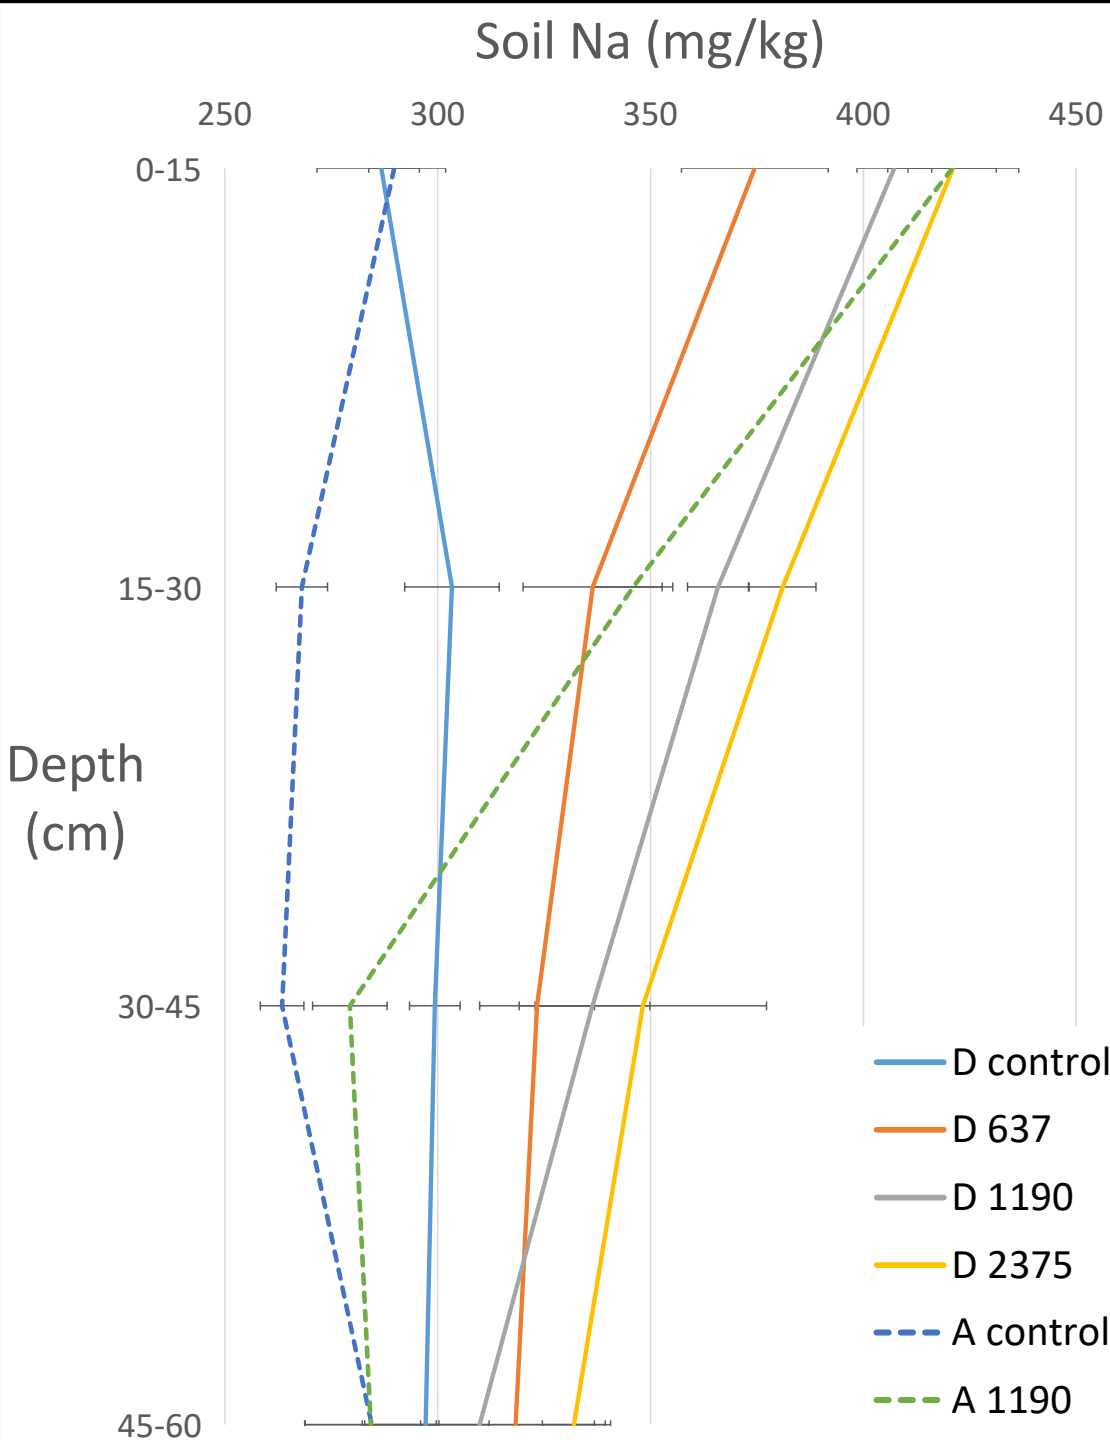
Increased Na
but no
excessive
accumulation

Na in irrigation water
= 63 mg/L

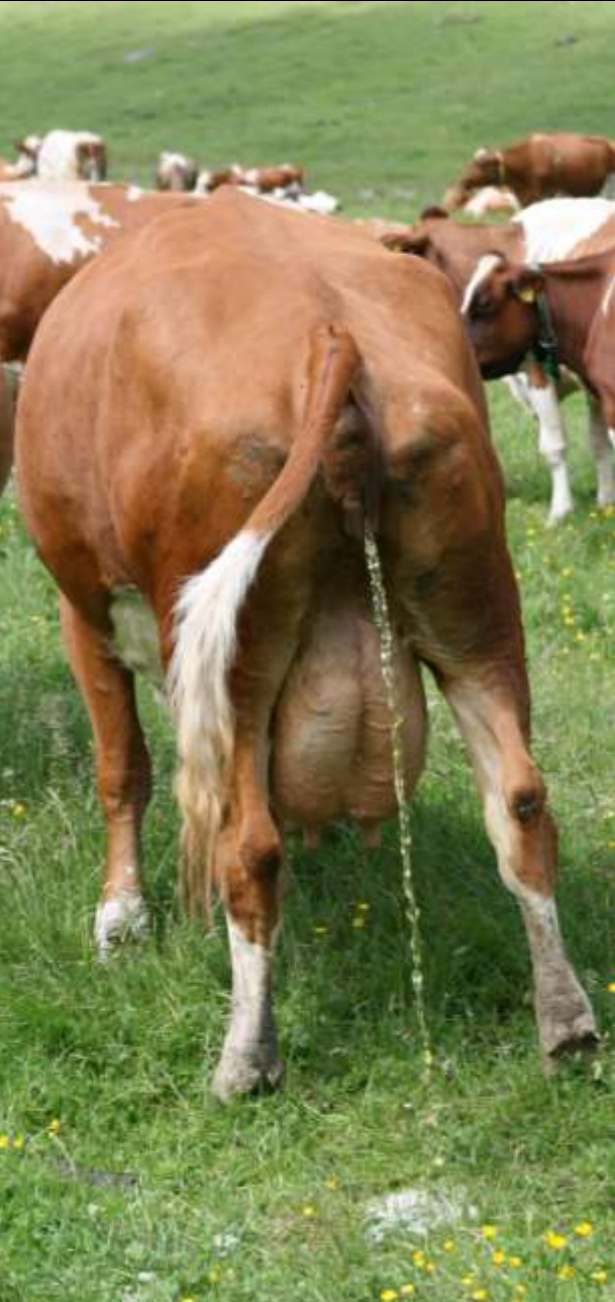
No significant nitrate leaching

- Total N in treated wastewater ca. 30 mg/L
- Average nitrate-N concentration in drainage <0.3 mg/L
- Total nitrate-N leached <1 kg/ha/yr in all treatments

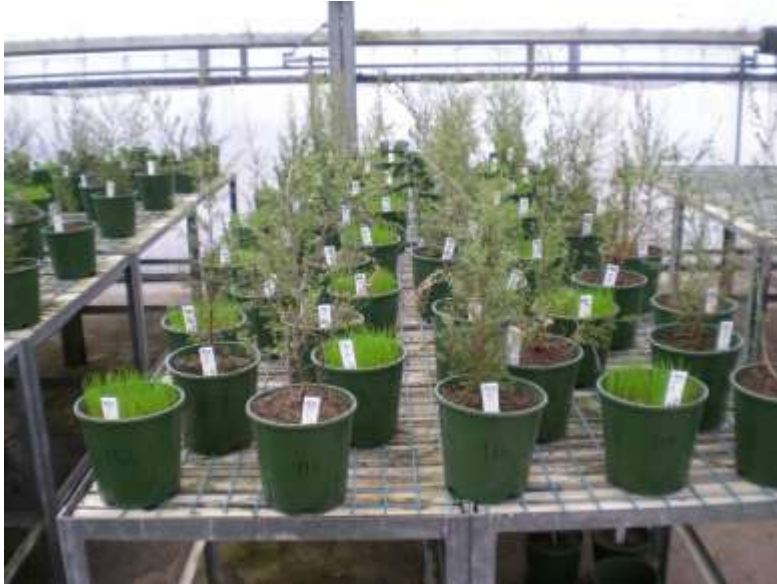
Manuka kills pathogens in soil

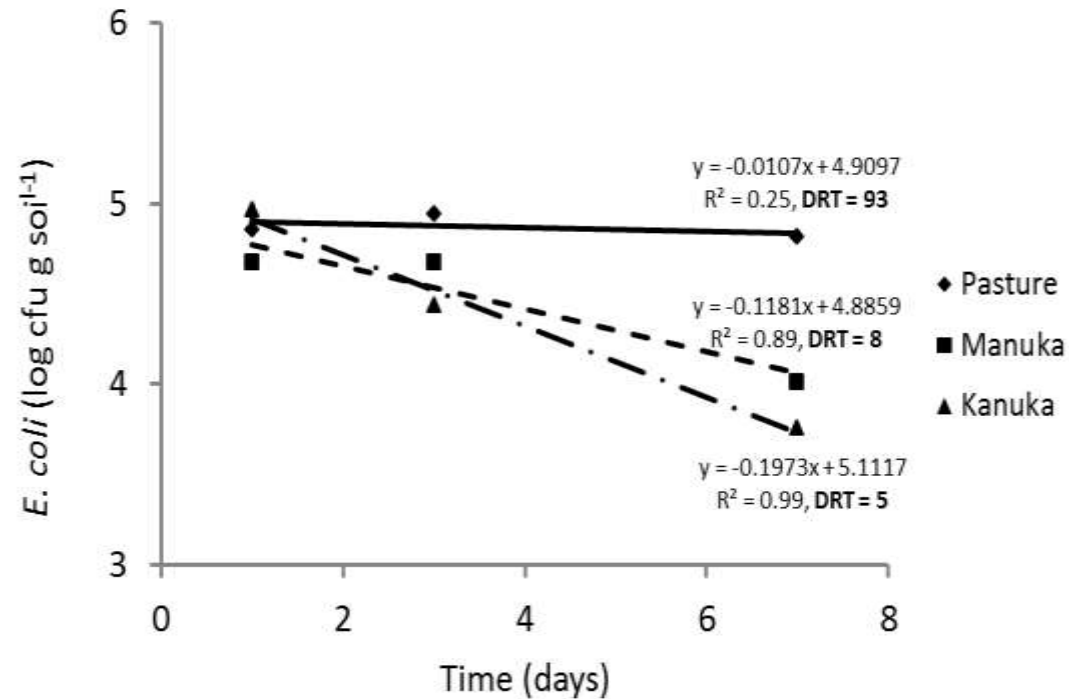
Enhanced die-off of *E. coli* under manuka

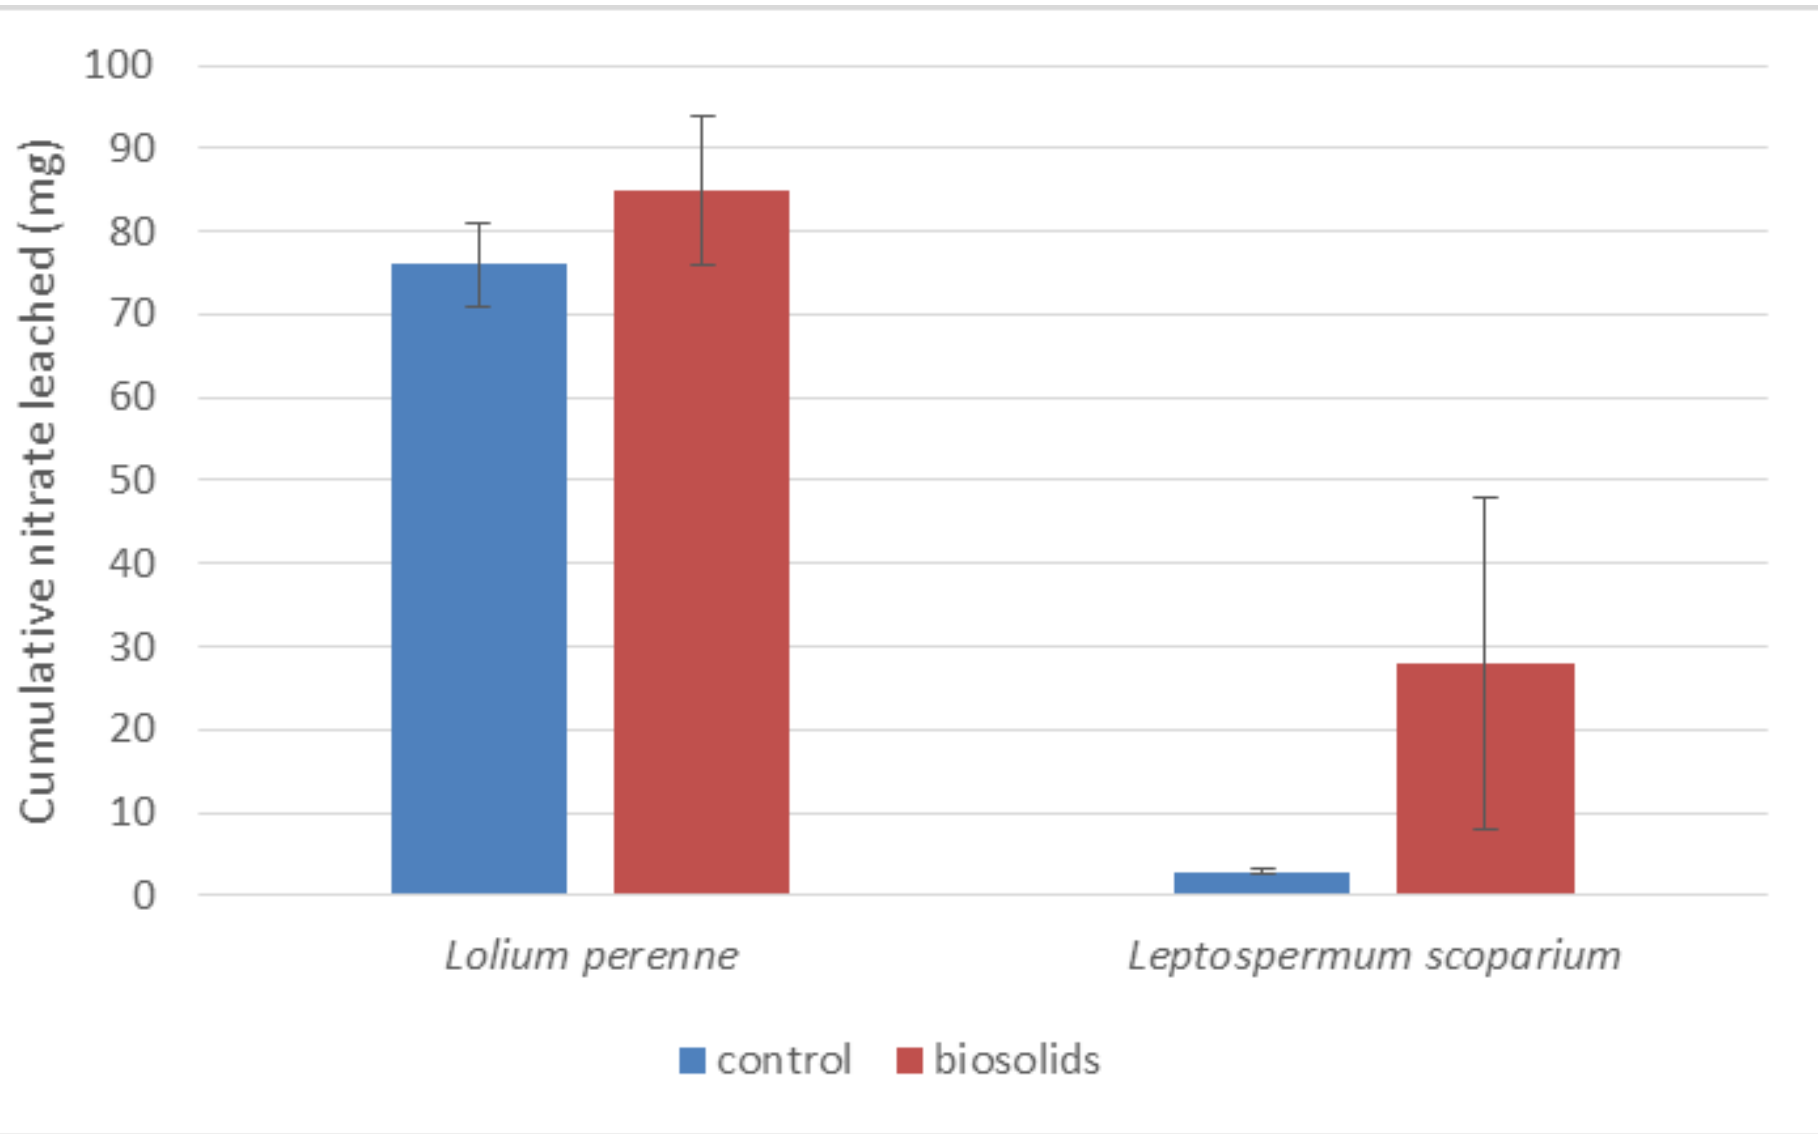
...and reduces nitrate leaching
