# **Wainui Stream water quality analysis and survey of onsite wastewater management systems**

**Wainui, 2019-2020**

*WCFM Report 2020-002*

PREPARED FOR: **Environment Canterbury and Christchurch City Council**

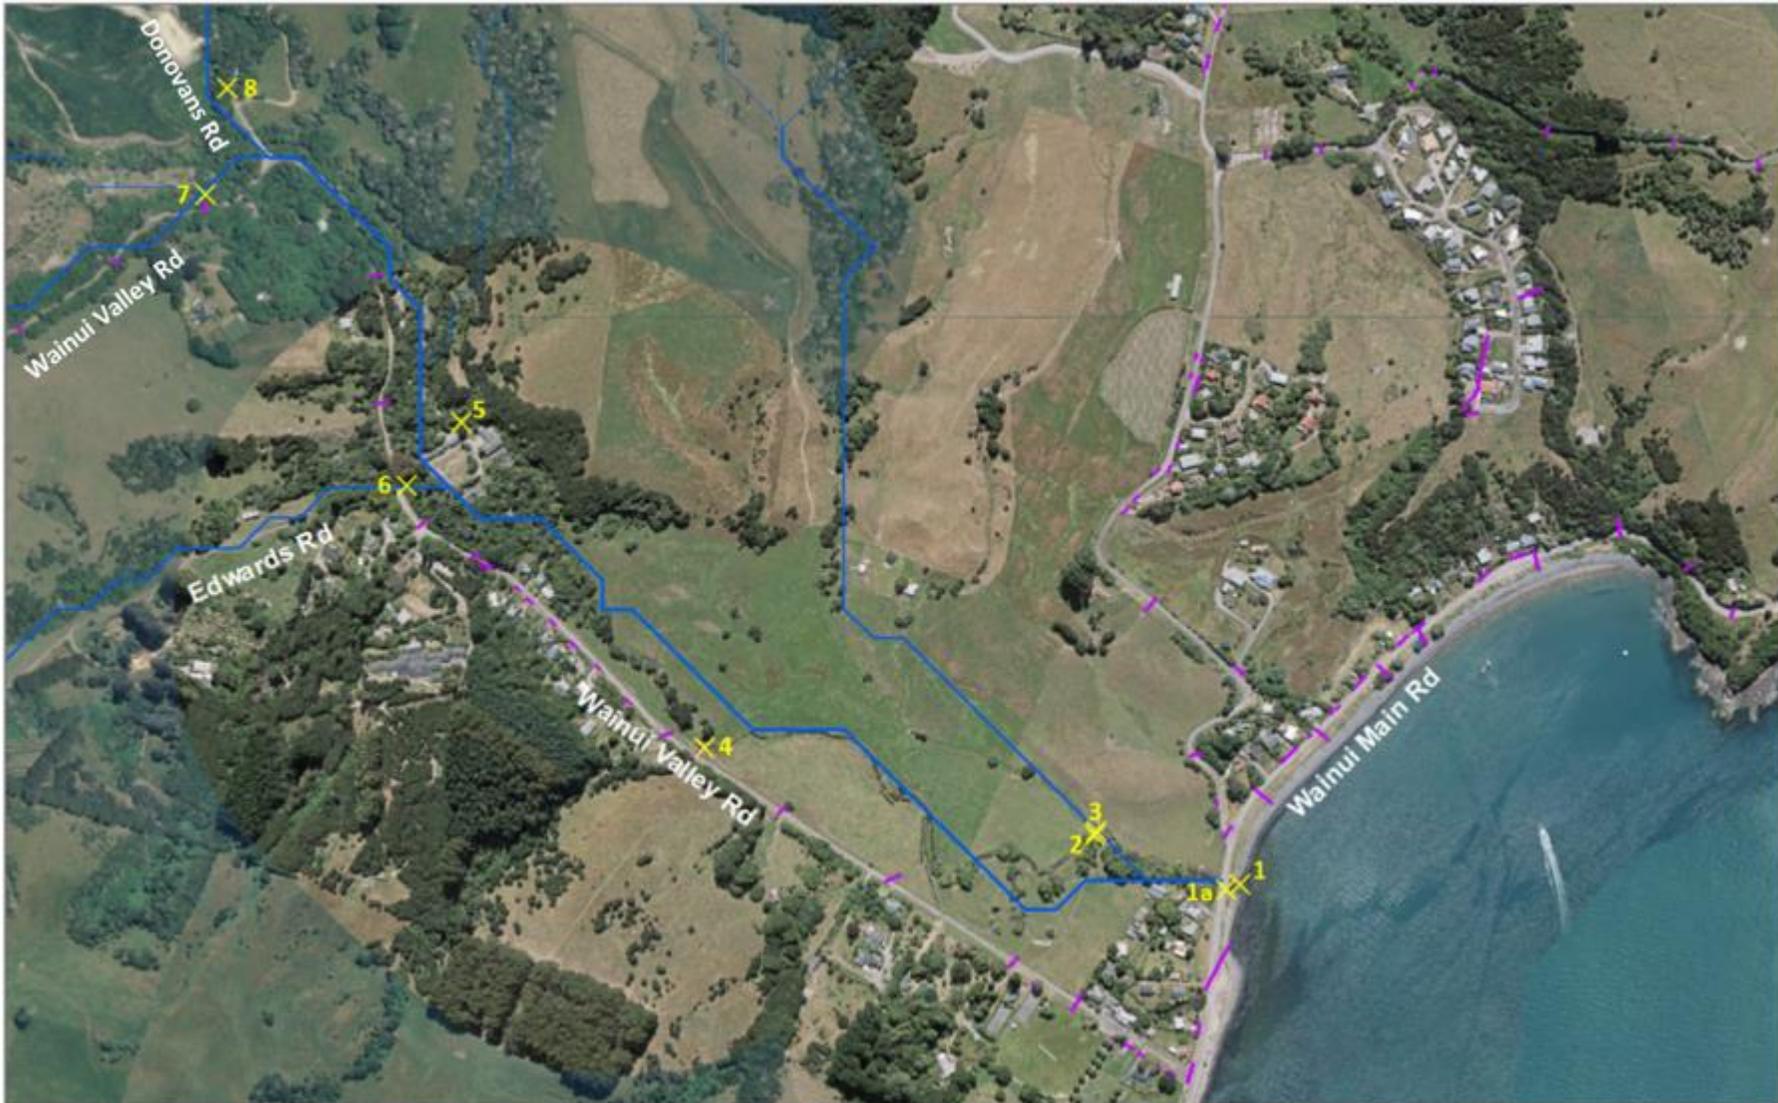
**Figure 5:** Map showing all sites sampled in the Wainui catchment, marked by crosses in yellow with their site number. Rivers shown in blue, their line width graded by stream order, data from the nzRec2\_v4 (NIWA). Piped stormwater courses shown in purple, data from Canterbury Maps (Environment Canterbury, 2017).

**Figure 5** shows the location of all sites sampled in relation to each other, while **Figure 6**, **Figure 7**, **Figure 8**, **Figure 9**, and **Figure 10** show more detailed locations of the respective sites. Of note is that the course of the waterways as depicted by the blue lines (from NIWA's REC2) do not correspond exactly to the stream courses as observed in the field and as seen in the aerial imagery.

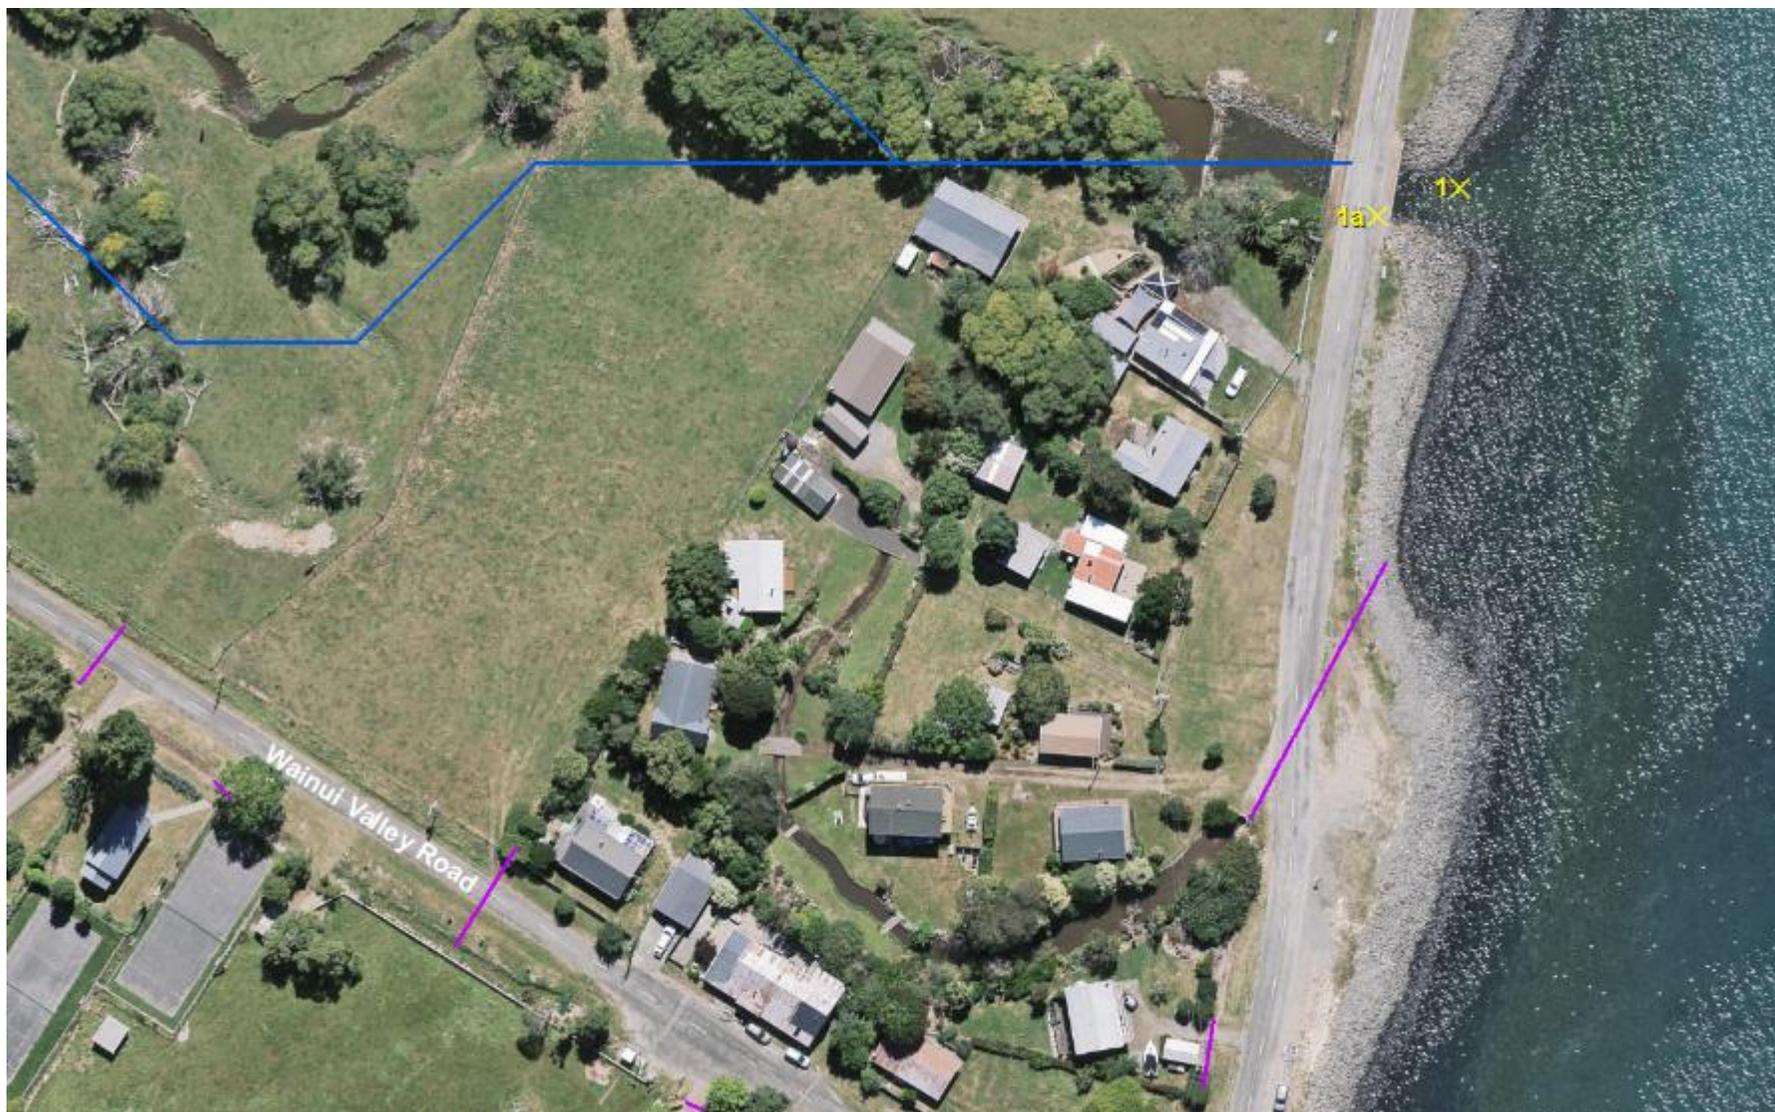
**Figure 6:** Map showing the detailed location of sites 1 and 1a (under the road bridge), marked in yellow. Rivers shown in blue, their line width graded by stream order, data from the nzRec2\_v4 (NIWA). Stormwater courses shown in purple, data from Canterbury Maps (Environment Canterbury, 2017).

**Figure 6** indicates a stormwater pipe going underneath the main road to the coast some 100m south of the bridge, however no outlet was observed in that area. The variation visible in the road surface suggests that the pipe likely goes towards the bridge and terminates at Site 1A. There is a waterway visible in the aerial imagery of **Figure 6** (though not depicted by a blue river line) flowing from an inlet just upstream of the rocky weir (not visible in **Figure 6**). This follows a loop between the houses and ends at the marked stormwater pipe under the bridge. The 'loop' was the original main stem of the stream, but a 'cut' in the channel was constructed to channel flows more directly to the sea and reduce the flood risk to the houses. It is assumed therefore that site 1a is the piped outlet of the original stream course, which still has some limited flow through it.

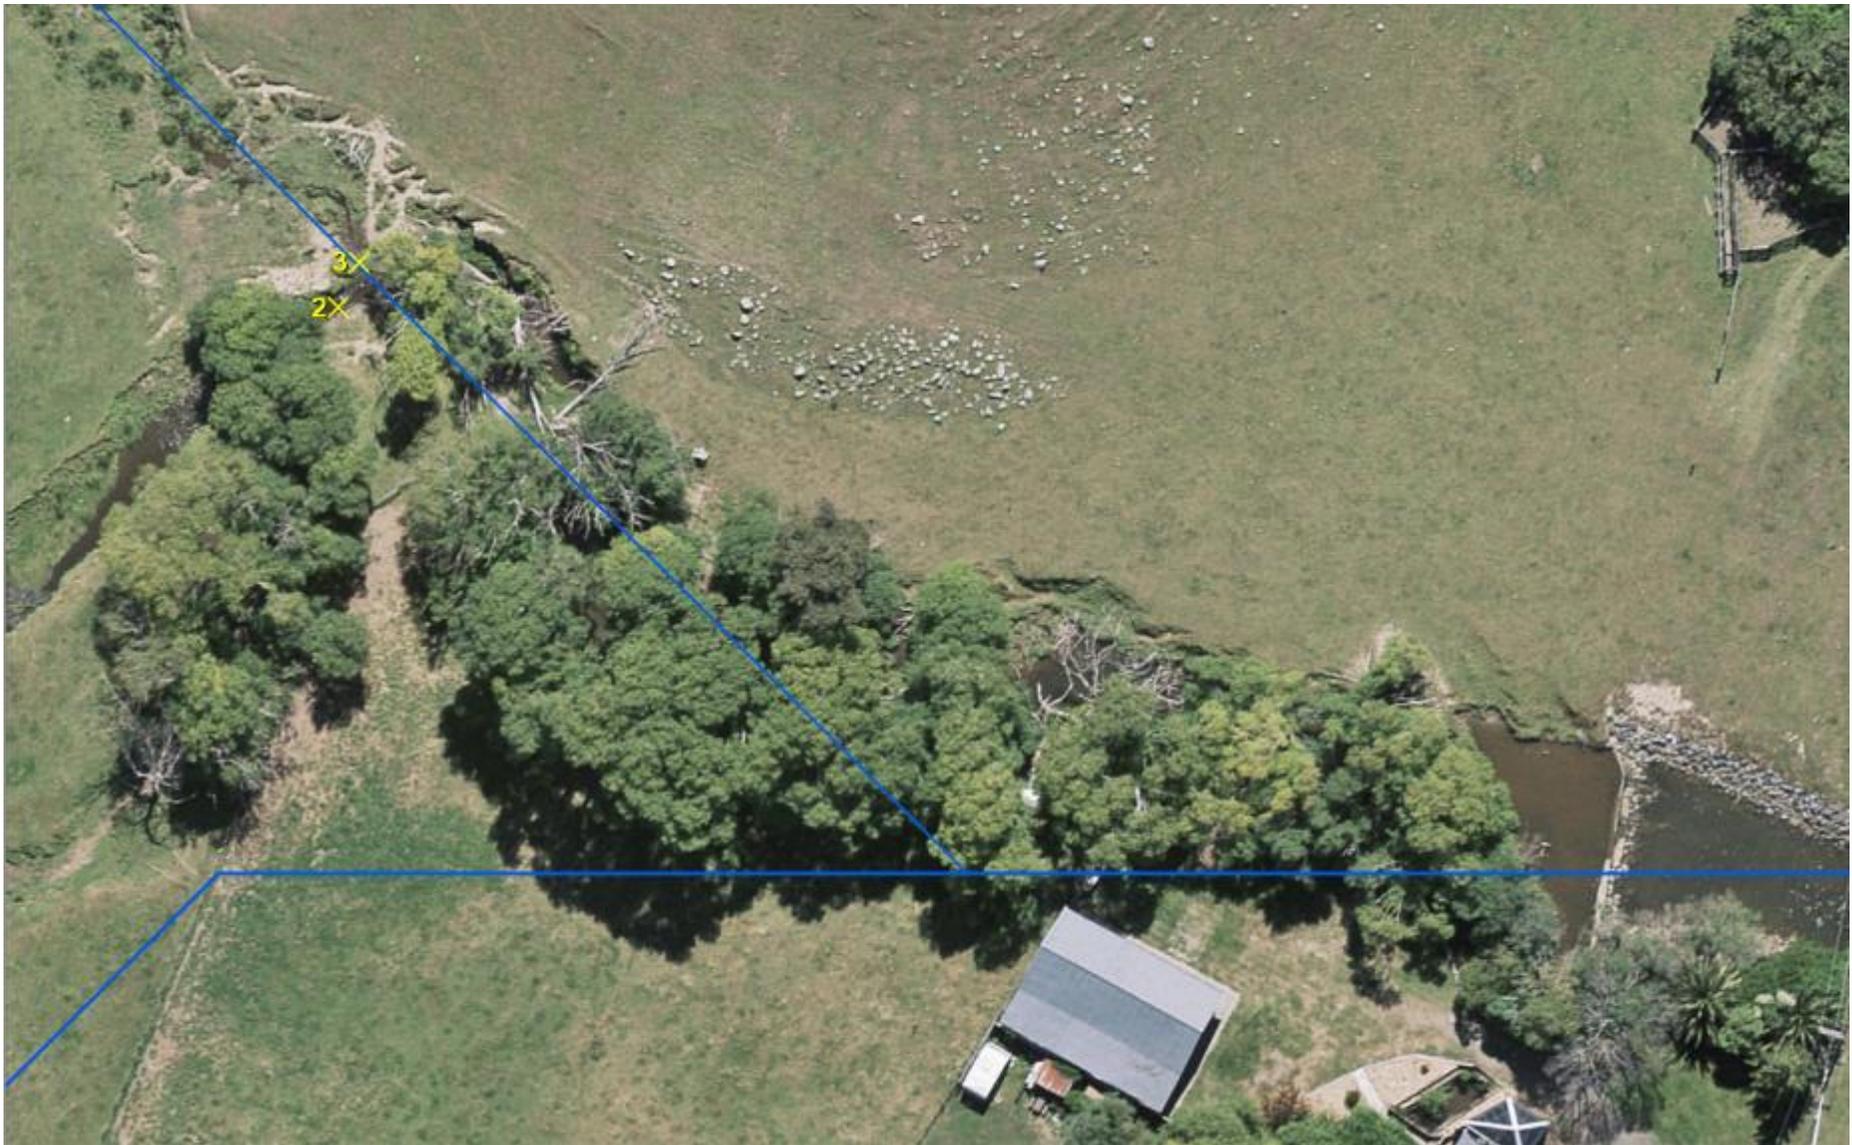
**Figure 7:** Map showing the detailed location of sites 2 and 3, marked in yellow. Rivers shown in blue, their line width graded by stream order, data from the nzRec2\_v4 (NIWA).

Site 2 (see **Figure 7** and Figure AI.5) is on the main stem of the Wainui Stream, immediately upstream of a riffle and the tributary sampled at Site 3. The surrounding area is farmland with only grasses and rushes around the stream area, and cows were observed in adjacent paddocks on several occasions. Of note are several changes from the aerial imagery depicted in **Figure 7** to present: The willow trees in the imagery have been cleared, the stream is fenced off from the adjacent paddocks, and riparian planting has been carried out within a riparian reserve towards the bridge.

Site 3 was on a small tributary, marked by a river line in **Figure 7** and shown in Figure AI.8. The flow velocity recorded was mostly less than 0.1 m/s, however it did peak at 0.5 m/s on 20/01/20. The upstream area was farmland, with cattle observed on many occasions, and there was a low culvert and crossing allowing cattle to cross the tributary immediately upstream of Site 3 (see Figure AI.9). Pukekos, grey herons and ducks were observed around the site. The streambed was sludgy with sediment and rocky, with aquatic plant life that

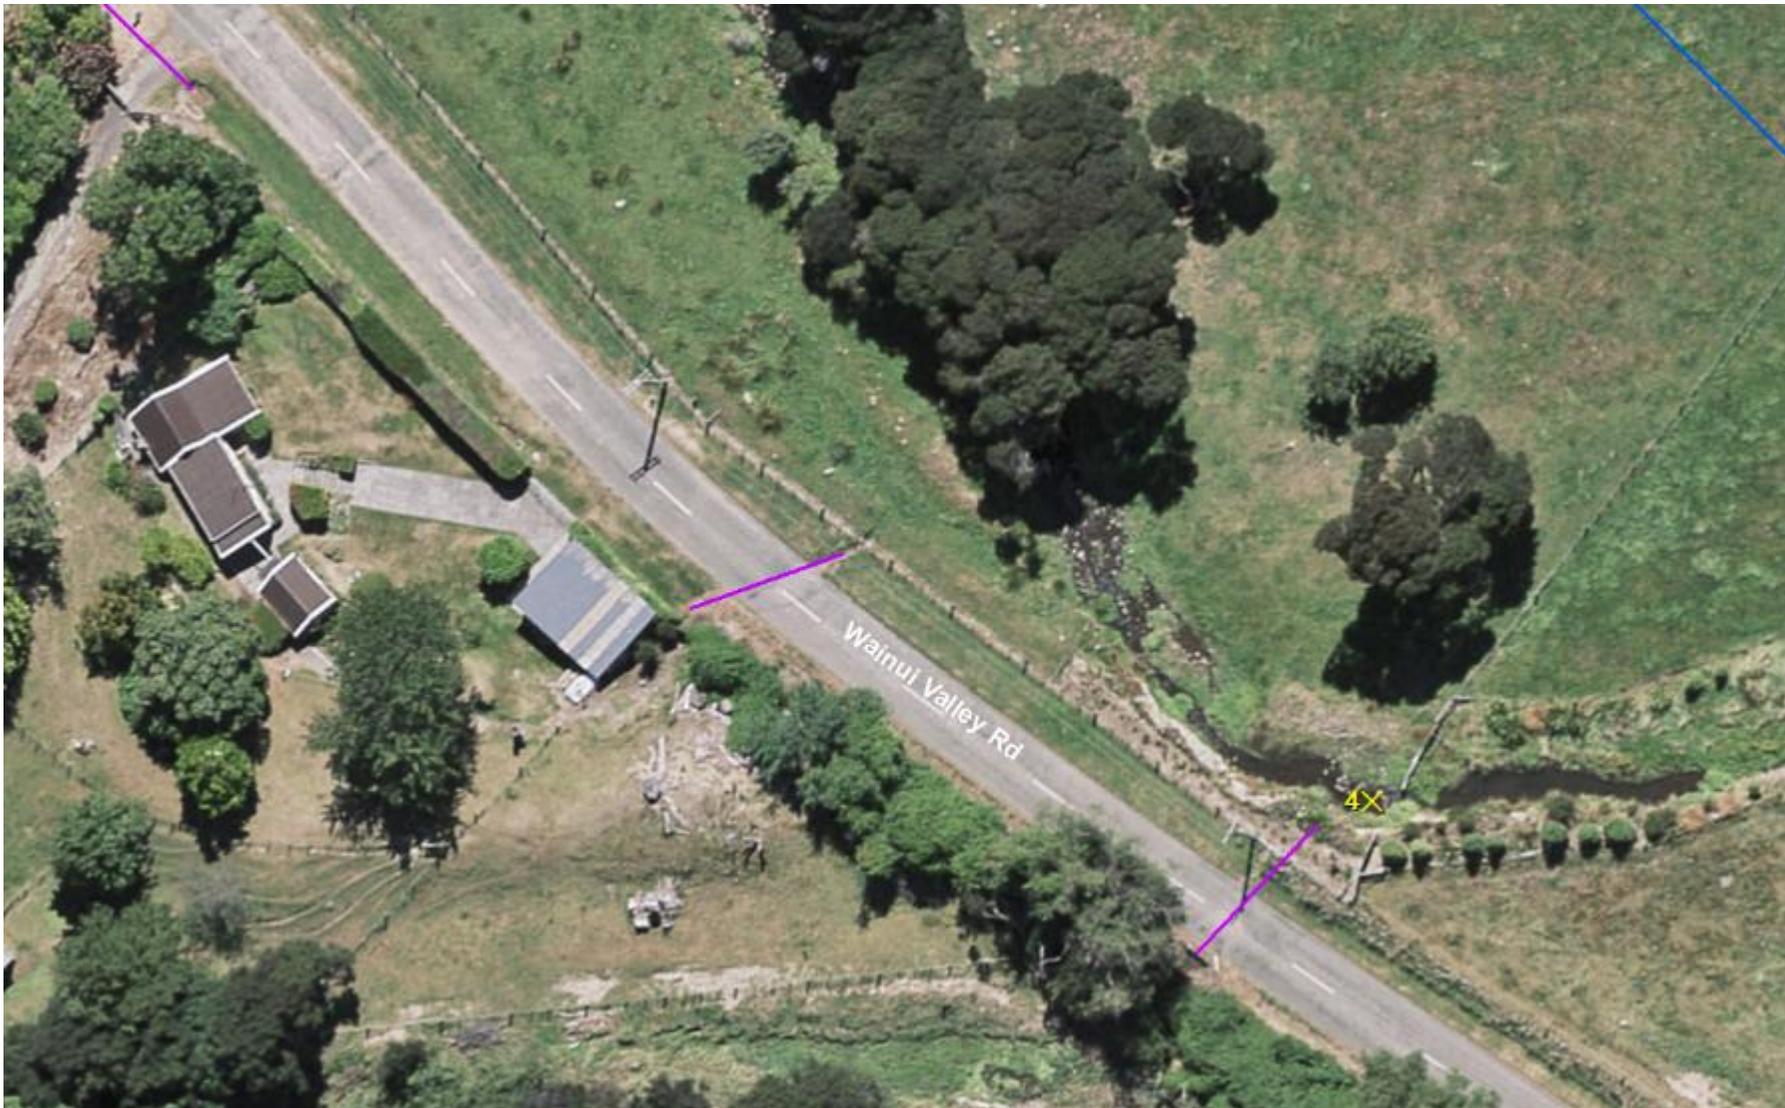
**Figure 8:** Map showing the detailed location of site 4 marked in yellow. Stormwater courses shown in purple, data from Canterbury Maps (Environment Canterbury, 2017). The nzRec2\_v4 does not show the river flow in the area, but the location of the stream is clear in the aerial imagery.

Site 4 was located on the main stem of the Wainui Stream (see **Figure 8**) in a paddock. This site was accessed freely by cattle at the time of sampling. Wainui Valley Road runs parallel to the stream alongside this reach and there were a few houses on the opposite side of the road (see Figures AI.11 and AI.12). The sampling point was immediately downstream of a stormwater drain flowing out from the road-side stream bank, as seen in **Figure 8**.

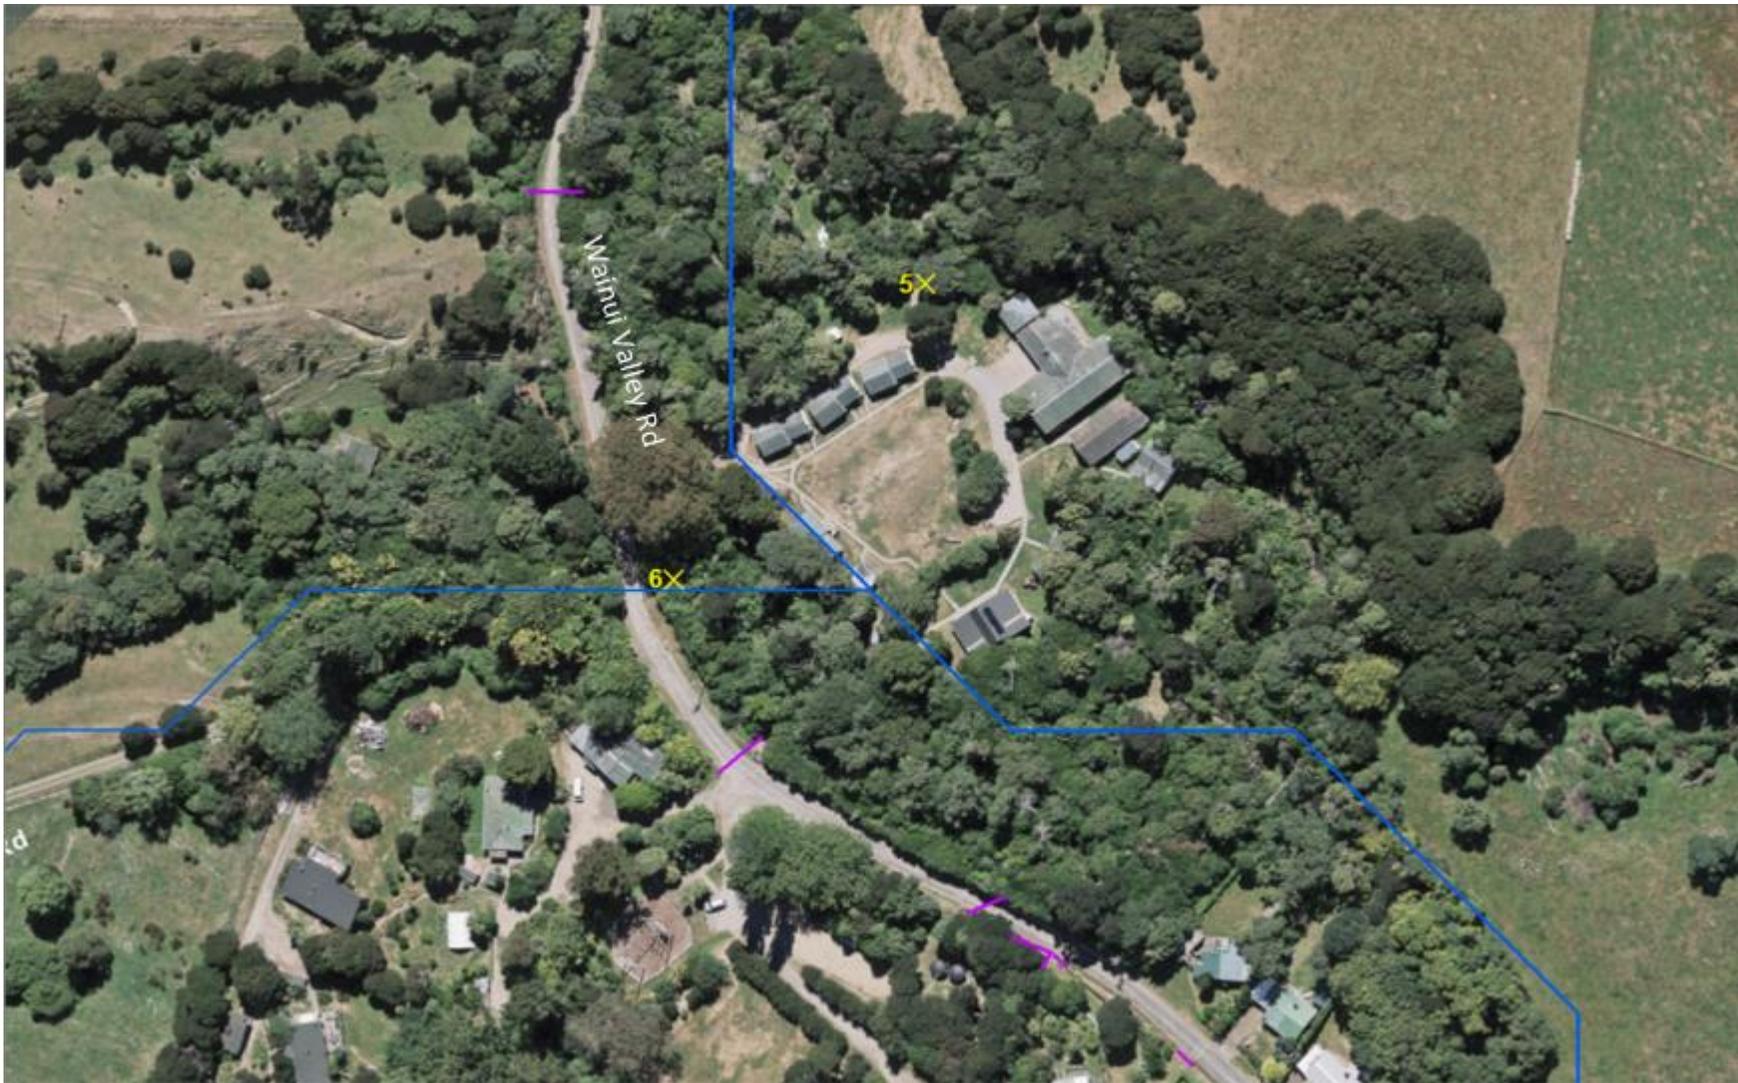
**Figure 9:** Map showing the detailed location of sites 5 and 6 marked in yellow. Stormwater courses shown in purple, data from Canterbury Maps (Environment Canterbury, 2017). The nzRec2\_v4 (in blue) shows the river course incorrectly as flowing on the road side of the YMCA camp (centre picture), however it actually flows around the far side on the camp where site 5 is marked.

Site 5 was on the main stem of the Wainui Stream, upstream of the confluence with the tributary sampled at site 6. This was located next to the YMCA camp, and immediately downstream from a footbridge, as seen in Figure AI.13 and **Figure 9**. A small valve from a pipe running underneath the bridge was usually dripping, and the camp manager confirmed that this was a fresh water pipe. During most sampling trips after the new year, the camp had groups of children staying, and the bridge was used as pedestrian access for other non-residential parts of the camp. Birds were the only wildlife noted at this site, but they were heard and not seen. The site was mostly under canopy cover, and there was some green algae present and leaf litter in the stream. The stream bed was rocky, with some deposited fine sediment present. The flow velocity was usually 0.1-0.2 m/s, but peaked at 0.4 m/s on 10/02/20. The water level of the stream at this location was visibly lower towards the end of our sampling program.

Site 6 was located on a tributary of the Wainui Stream, immediately downstream from a road bridge, which had the occasional car driving over it (see Figure AI.13 and **Figure 9**). The confluence of this tributary and the Wainui Stream main stem was downstream of Site 5. This was below the camp unlike what is indicated by the river course in **Figure 5**. The flow velocity at this site was generally higher than at site 5, usually varying between 0.2-0.5 m/s. The site was under canopy cover and birds (fantails and kereru in particular) were observed in the area. The stream bed was rocky with some fine sediment or brown algae, and leaf litter.

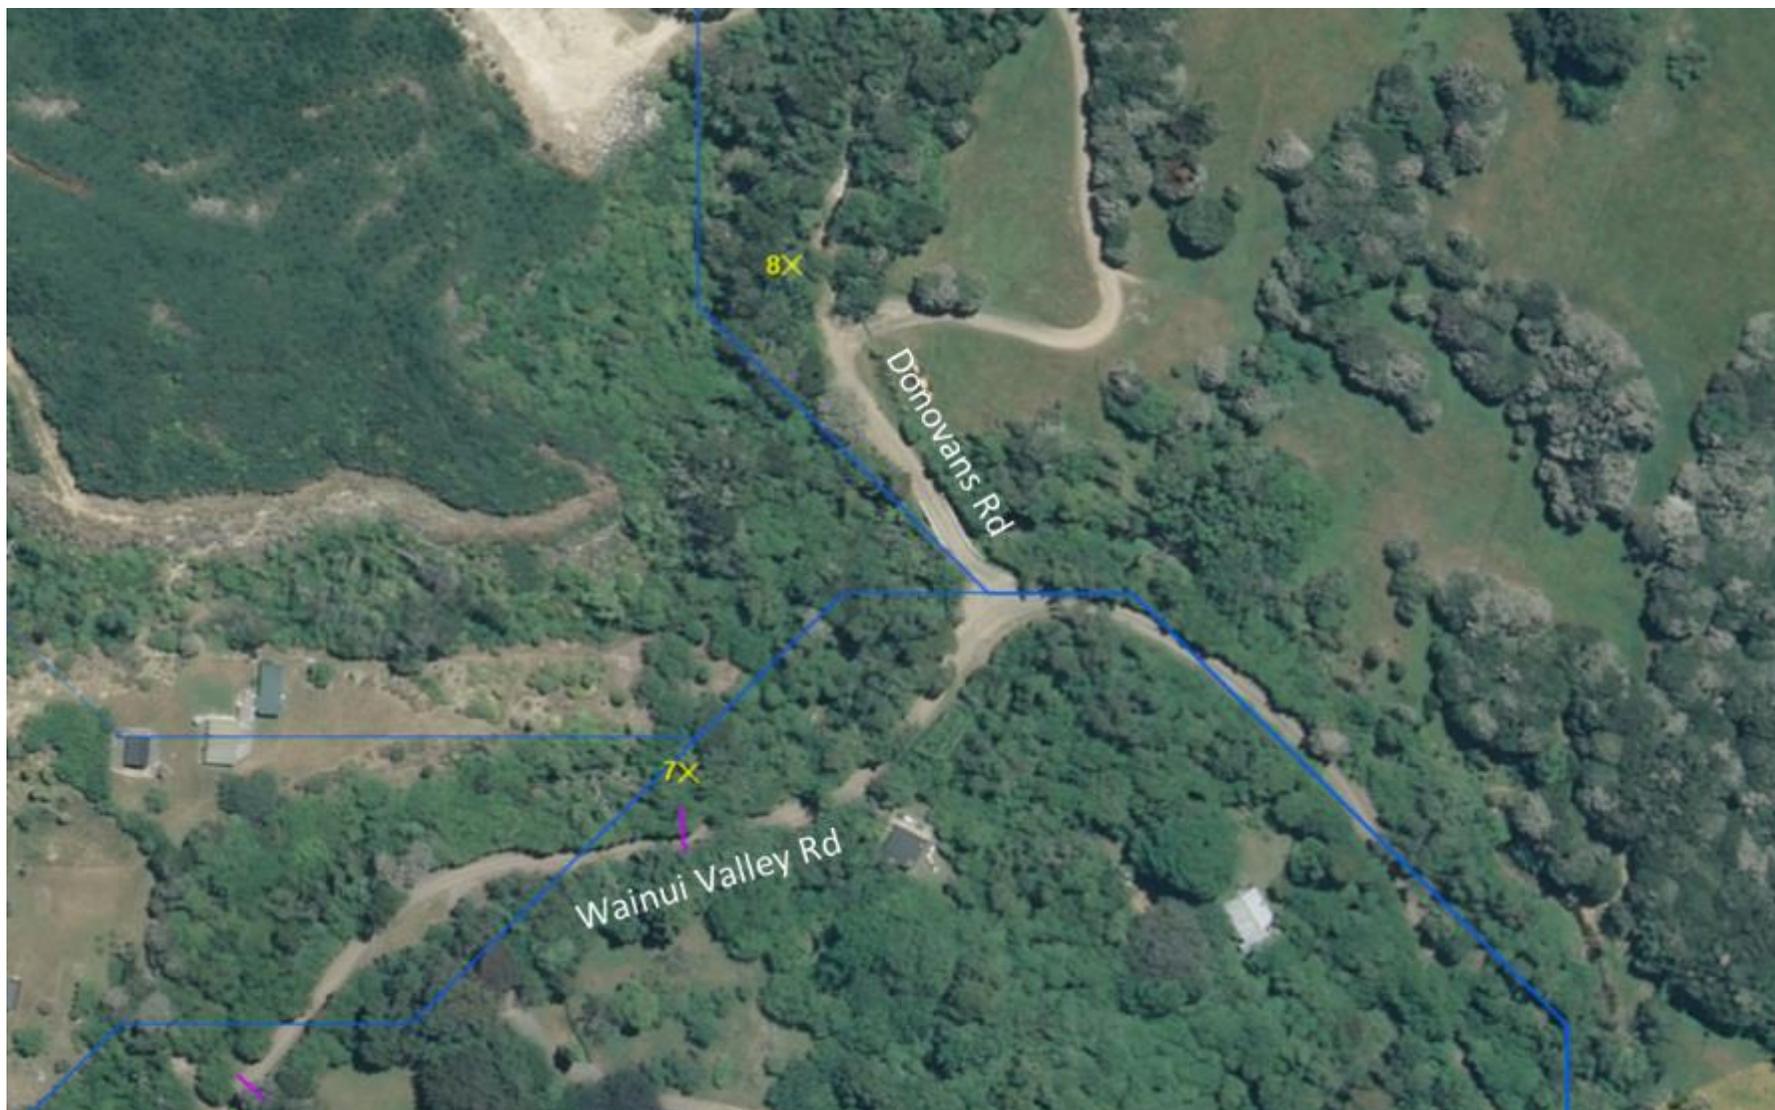
**Figure 10:** Map showing the detailed location of sites 7 and 8 marked in yellow. Stormwater courses shown in purple, data from Canterbury Maps (Environment Canterbury, 2017). Rivers shown in blue, their line width graded by stream order, data from the nzRec2\_v4 (NIWA).

Site 7 was located on a tributary of the Wainui Stream, off a gravel section of Wainui Valley Road. Its confluence with the main stem of the Wainui Stream was downstream of site 8, as seen in **Figure 10**. There were homes on the opposite side of the gravel road, and the road was used infrequently by cars. As Figure AI.14 shows, the site was covered by native canopy, and had a rocky bed with some brown benthic algae/sediment and leaf litter in the stream. A dozen dead hedgehogs and possums were found dumped approximately 5m from the stream on a bank above, and while not visible from the sample site the odour persisted throughout the sampling program. The flow velocity was generally 0.1-0.2 m/s.

Site 8 was on the main stem of the Wainui Stream near the start of Donovans Road, and was the most upstream site sampled (see **Figure 5** and **Figure 10**). It was immediately downstream of a road bridge (see **Figure AI.15**) on Donovans Road, which was used infrequently by cars. There was a farm downstream on the other side of the road. Birdsong was heard on most sampling trips, and the site was under canopy cover. The stream bed was rocky with some brown sediment/algae, moss and green algae was also observed on the rocks. The flow velocity varied between 0.1 and 0.3 m/s. On most sampling occasions, a beige foam was observed downstream of the sampling point (see **Figure AI.16**). This had gone completely by the last trip on 10/02/20. It is likely the foam was of natural origin, forming due to the decay of natural organic matter from the surrounding forest and aeration.

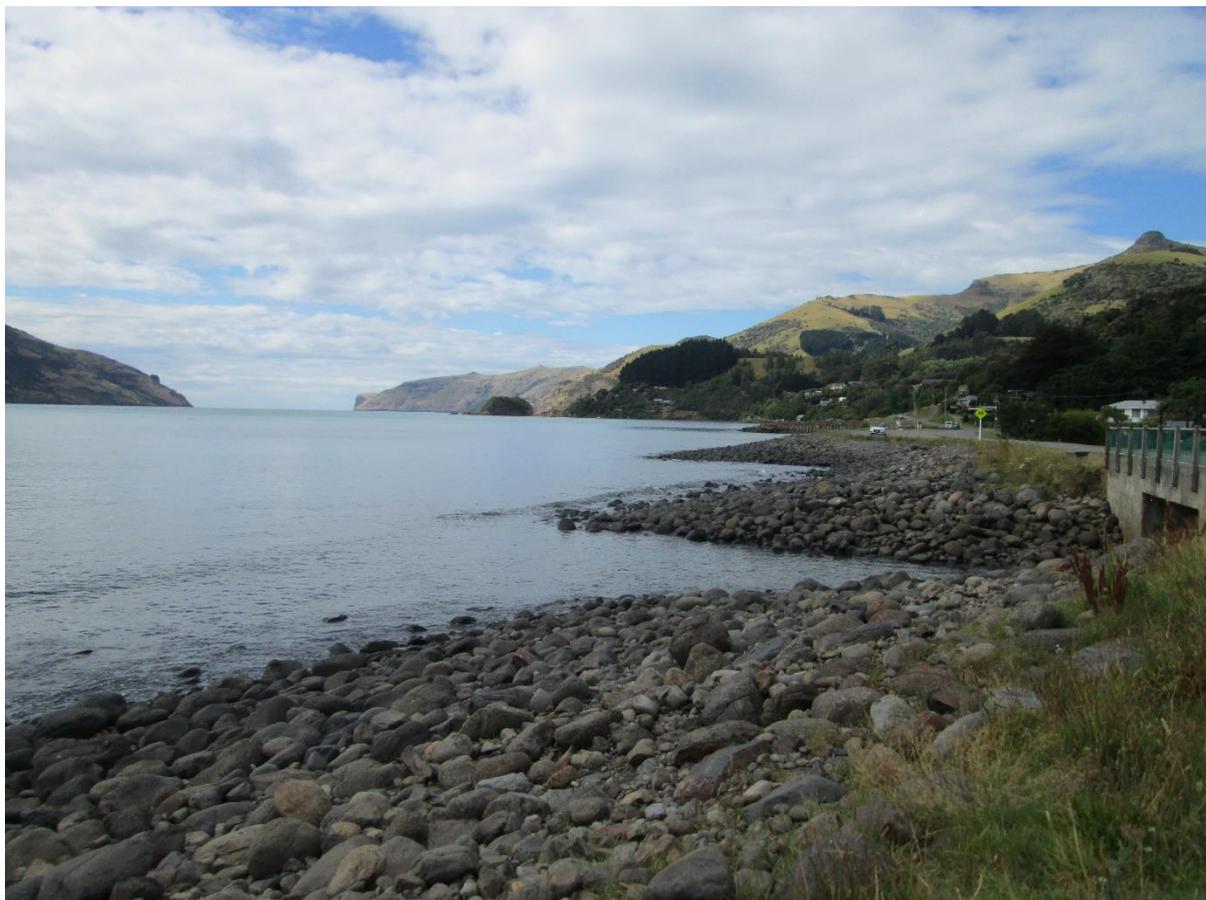
As seen in Figure AI.1 (below) and **Figure 6**, Site 1 was located at the mouth of Wainui Stream, where it mixes with the seawater. As such, the exact location of the sample point varied slightly depending on tide height at the time of sampling.

The main road (Wainui Main Road) runs along the coast and over the bridge next to this site (seen to the right in Figure AI.1). There are residential homes on the inland side of the main road, and a few people were observed walking, swimming and/or boating in the area on most sampling trips, though not the first (13/12/19) or last two trips (03/02/20 and 10/02/20). On three occasions a cruise ship was seen further out in the harbour towards Akaroa. Wildlife observed was mainly birds such as ducks, oyster catchers, and seagulls. The stream bed was rocky with some pebbles, and consistently had green slippery algae growing on the rocks that were submerged at higher tide levels. The sample point was tidal, and samples were taken as close to low tide as possible. This meant it was either sampled first or last out of the nine sites within the 9-3pm sampling window.

**Figure AI.1:** Site 1 (taken 06/01/20).

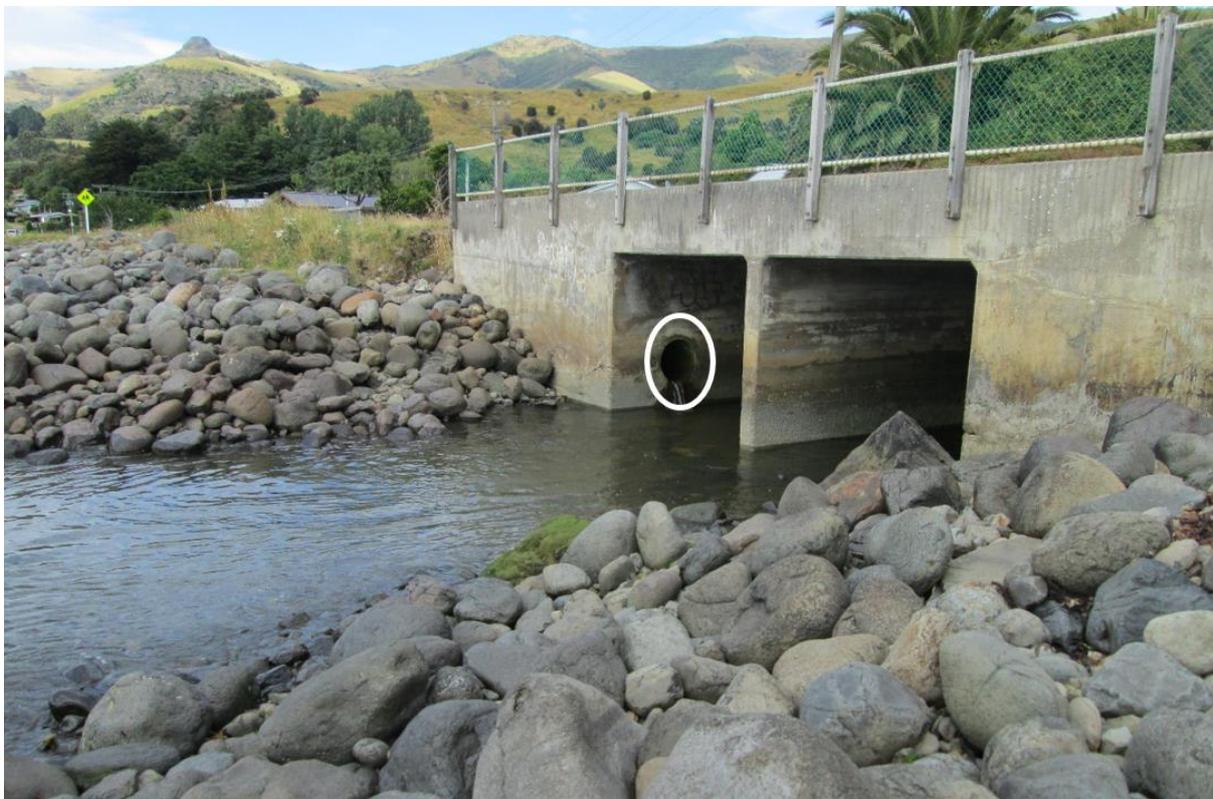
Site 1a was added to the sampling plan on the third monitoring trip (30/12/19). This was because water was observed flowing out of the concrete pipe underneath the bridge on previous trips (see circled area in Figure AI.2). The flow seemed to vary slightly between weeks. On one trip (13/01/20) the smell of urine was noted and on another (20/01/20) an oily residue was observed on the surface of the water in the pipe and the water directly below its outfall. As seen in Figure AI.3, green algae was growing on the upper areas of the pipe. Brown staining was present on the concrete below the pipe and the pipe was partially submerged during high tides (Figure AI.4).

**Figure AI.2:** Site 1a circled in white (taken 06/01/20).

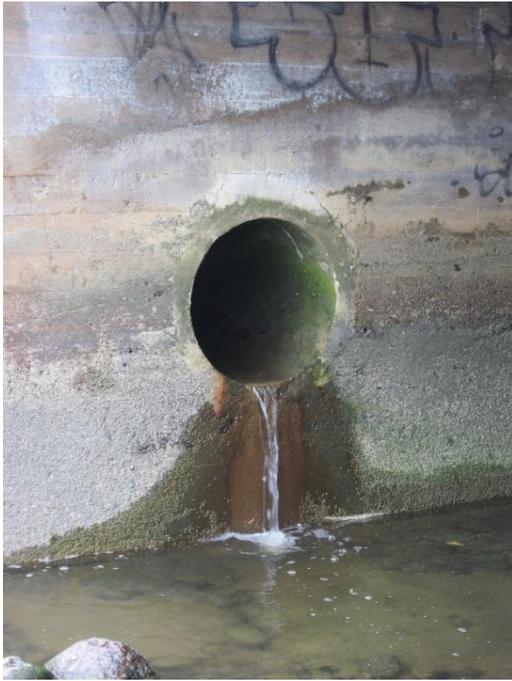
**Figure AI.3:** Close up of Site 1a (taken 13/01/20).

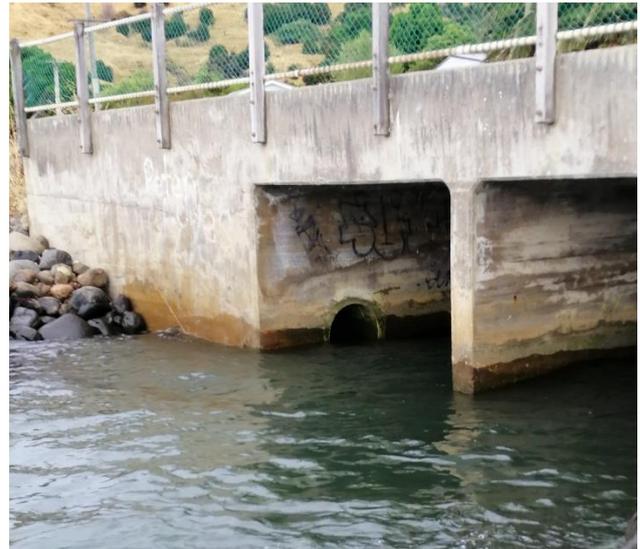
**Figure AI.4:** Site 1a at higher tide (taken 03/02/20).

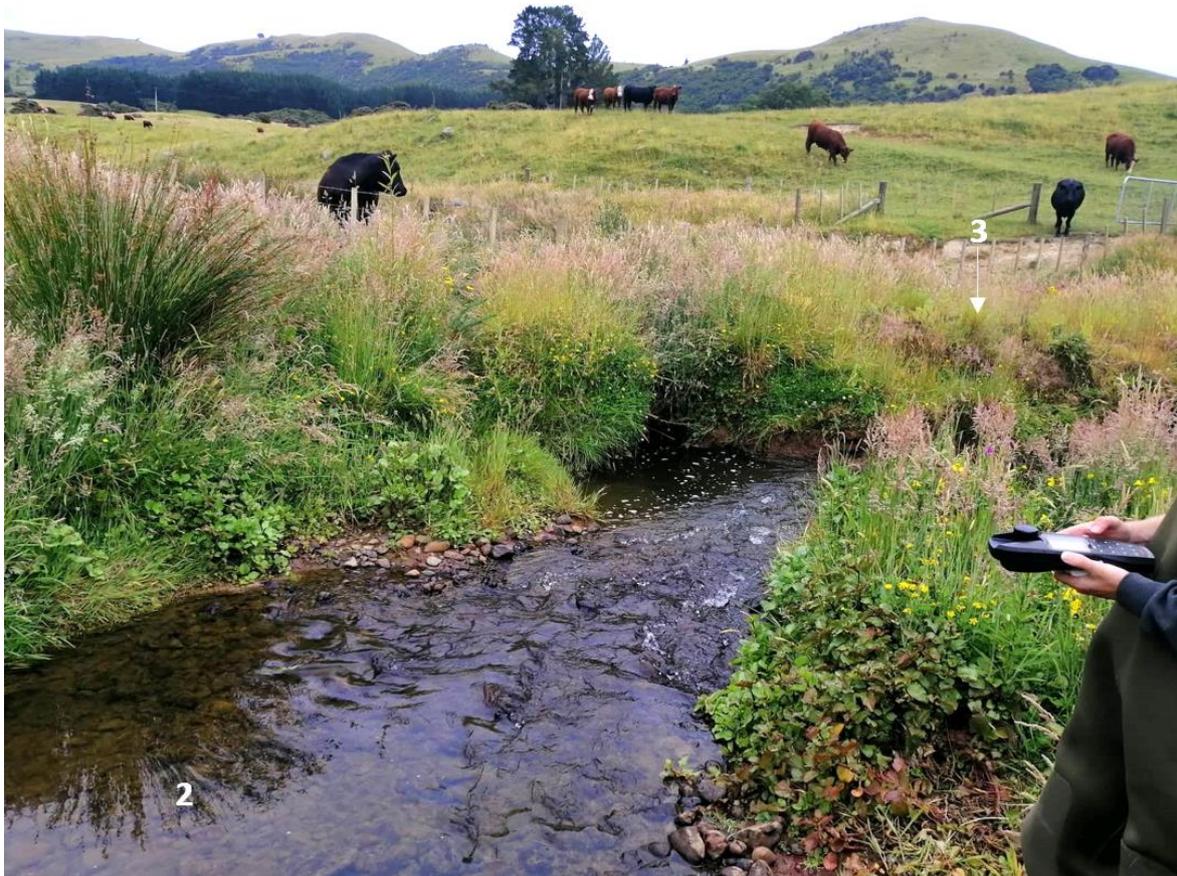
**Figure AI.5:** Site 2 sampling area marked by white number. Site 3 also marked by arrow and number (taken 23/12/19)

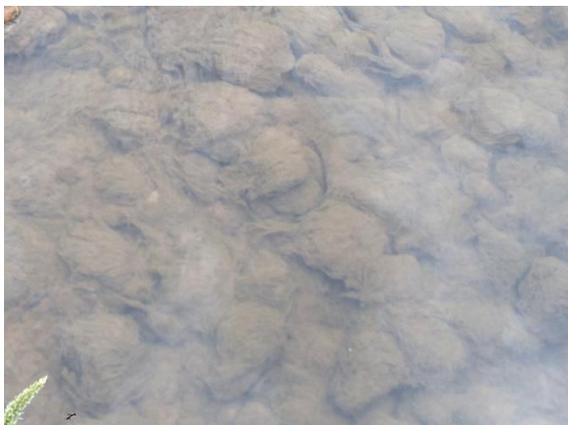
**Figure AI.6:** Example of the benthic brown sludge observed in various sites (taken at site 2, 13/12/19)

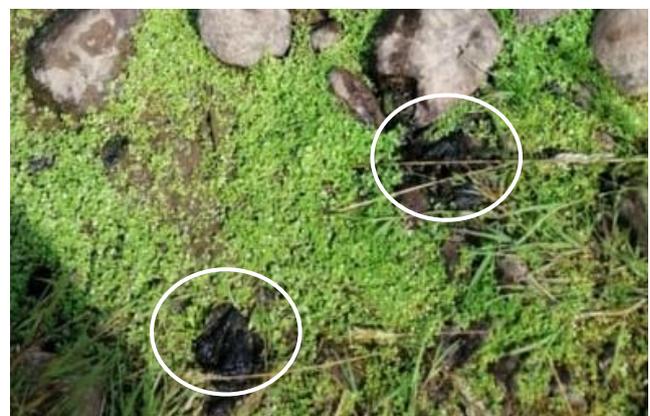
**Figure AI.7:** Unidentified faeces (circled) at site 2 (taken 27/01/20).

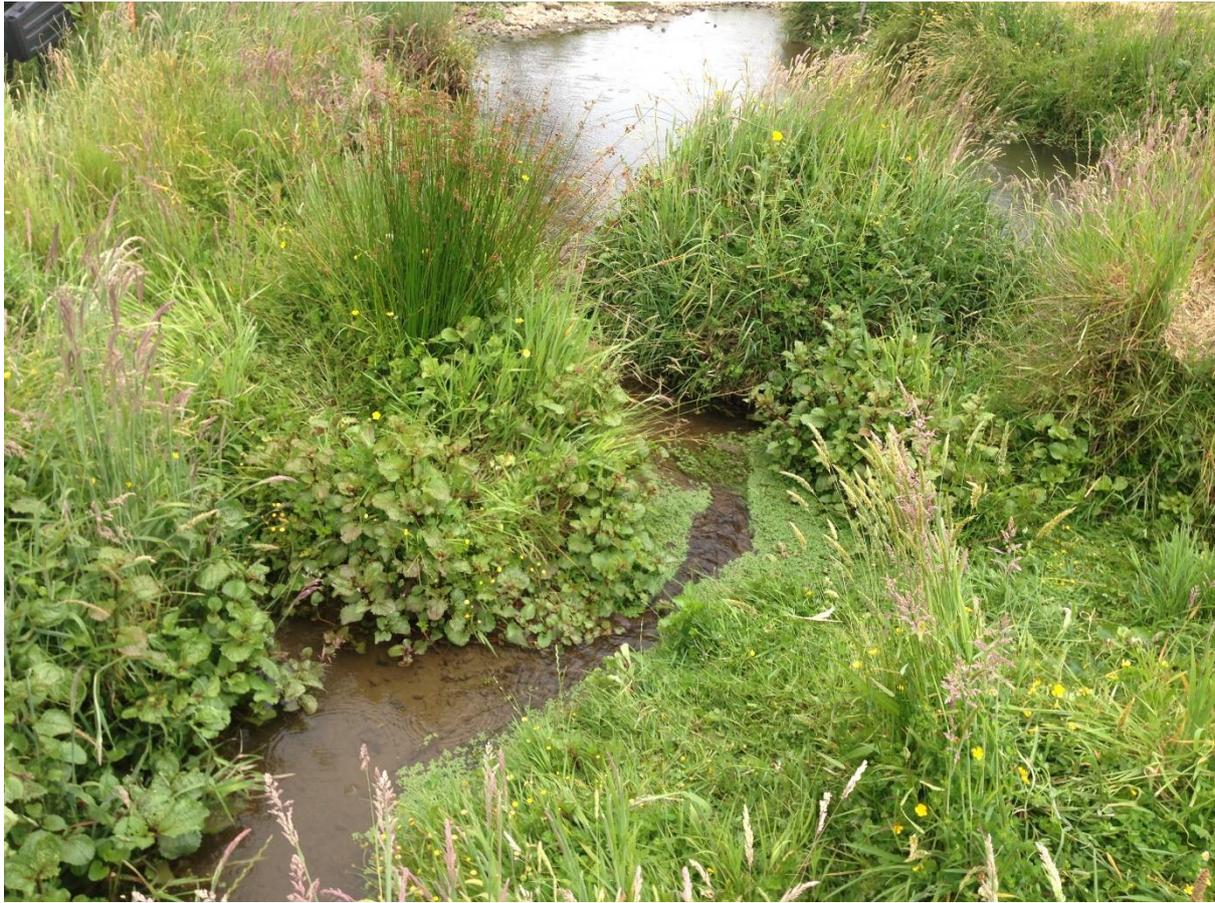
**Figure AI.8:** Site 3 (lower portion of photo), looking downstream showing its connection to the main stem of the Wainui Stream (taken 13/12/19).

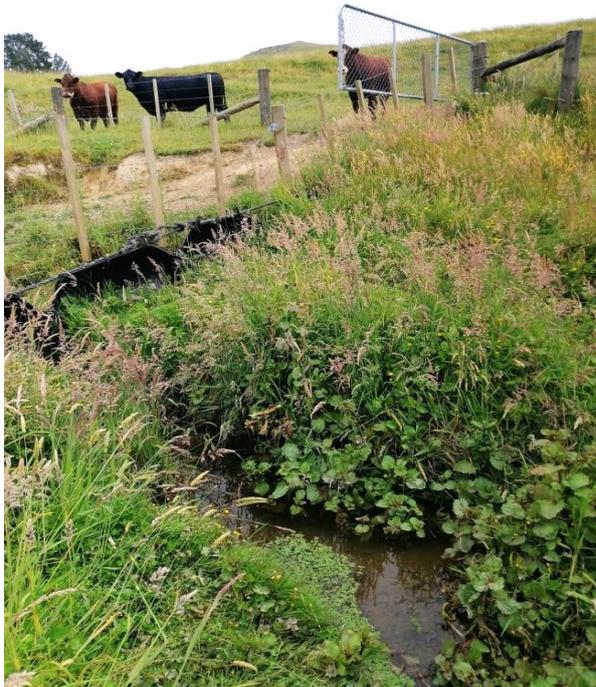
**Figure AI.9:** Site 3 looking upstream (taken 23/12/19).

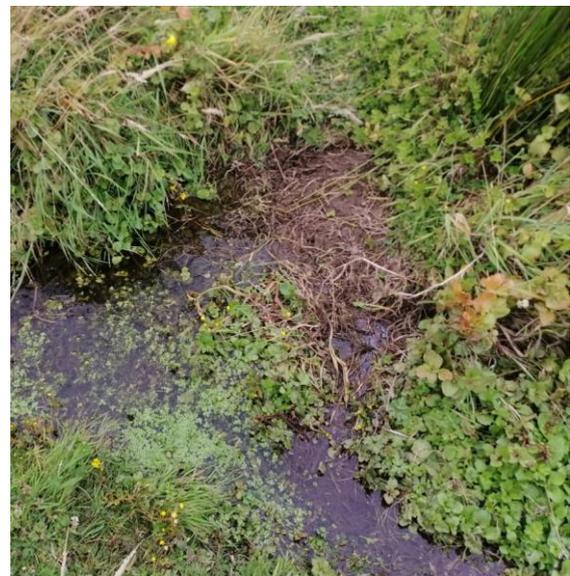
grew to almost cover the whole sample site (see Figure AI.10). On 10/02/20 the bank looked like it had been well trodden down, but it was not clear by what type of animal and there was no evidence of cow tread. On 27/02/20, small unidentified faeces were observed in the tributary and on the bank only a few centimetres upstream from where the water samples were taken.

**Figure AI.10:** Site 3, showing growth of aquatic plants (taken 03/02/20).

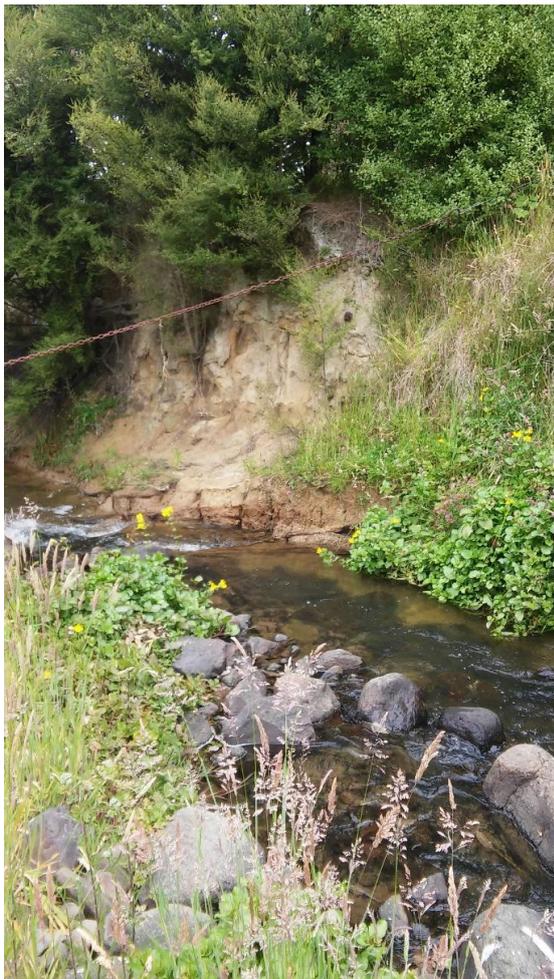
Cattle were frequently seen in the paddock or in an adjacent one, and cowpats and tread were observed on the stream bank on multiple occasions. Pukekos were seen in the area, and on one occasion the smell of dead animal was noted. People were seen around the houses and on the road adjacent, though this lessened in February. On one occasion a resident was observed upstream washing their boat on the roadside closest to the stream. The stream banks were covered with grasses, and the stream bed was rocky with a brown or green algae usually covering much of the stony bed. This was generally the fastest flowing site, with flow velocities of 0.3-0.5 m/s. The water level of the stream at this location was visibly lower towards the end of our sampling program.

**Figure AI.11:** Site 4, looking downstream (taken 30/12/19).
