# **Wainui Stream water quality analysis and survey of onsite wastewater management systems**

**Wainui, 2019-2020**

*WCFM Report 2020-002*

PREPARED FOR: **Environment Canterbury and Christchurch City Council**

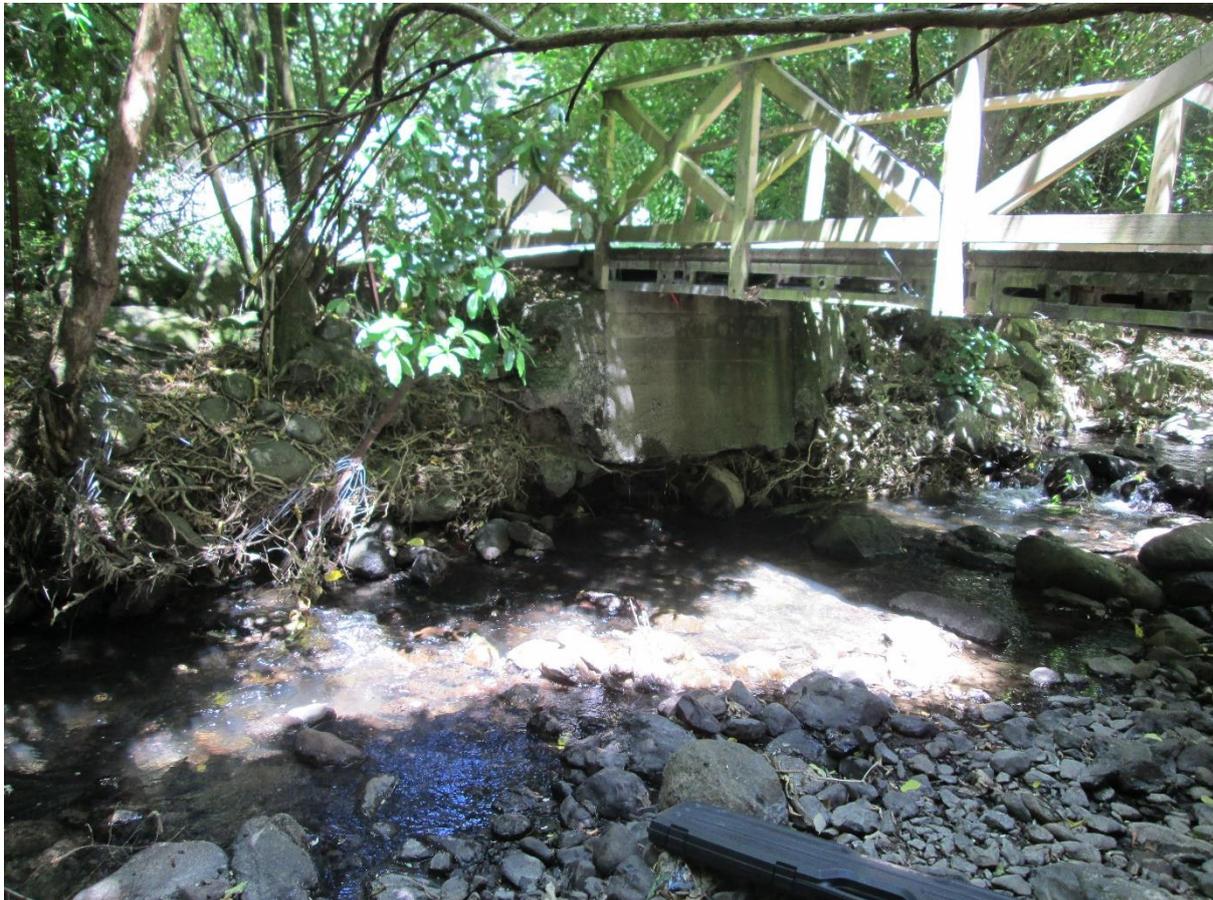
Site 5 was on the main stem of the Wainui Stream, upstream of the confluence with the tributary sampled at site 6. This was located next to the YMCA camp, and immediately downstream from a footbridge, as seen in Figure AI.13 and **Figure 9**. A small valve from a pipe running underneath the bridge was usually dripping, and the camp manager confirmed that this was a fresh water pipe. During most sampling trips after the new year, the camp had groups of children staying, and the bridge was used as pedestrian access for other non-residential parts of the camp. Birds were the only wildlife noted at this site, but they were heard and not seen. The site was mostly under canopy cover, and there was some green algae present and leaf litter in the stream. The stream bed was rocky, with some deposited fine sediment present. The flow velocity was usually 0.1-0.2 m/s, but peaked at 0.4 m/s on 10/02/20. The water level of the stream at this location was visibly lower towards the end of our sampling program.

*Figure AI.13: Site 5, looking upstream (taken 06/01/20).*

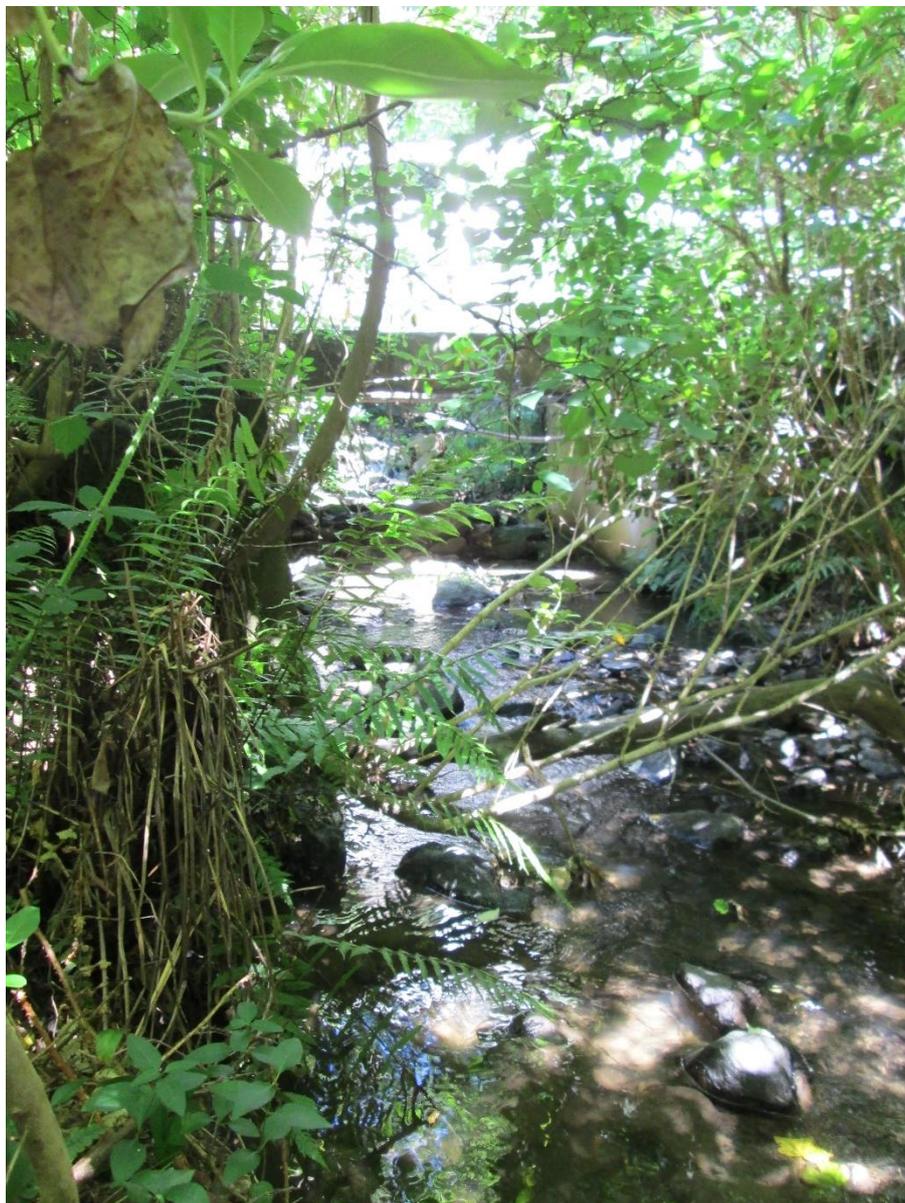
Site 6 was located on a tributary of the Wainui Stream, immediately downstream from a road bridge, which had the occasional car driving over it (see Figure AI.13 and **Figure 9**). The confluence of this tributary and the Wainui Stream main stem was downstream of Site 5. This was below the camp unlike what is indicated by the river course in **Figure 5**. The flow velocity at this site was generally higher than at site 5, usually varying between 0.2-0.5 m/s. The site was under canopy cover and birds (fantails and kereru in particular) were observed in the area. The stream bed was rocky with some fine sediment or brown algae, and leaf litter.

*Figure AI.13: Site 6, looking upstream (taken 06/01/20).*

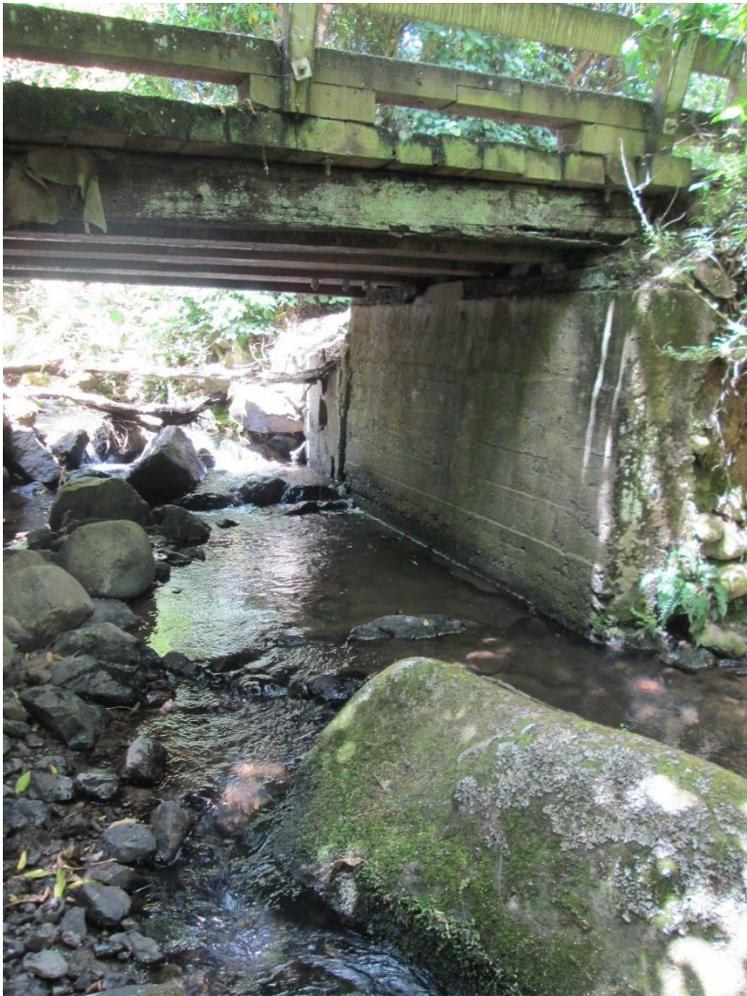
Site 8 was on the main stem of the Wainui Stream near the start of Donovans Road, and was the most upstream site sampled (see **Figure 5** and **Figure 10**). It was immediately downstream of a road bridge (see **Figure AI.15**) on Donovans Road, which was used infrequently by cars. There was a farm downstream on the other side of the road. Birdsong was heard on most sampling trips, and the site was under canopy cover. The stream bed was rocky with some brown sediment/algae, moss and green algae was also observed on the rocks. The flow velocity varied between 0.1 and 0.3 m/s. On most sampling occasions, a beige foam was observed downstream of the sampling point (see **Figure AI.16**). This had gone completely by the last trip on 10/02/20. It is likely the foam was of natural origin, forming due to the decay of natural organic matter from the surrounding forest and aeration.

**Figure AI.15:** Site 8, looking upstream (taken 06/01/20).

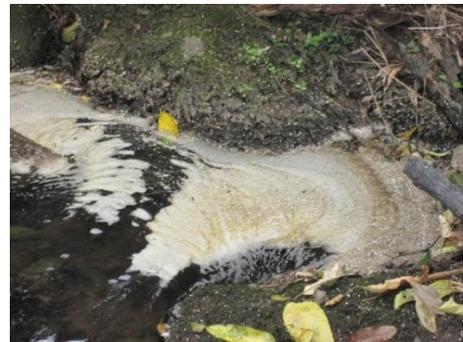
**Figure AI.16:** Beige foam observed downstream of site 8 (taken 06/01/20).
