Replacement of Akaroa Wharf: assessment of effects on benthic ecology

Cawthron Report 3921

Prepared for Christchurch City Council

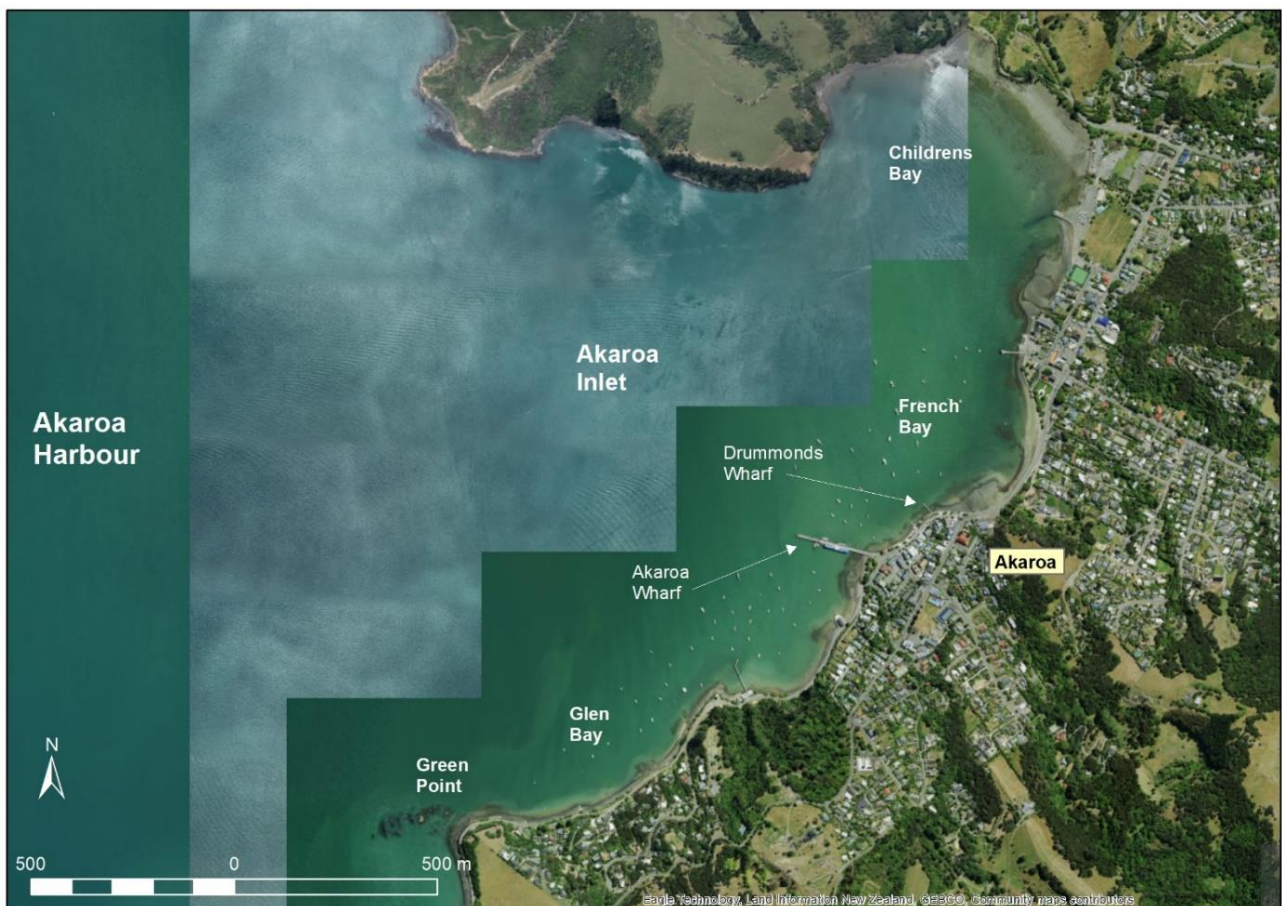
Figure 1. Composite aerial view of the Akaroa township showing locations for Akaroa and Drummonds wharves within the central harbour region. Basemap: NZ Imagery (Eagle Technology, Land Information New Zealand, GEBCO, Community maps contributors).

Akaroa Wharf, located in French Bay on the eastern side of Akaroa Harbour (Figure 1), was built in 1887 and is now at the end of its design life and no longer economic to maintain. Christchurch City Council (CCC) intends to remove the existing structure and rebuild it at its present location, with some modifications to improve its function and allow for future sea-level rise and storm surges.

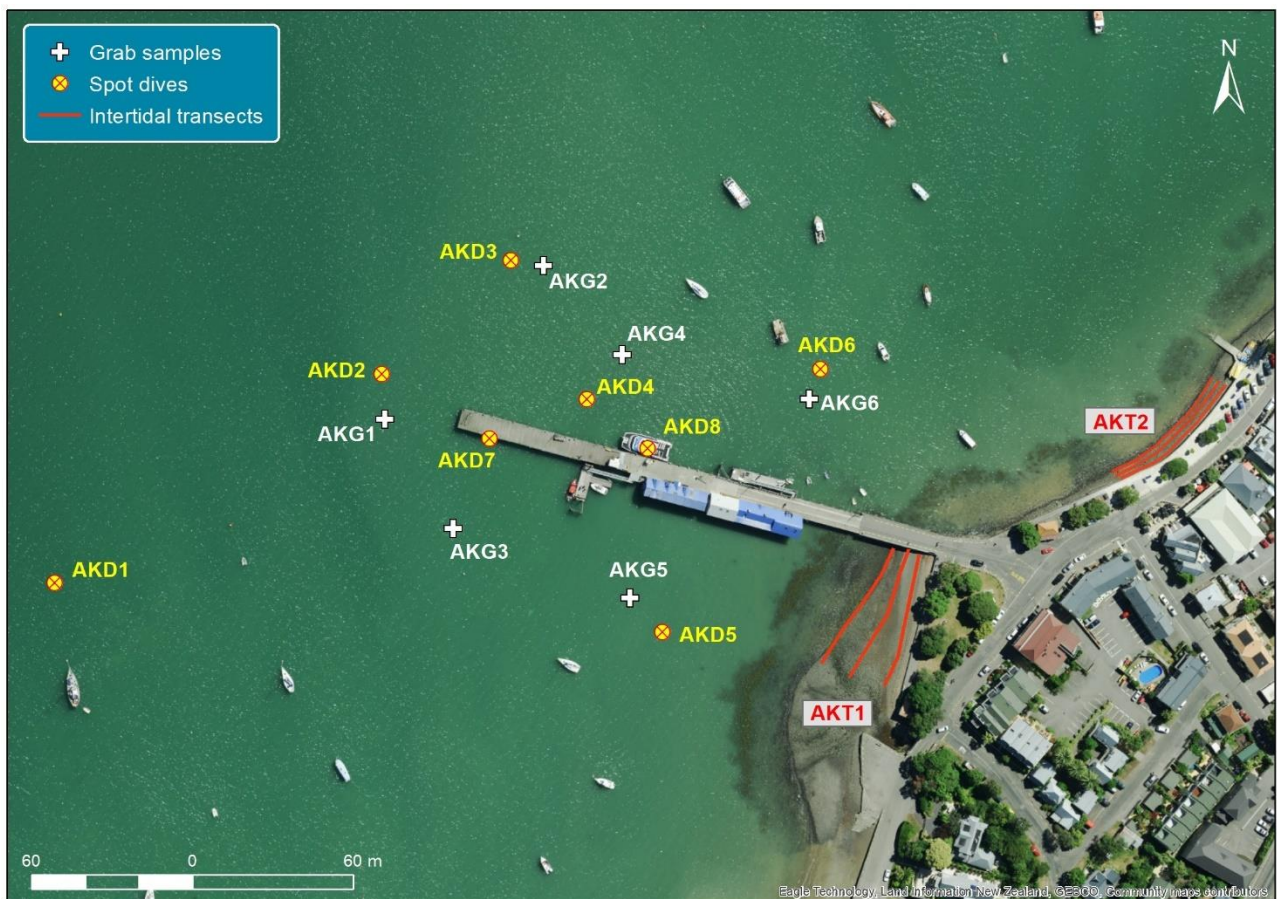
Figure 4. Vicinity of Akaroa Wharf showing locations of benthic grab samples, spot dives and intertidal transect surveys undertaken on 20–23 March 2023. Basemap: NZ Imagery (Eagle Technology, Land Information New Zealand, GEBCO, Community maps contributors).

Subtidal sediments were collected using a frame-mounted 0.1 m² stainless-steel van Veen grab at six stations within the vicinity of the wharf (Figure 4). The stations were pre-established from sonar mapping as being clear of hard substrates nearer to shore. This sampling method collects a relatively undisturbed section of surficial sediment down to a depth of 10–12 cm in the profile. Upon retrieval, the grab contents were sub-sampled using standardised corers to provide material for sediment and infauna analyses.

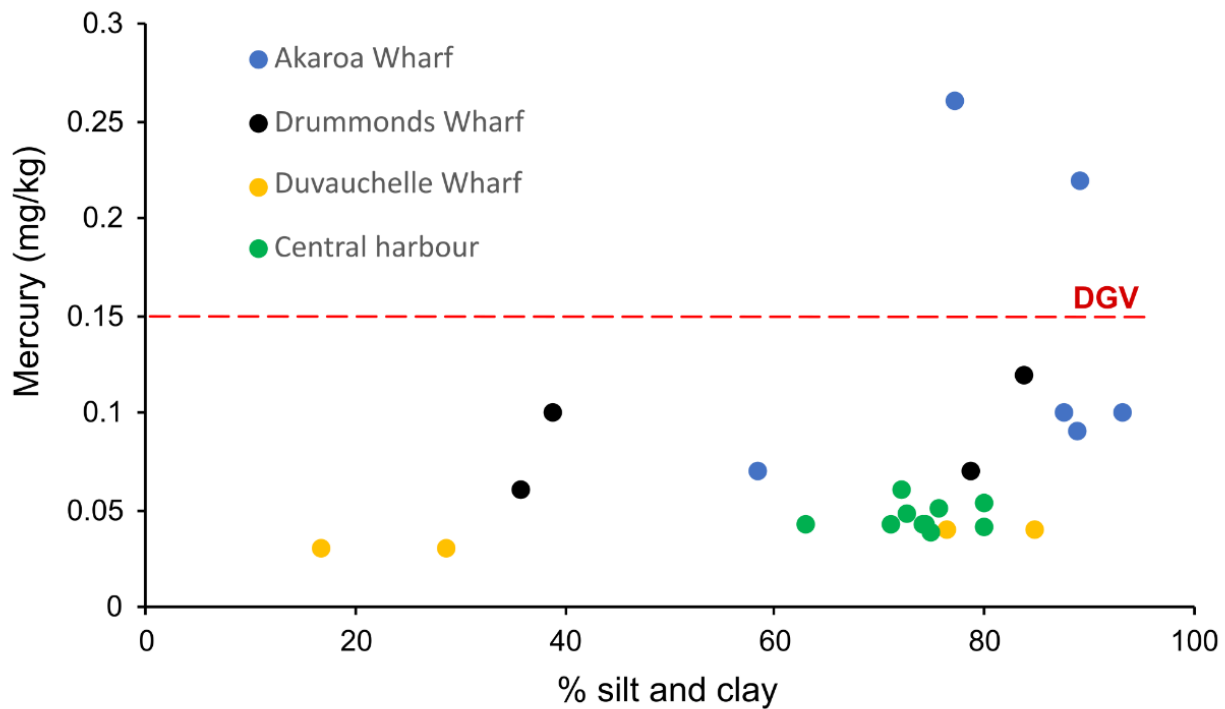
Figure 6. Concentrations of mercury against the percentage of silt and clay in sediments from around three wharves in Akaroa Harbour (2023 survey, including present study) and in the central harbour channel (data from Sneddon and Clement 2014). The default guideline value (DGV) for mercury is overlaid.

It is notable that concentrations of mercury in Duvauchelle Bay (Sneddon and Morrissey 2023b) and the 2014 central harbour transect were lower (and all below the DGV criterion) than around Akaroa Wharf. This would appear to rule out a catchment source (such as volcanic soils) for the relatively elevated concentrations around the wharf in general and at the two sites north of the wharf in particular. Plotting the concentration of mercury against the proportion of mud (silt plus clay) in the sediment produced a wide scatter of points (Figure 6). Apart from the two samples exceeding DGV both occurring at the muddier end of the range, there was no clear relationship between concentration and sediment texture. The amount of variation among the samples is unusual – if concentrations simply represented natural background concentrations, they would likely be more homogeneous. Nonetheless, excluding stations AKG4 and AKG6, concentrations of mercury around Akaroa Wharf were similar to background concentrations in Lyttelton Harbour / Whakaraupō (0.04–0.08 mg/kg; Cawthron Institute, unpublished data).

As far as we are aware, Akaroa township has never supported any industrial activity that might result in mercury contamination. The relative proximity to the wharf of the two stations with the highest mercury concentrations might suggest a source in antifouling paints, which before the 1960s sometimes contained mercury. Hull cleaning on a tidal grid or similar facility near the wharf might have released

mercury in paint flakes. Cargo spillages are another possible source. Rock phosphate, for example, contains trace amounts of mercury.¹³ The fact that concentrations around Akaroa Wharf were higher than in most of the Duvauchelle Bay and mid-channel samples is consistent with a now diffuse historical source such as spillage of break-bulk cargo.

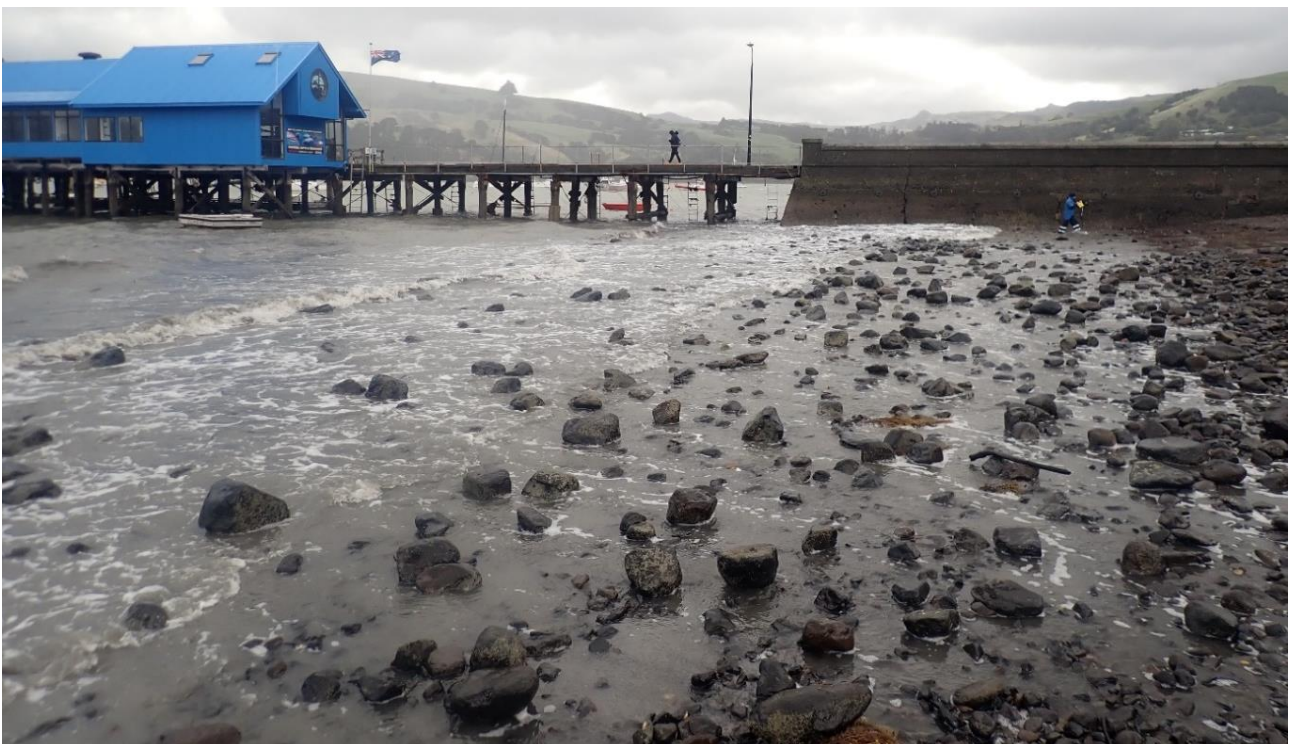
Figure 10. Boulder / cobble beach at Transect AKT1. Photographed at low tide on 22 March 2023 looking northeast towards Akaroa Wharf.

Transect AKT1 was located on the south side of Akaroa Wharf, running from the seawall at its base to the mouth of Aylmers Stream, which discharges across the beach (Figures 4 and 10).

No conspicuous organisms were observed in the high-tide zone. Being mostly open sand, the mid-zone supported a sparse community associated with sporadic embedded boulders. The only such biota observed were the grazing gastropod *Diloma aethiops* and barnacles (*Chamaesipho columna*).

The algal community along the transect was sparse. Neptune's necklace weed (*Hormosira banksii*) was present but only as isolated individual plants. Small patches of crustose coralline algae occurred on some cobbles (often associated with residual macroalgal holdfasts, which suggested displacement from subtidal areas). Sporadic small patches of black and brown encrusting algae were also observed. As with algae, low-tide fauna were sparse and mostly limited to the larger embedded boulders. However, *D. aethiops* was common where such stable substrates occurred, as were *S. cariniferus* and barnacles (*C. columna* and *Austrominius modestus*). Several limpets were also present (*C. ornata*, *Patelloida corticata*, *Notoacmea* sp.), along with very occasional blue mussels (*Mytilus galloprovincialis*).

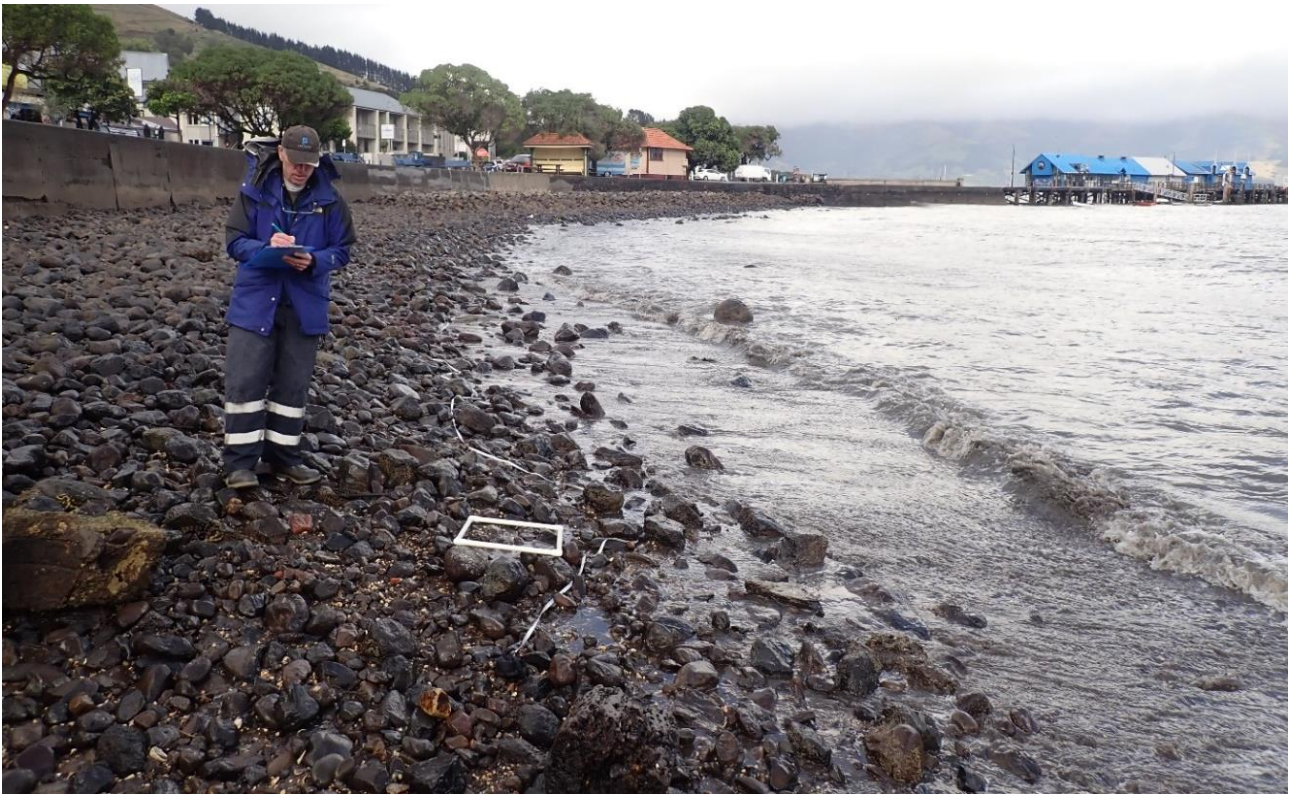
Figure 11. Boulder / cobble beach at Transect AKT2. Photographed at low tide on 22 March 2023 looking southwest towards Akaroa Wharf.

Transect AKT2 was on the north side of Akaroa Wharf, starting 50 m from the wharf base and running to a point approximately 50 m from Drummonds Wharf (Figures 4 and 11).

The high zone was adjacent to the seawall and consisted of boulders and cobbles with interstitial gravel material. There were two stormwater discharge pipes positioned to discharge directly onto the upper beach. The mid-zone featured a similar mixed substrate but with fewer large boulders. In the low zone, medium to coarse sands were more prevalent among cobble material. The surveys were undertaken during a significant southerly wind event in Akaroa, and open sand patches that had been observed on the low shore the day before the survey had been washed out by waves overnight.

Conspicuous high-zone fauna were completely absent from exposed substrate surfaces and were observed only under boulders, where the top shell *Diloma aethiops*, the whelk *Haustrum scobina* and small limpets (*Notoacmea parviconoidea*) could be found, along with shore crabs (*Cyclograpsus lavauxi*) and half crabs (*Petrolisthes elongatus*).

In the mid-zone, there was a sparse presence of calcareous tube worms (*Spirobranchus cariniferus*) and barnacles (*Chamaesipho columna*), along with sporadic *D. aethiops*, *H. scobina* and limpets (*Cellana ornata*). Beneath boulders, *P. elongatus* were quite prevalent and the chiton *Chiton glaucus* was also observed.
