Proposed Naval Point Development

Geotechnical Desktop Study

Prepared for Christchurch City Council Prepared by Tonkin & Taylor Ltd Date July 2020 Job Number 1014599.v1

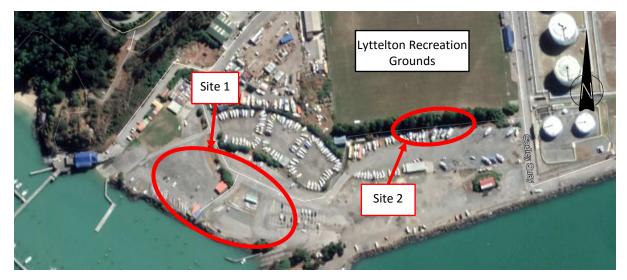
Figure 1: Approximate locations of the two sites considered in this report (map data: Google).

- A one or two-storey building for the Naval Point Marine Rescue Trust (NPMRT), refer Site 1 on Figure 1 below.
- A small one-storey pavilion/sports changing room building, locate are the southern end of the Lyttelton Recreation Grounds, refer Site 2 on Figure 1 below.

If liquefaction susceptible soils are identified at the proposed sites then the effects of lateral spreading may extend landward by approximately 100 m from the free edge (i.e. the rock revetment/breakwater). Therefore, if lateral spreading were to occur it would unlikely affect the proposed Sports pavilion, but would affect the proposed NPMRT building (based on our current understanding of the proposed locations in Figure 1).

We understand the proposed sports pavilion will be a relatively small single-storey structure located at the south side of the Lyttelton Recreation Grounds (refer Figure 1 - Site 2). Based on currently available information we expect shallow foundations constructed on a geogrid-reinforced gravel raft would likely be a suitable option to consider for this structure. The gravel raft would typically extend 1.5 - 2 m below the underside of the foundations, and extend 1.5 - 2 m beyond the building

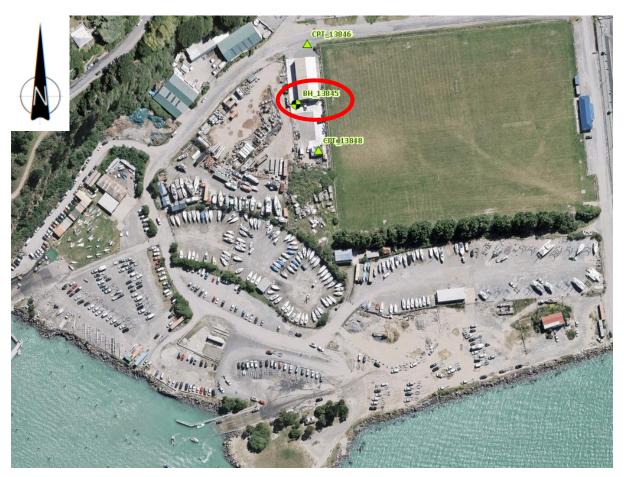
Deep geotechnical investigations located near the proposed development sites (BH_13845 circled in red is attached).

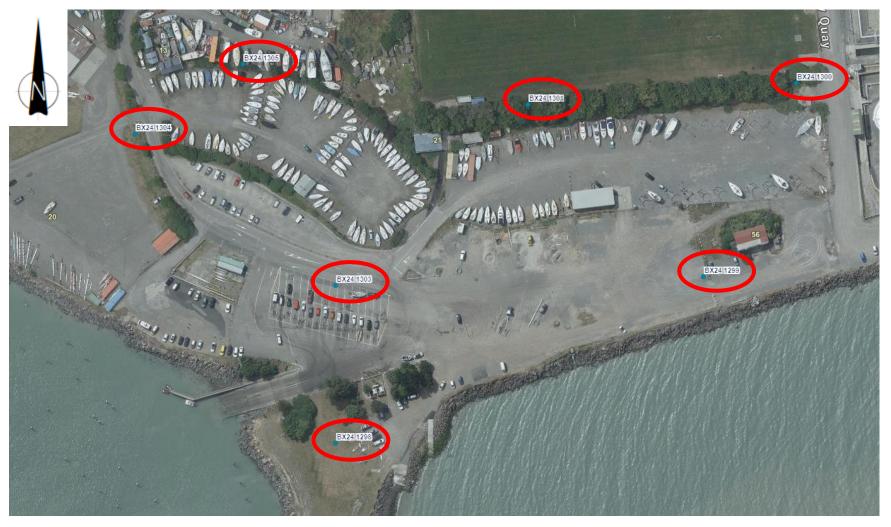
Well locations near the proposed development sites (wells are circled in red and attached). Image source: Canterbury Map
