# *Tonkin & Taylor Christchurch Central City Geological Interpretative Report*

Christchurch Central City  
Geological Interpretative Report

December 2011 (Version 1.1)

T&T Ref: REP-CCC-INT

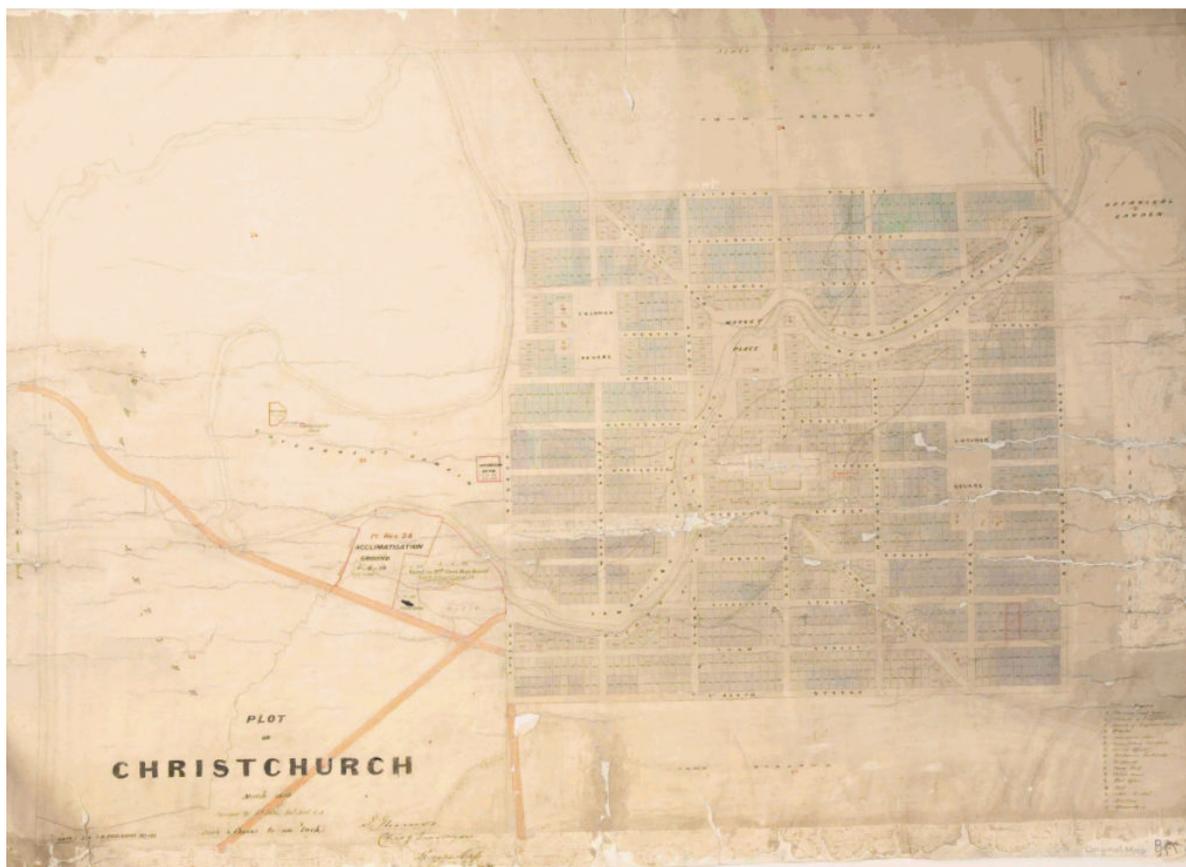
**Figure 3.1: Extract of Black Map dating from March 1850 (Sheet 2).**

An extract of the March 1850 map (Sheet 2) covering the CBD area is shown in Figure 3.1.

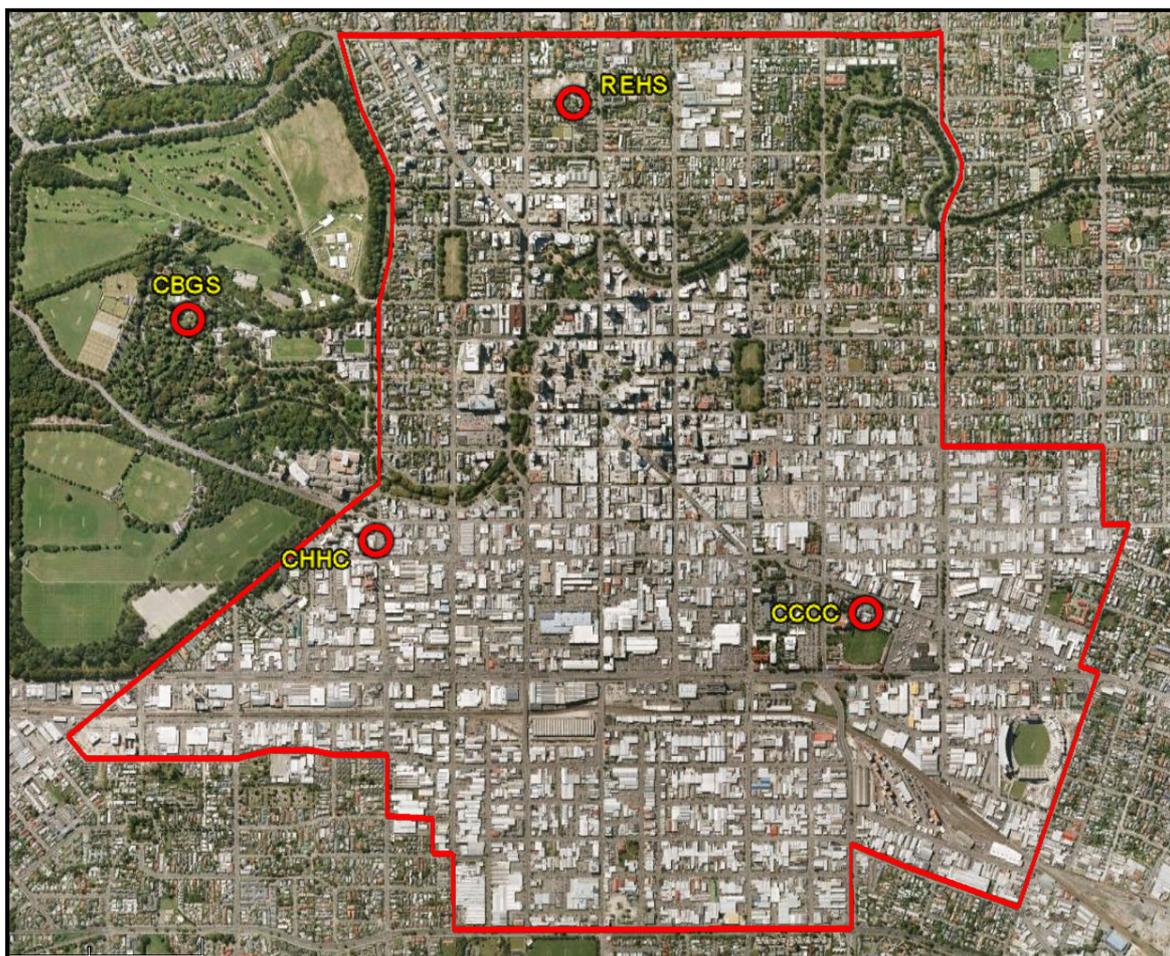
**Figure 6.2: Strong motion sites located in Christchurch CBD**

strong motion accelerometers in Christchurch. This includes four sites within the central city, as shown in Figure 6.2.
