Subdivision of
254-256 Fitzgerald Avenue
Richmond
Christchurch

Geotechnical Assessment Report

REFERENCE NUMBER: 5595

DATE: February 2021

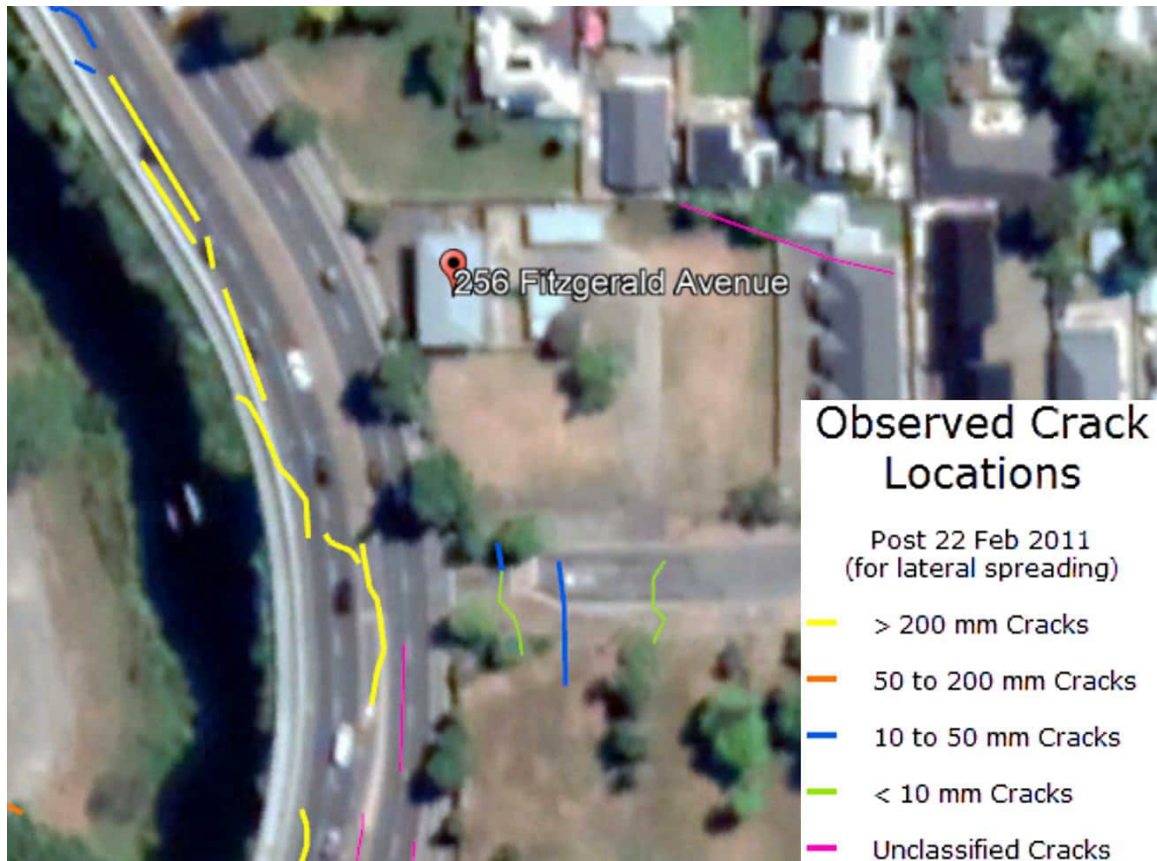
Figure 4-1 Ground cracks as recorded for EQC (from NZGD)

Ground cracks as recorded by consultants for EQC (EQC, 2012) are shown running along the river side of Fitzgerald Ave and out to the median strip opposite Harvey Terrace (Figure 4-1). Some relatively minor cracks (green are under 10 mm and blue are under 50 mm) are seen along Harvey Terrace adjacent to the site.

Only one crack is recorded on the site itself, an 'unclassified crack crossing the north-east edge of the site. Unclassified cracks are generally minor in nature and the orientation of this crack is not consistent with lateral spread.

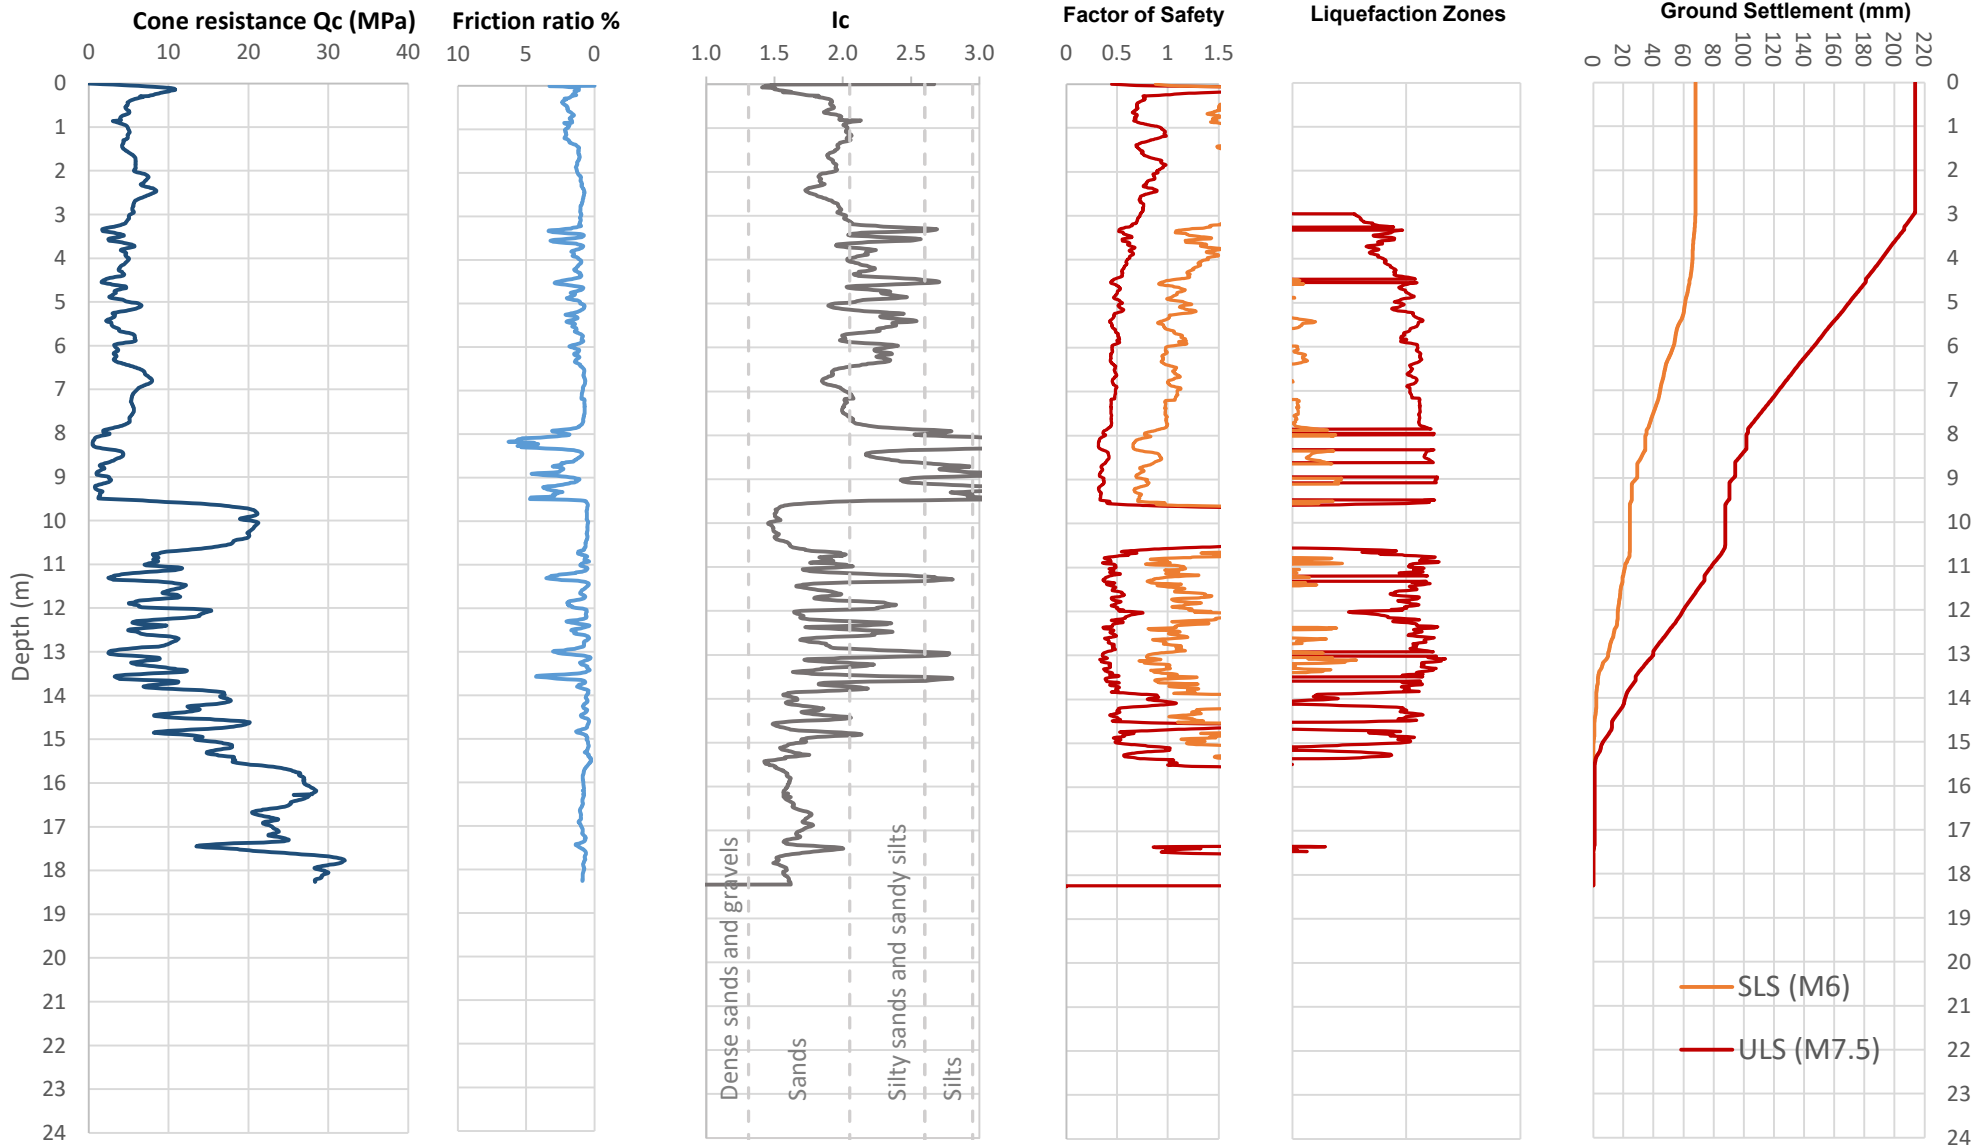
Liquefaction Potential Analysis CPT_564

ref: Boulanger & Idriss 2014, Zhang 2002
