Medium Density Housing Research

Additional Case Studies

Christchurch City Council

Technical Report

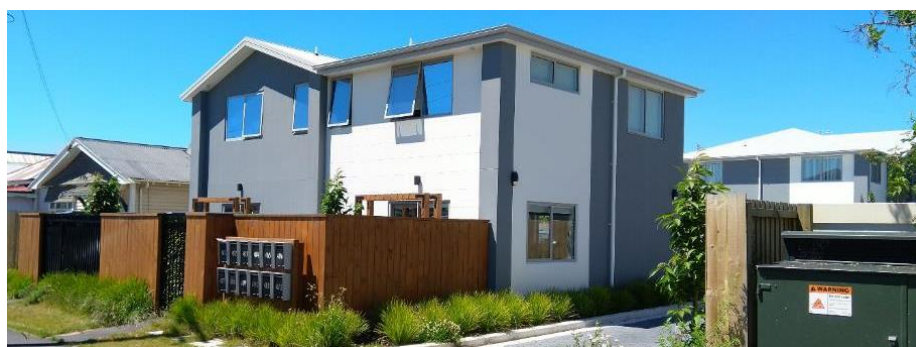
One trend that was evident was that there was confusion over fronts and backs of houses, with internally facing front doors and private space at the street. Sometimes screening had been used to block views through transparent fencing, indicating a poor balance between privacy and street engagement.

Figure 1: Front Outdoor living space has been screened in this example

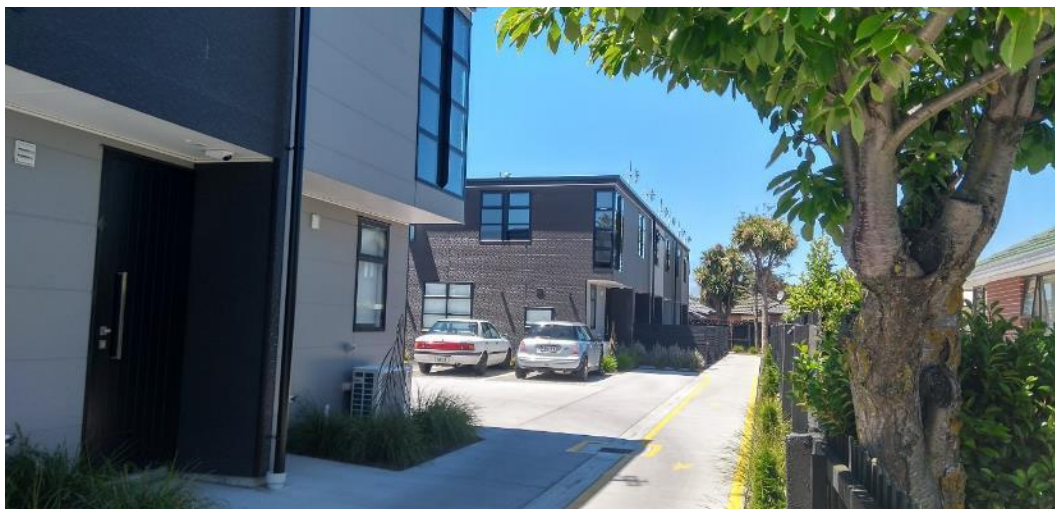
Category C3 is concerned with privacy and the impact on neighbours. For many sites, there was more than one building, usually due to centralised car parking. This avoided the common issues of a long building sideways to the street, dominating views and outlook. Prominent overlooking was also avoided and the scale of building was also not considered overbearing.

Figure 2: A common typology is two buildings with central car parking

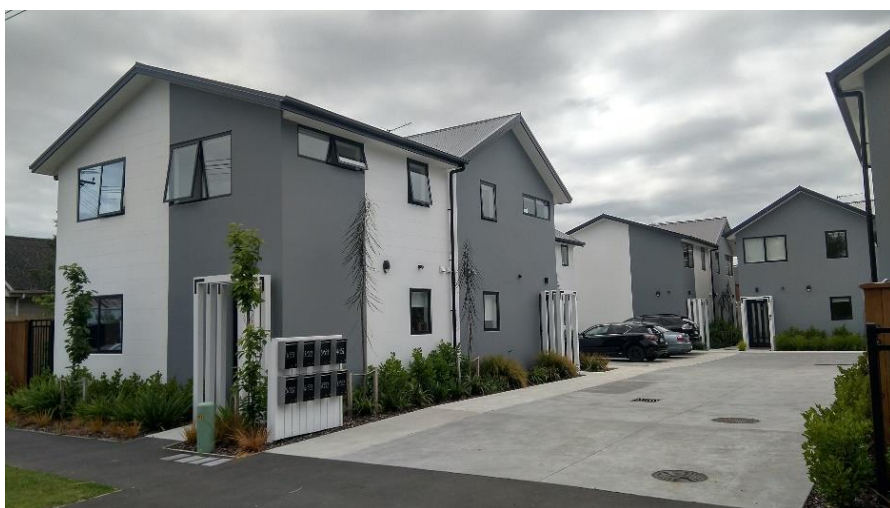
In part, the good scores were driven by the form of developments as previously discussed under “Site” (generally not in a single run and so the roofline and building line were broken into two or more buildings). One good example with a long terrace broke it into two blocks at first floor by stepping a unit down (ie inserting a single storey studio unit into the centre of the row). Sometimes the buildings were quite blocky, but the larger (longer) building was usually at the rear.

Figure 3: This development consisted of several smaller buildings (duplexes)

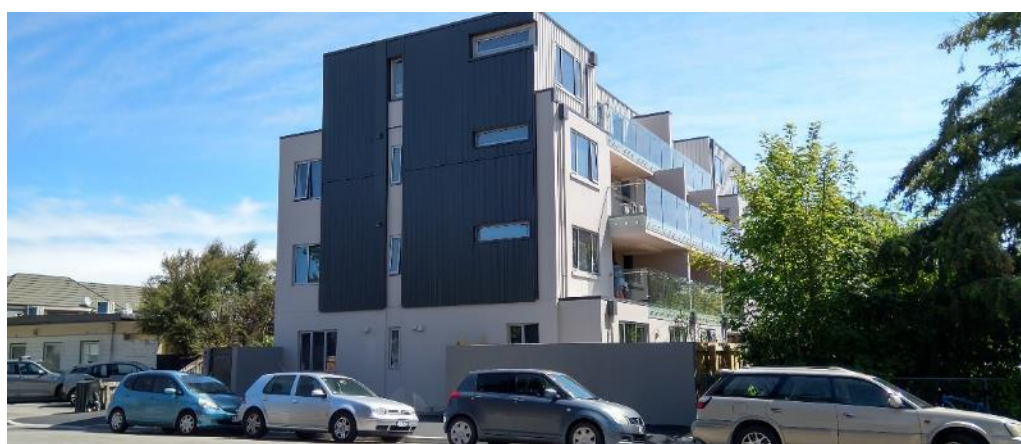
The first of these is due to overlooking and loss of outlook, from large buildings built along the boundaries, usually perpendicular to the street. This is an issue with the shape of sites and the predominant “sausage block” development, the impacts of which increase with height – for example several rows of balconies overlooking neighbours. These contrast with the lower scale RMD zone that recorded good outcomes in relation to this matter.

Four storey development built lengthways on a narrow section creates issues of overlooking and enclosure for neighbours

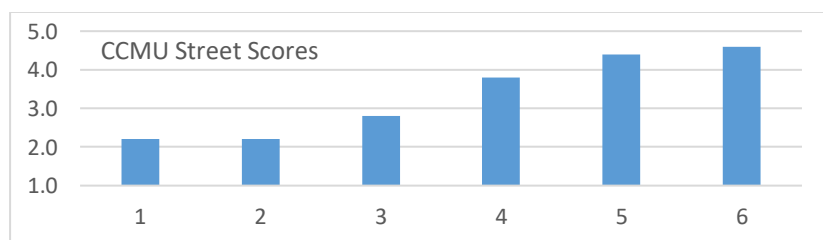
CCMU sites had a combined score of 3.3 for category B3, which is comfortably meeting the “basic” threshold. However, there was considerable variability, including 2 developments that rated inadequate. These low-performing sites did enclose the street, but were rated at most inadequate for all other measures. Issues with poor street interface were evident, along with some poor detailed resolution. The units had quite a commercial appearance in one case, although the area was clearly predominantly residential and becoming more so. The zoning does not reflect the transition to residential which is apparent in this particular area.

Figure 2: There is a variable range of street outcomes in the CCMU zone

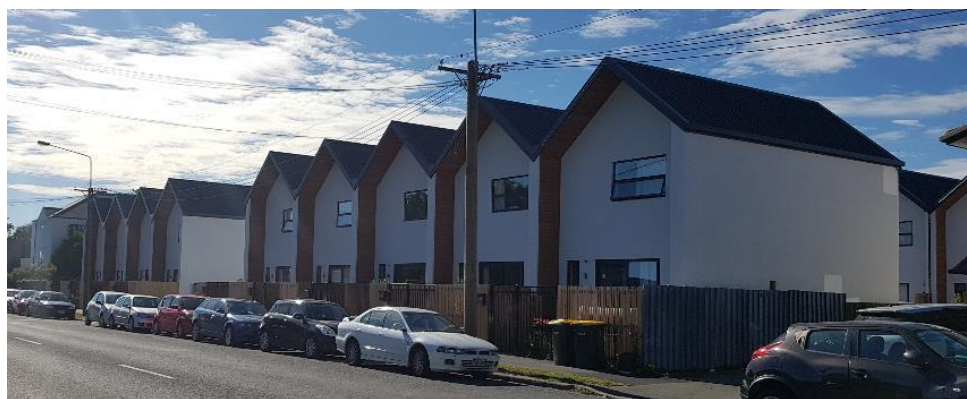
Above: Two storey housing encloses the street, but with outdoor living space at the street front which has created a lack of privacy and led to screening

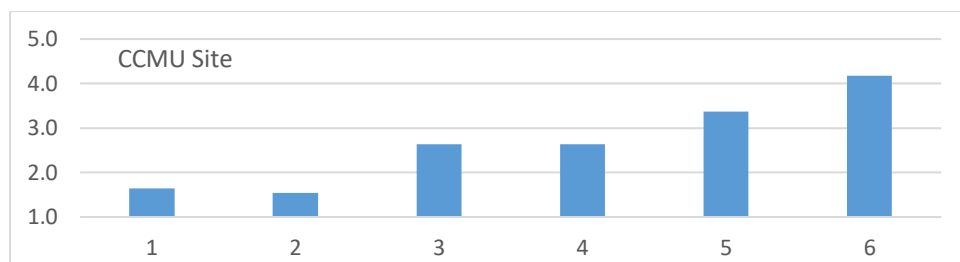
Figure 3: Range of site outcomes in the CCMU zone

- a lack of surveillance within the sites, communal spaces that lacked ownership and purpose
- a lack of privacy that is likely to discourage surveillance (curtains were often closed). In two cases, ranchsliders overlooked car parks, in one with no separation from passers-by at all.
- The car-free sites usually had narrow accessways with little space for passing or avoidance.

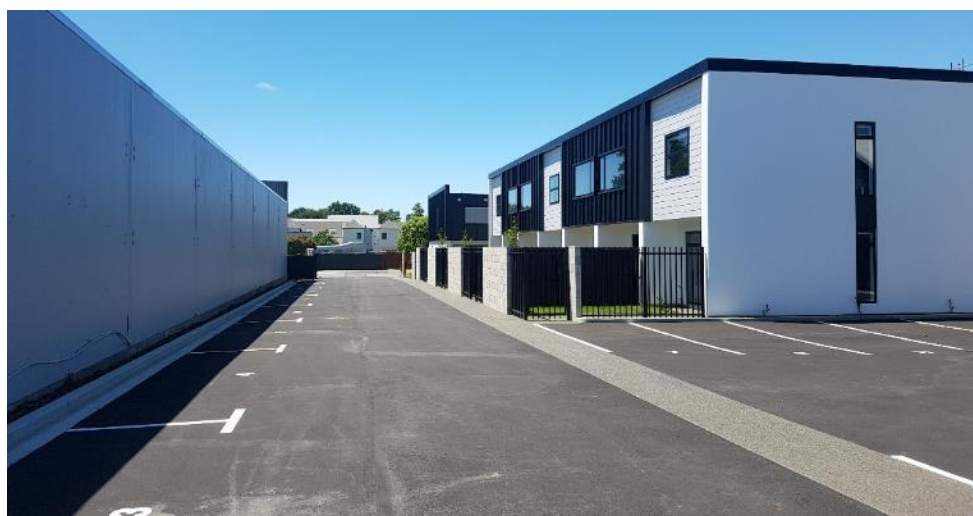
Other low scores were for categories C4 and C7, which relate to the quality of communal areas. Where there was centralised car parking, the car parks were poorly landscaped, vehicle dominated and communal spaces were not useful, due to narrow dimensions and poor location at the margins of the site.

Vehicle dominated accessway

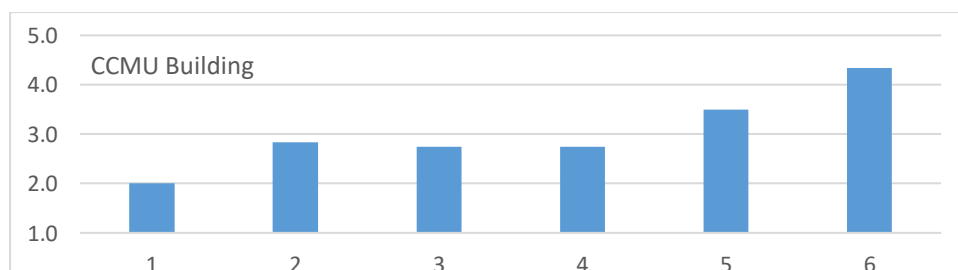
Of the functional criteria, categories D7 and D9 were not usually well met (storage and privacy). Internal storage is not generally well provided. Some units had external storage (sheds) in visually intrusive locations in front of the units. One development provided leasable storage cupboards, which is a higher quality and practical solution.

Poor management of privacy was in part due to the views into apartments from communal and public space without adequate separation or planting. These privacy issues were sometimes reflected in poor scores for category D8, where unusual layouts had been employed (including one example where houses were accessed through the bedrooms), as well as the more common front and back issue where entrances are internalised.

Figure 4: Range of building outcomes in the CCMU zone

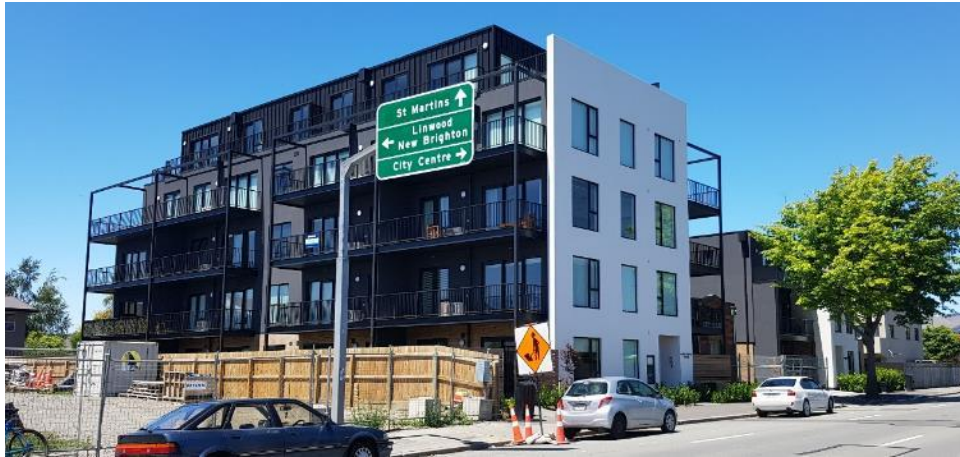
This building demonstrates visual interest and good materiality (but does overlook neighbours)

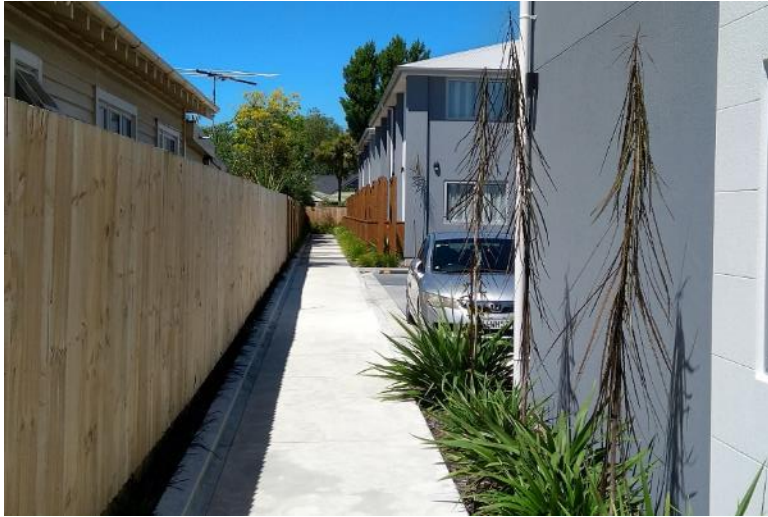
48 Ward Street

A development of 10 two bedroom units and 2 one bedroom units in Addington. The development consists of two units beside the street, a central car park and a rear terrace. It also includes a separate walking access from the street.

Scoring Summary	
Neighbourhood	4.0
Street	2.8
Site	3.5
Building	3.9
Total	3.5

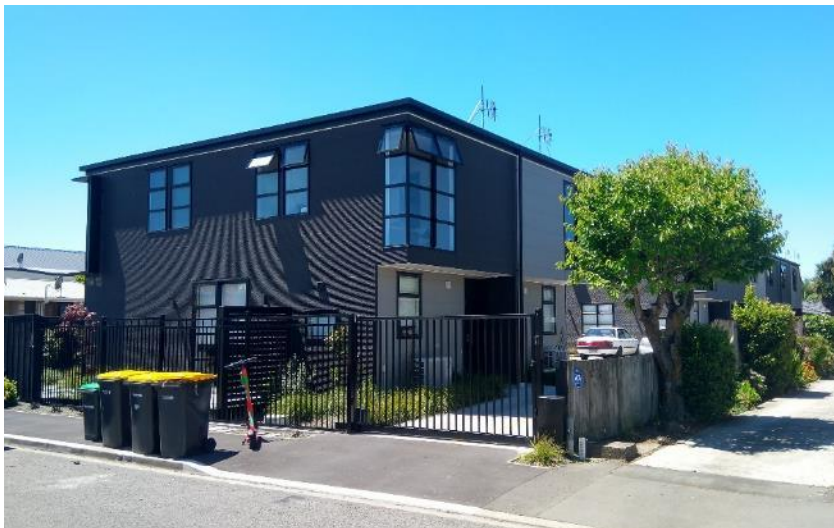
68 Barbour Street

A development of 8 two bedroom units in Charleston. The development consists of two units beside the street, a central car park and a rear terrace. It also includes a separate walking access from the street.

Scoring Summary	
Neighbourhood	3.3
Street	3.0
Site	3.0
Building	2.9
Total	3.1

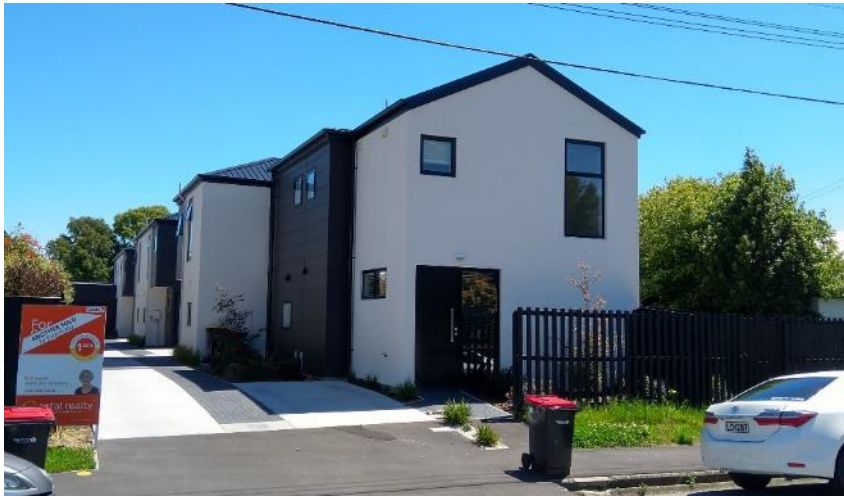
9 Bolton Avenue

A development of 5 two bedroom units and 1 one bedroom units in Spreydon. The development consists of a single terrace of units, some with garages and an additional parking space at the front.

Scoring Summary	
Neighbourhood	3.3
Street	3.2
Site	3.3
Building	3.0
Total	3.2

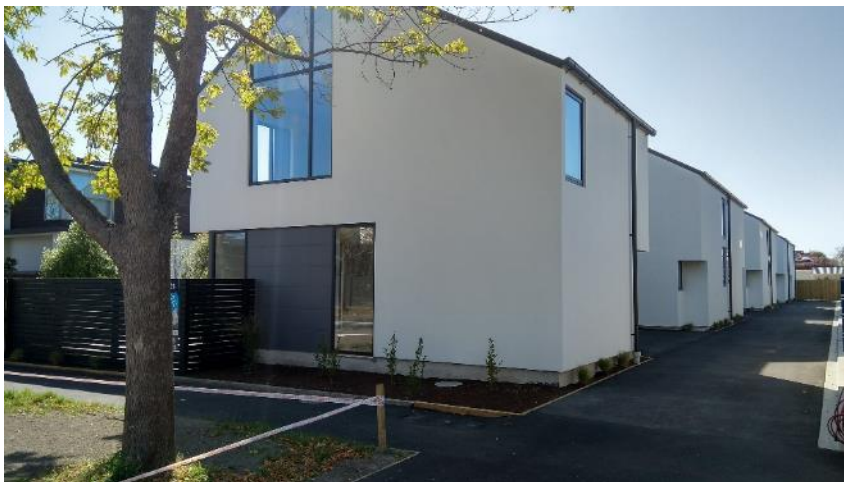
70 Bishop Street

A single building containing seven two bedroom units with garages in Edgeware.

Scoring Summary	
Neighbourhood	3.7
Street	2.6
Site	2.5
Building	2.9
Total	2.9

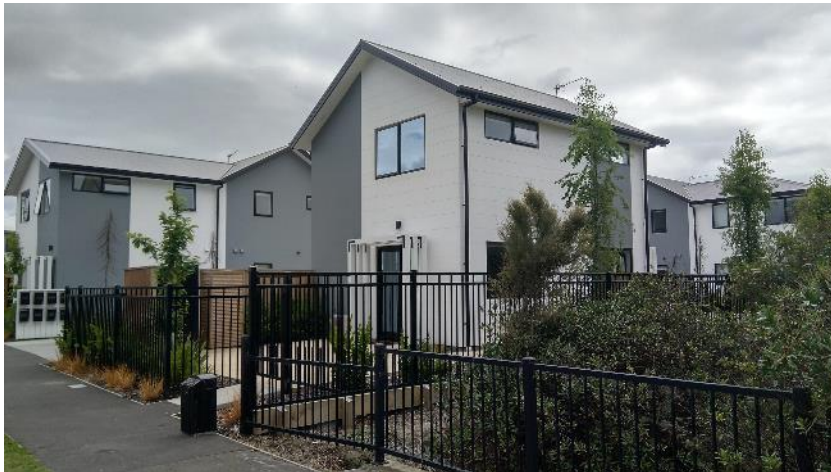
554 Madras Street

Seven units in St Albans, built over two original sites and centred around a landscaped car-park, and adjacent to a stream. The development consists of three duplexes and a single unit. Two of the units are adjacent to the street. One has a front door facing it and another has outdoor living space in the setback.

Scoring Summary	
Neighbourhood	4.7
Street	3.6
Site	3.9
Building	3.8
Total	4.0

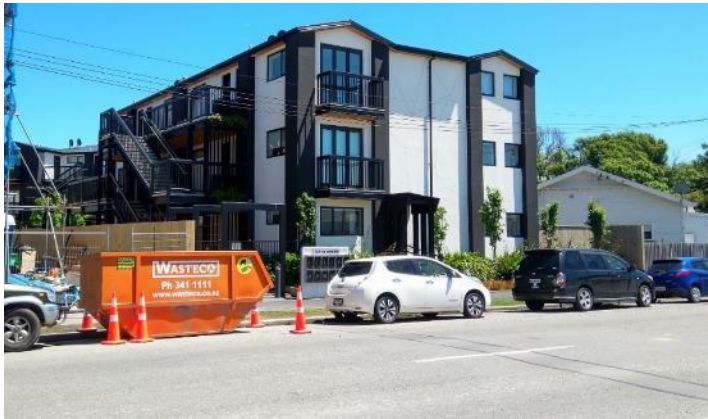
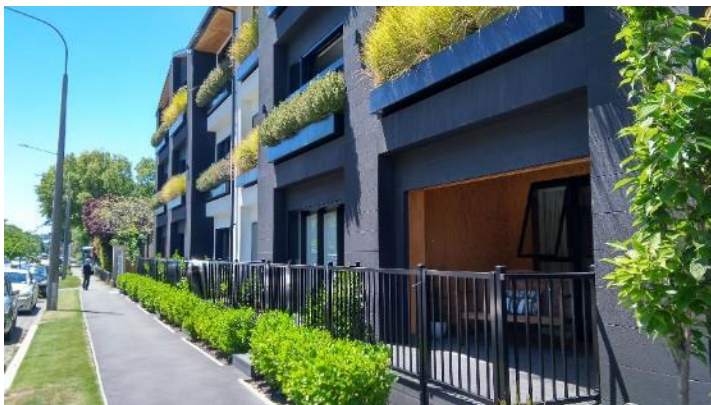
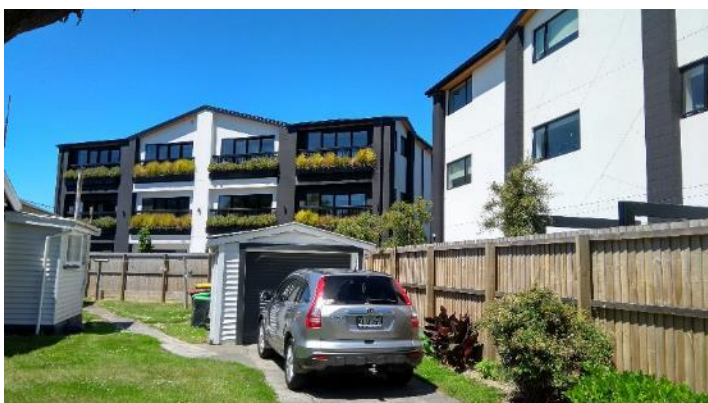
466 Hagley Avenue

30 units in two blocks, one of which overlooks Hagley Park. There is a central shared communal space. Units in the Selwyn Block (not facing the park) do not have an outdoor living space – instead there is a Juliet Balcony and they are larger than the minimum size (for one bed units). Access to upper floor apartments is via a breezeway. The Selwyn Block units do have a large area of glazing facing the site next door.

Scoring Summary	
Neighbourhood	3.7
Street	4.0
Site	3.0
Building	2.8
Total	3.4

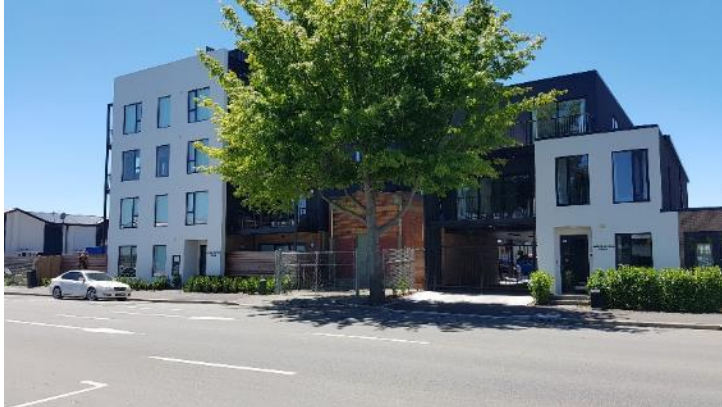
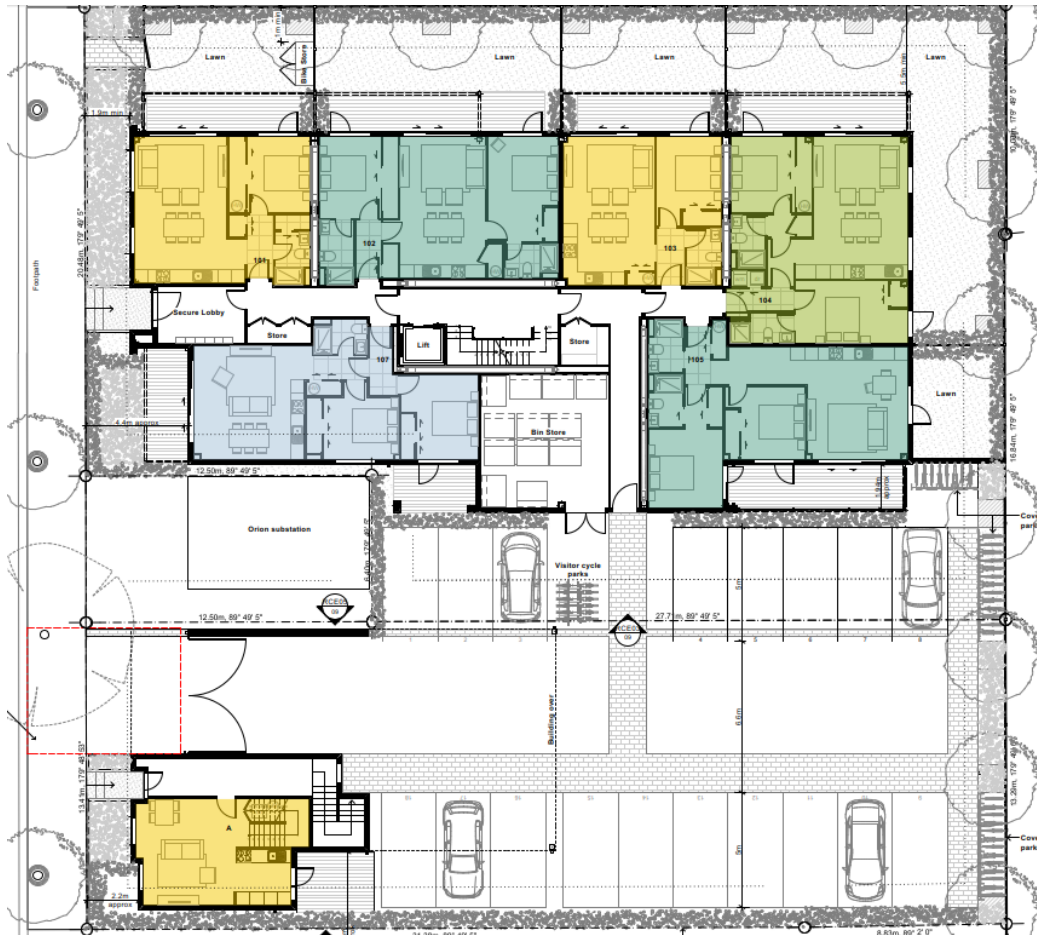
272 Barbadoes Street

A five storey apartment complex in two buildings with 32 units in all. The smaller building sits in front of a car parking area and there is a separate pedestrian entrance into the main building. There is no communal space and upper floor units have balconies of around 12m².

Scoring Summary	
Neighbourhood	4.3
Street	3.8
Site	2.9
Building	3.0
Total	3.4

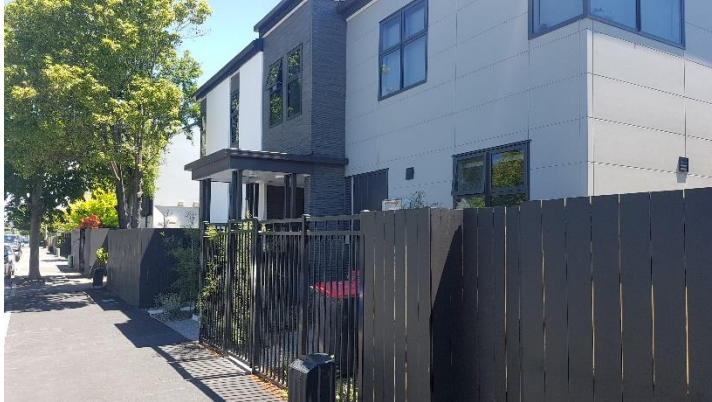
269 Kilmore Street

A complex of one bedroom apartments with a central internal corridor. The complex is car-free and each of the units has around 16m² of private outdoor living space. Units are two storey with a townhouse-style layout, but accessed internally.

Scoring Summary	
Neighbourhood	4.0
Street	2.8
Site	3.4
Building	3.0
Total	3.3

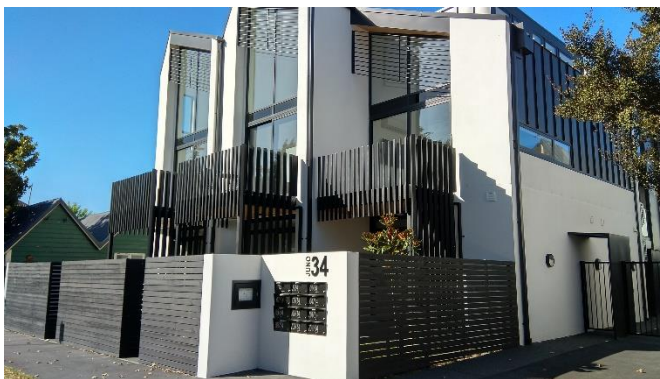
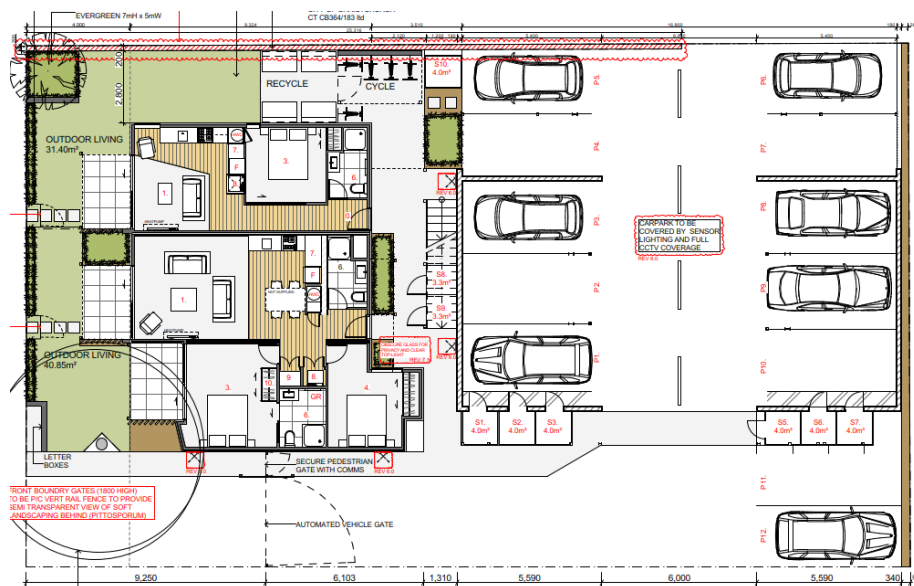
36 Cranmer Square

A four storey apartment complex in the central city facing Cranmer Square. The complex has a smaller front building facing the square, and a larger building facing the internal boundaries. Access to the rear building is from a breezeway and via the driveway. Parking is located behind the front building but underneath the rear one.

Scoring Summary	
Neighbourhood	3.7
Street	2.6
Site	2.1
Building	2.7
Total	2.8

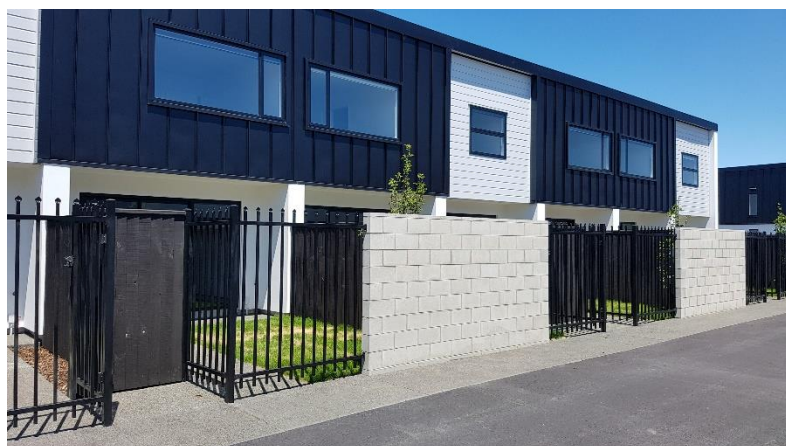
361 Madras Street

A two storey townhouse complex in the CCMU zone at the north of the city. The area is transitioning to residential use but the property to the north was industrial at the time of construction. This has led to an unusual site layout where the access is on the north side of the development and the houses are accessed through the outdoor living space. There is a central carpark and a small communal outdoor space at the rear of the site.

Scoring Summary	
Neighbourhood	3.0
Street	2.2
Site	1.6
Building	2.0
Total	2.2

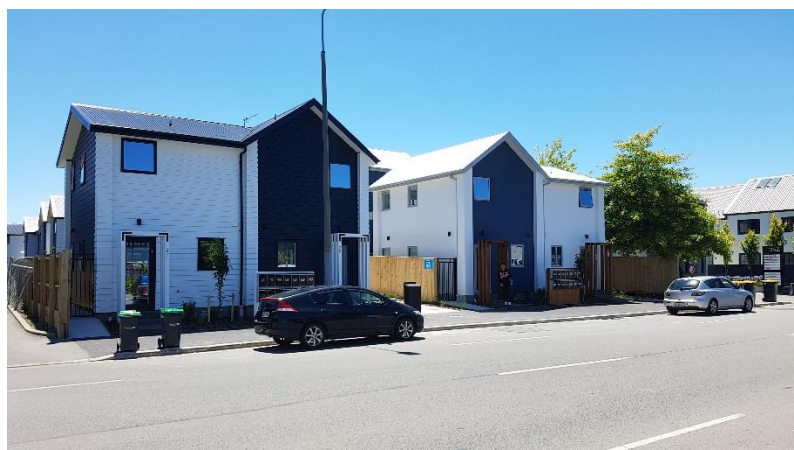
201-205 Salisbury Street

A two and three storey townhouse complex in the CCMU zone at the north of the city, adjacent to an established large format retail site. A large consolidated site was developed with two adjacent rows of houses on separate accessways. Two sets of duplexes front the street, with rows of housing behind, divided into a number of blocks with some varied articulation.

Scoring Summary	
Neighbourhood	4.0
Street	4.0
Site	3.4
Building	3.5
Total	3.7

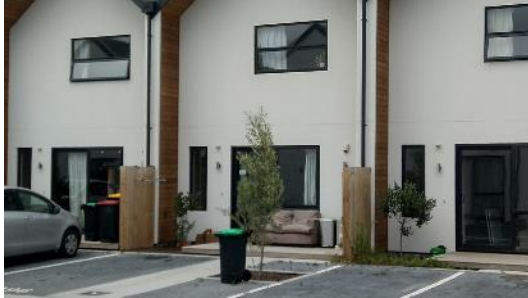
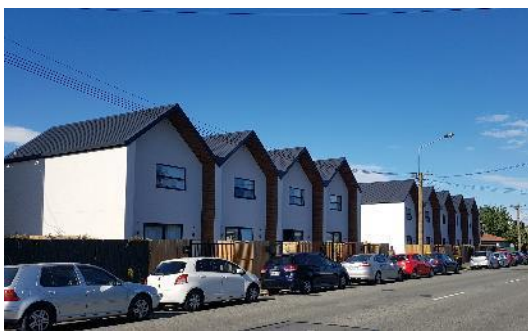
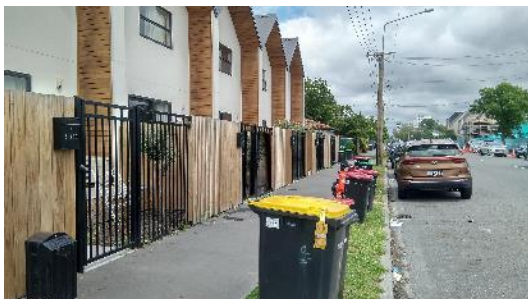
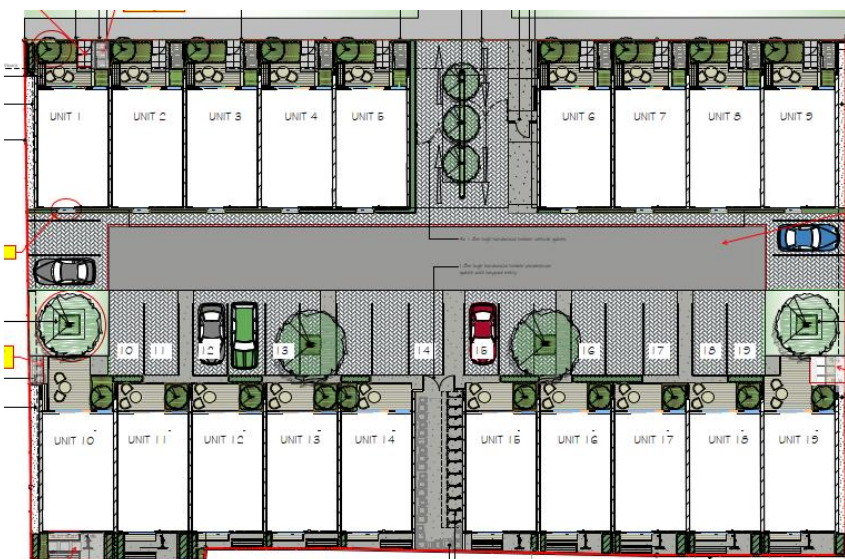
290 Hereford Street

19 3 bedroom units in the central city, in 4 blocks with a central car park. Each has a small outdoor living area at the front facing the street or car park. Some communal space present in the car park corners.

Scoring Summary	
Neighbourhood	2.3
Street	2.6
Site	1.5
Building	2.8
Total	2.3
