**IN THE MATTER**      of the hearing of submissions on Plan Change 14 (Housing  
and Business Choice) to the Christchurch District Plan

**STATEMENT OF PRIMARY EVIDENCE OF GAVIN JOHN STANLEY ON  
BEHALF OF CHRISTCHURCH CITY COUNCIL**

**QUALIFYING MATTER: HERITAGE (HERITAGE SITES)**

**3380/004 R2 – BUDGET REPAIR ESTIMATE – HIN 390 – FORMER DWELLING AND SETTING – 325  
MONTREAL STREET, CHRISTCHURCH**

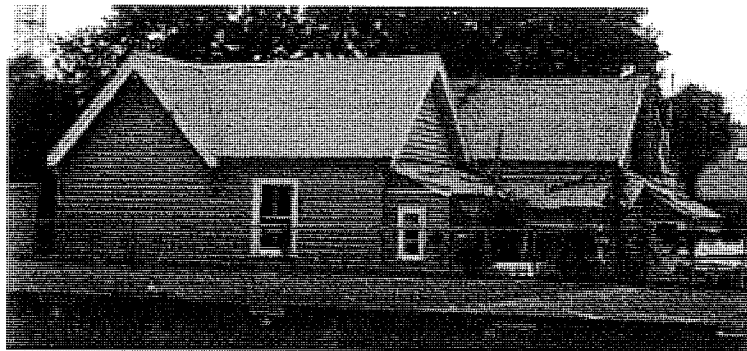
"Cross gable" roof form. Note twin gables at rear.

On the rear face of the transverse gable are twin gables with a central gutter. At the rear of the cottage are a series of lean-to roof forms over the kitchen, bathroom and entry porch. The windows in the cottage generally comprise double hung sashes. The exceptions are casement or louvre windows to the kitchen and bathroom. The front door was a panel type which has since been overlaid with plywood.

The "cross gable" roof which had gables running at right angles to one another was a device commonly found in British cottages. The form was transplanted to the colonies such as New Zealand where it acquired a verandah to exclude the harsh rays of the Southern hemisphere sun. The resulting bay cottages were the forerunner of that New Zealand icon, the bay villa.

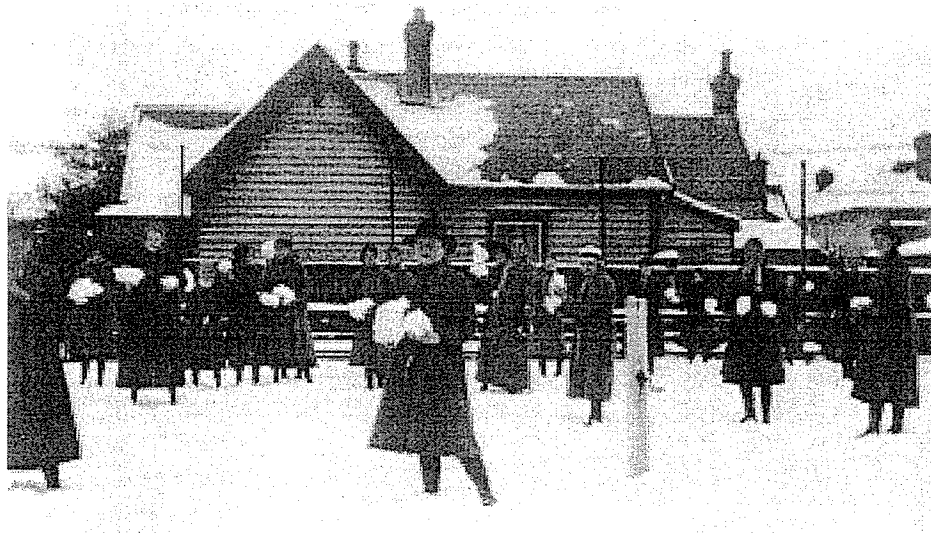
Undated early photograph of the cottage. Note slate roofs, chimneys and bullnose verandah at left of photograph. Note also evidence of earlier colour scheme.

As noted earlier, other changes to the exterior include the removal of the original bull-nose roofed verandah and the front two chimneys. The original roof slate roof was replaced with corrugated steel. The window joinery to the kitchen bathroom and toilet was also changed.

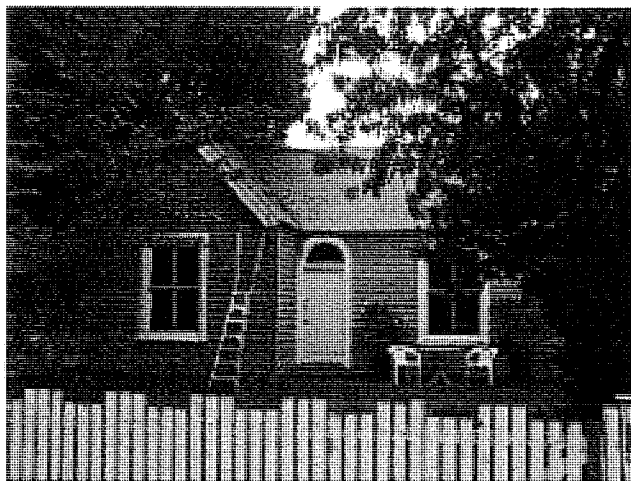
The cottage in its setting. Note mature trees and later picket fence.

<b>Setting</b> The cottage remains on its original site and this contributes to its significance. Changes have occurred with newer buildings continuing to be erected. The mature trees surrounding the cottage contribute to a sense of history and permanence. It has considerable significance.			
<b>Contributing Fabric</b> Mature trees.	HF	Considerable	H,A,S, Sc
<b>Other fabric</b> Picket fences. Corrugated steel fences. Asphalt paving. Concrete terrace.	LF LF LF LF	Not relevant Not relevant Not relevant Intrusive

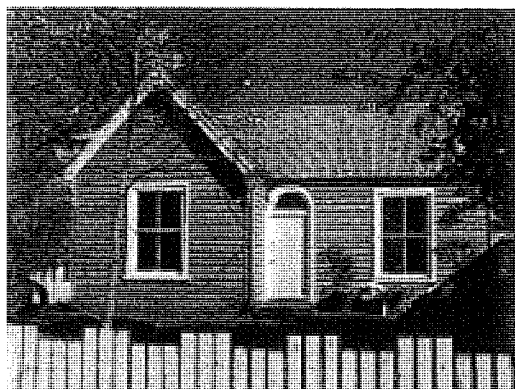
## ELEVATION –NORTHEAST

<b>Description</b>	
Foundation:	Volcanic stone.
Walls:	Weatherboards.
Joinery	Double hung windows, paneled door overlaid.
Trim:	Moulded facings to windows, door. Timber fascias, bargeboards, soffit.
<b>Modifications</b>	
Elevation is generally in its original form although the removal of the verandah detracts from its significance.	
Verandah removed and concrete terrace constructed. Front door overlaid. Corner box at north corner replaced.	
<b>Significance</b>	
Present overall rating – considerable	
Potential rating – considerable	
Considerable	Stone foundation, weatherboards, original trim, double-hung windows, gable brackets.
Some	Front door.
Not relevant	Recent trim.
Intrusive	Overlay to front door, concrete terrace.
<b>Condition</b>	
Foundation	Stone deteriorating.
Weatherboards	Some borer, paint flaking.
Trim:	Decay at bottom of corner box, north side of barge board to gable.
Joinery:	Window to room 2. Paint flaking and putty missing. Sill cracked. Paint flaking from door sill.

<b>Recommendations</b>	
Consider reconstruction of verandah.	
Replace deteriorated foundation stones.	
Replace weatherboards as required.	
Repair joinery and reputty glass.	
Remove overlay to door and repair as required.	
Provide new corner boxes to correct profile.	
Sand and repaint timberwork in heritage colours.

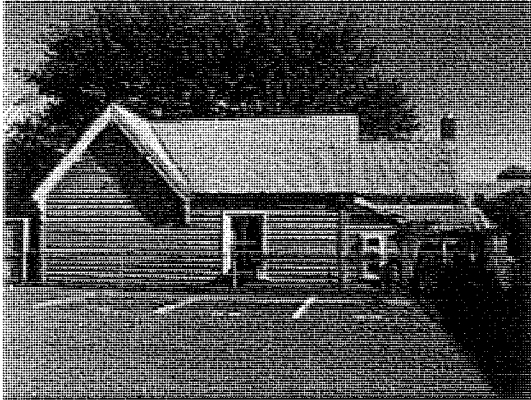
## ELEVATION –NORTHWEST

Description	
Foundation:	Volcanic stone.
Walls:	Weatherboards.
Joinery	Double hung windows. Casement & louvre windows to additions.
Trim:	Moulded facings to windows. Timber fascias, bargeboards, soffit.
Modifications	
The additions at the rear have arisen out of a particular need and can be considered to be part of the fabric of the house.	
Kitchen and bathroom additions to rear.	
Significance	
Present overall rating – some	
Potential rating – some	
Considerable	Stone base, weatherboards, original trim, double-hung windows, gable brackets.
Some	Later additions, casement windows, trim.
Intrusive	Louvre windows to kitchen.
Condition	
Foundation	Stone deteriorating.
Weatherboards	Paint flaking.
Trim:	Paint flaking, possible decay in corner box.
Joinery:	Paint flaking and putty deteriorating.
Recommendations	
Generally retain additions, but consider replacement of kitchen window.	
Replace deteriorated foundation stones.

Repair joinery and reputty glass.	
Sand and repaint timberwork in heritage colours.

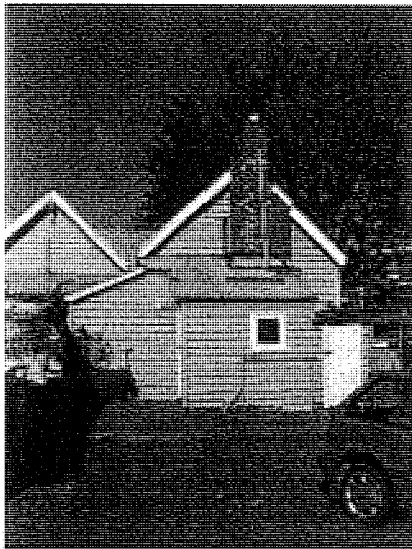
## ELEVATION – SOUTHWEST

Description	
Foundation:	Concrete.
Walls:	Weatherboards.
Joinery	Casement sash, t&g door with glazed panel.
Trim:	Plain facings to joinery. Timber fascias, bargeboards, soffit.
Modifications	
The additions to this elevation add to the vernacular character of the cottage.	
Early addition to south wing. Chimney constructed.	
Kitchen and bathroom additions.	
Services added.	
Significance	
Present overall rating – some	
Potential rating – some	
Considerable	Brick chimney, gable brackets.
Some	Weatherboards, trim, joinery.
Intrusive	Later services.
Condition	
Chimney	Top section rebuilt, other areas repointed.
Weatherboards	Paint flaking.
Trim:	Paint flaking from barge boards, trim.
Recommendations	
Generally retain additions.	
Tidy up previous repairs to chimney.	
Remove intrusive services.	
Sand and repaint timberwork in heritage colours.

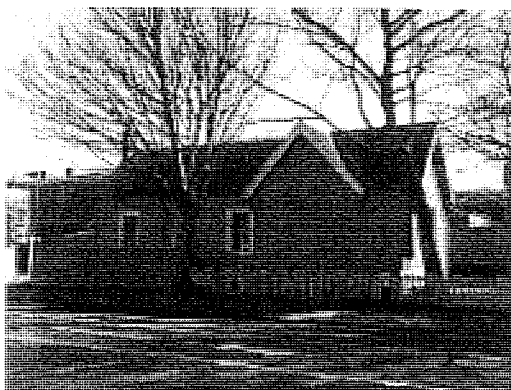
## ELEVATION – SOUTHWEST

Description	
Foundation:	Volcanic stone.
Walls:	Weatherboards.
Joinery	Double hung windows.
Trim:	Moulded facings to windows. Timber fascias, bargeboards, soffit.
Modifications	
Elevation has early and later additions. The additions are in character and do not detract from the house.	
Various additions constructed.	
Window to toilet not original.	
Service pipe added.	
Significance	
Present overall rating – considerable	
Potential rating – considerable	
Considerable	Weatherboards, original trim, double-hung windows, gable brackets.
Some	Various additions, casement window.
Intrusive	Later services.
Condition	
Weatherboards	Some decay in replacement boards, extensive borer.
Joinery:	Paint flaking.
Recommendations	
Generally retain additions.	
Remove later services.	
Sand and repaint timberwork in heritage colours.
