Captain Robert Falcon Scott Statue

Repair Project Update

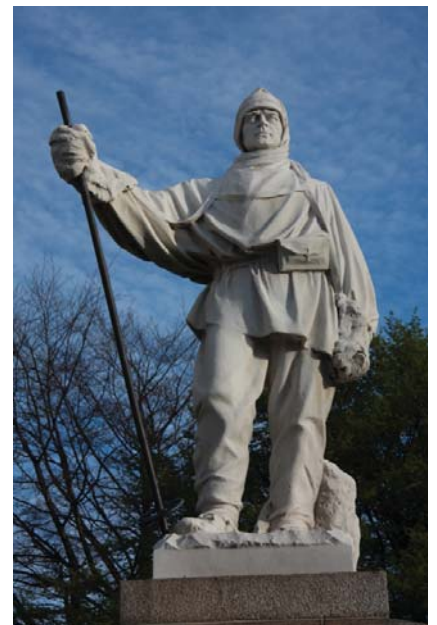
The replica leg was rocked back and forth on its base under an incrementally increasing loading. The design target was to withstand a 1.5-tonne load and this was achieved with only minor cracking in the structure.

That load correlates to a 1 in 1000-year earthquake event, and with the added protection of base isolation in the plinth, the engineers say cracking would not occur and the statue will be able to withstand a 1 in 2500-year earthquake event.

Engineers check the replica leg for cracking during the load testing process.
