Christchurch Fish Barriers Update

September 2022

Prepared for:
Christchurch City Council

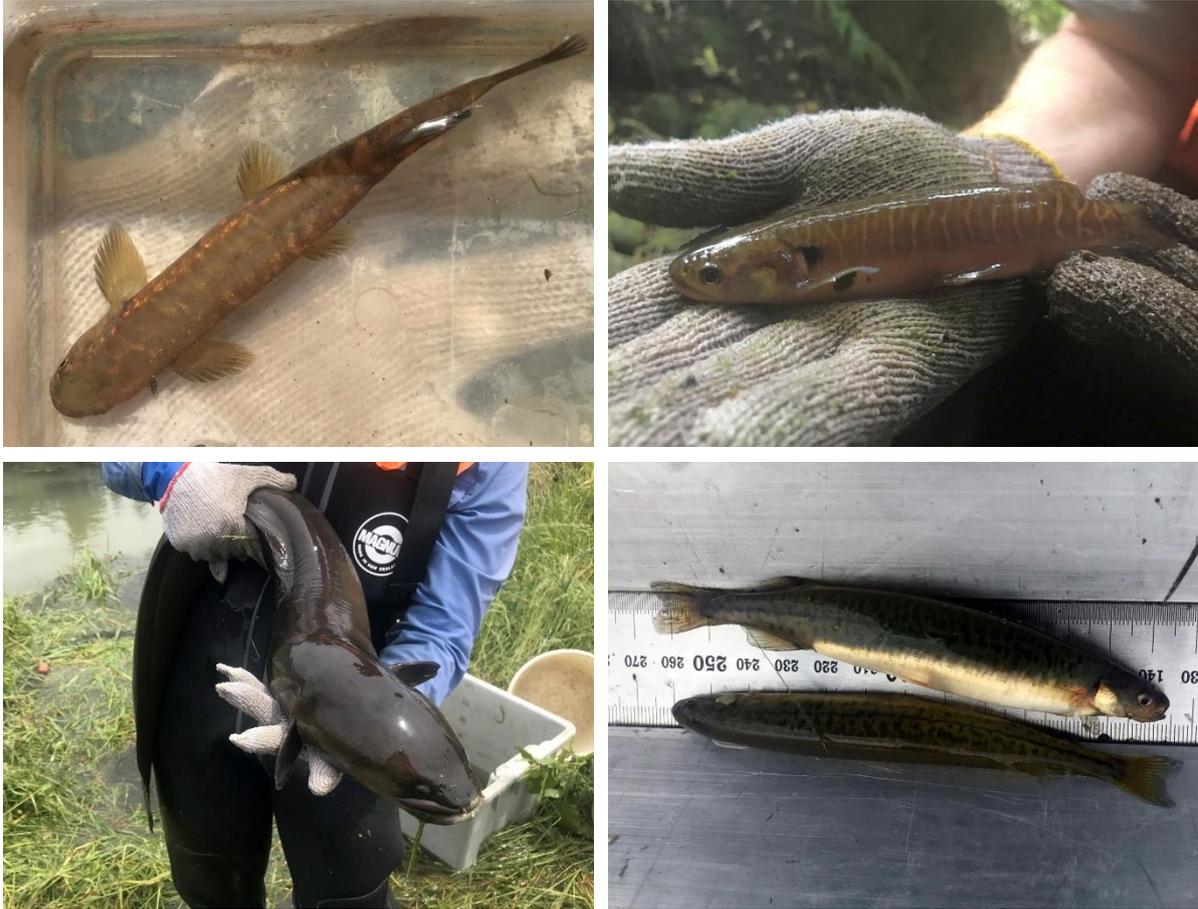
Figure 3: Examples of some of the fish species caught during the surveys. Clockwise, beginning in the top left, they include: a kōaro from Okuti River Branch No. 9, a banded kōkopu from Stream Reserve Drain, two inanga from Miln Drain, and a longfin eel, also from Miln Drain.

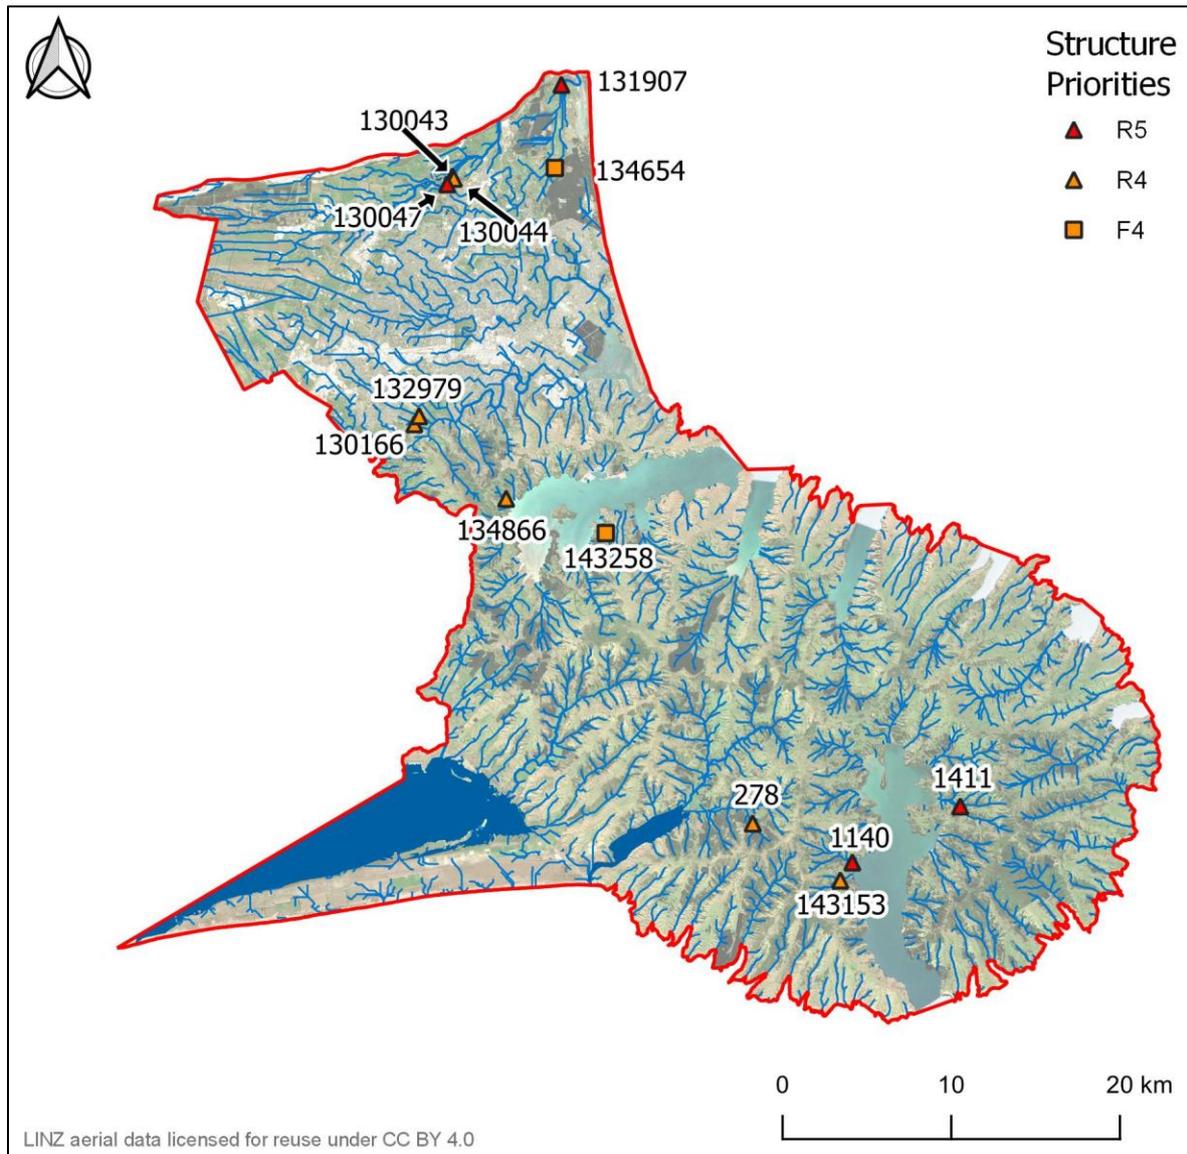
Figure 5: The location of CCC owned structures that are a high priority for remediation (R5 and R4) or fish surveys (F4). Structures labelled with their FPAT ID numbers.

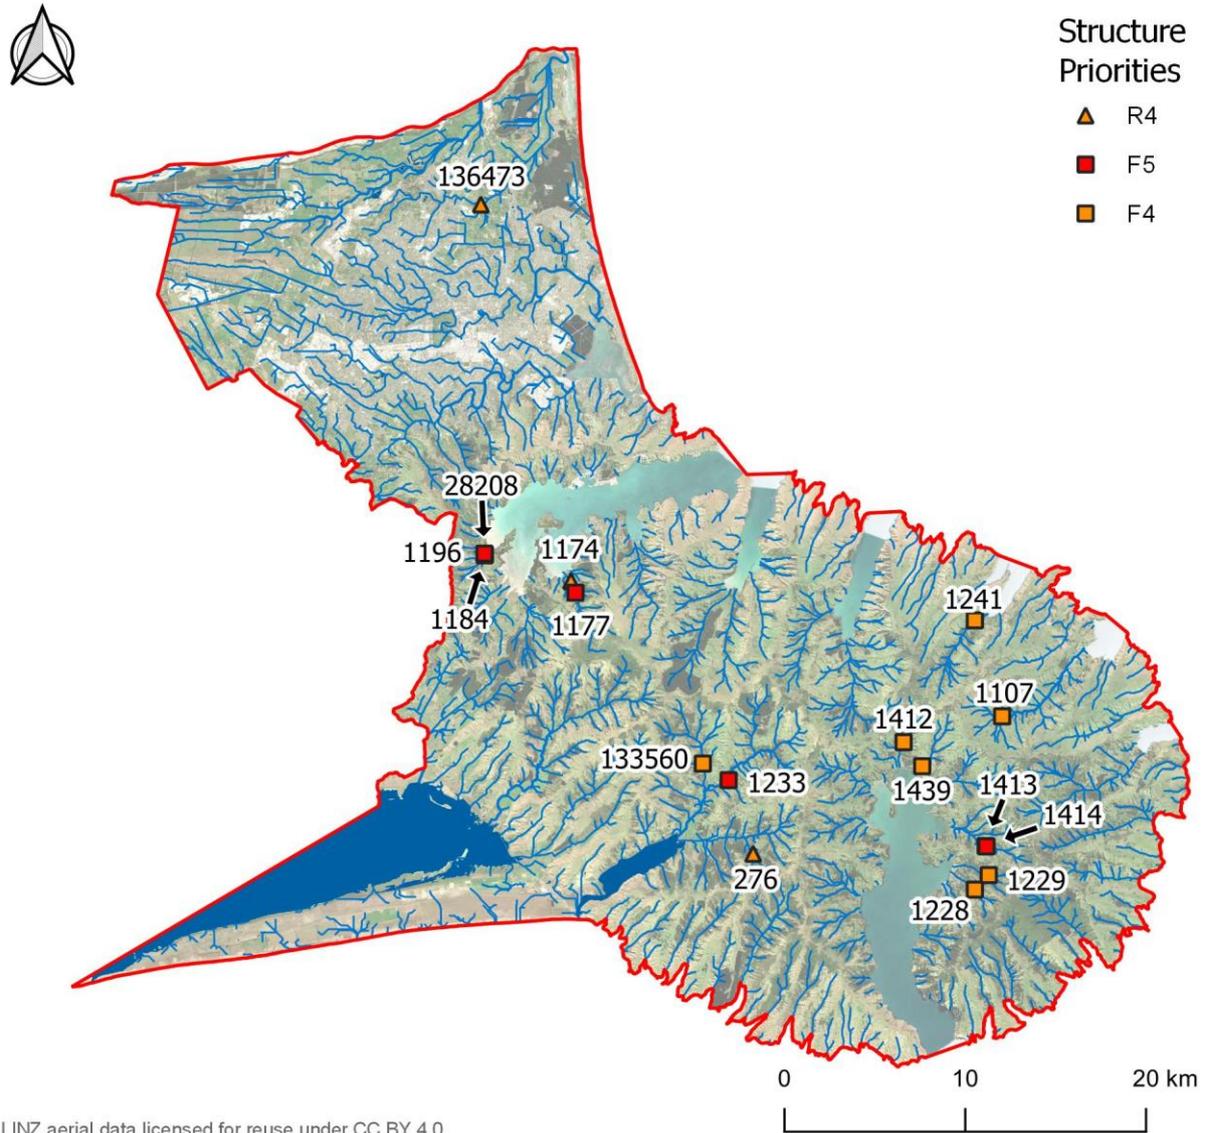
Figure 1: Location of high remediation and fishing priority structures that were not identified as CCC assets. Note that all these structures are of unknown ownership, except for structures with the FPAT ID's 136473 and 1233, which are under private and NZTA ownership, respectively.
