REPORT TO CANTERBURY EARTHQUAKE RECOVERY AUTHORITY

Argent Building
82 Peterborough Street, Christchurch

Detailed Engineering Evaluation and Initial Evaluation Procedure Assessment

Project Argent Building, 82 Peterborough Street

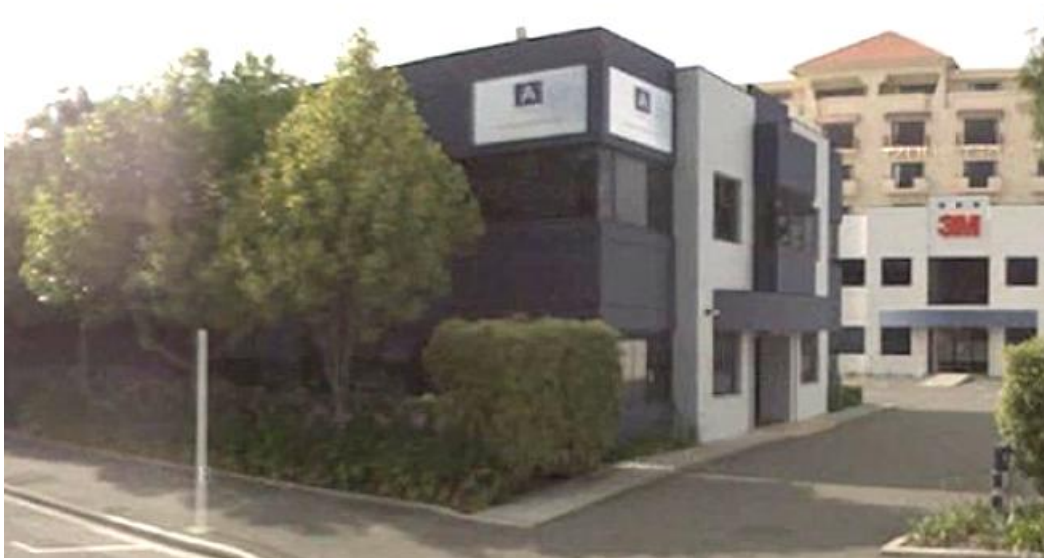
Figure 1: The Argent Building, 82 Peterborough Street

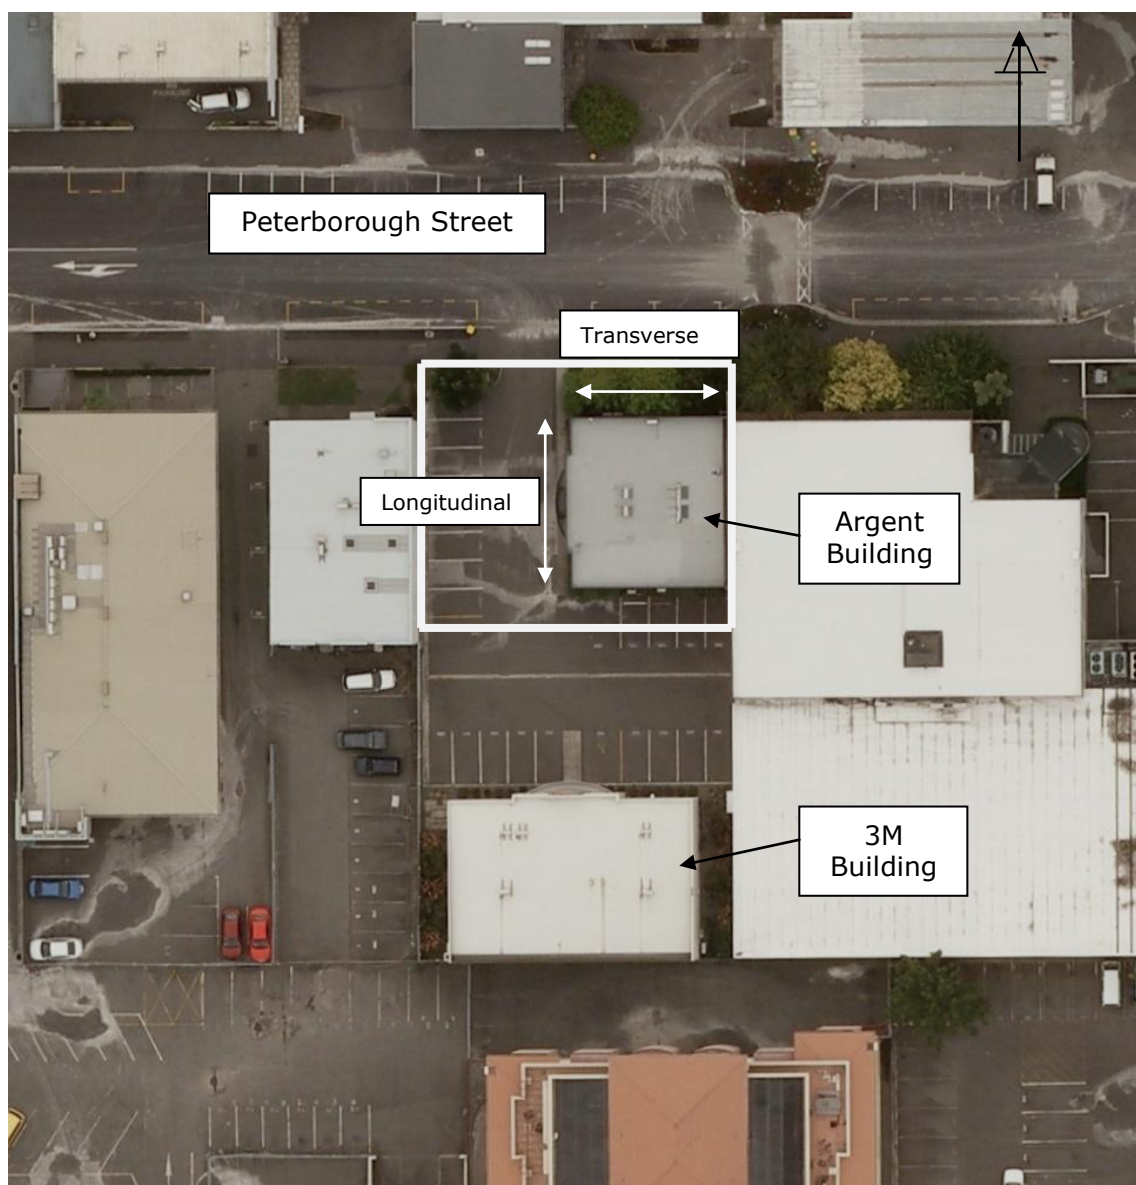
Figure 2: Christchurch Post-earthquake Aerial Photo (24 February 2011) showing site.

Some minor liquefaction was observed – water, sand and fine silts were ejected in the carpark and roadway adjacent to the building, indicating liquefaction of the underlying soils.

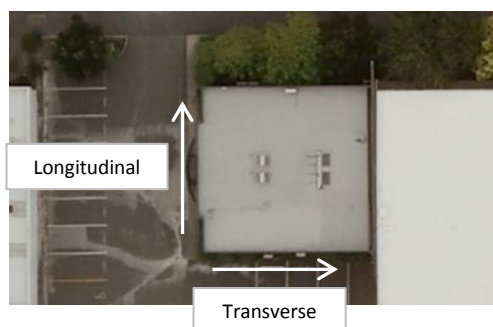
1.1 Photos (attach sufficient to describe building)

Built c1999, Two storey office building, lateral load resisting systems RC panel walls supporting either the light metal roof or the HIBOND concrete floor slabs, ductility $\mu = 1.25$
