Our Ref: 1587

12 September 2011

Re: Avebury Park Residence – POST-EARTHQUAKE INSPECTION

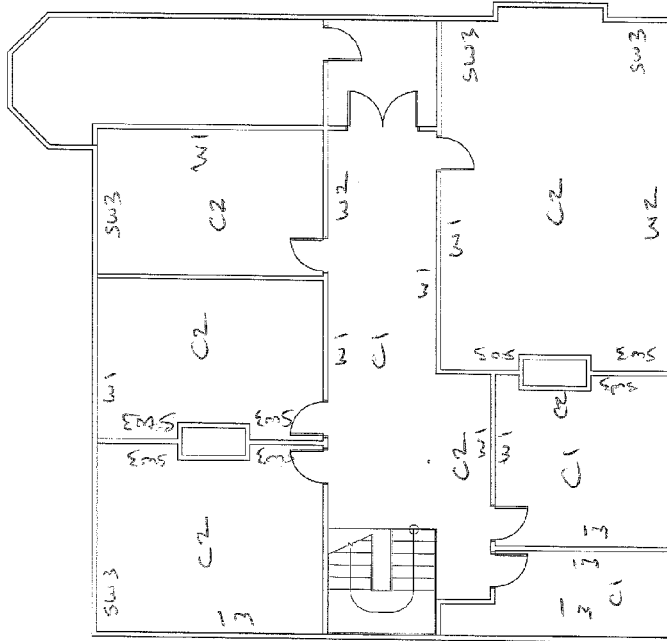
AVEBURY HOUSE GROUND FLOOR
11:00 at A3

See report for damage level.

- C1 ceiling cracks
- C2 major cracking in ceiling
- W1 walls cracking
- W2 major wall cracking
- SW3 replace lining or re-plaster lining

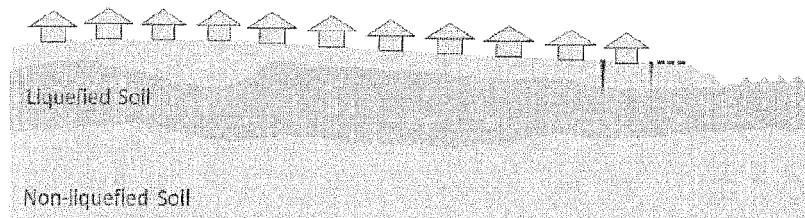
Figure B5. Schematic section of land damage in the suburb of Avonside (west to east)

Figure B5 illustrates the type and extent of land damage that was observed in Avonside. In this sketch, buildings/ properties where land damage has been observed are coloured yellow. Roads are illustrated by the dashed line.

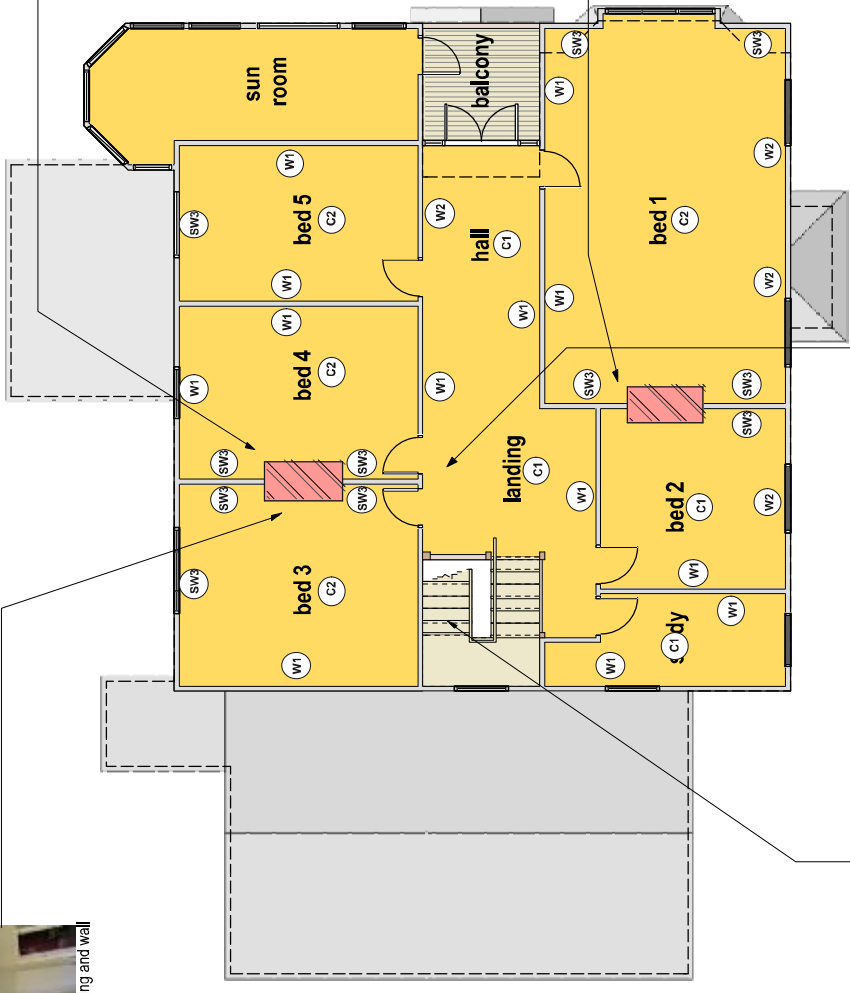
damage to walls in hallway

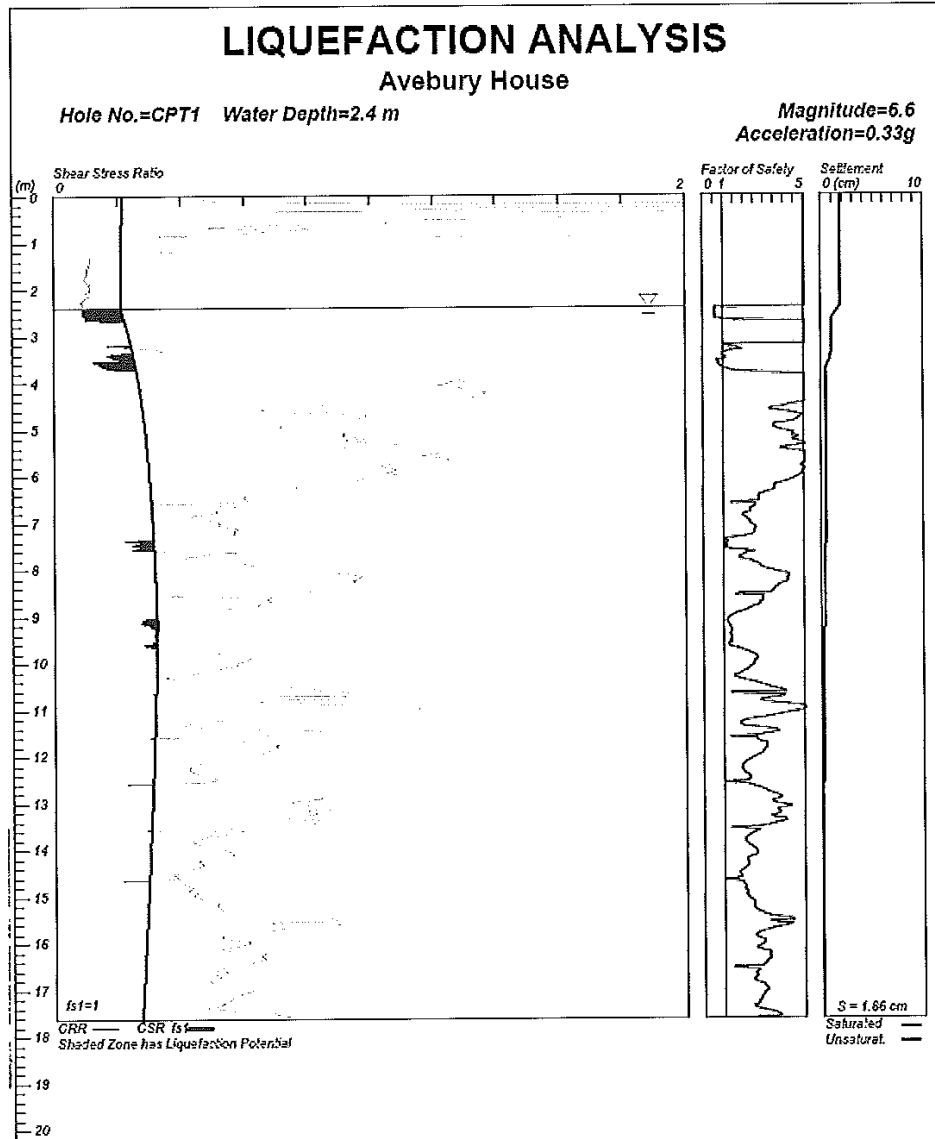
Figure 5: Layers of liquefaction potential in CPT1 for ULS seismic loads.

The analyses show that the saturated sandy silt layers within the 3.8m of alluvium beneath the building are likely to be prone to liquefaction during an ULS seismic event (see Figure 5).

Despite this, the dense sand from 3.8m to 6.4m depth is unlikely to have liquefied and is therefore expected to be a suitable bearing layer.
