Biddick Courts BE 0707 EQ2

**Detailed Engineering Evaluation
Quantitative Assessment Report**

**14 Claydon Place, Dallington
Christchurch**

Date: August 2015
Reference: 6-QUCC1.98
Status: Final – R1

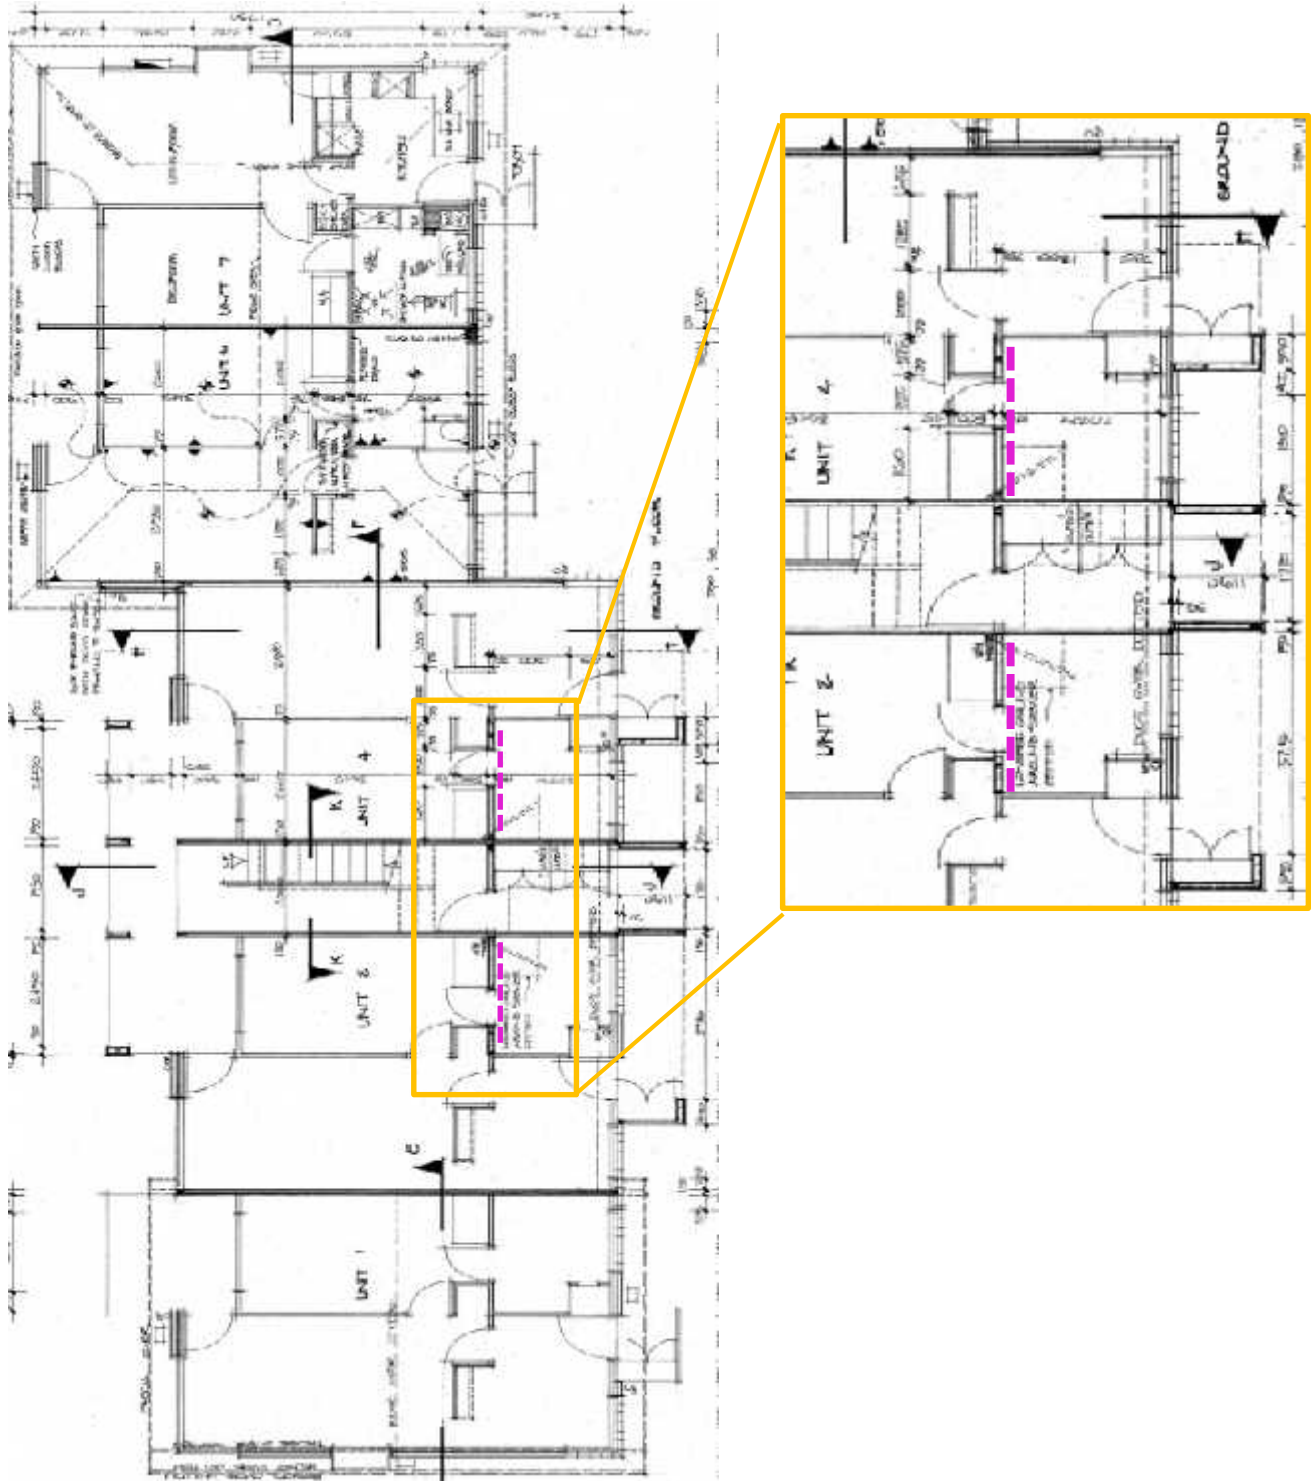
Block A – Ground Floor Plan

----- - location of strengthening between first floor slab and wall panel. Angles are to be located above the ceiling in the bathroom.

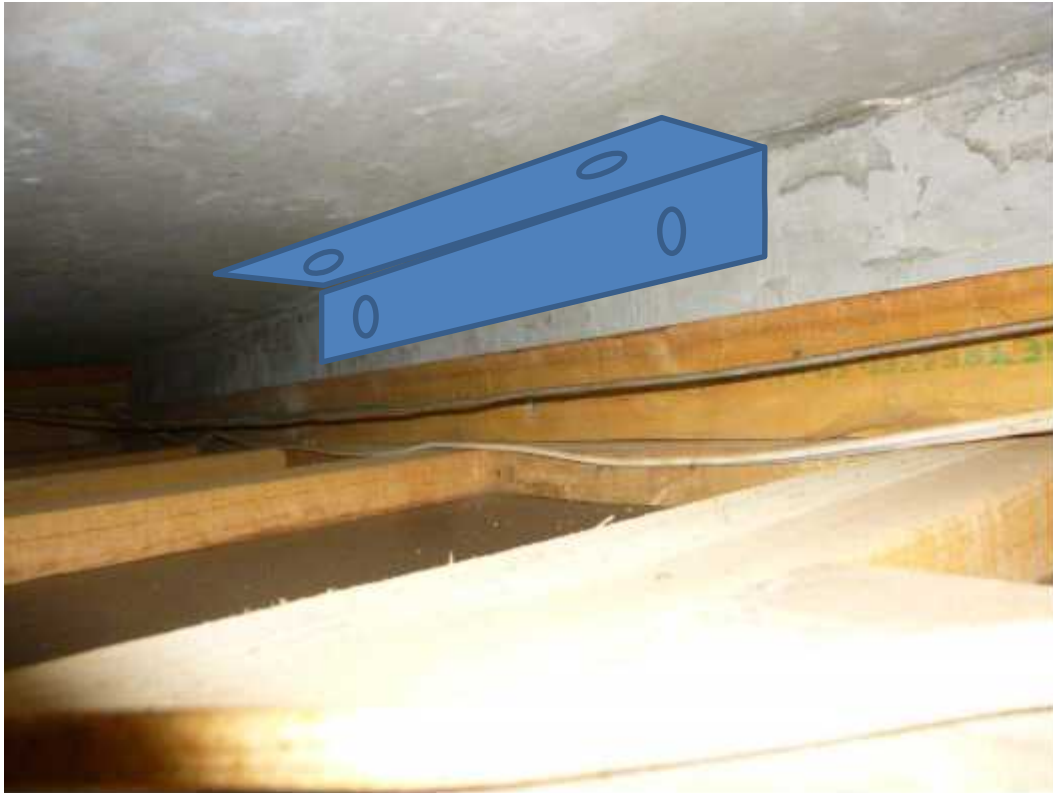
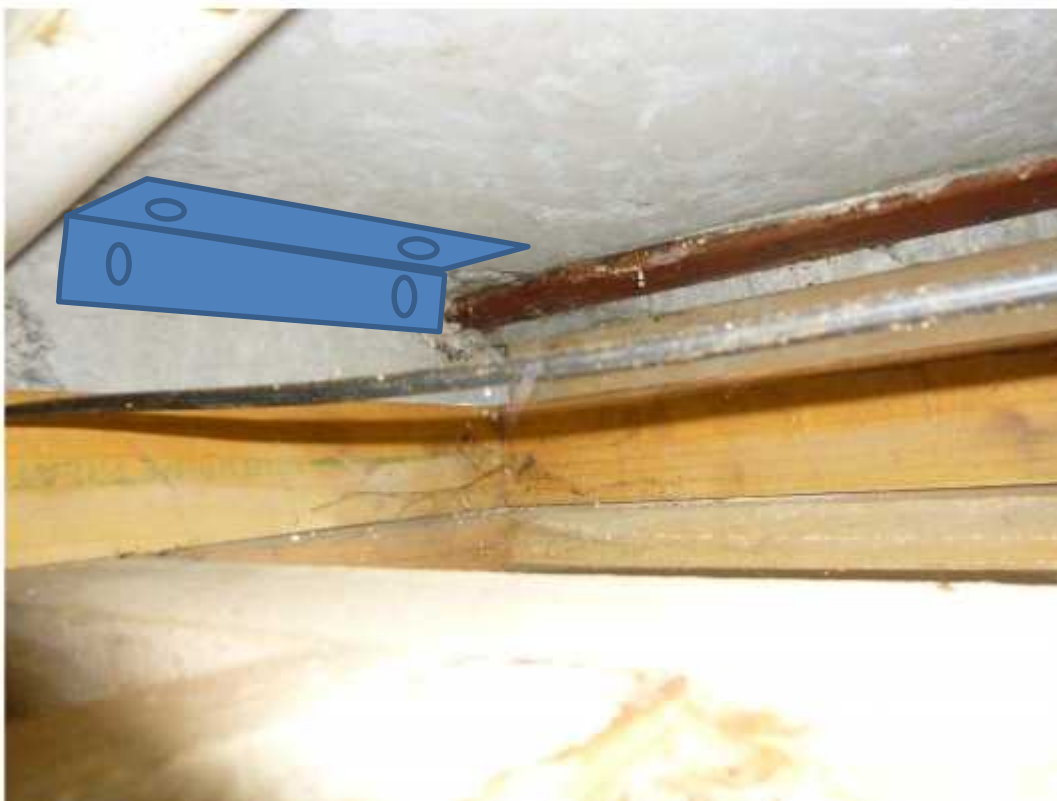
Indicative location of angles above bathroom ceiling.
