Bishopdale Community Crèche

Detailed Engineering Evaluation

Quantitative Assessment Report

Date: 30 March 2012

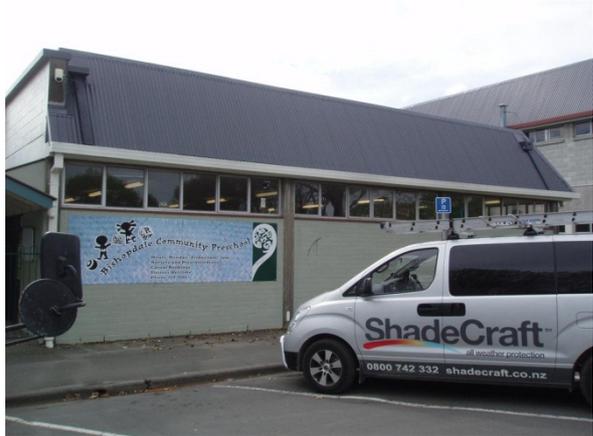
Bishopdale Community Crèche		
No.	Item description	Photo
1.	General view of the crèche from the west

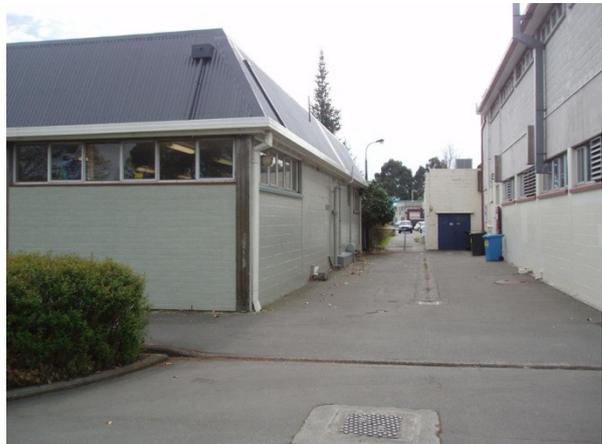
A photograph showing the south west facade of the crèche. The building features a grey corrugated metal roof and a light-colored brick wall. A large, rounded bush is in the foreground.
3.	SE Elevation and service corridor
