Christchurch City Council  
PRK\_3035\_BLDG\_002  
Greenwood Park Shed  
450 Summit Road

QUANTITATIVE REPORT  
FINAL

- Rev B
- 25 September 2013

QUANTITATIVE ASSESSMENT REPORT

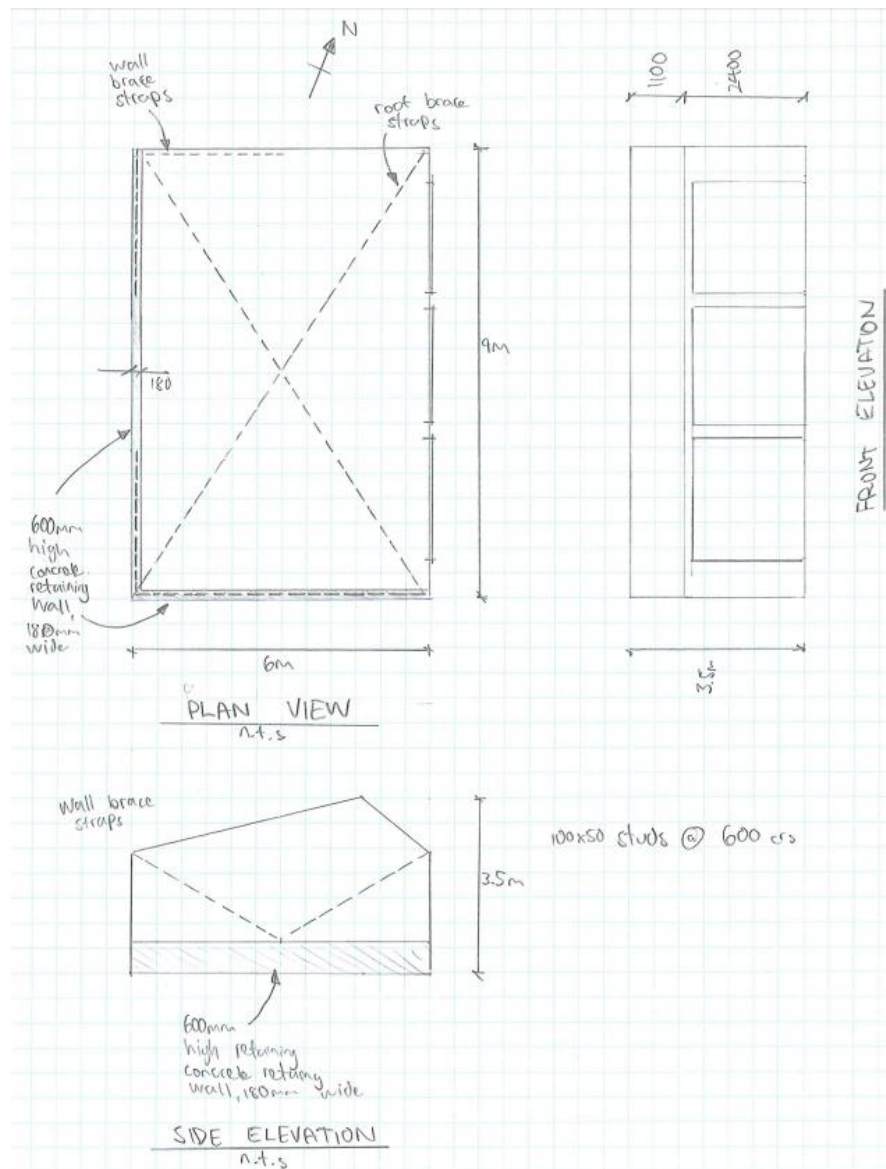
**Figure 3: Sketch of plan view of Wool Shed from site measurements**

The building is a single storey timber framed three bay garage building. The buildings foot print is 9m x 6m. The roof and the walls of the building are clad in corrugated metal. The building sits on a slab on grade foundation, and has low lying retaining walls on the south and west ends of the building.
